Subject: Hotchkiss Fed 12-89 #18-22D - 2025 Soil Sampling

Thank you for the opportunity to support Gunnison Energy with their 2025 plug and abandonment soil sampling in Delta and Gunnison County, Colorado. This report outlines the results and data from in field soil sampling.

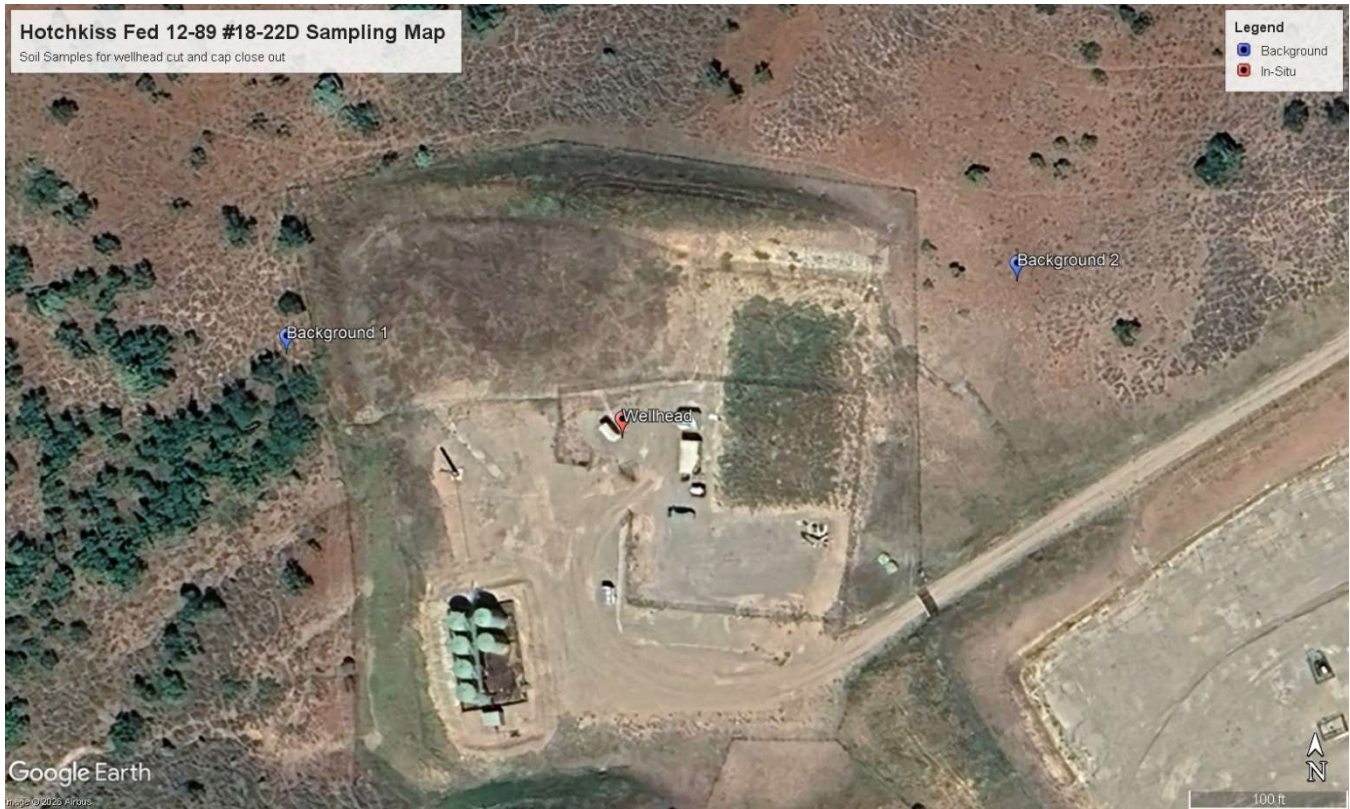
Sample Maps:

In-Situ wellhead sample was taken from the side wall of the excavated cellar prior to cut and cap. The sample was collected at the location and depth where the flowline and wellhead would have connected. The remaining side wall inspection indicated no other signs of impact.

Background sample 1 was taken at a depth of 8" below ground level, to be used as a shallow comparison. Background sample 2 was taken at 36" below ground level, to be used as deep comparison for wellhead in-situ.

TAQ Sample Name	Origins Sample Name	Lat	Long
Hotchkiss Fed 12-89 #18-22D Wellhead	HORH FED WH	39.017607	-107.379804
Hotchkiss Fed 12-89 #18-22D Background 1	HORH FED BG1	39.017751	-107.380548
Hotchkiss Fed 12-89 #18-22D Background 2	HORH FED BG1	39.017874	-104.378928
