Final Reclamation and Stormwater Inspection

Location ID: 328631

Well Name: GORDON RED V #10-15

Inspection Document #: 718601338

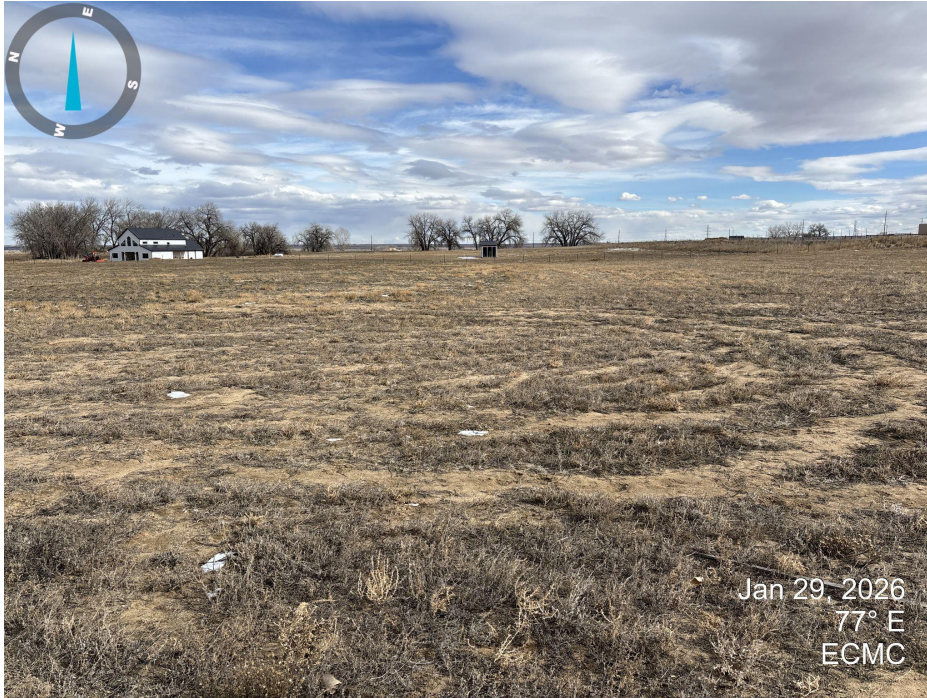
Photo 1. Looking east down the former access road from the well location. There appears to be limited desirable vegetation on the access road.

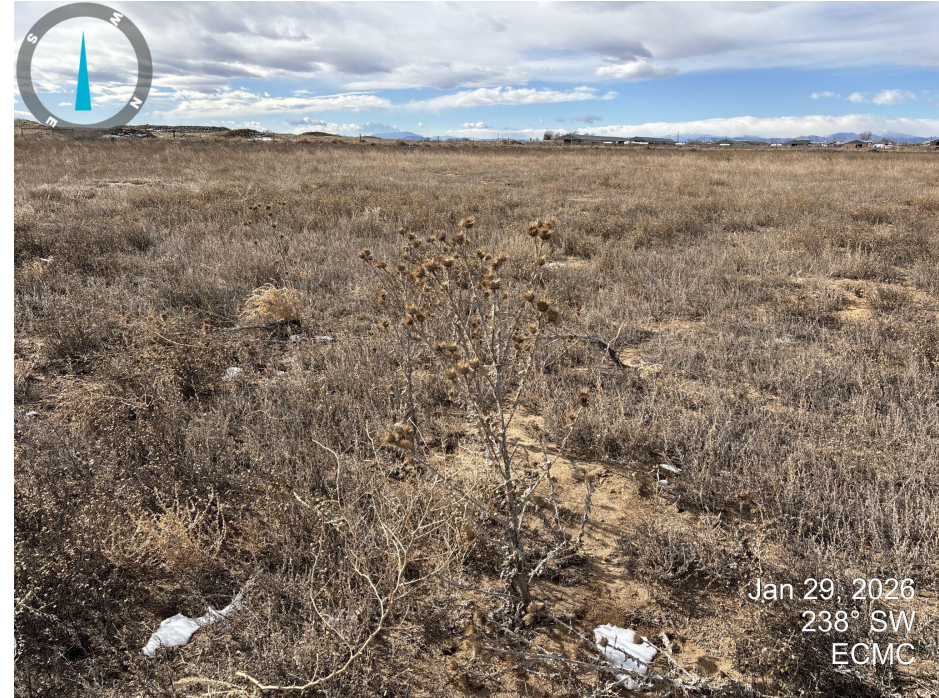
Photo 2. Looking west across the well location from the east side. List B noxious weed scotch thistle is present throughout the location. Scotch thistle rosettes were observed throughout the location.

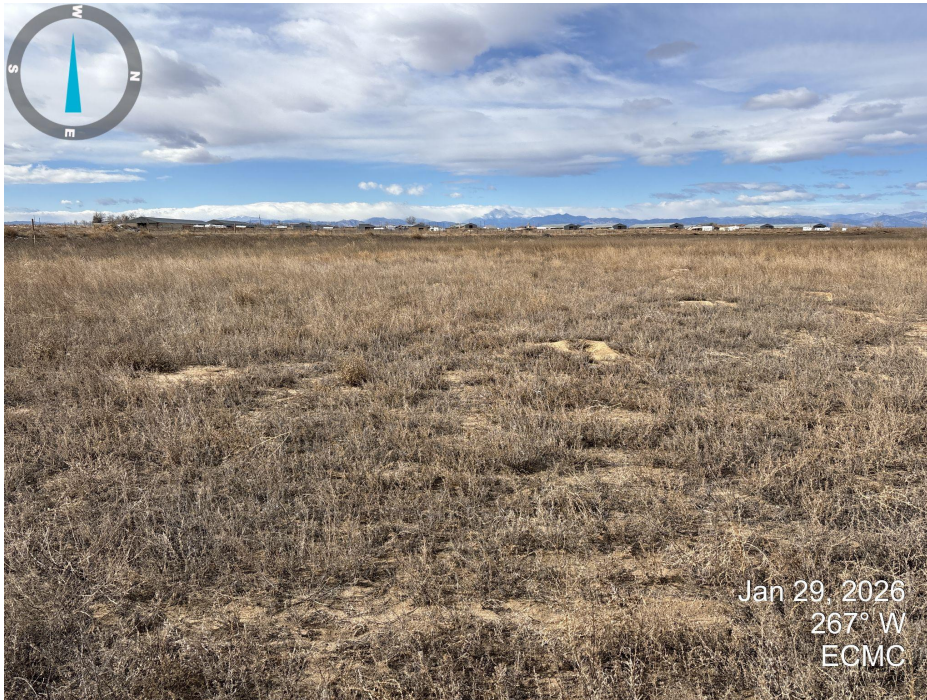
Photo 3. Looking west from the wellbore area. The vegetation on the location consists primarily of undesirable weeds such as kochia and russian thistle. A limited amount of native forbs may be present on the location. The location is not reflective of the surrounding reference area.

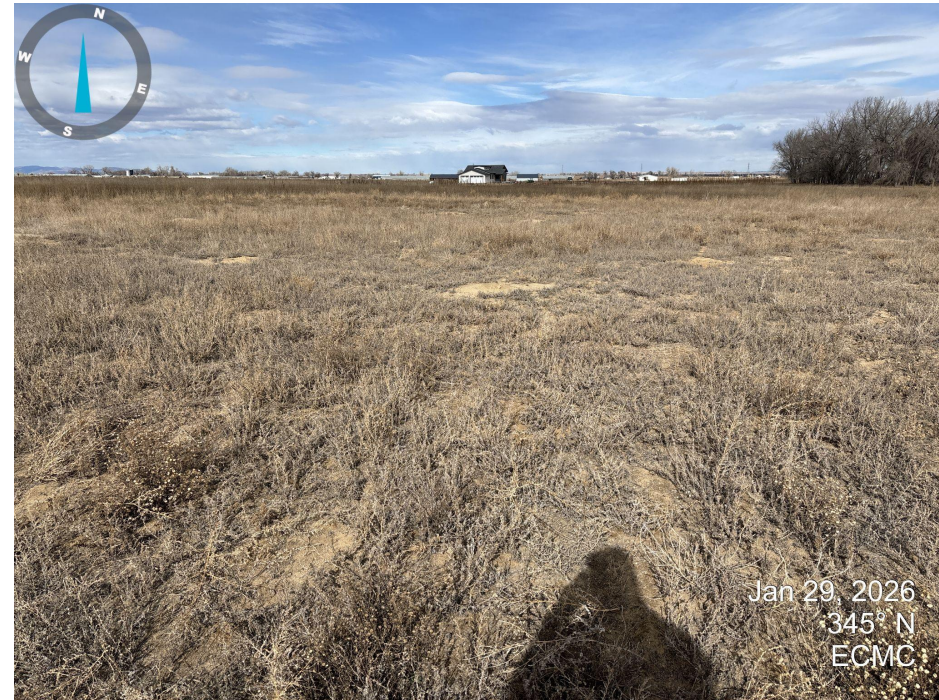
Photo 4. Looking north from the wellbore. See photo 3 comments.

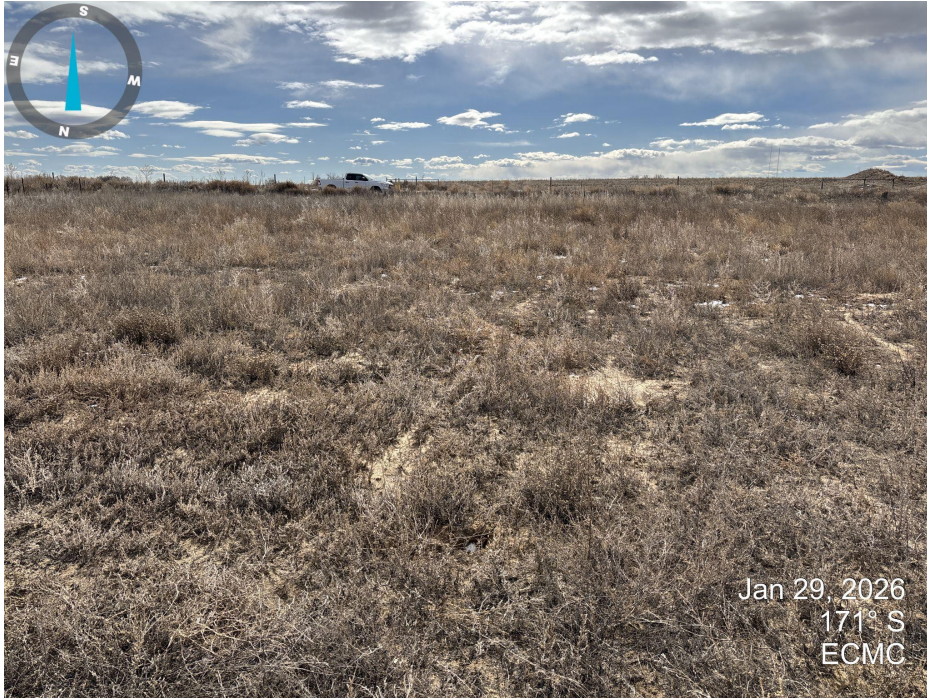
Photo 5. Looking south from the wellbore. See photo 3 comments.

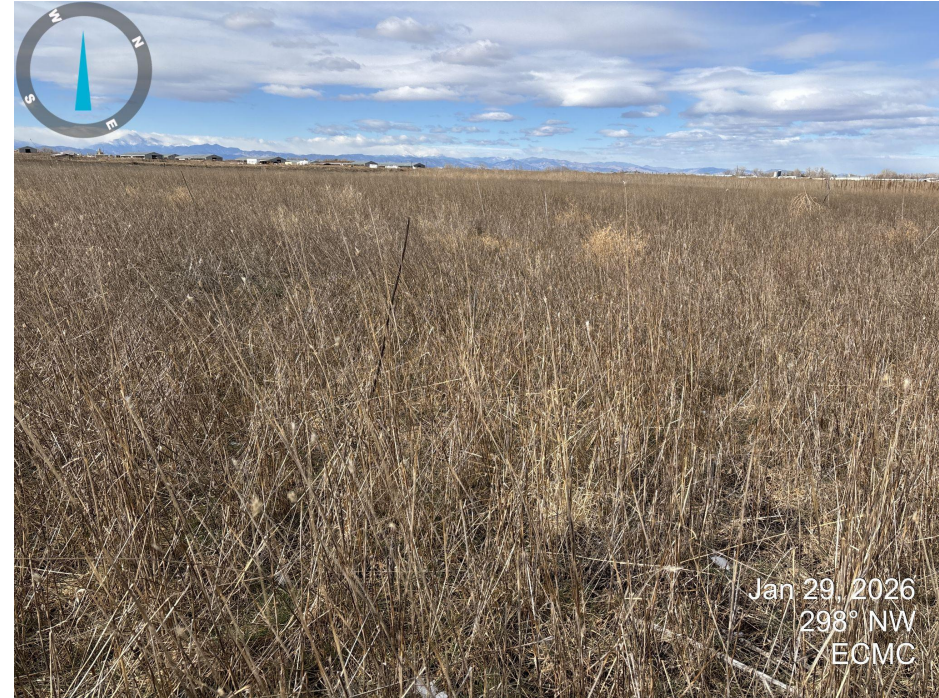
Photo 6. Reference vegetation to the north of the well location. The reference area surrounding the well location consists primarily of cereal rye which may be considered an undesirable weed. Russian thistle and kochia are also present in the reference area.
