# INSPECTION PHOTOS

**Well: GOLDEN EAGLE 33-07**

**API #: 05-071-09513**

**INSPECTION DOC #: 716301946**

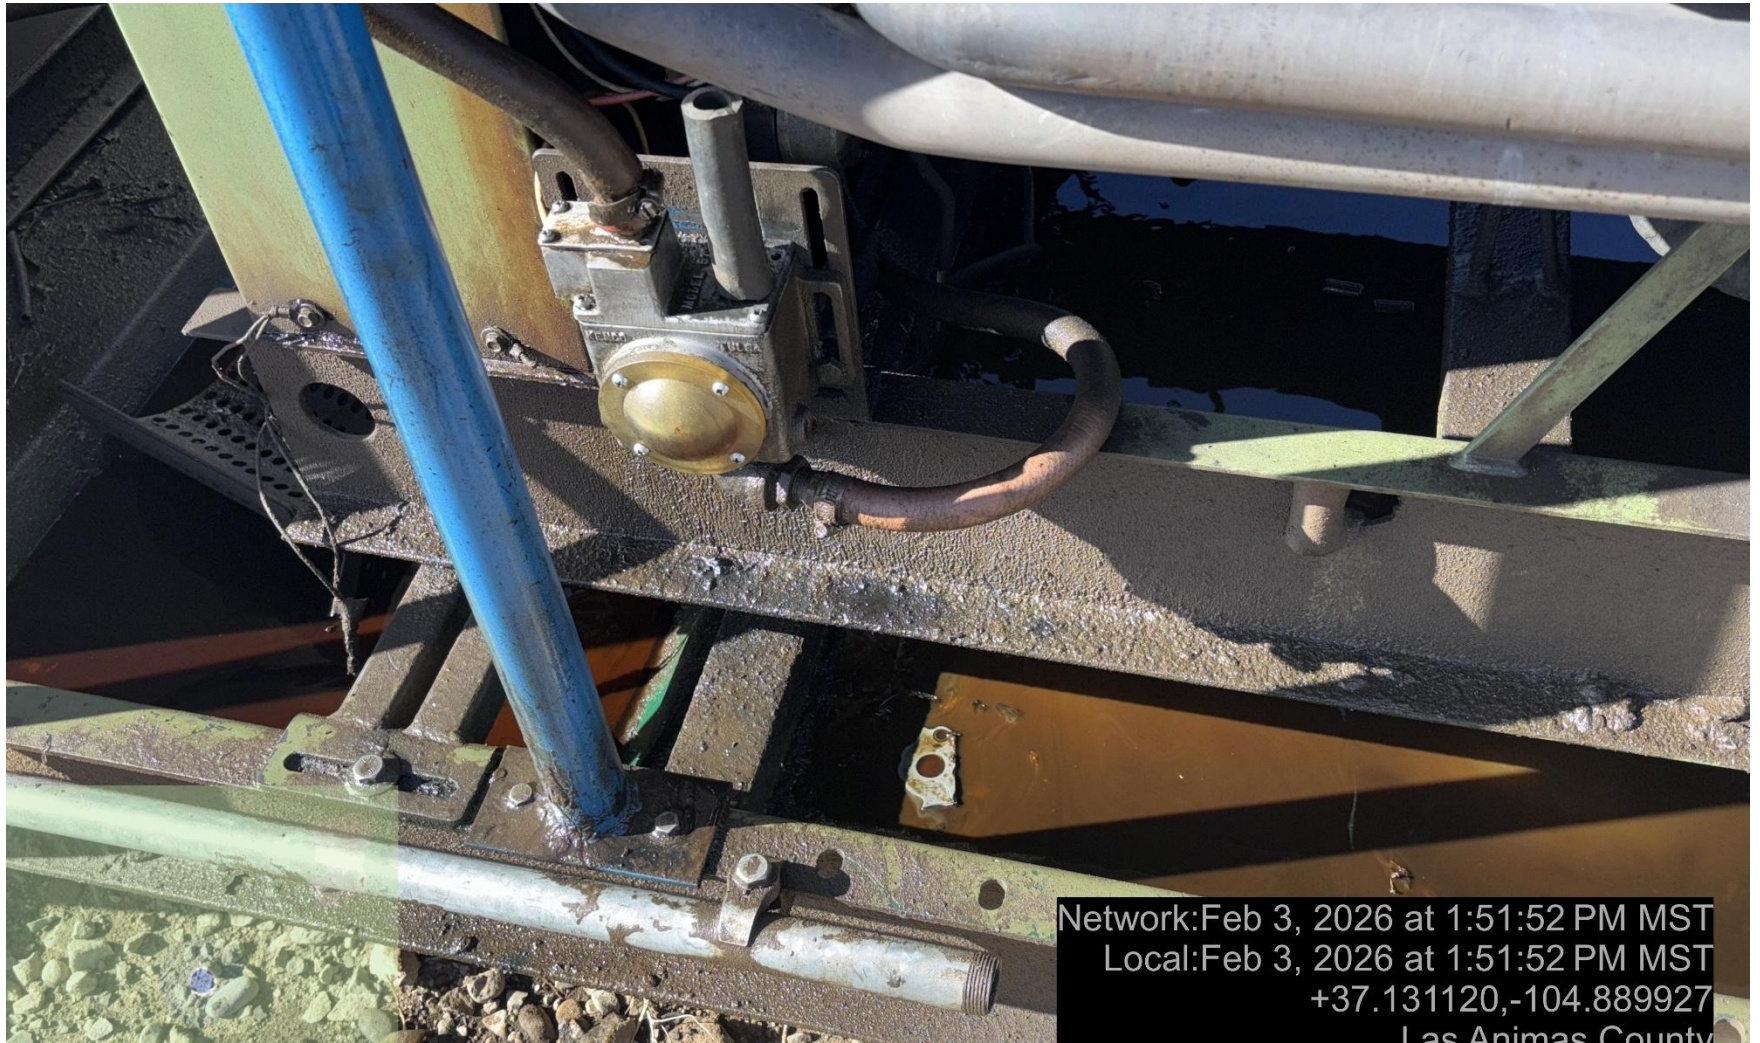
**PHOTO 5: AREA OF IMPACTED SOIL AROUND WELLHEAD BOTH OILY STAINING AND WHITE CHALKY MINERAL BUILDUP FROM REPEATED WELL PACKING LEAKING. Conduct maintenance on equipment, cleanup stained material and review self inspection processes. COMPLY WITH RULE 1002,.(2).D. CA DATE 2-10-2026.**
