# Inspection Photos

Operator: QB Energy Operating LLC #10844

Location ID: 323979

Inspection Doc: 719200794

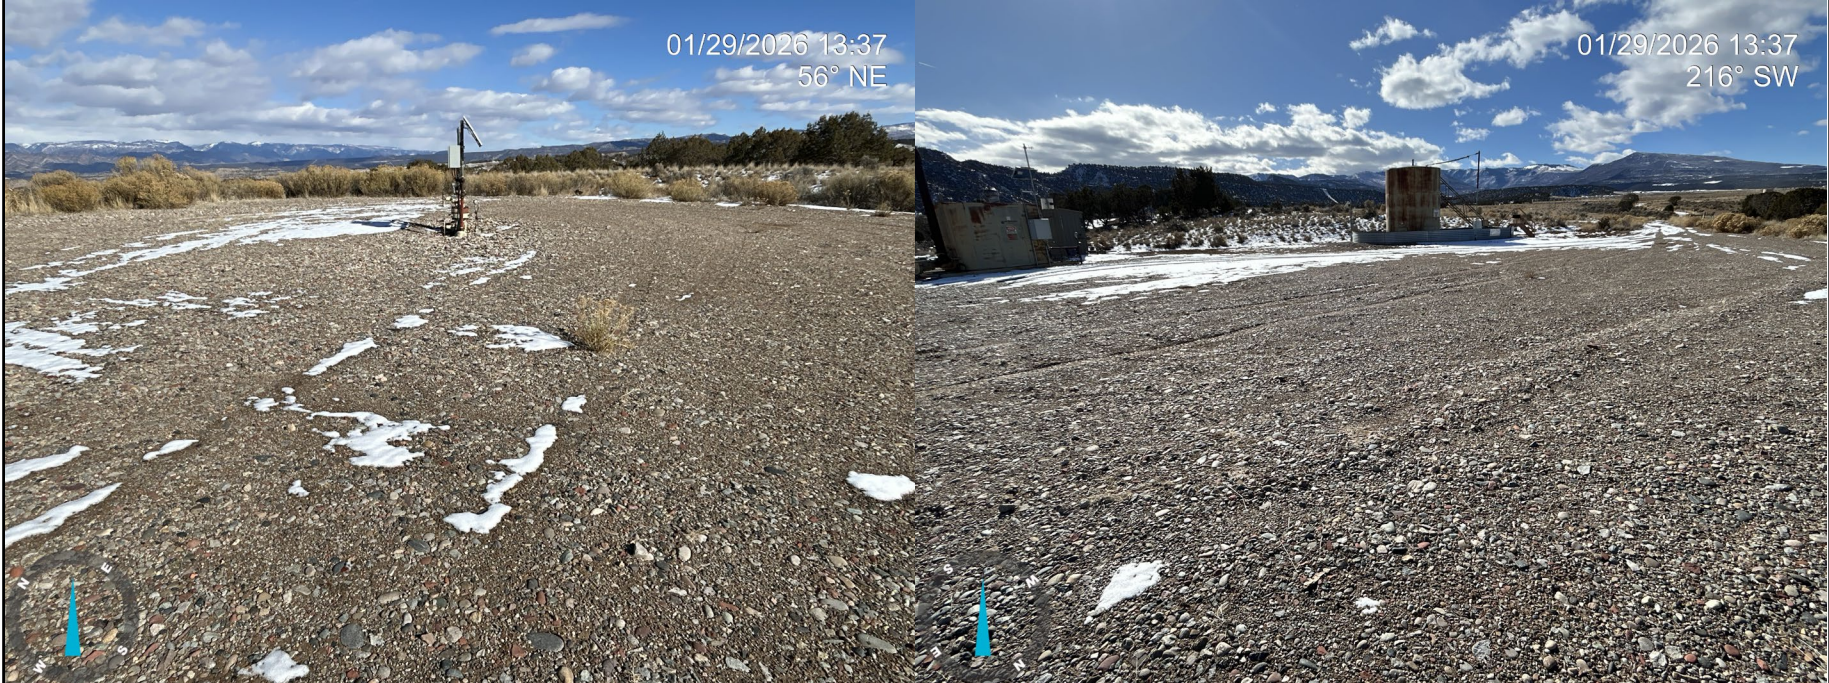
**Photo 1:** Photos showing an overview of the location looking northeast and southwest, respectively.

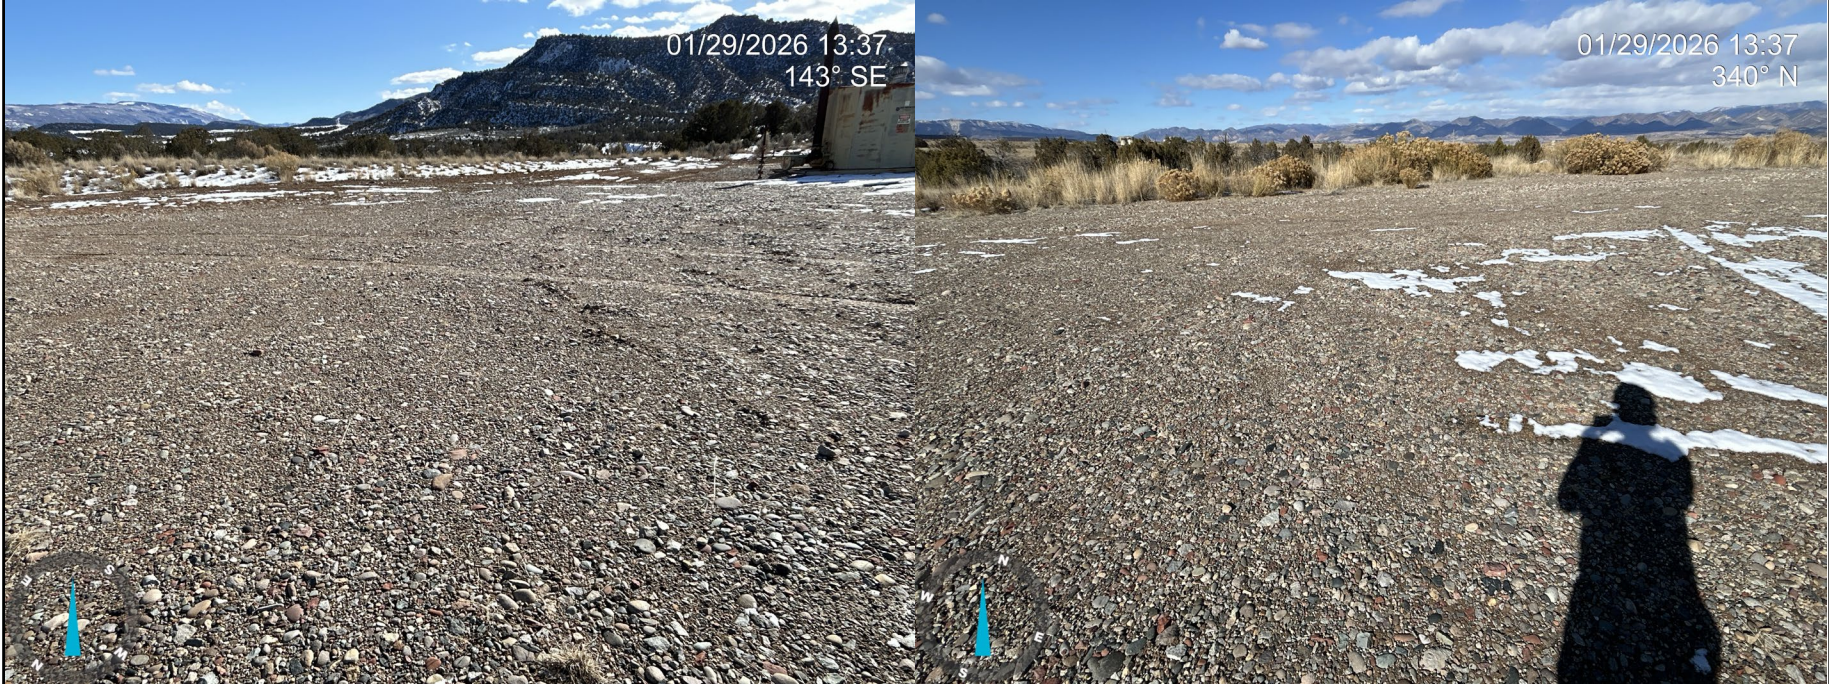
**Photo 2:** Photos showing an overview of the location looking southeast and north, respectively.

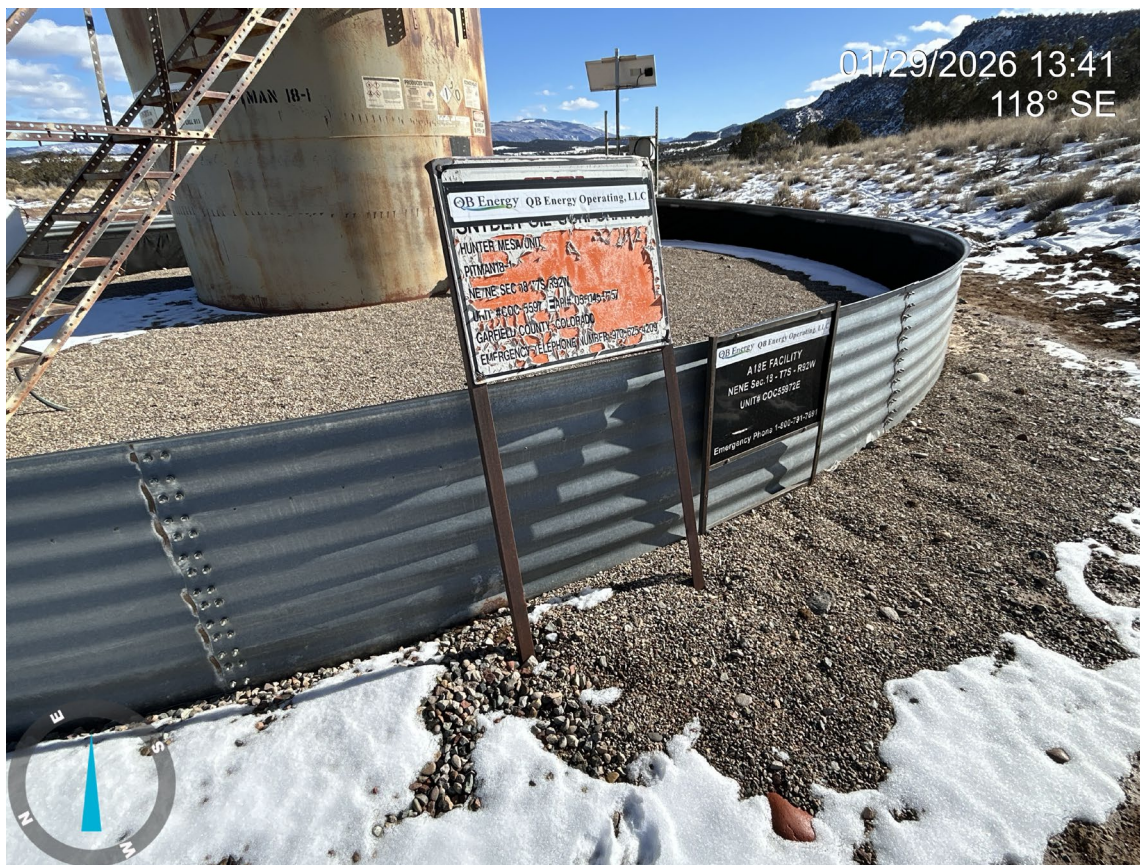
**Photo 3:** Photo showing signage that is peeled/illegible and appears to be trash/debris. Removal is required; comply with Rule 606.d.
