# Inspection Photos

February 3rd, 2026

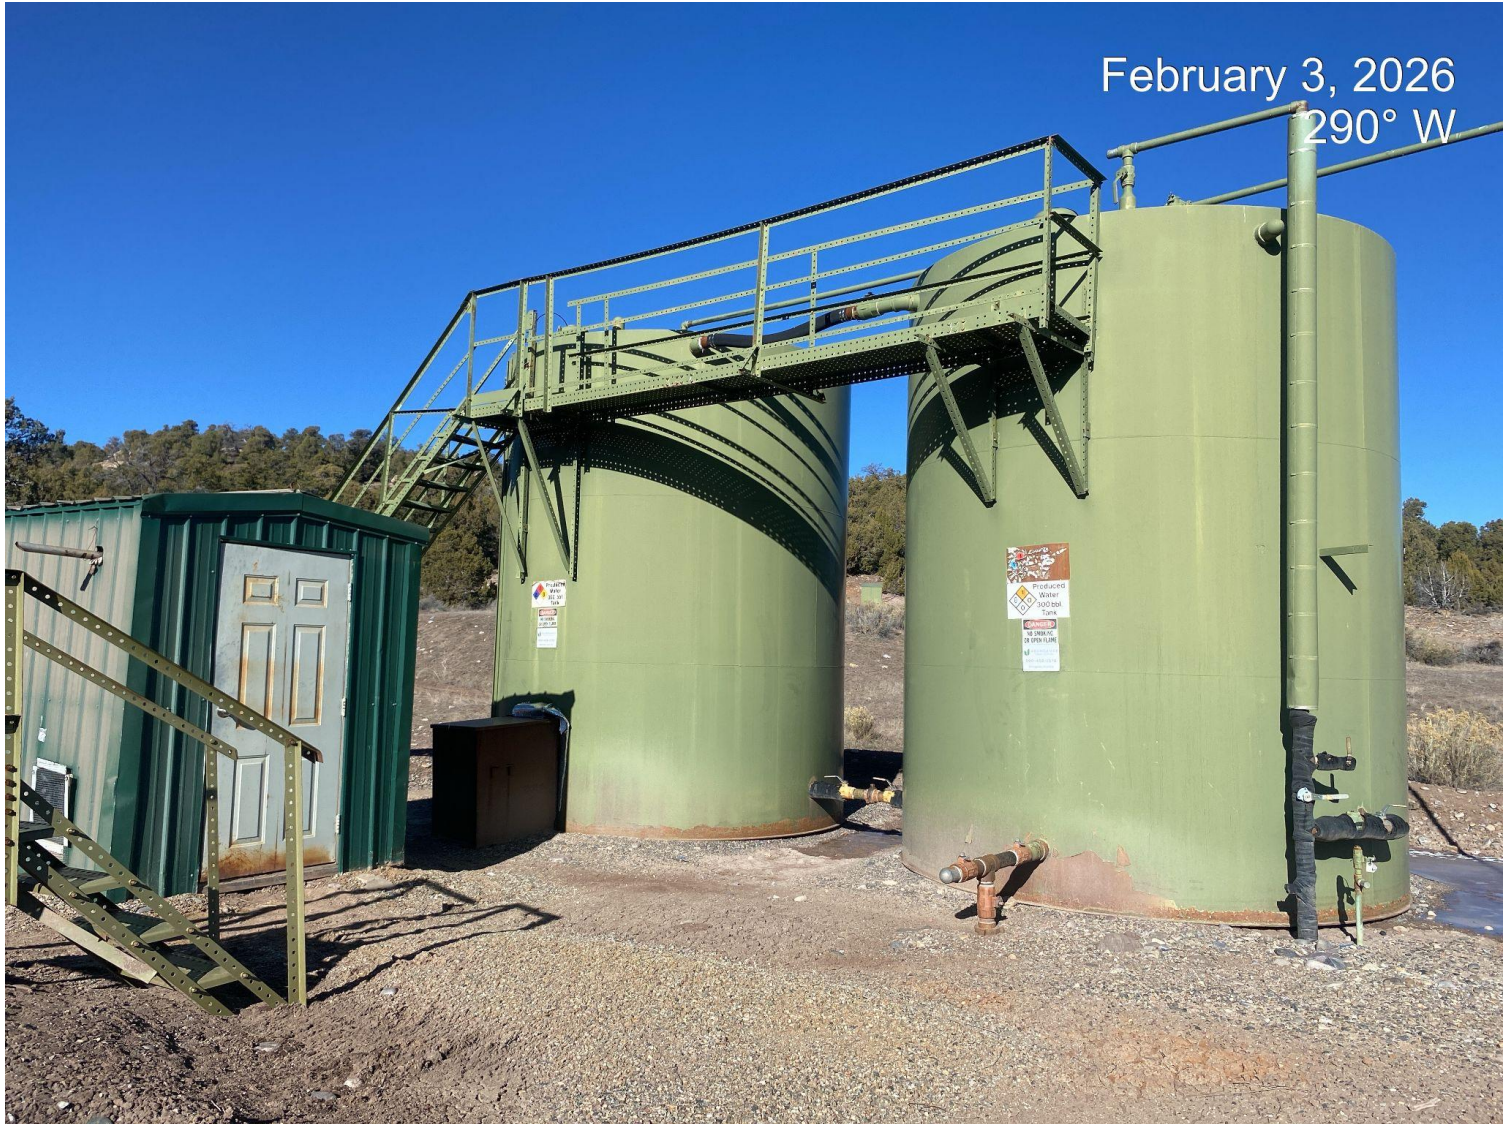
**Photo 3.** NFPA Label on produced water tank has deteriorated and is no longer legible.

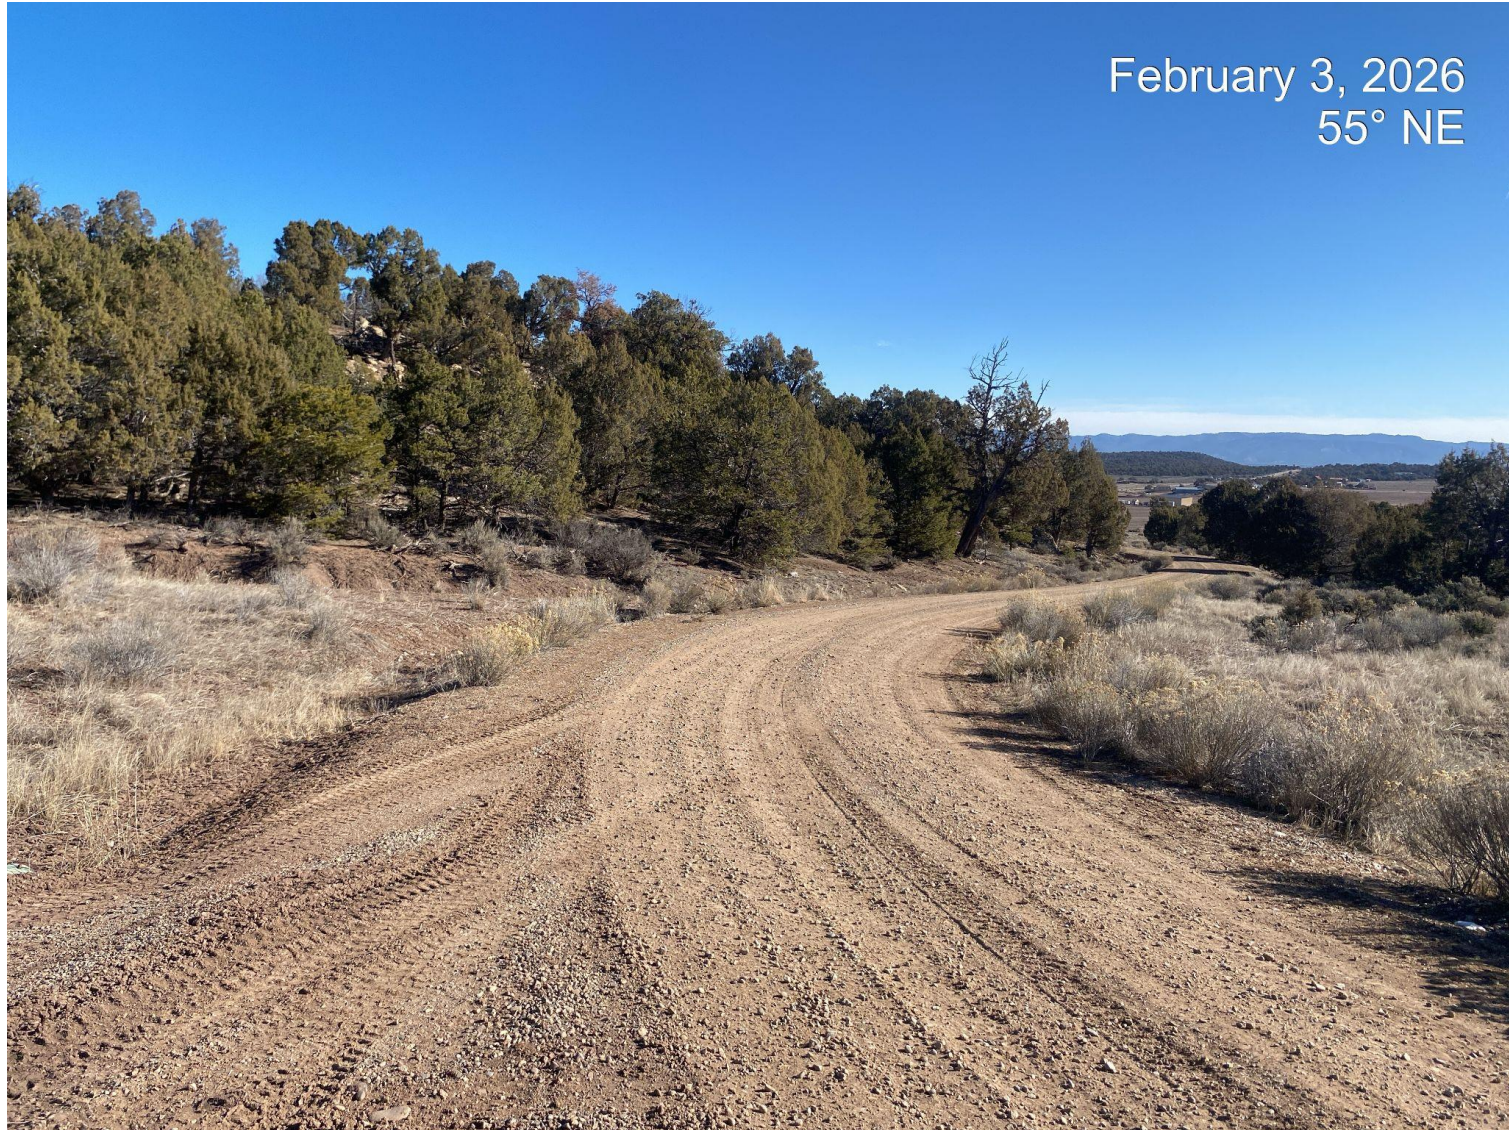
**Photo 4.** View of access road leading to location, access road appear stabilized at this time.
