# Final Reclamation Inspection

Operator: EXTRACTION OIL & GAS INC - 10459

Location ID: 430547

Inspection Photos  
Location Name: BDE Facility/27NW  
Location ID: 430547

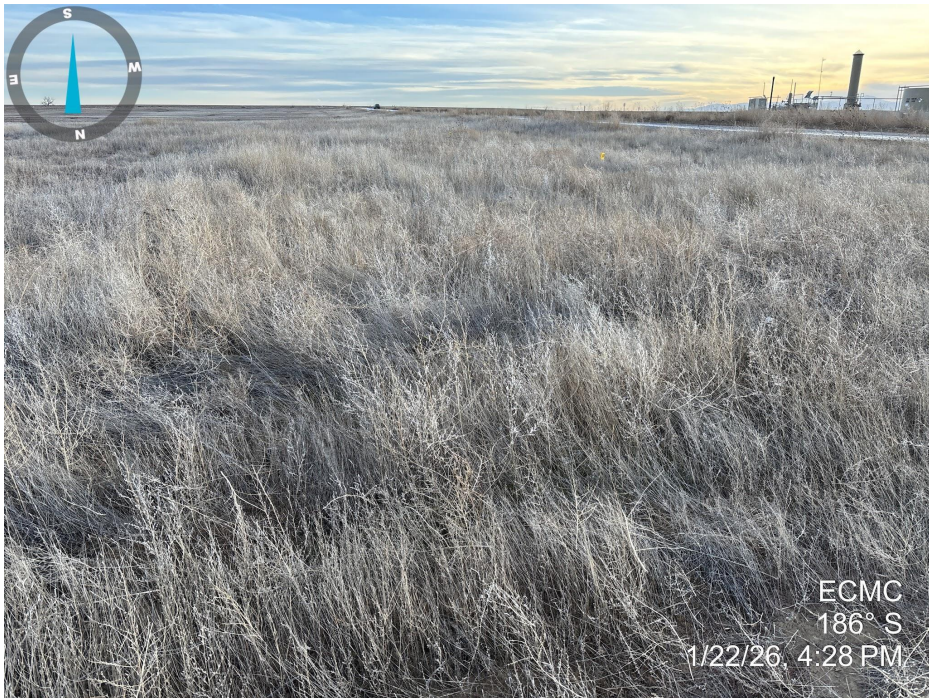
**Photo 1.** Photo taken of the tank battery location, facing south. Photo illustrates that final reclamation activities have taken place, but vegetation establishment does not meet Rule 1004 standards. Weedy annual vegetation including kochia (*Bassia scoparia*) was observed across the location.

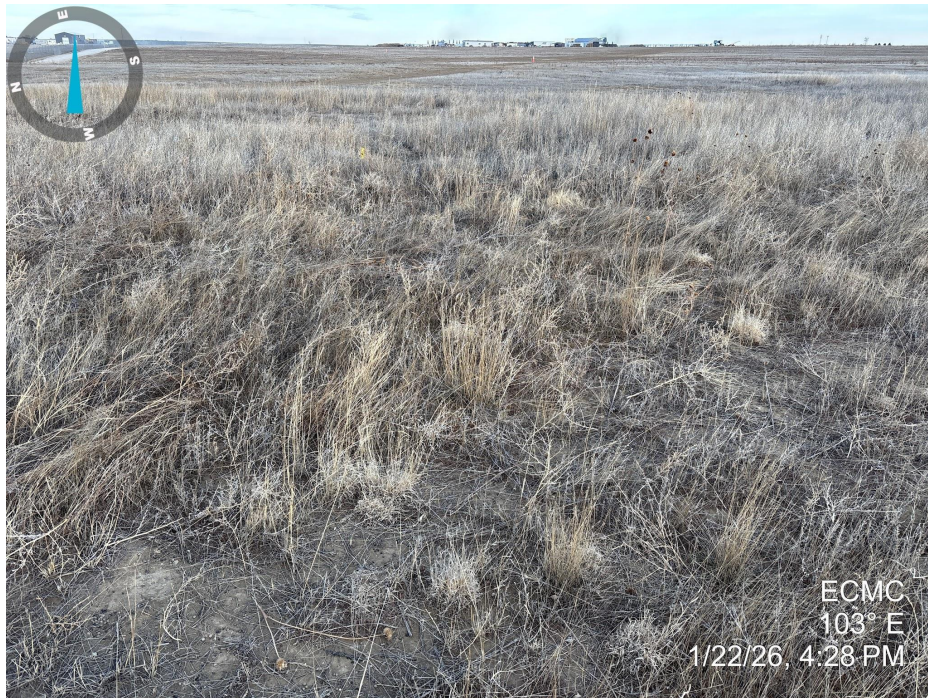
**Photo 2.** Photo taken of the tank battery location, facing east. See comments under Photo 1.

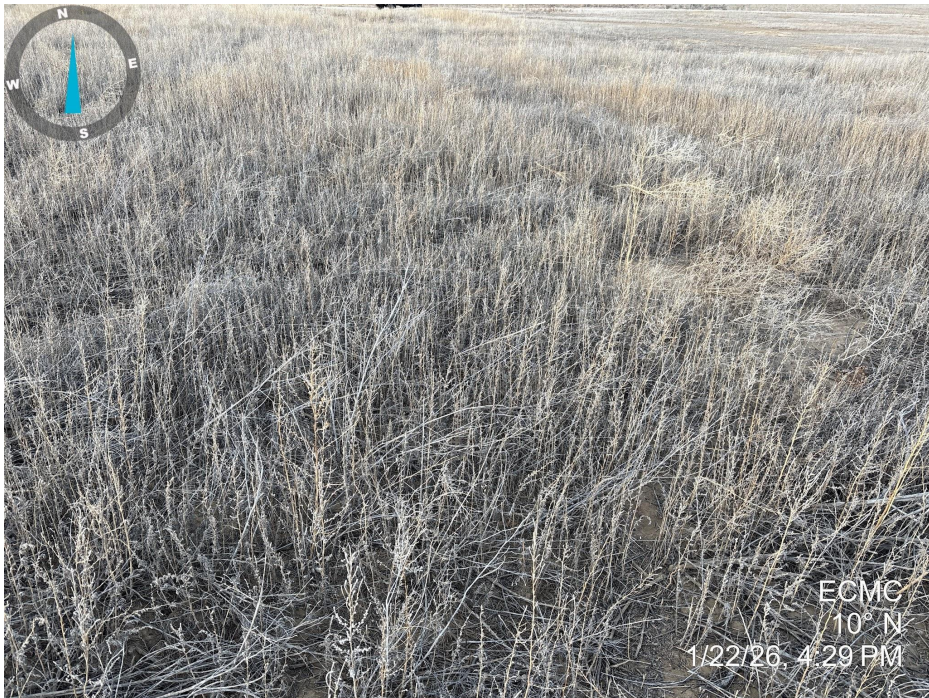
**Photo 3.** Photo taken of the tank battery location, facing north. See comments under Photo 1.

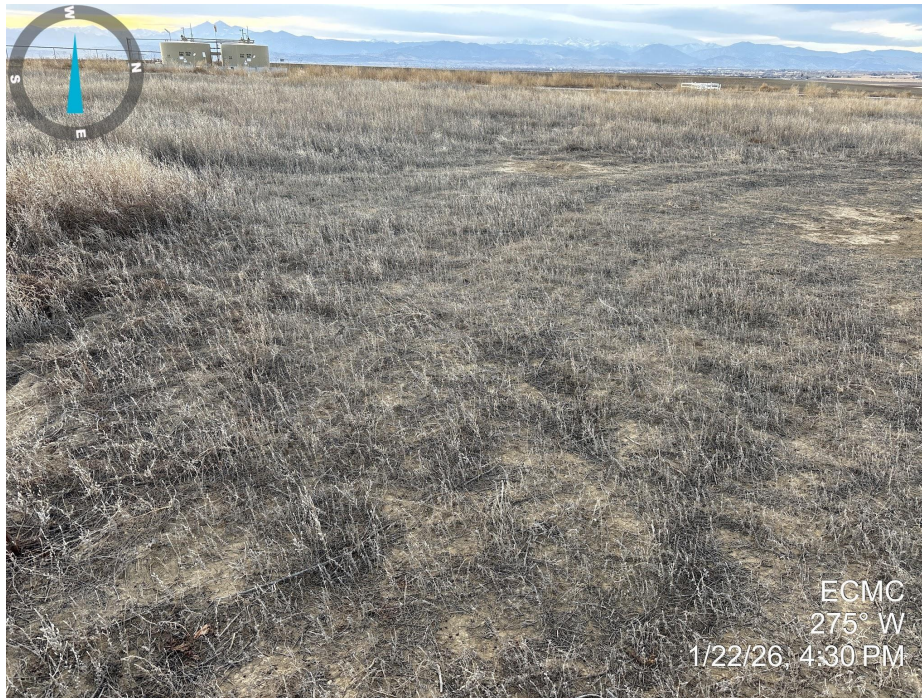
**Photo 4.** Photo taken of the tank battery location, facing west. See comments under Photo 1.

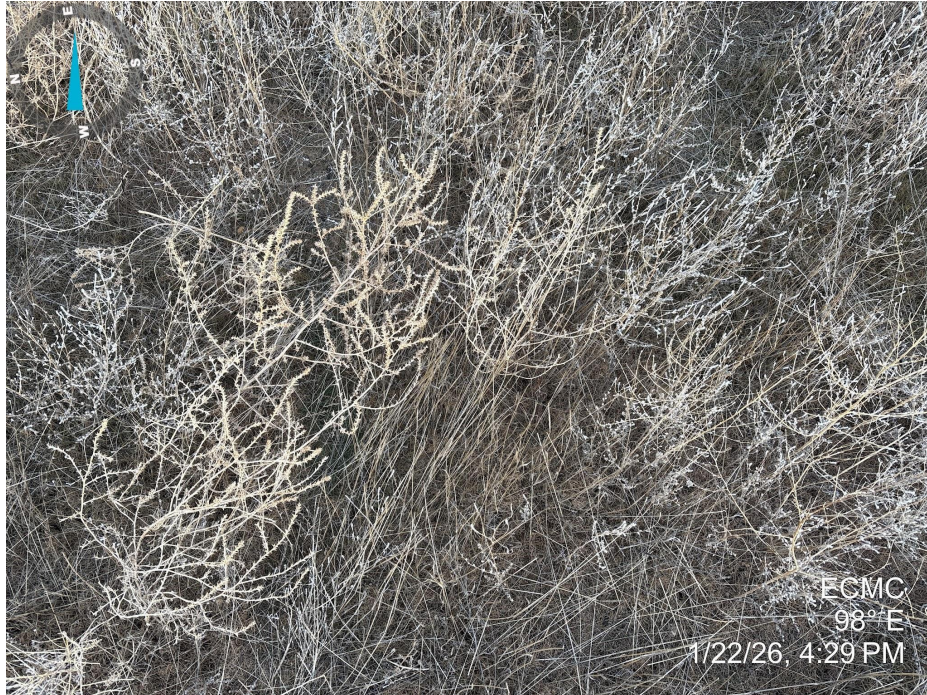
**Photo 5.** Photo of ground cover at the location. Photo illustrates weedy annual vegetation including kochia (*Bassia scoparia*) and russian thistle (*Bassia scoparia*).

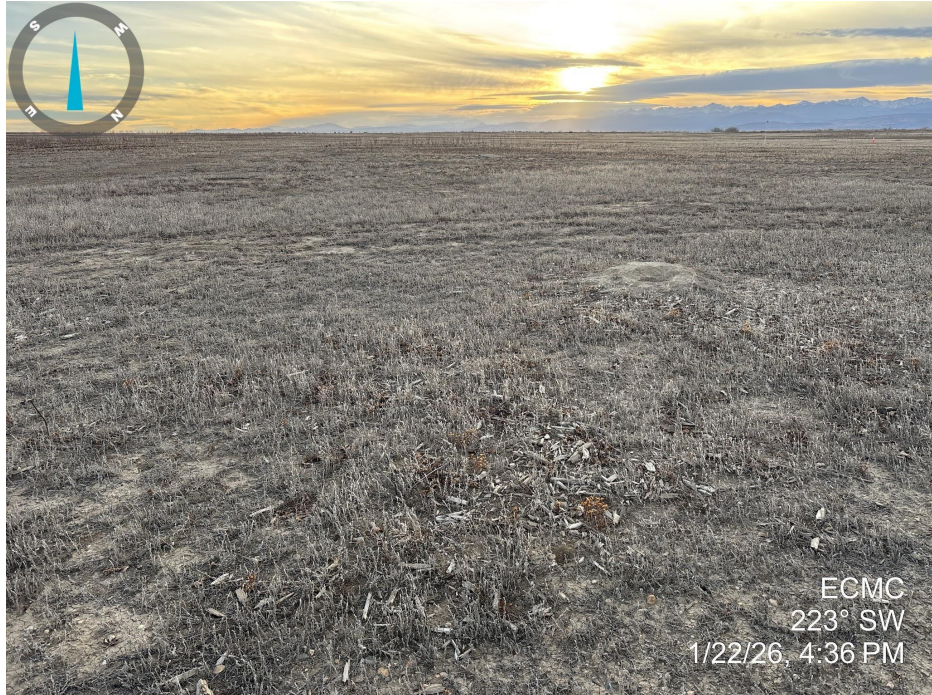
**Photo 6.** Photo taken of the reference area to the location, east of the location, facing southwest. Photo illustrates weedy annual vegetation.
