Final Reclamation Inspection

Operator: EXTRACTION OIL & GAS INC - 10459

Location ID: 430544

Inspection Photos
Location Name: BDE Multi Well Pad 27NW
Location ID: 430544

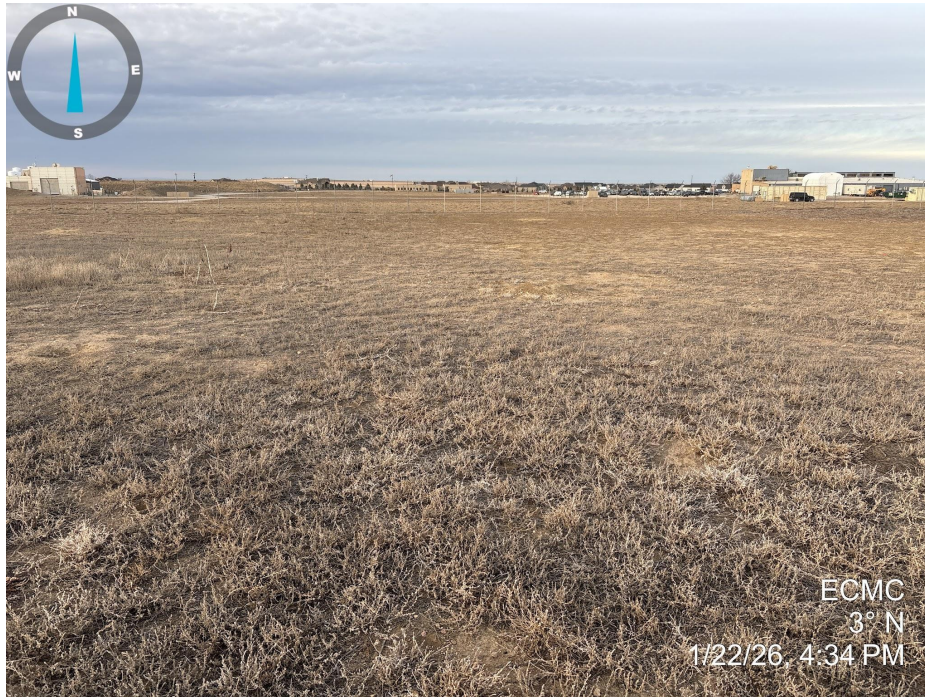
Photo 1. Photo taken of the multi-well location, facing north. Photo illustrates that final reclamation activities have taken place, but vegetation establishment does not meet Rule 1004 standards. The location is dominated by weedy annual vegetation including kochia (*Bassia scoparia*).

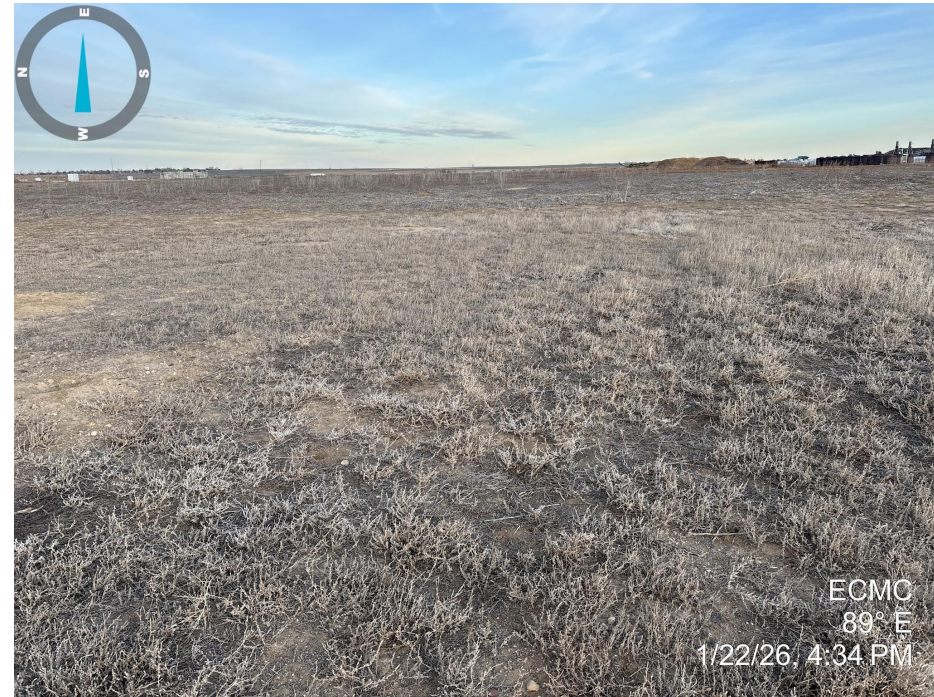
Photo 2. Photo taken of the multi-well location, facing east. See comments under Photo 1.

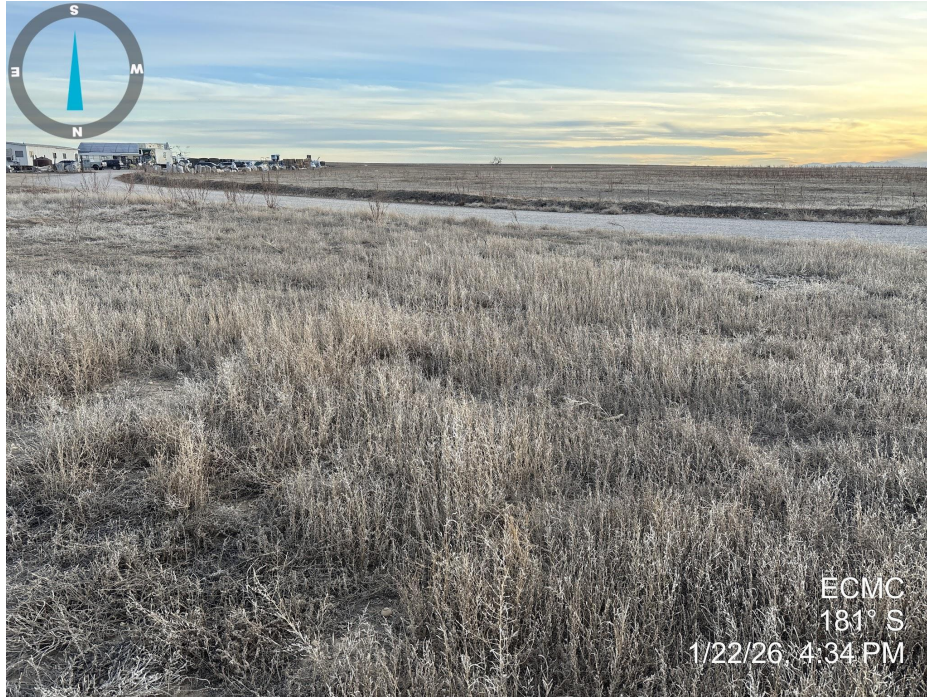
Photo 3. Photo taken of the multi-well location, facing south.
See comments under Photo 1.

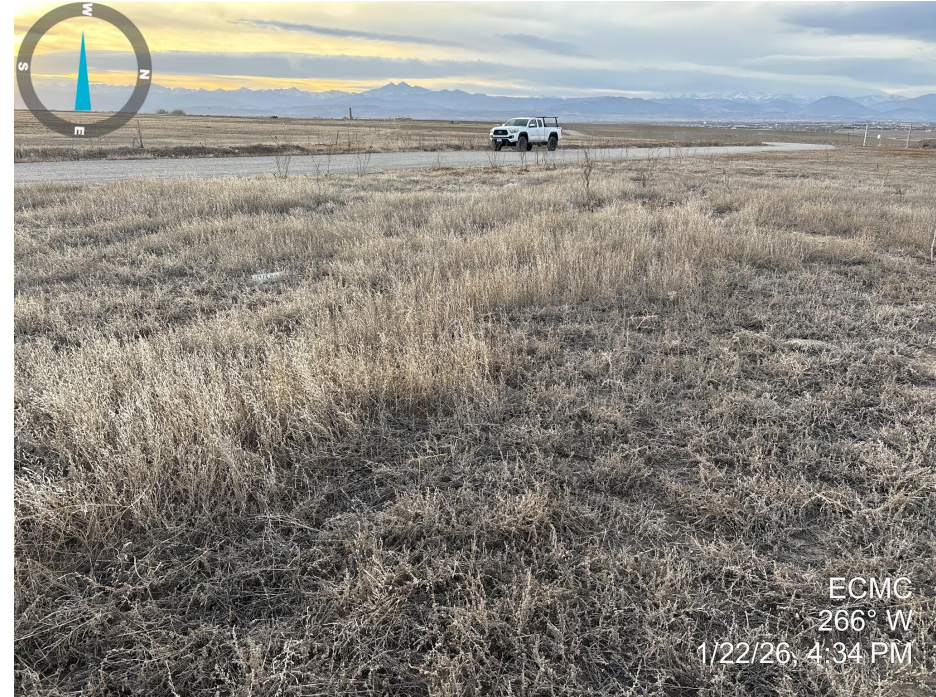
Photo 4. Photo taken of the multi-well location, facing west.
See comments under Photo 1.

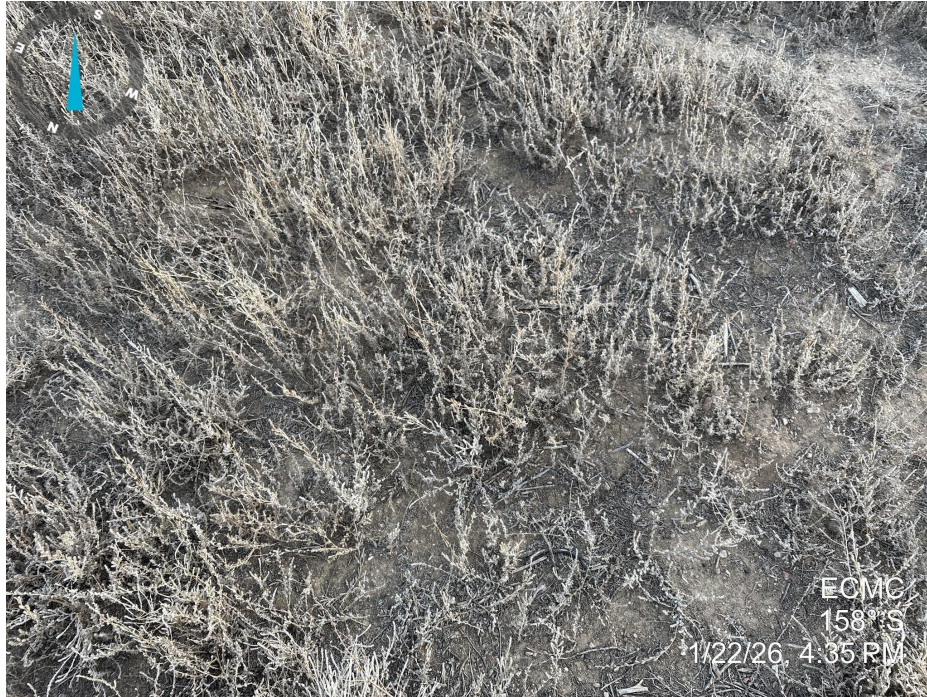
Photo 5. Photo of ground cover at the location. Photo illustrates weedy annual vegetation including kochia (*Bassia scoparia*).

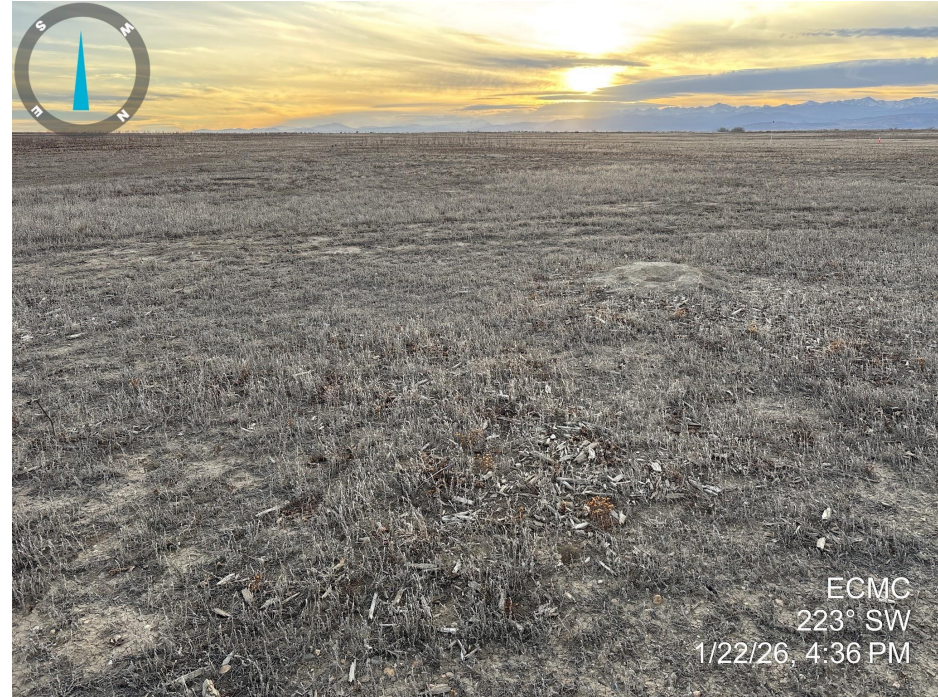
Photo 6. Photo taken of the reference area to the location, west of the location, facing southwest. Photo illustrates weedy annual vegetation.
