# Final Reclamation Inspection

Operator: NOBLE ENERGY INC - 100322

Location ID: 309764

Inspection Photos  
Location Name: PEDRO STATE G #36-18  
Location ID: 309764

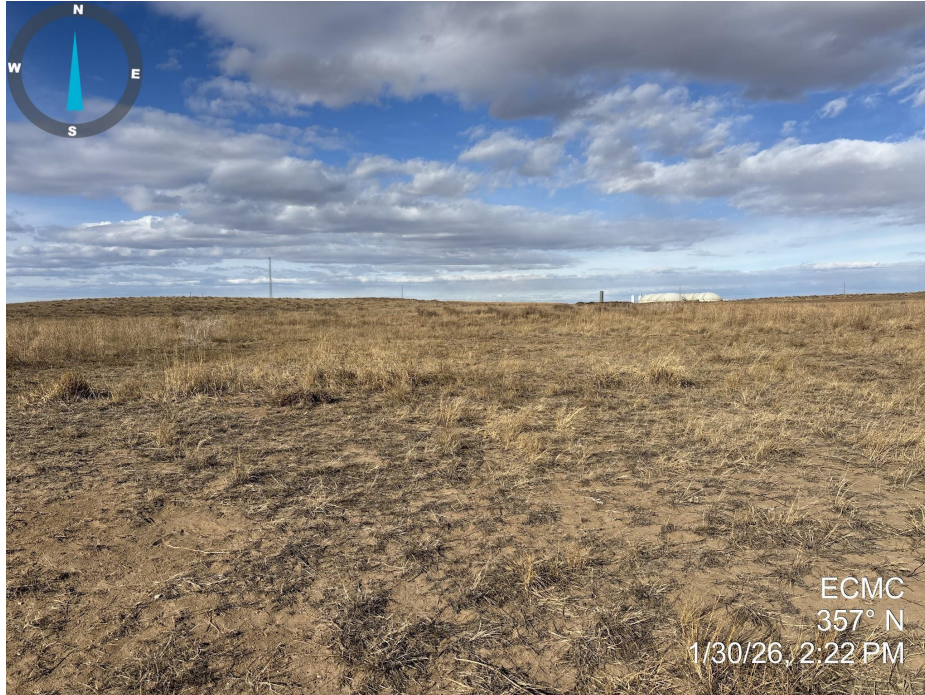
**Photo 1.** Photo taken of the well location, facing north. Photo illustrates that final reclamation activities have taken place, with evidence of drill rows from seeding, but vegetation establishment does not meet Rule 1004 standards.

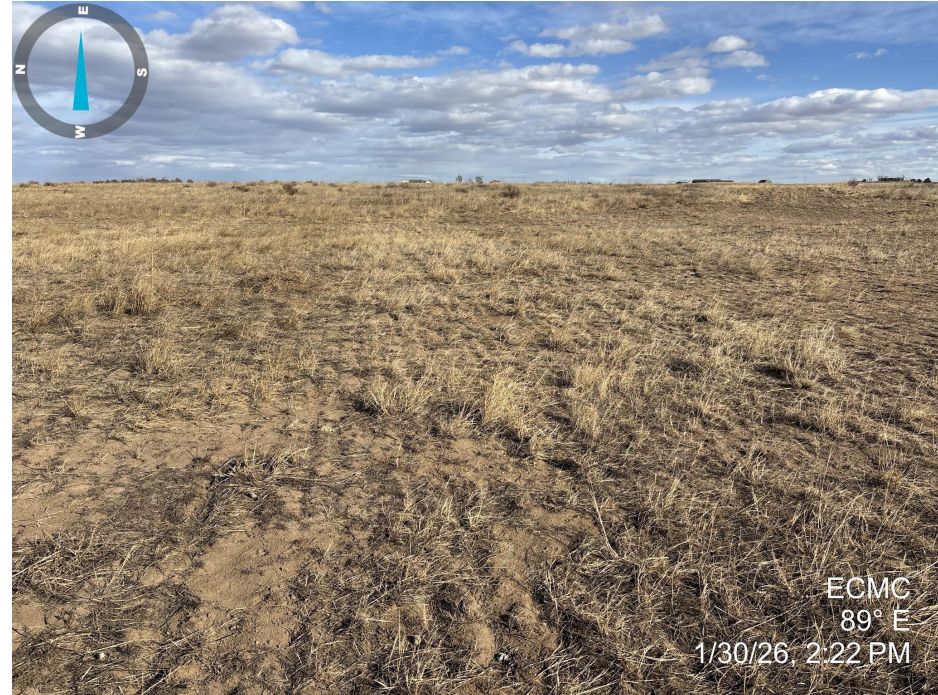
**Photo 2.** Photo taken of the well location, facing east. See comments under Photo 1.

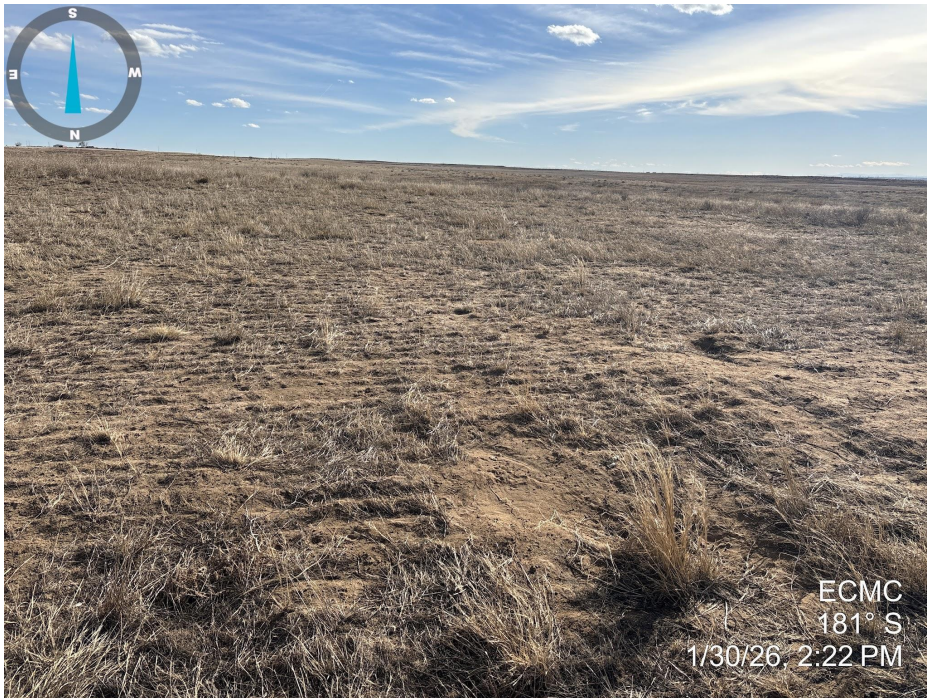
**Photo 3.** Photo taken of the well location, facing south. See comments under Photo 1.

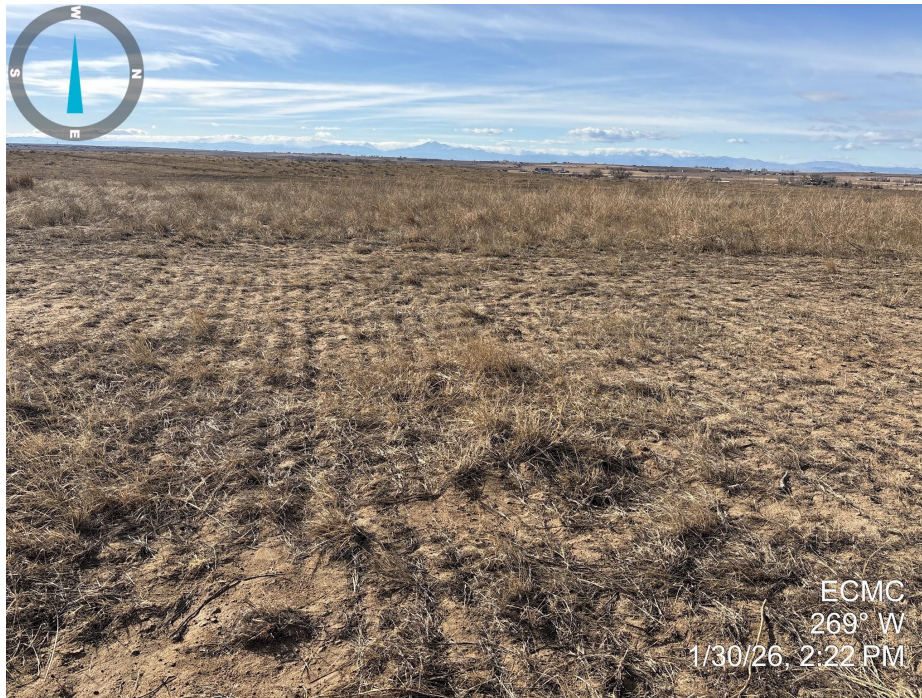
**Photo 4.** Photo taken of the well location, facing west. See comments under Photo 1.

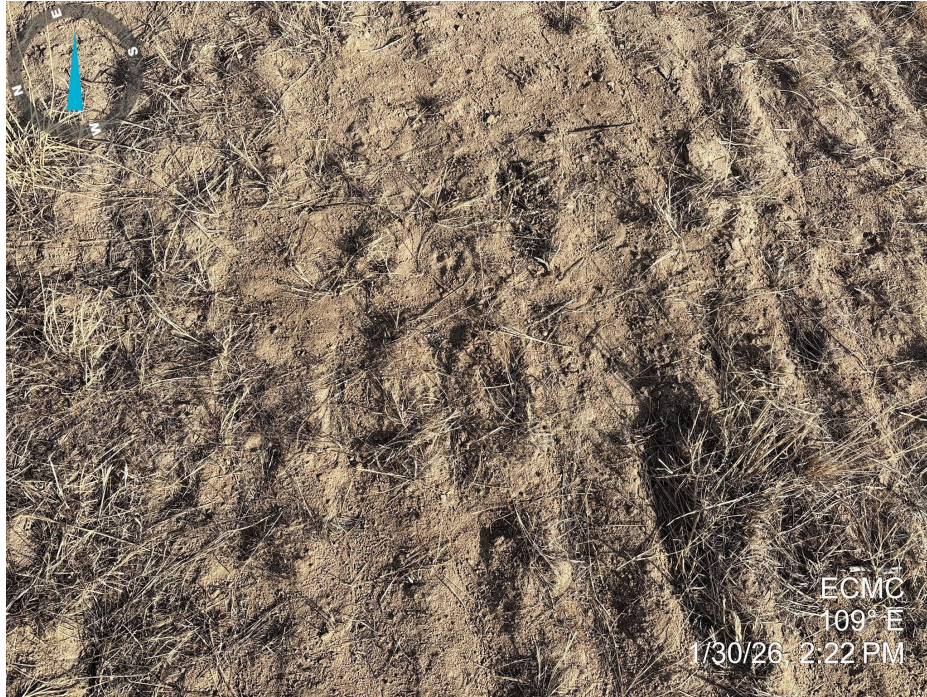
**Photo 5.** Photo taken of ground cover at the well location. Photo illustrates perennial grass and drill rows from seeding.

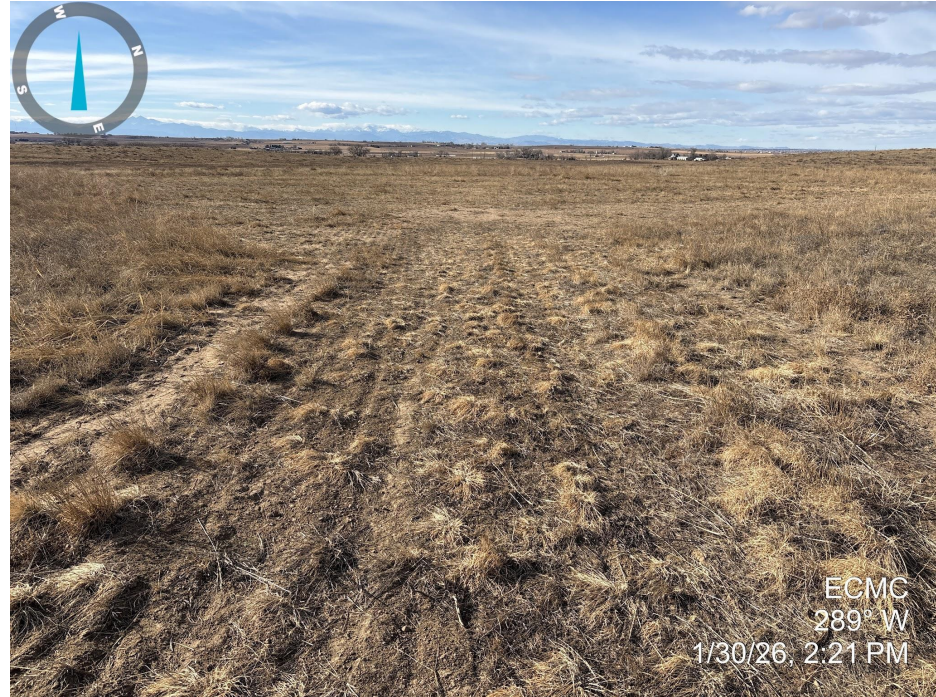
**Photo 6.** Photo taken of the access road to the location, facing west, towards the location. Photo illustrates that final reclamation activities have taken place, with evidence of drill row seeding, but vegetation establishment does not meet Rule 1004 standards.

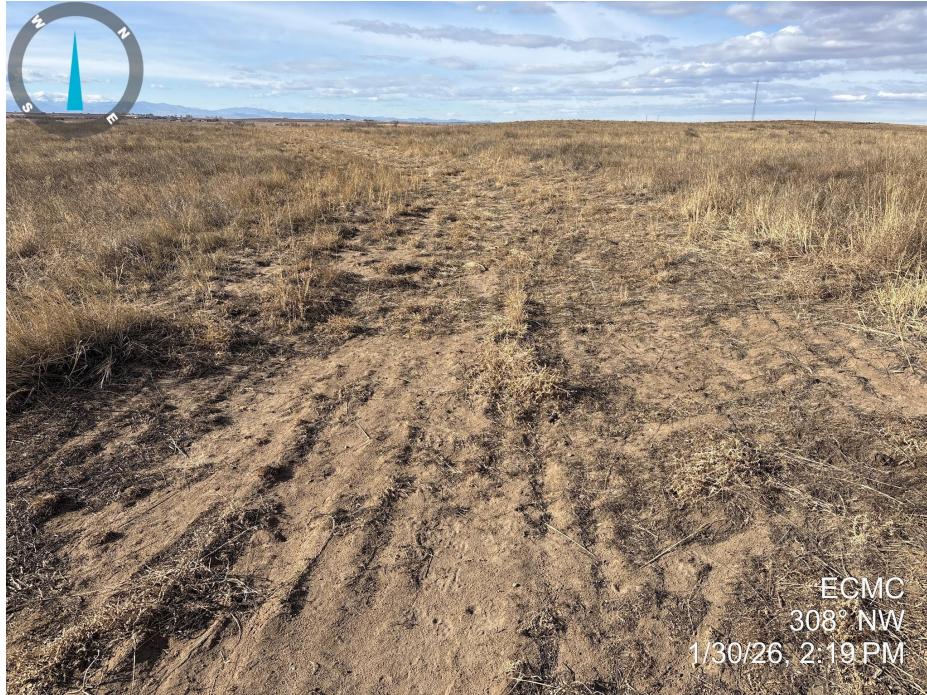
**Photo 7.** Photo taken of the access road to the well location, facing northwest. See comments under Photo 6.

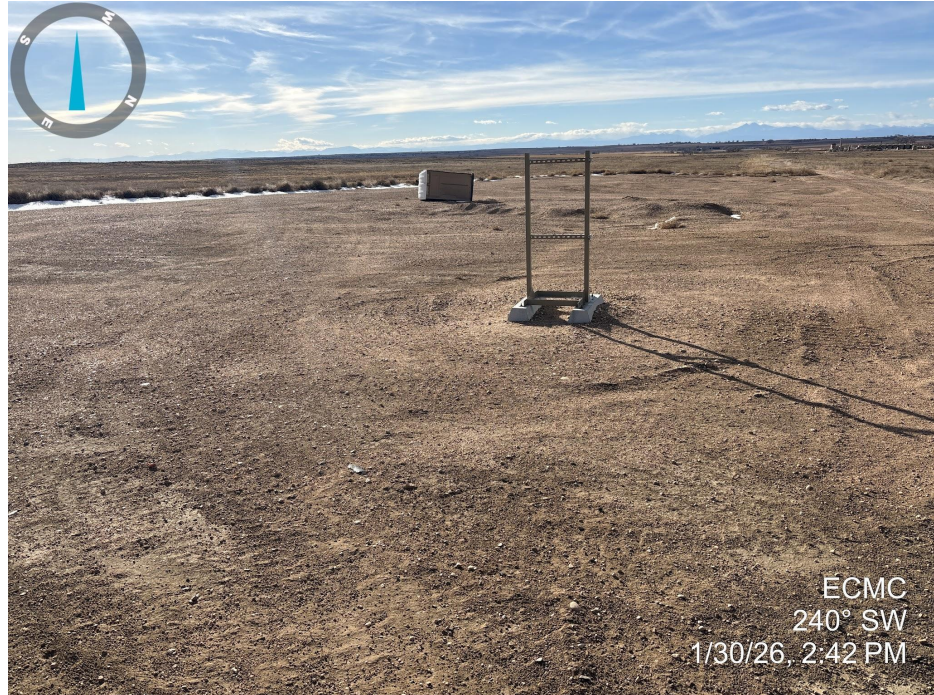
**Photo 8.** Photo taken of the tank battery location, facing southwest. Photo illustrates that final reclamation activities have not taken place at the tank battery. A porta potty was observed at the location tipped over.

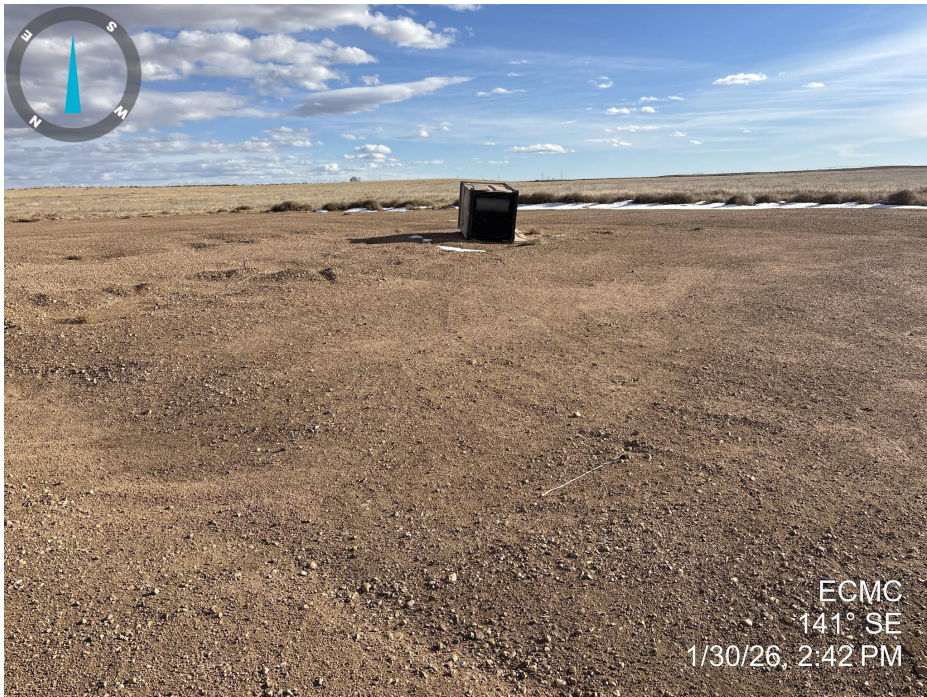
**Photo 9.** Photo taken of the tank battery location, facing southeast. See comments under Photo 8.

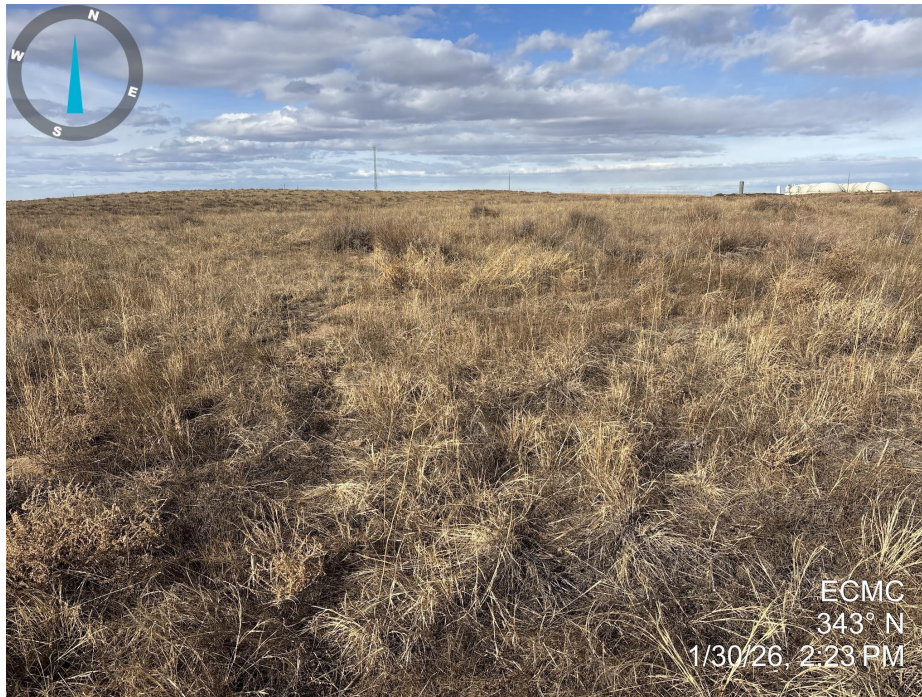
**Photo 10.** Photo taken of the reference area to the location, north of the location, facing north. Photo illustrates perennial grass and weedy annual vegetation.
