# Final Reclamation Inspection

Operator: NOBLE ENERGY INC - 100322

Location ID: 305340

Inspection Photos  
Location Name: GERRITY STATE G #36-17  
Location ID: 305340

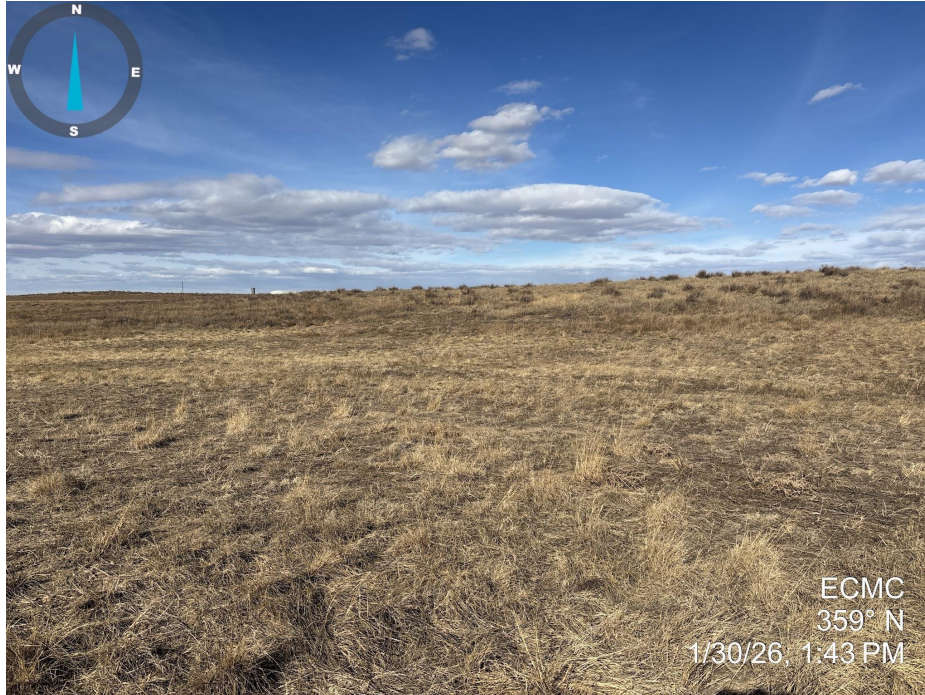
**Photo 1.** Photo taken of the well location, facing north. Photo illustrates that final reclamation activities appear to have taken place and perennial grass vegetation is establishing.

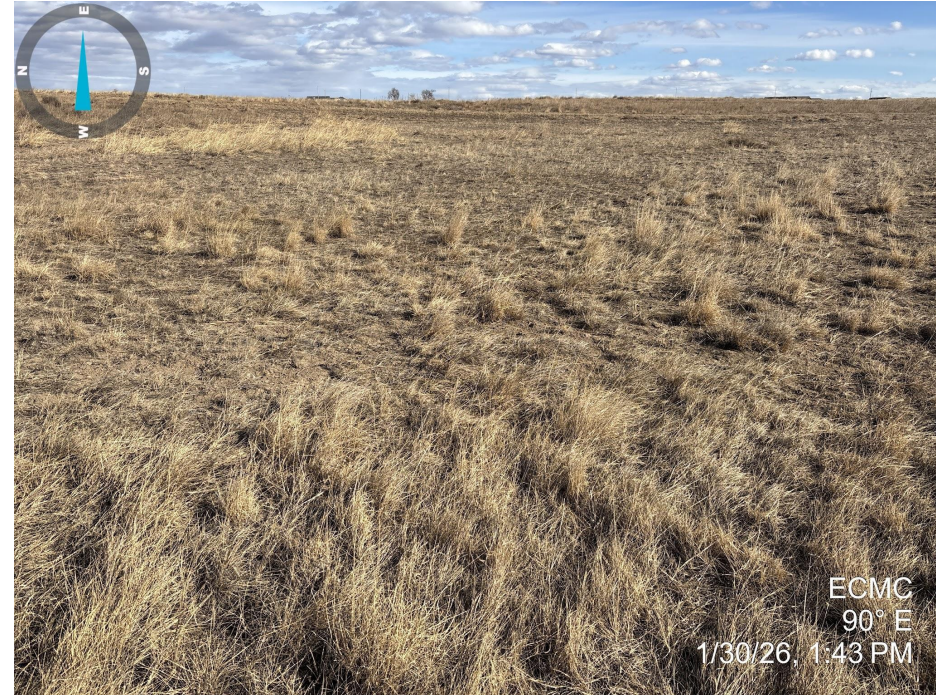
**Photo 2.** Photo taken of the well location, facing east. See comments under Photo 1.

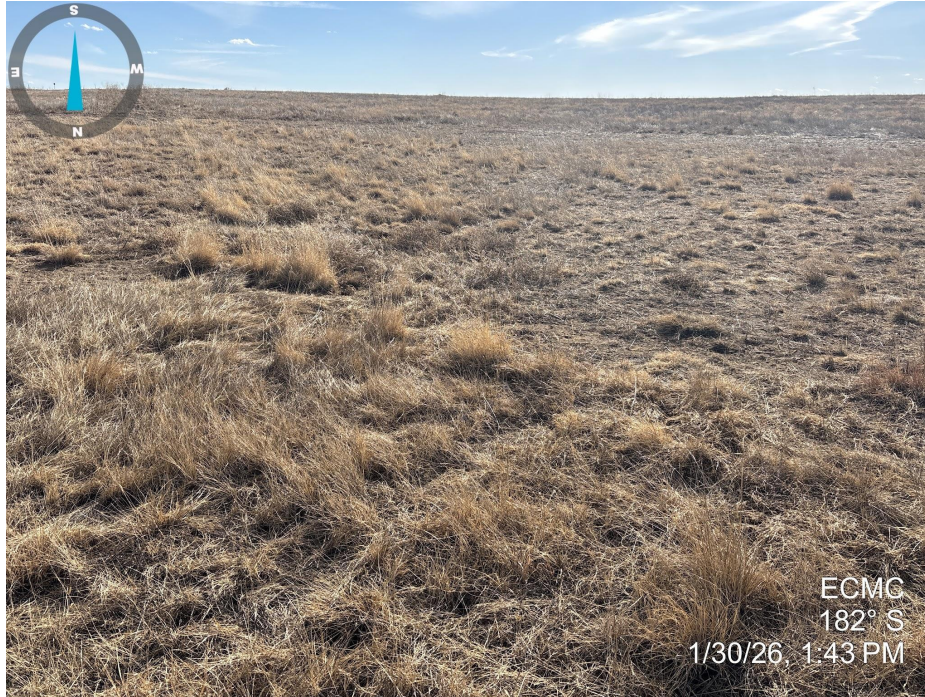
**Photo 3.** Photo taken of the well location, facing south. See comments under Photo 1.

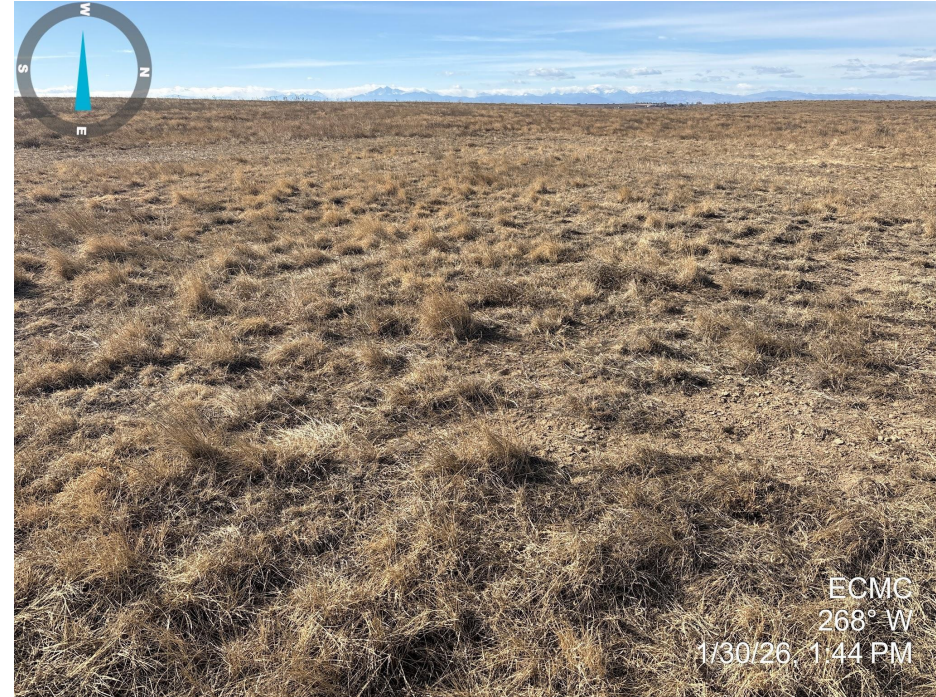
**Photo 4.** Photo taken of the well location, facing west. See comments under Photo 1.

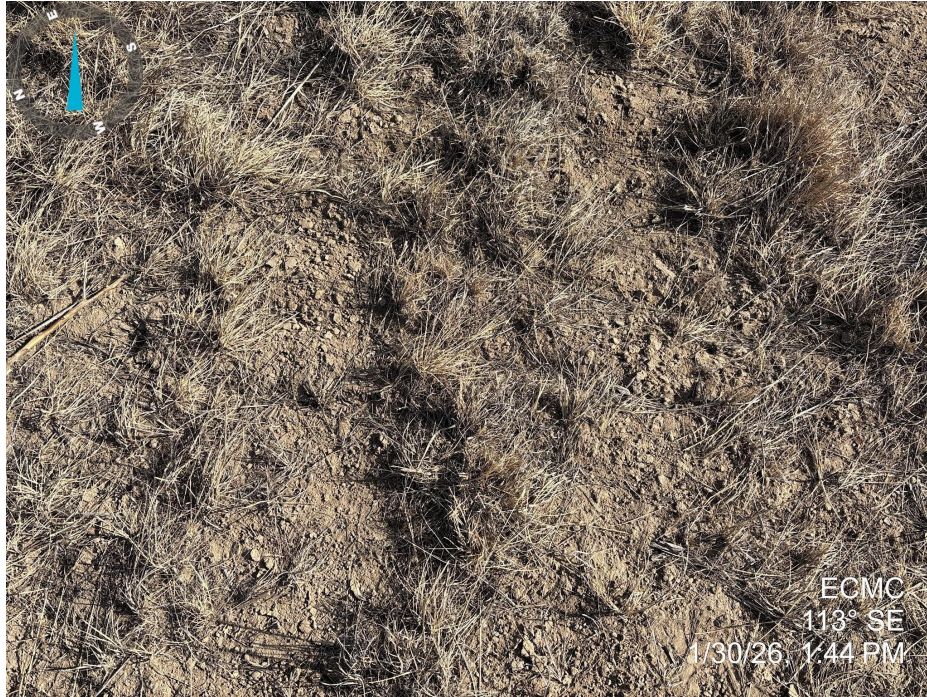
**Photo 5.** Photo taken of ground cover at the well location. Photo illustrates perennial grass and bare ground.

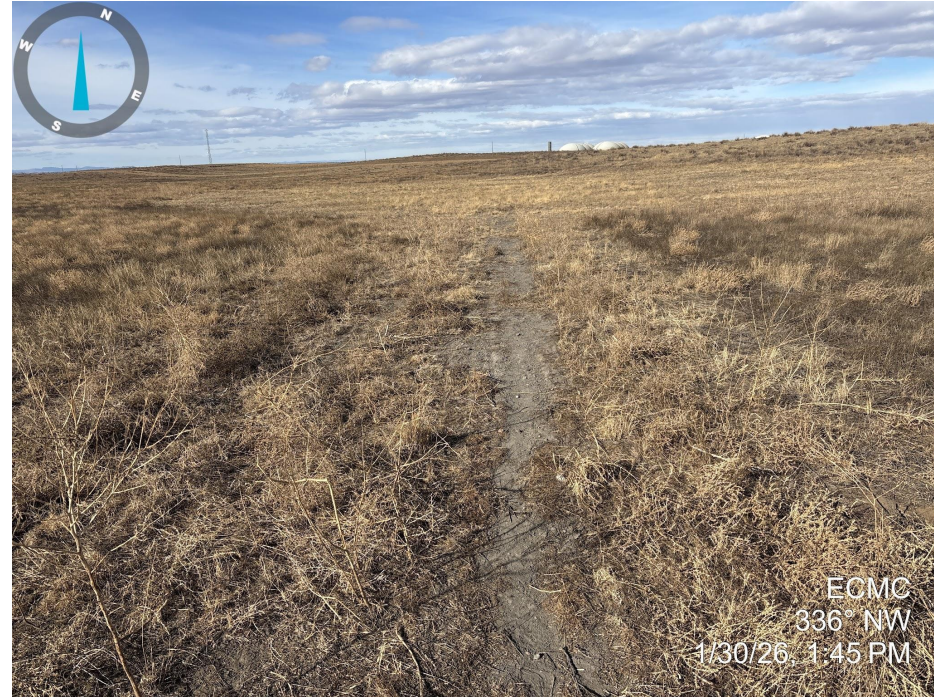
**Photo 6.** Photo taken of the access road to the location, facing northwest, towards the location. Photo illustrates bare ground and weedy annual vegetation, including kochia (*Bassia scoparia*) and russian thistle (*Salsola tragus*).

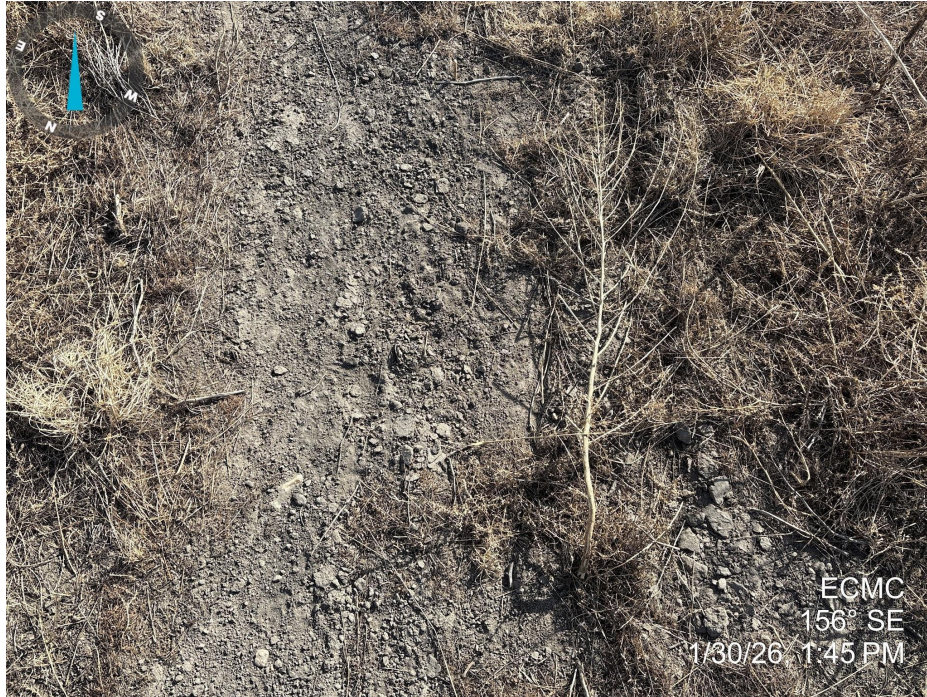
**Photo 7.** Photo taken of ground cover along the access road to the location. Photo illustrates bare ground remains along the access road.

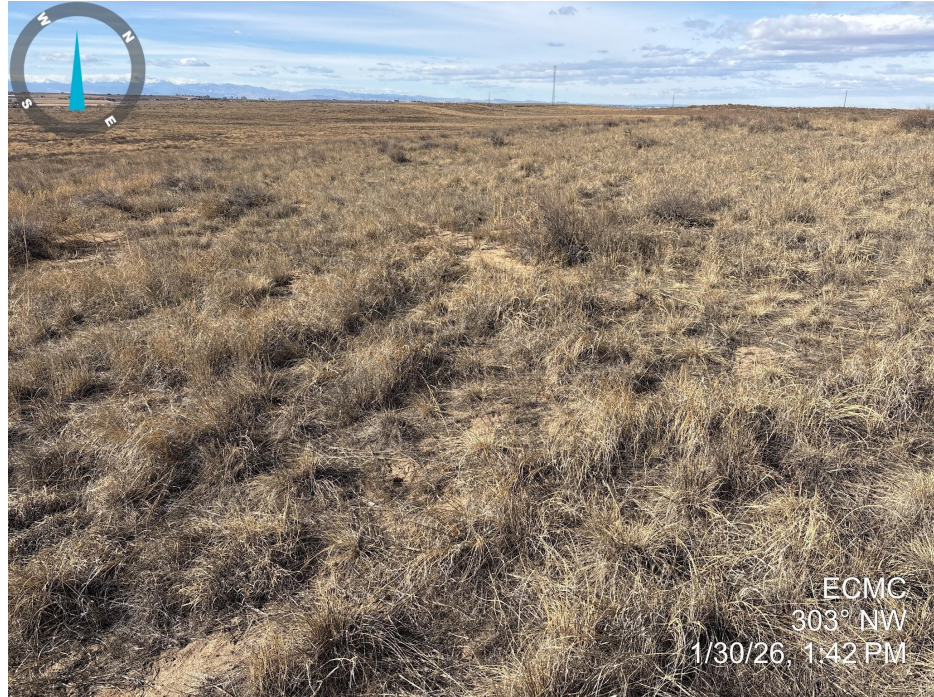
**Photo 8.** Photo taken of the reference area to the location, northwest of the location, facing northwest. Photo illustrates perennial grass and weedy annual vegetation.
