Final Reclamation Inspection

Operator: NOBLE ENERGY INC - 100322

Location ID: 326693

Inspection Photos
Location Name: GERRITY STATE G #36-07
Location ID: 326693

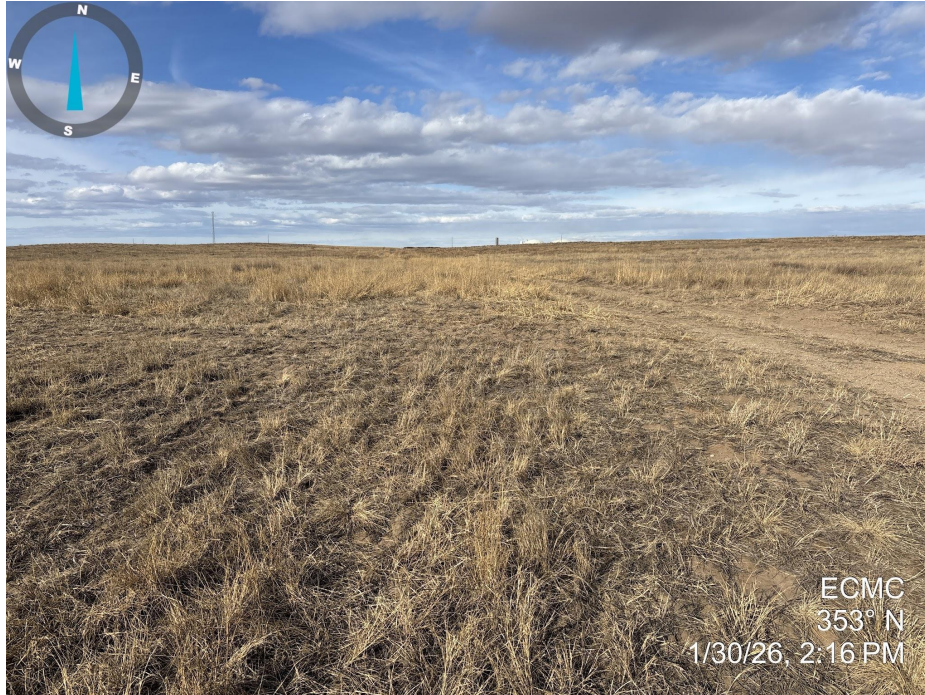
Photo 1. Photo taken of the well location, facing north. Photo illustrates that final reclamation activities have taken place, with evidence of drill rows from seeding, but vegetation establishment does not meet Rule 1004 standards.

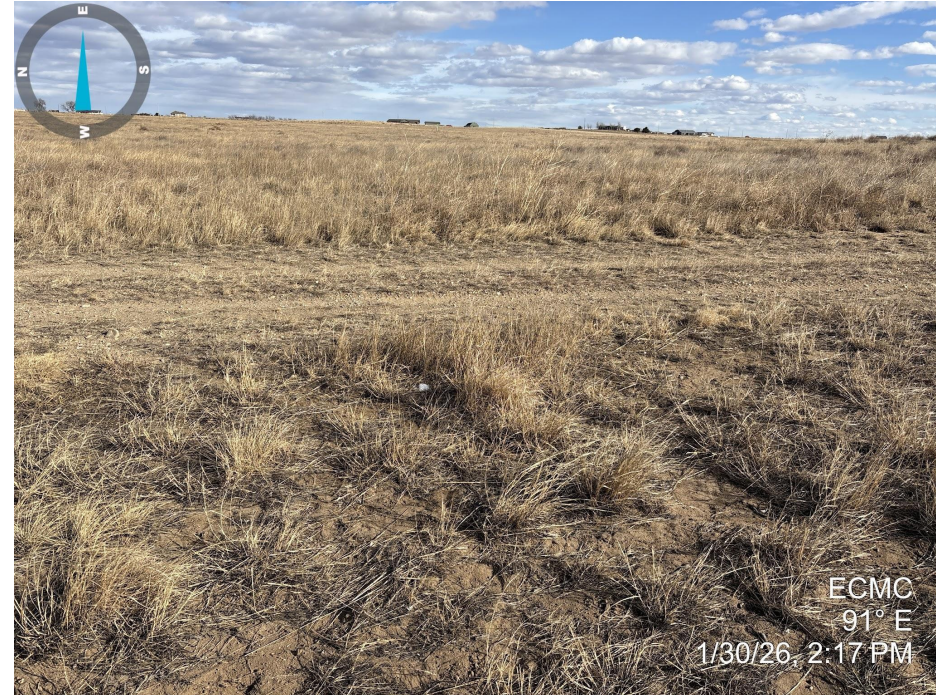
Photo 2. Photo taken of the well location, facing east. See comments under Photo 1.

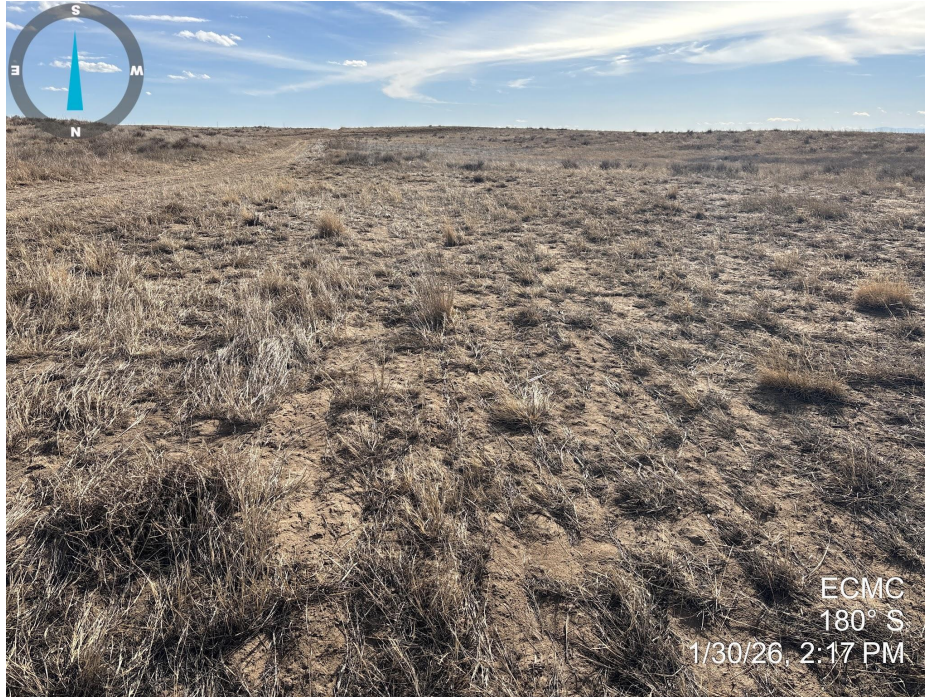
Photo 3. Photo taken of the well location, facing south. See comments under Photo 1.

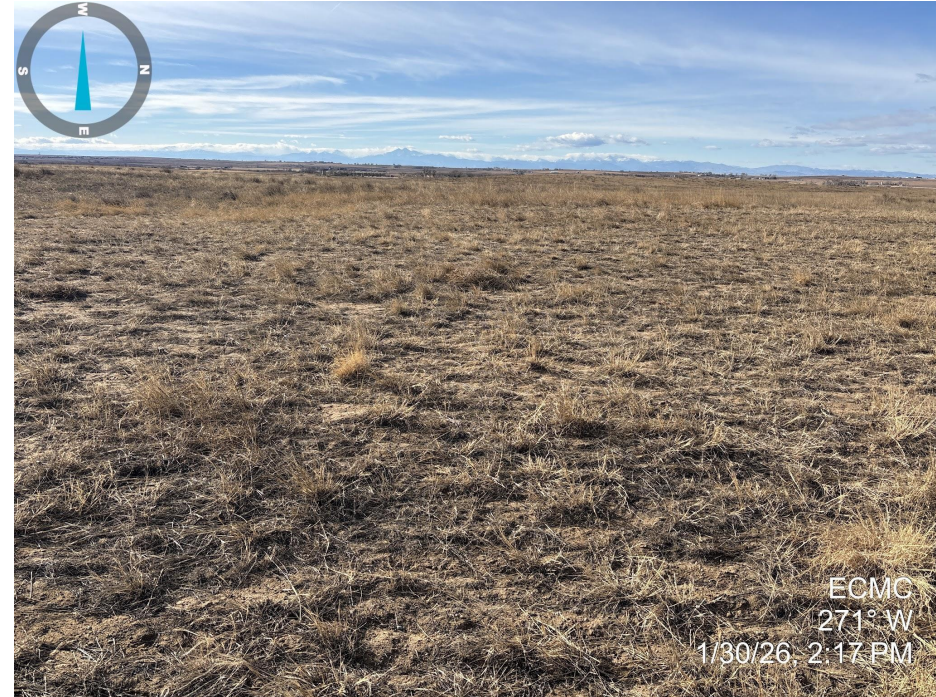
Photo 4. Photo taken of the well location, facing west. See comments under Photo 1.

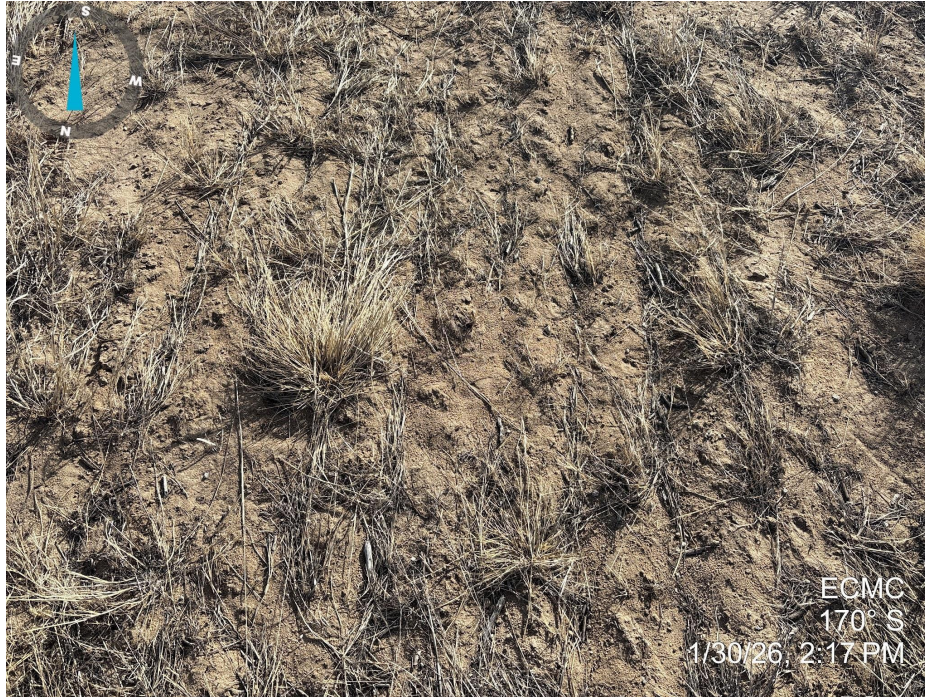
Photo 5. Photo taken of ground cover at the well location. Photo illustrates perennial grass and drill rows from seeding.

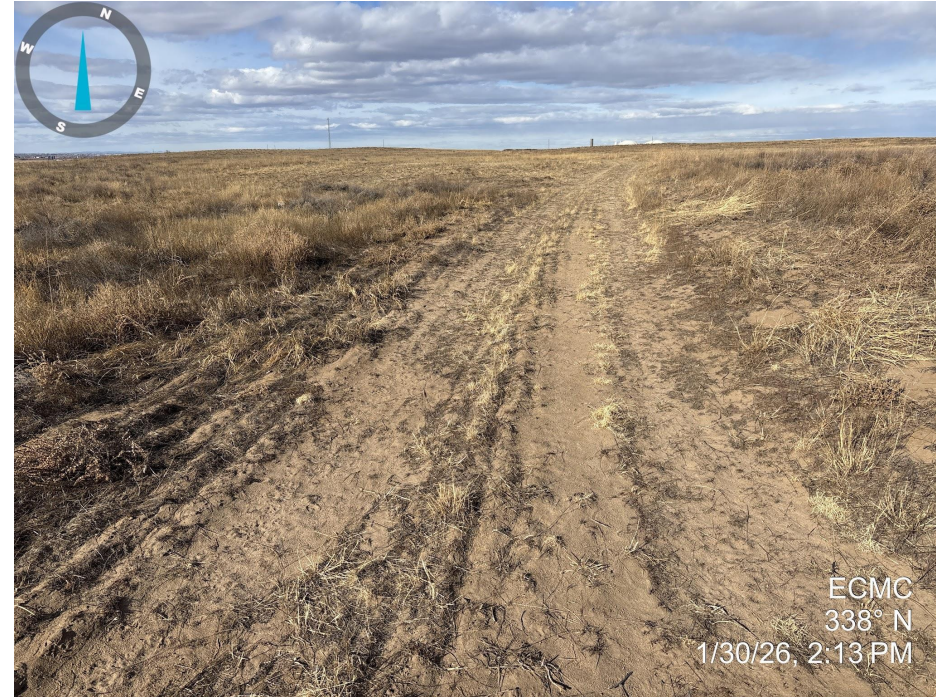
Photo 6. Photo taken of the access road to the location. Photo illustrates that the access road does not meet Rule 1004 standards as bare ground remains across the road.

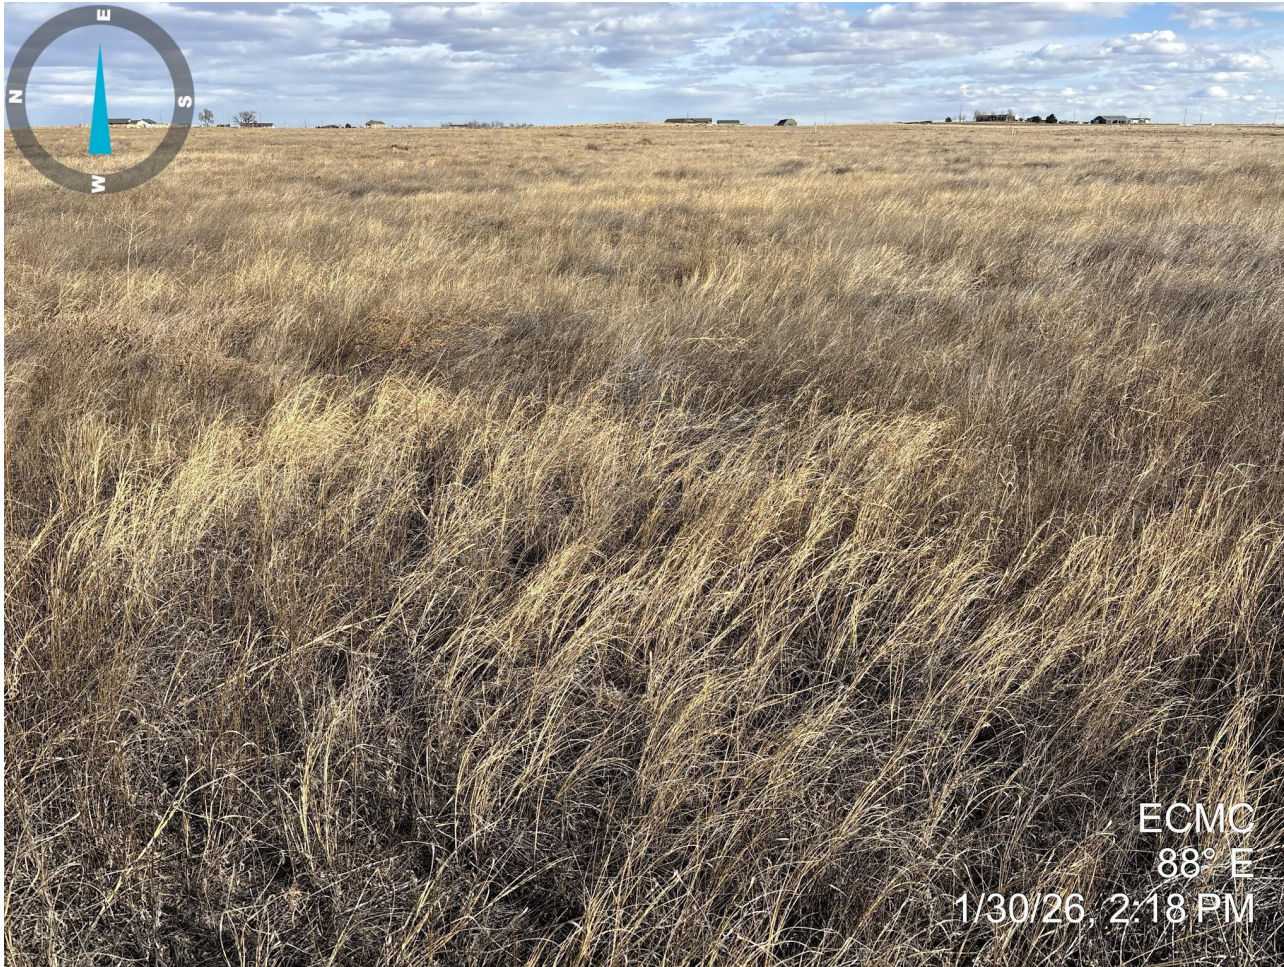
Photo 7. Photo taken of the reference area to the location, northeast of the location, facing east. Photo illustrates perennial grass and weedy annual vegetation.
