# Final Reclamation Inspection

Operator: NOBLE ENERGY INC - 100322

Location ID: 326710

Inspection Photos  
Location Name: STATE R G #36-3  
Location ID: 326710

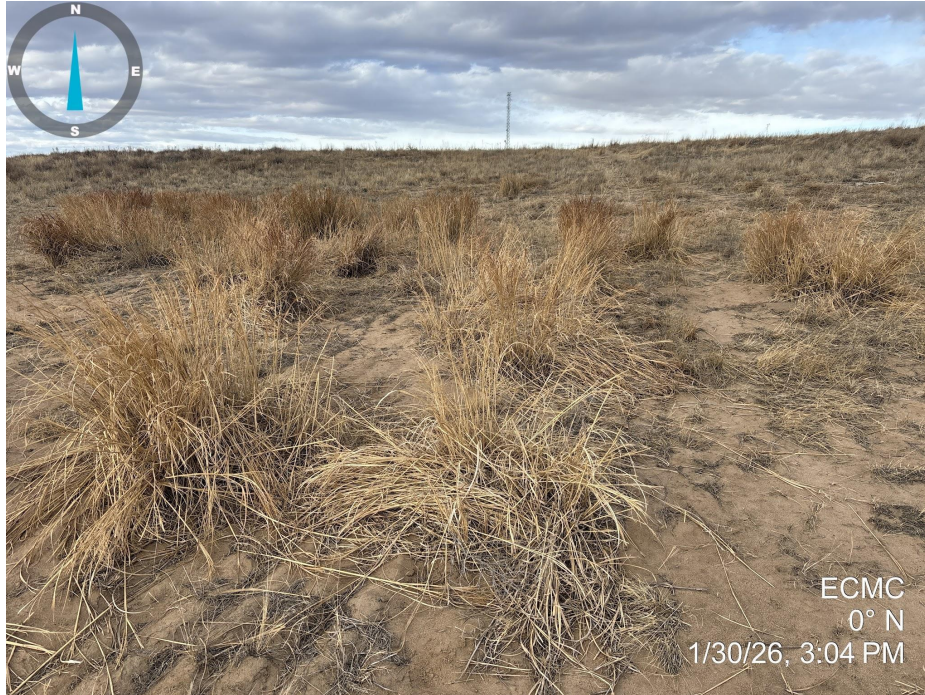
**Photo 1.** Photo taken of the well location, facing north. Photo illustrates that final reclamation activities appear to have taken place, with evidence of drill row seeding, but vegetation has not established to Rule 1004 standards.

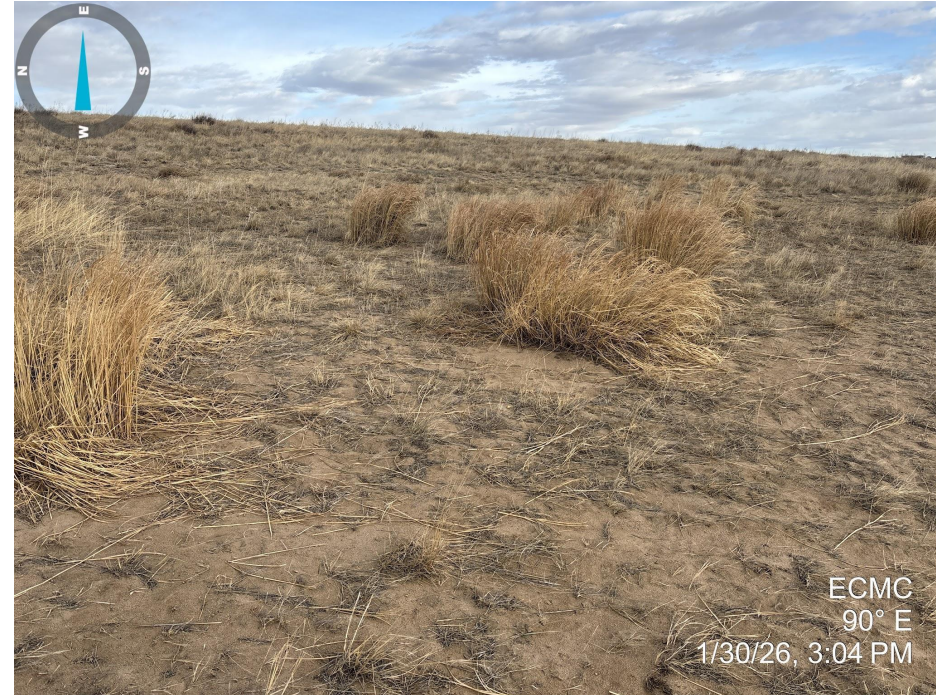
**Photo 2.** Photo taken of the well location, facing east. See comments under Photo 1.

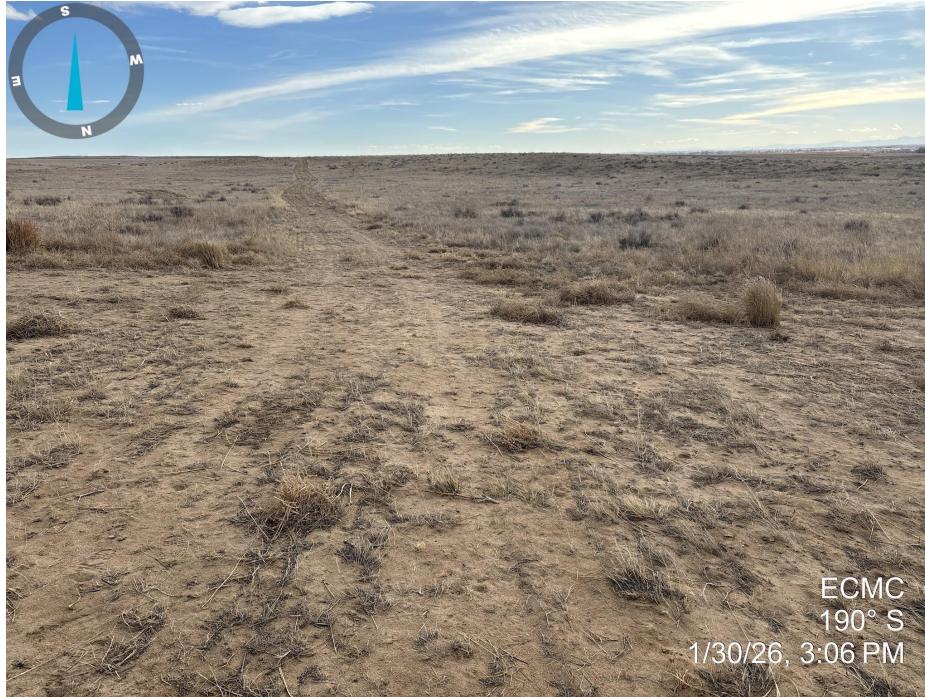
**Photo 3.** Photo taken of the well location, facing south. See comments under Photo 1.

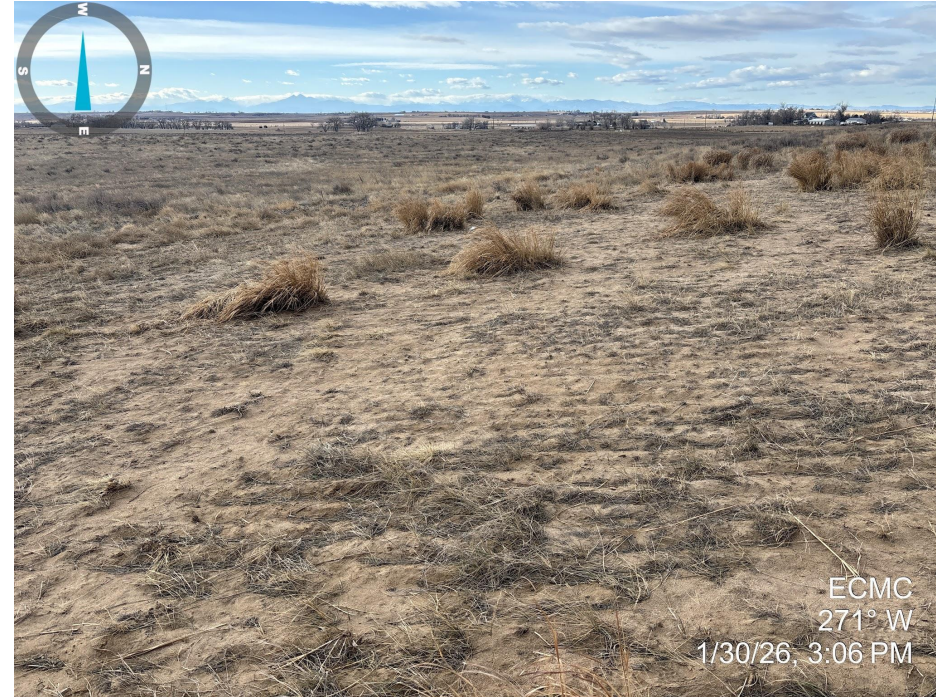
**Photo 4.** Photo taken of the well location, facing west. See comments under Photo 1.

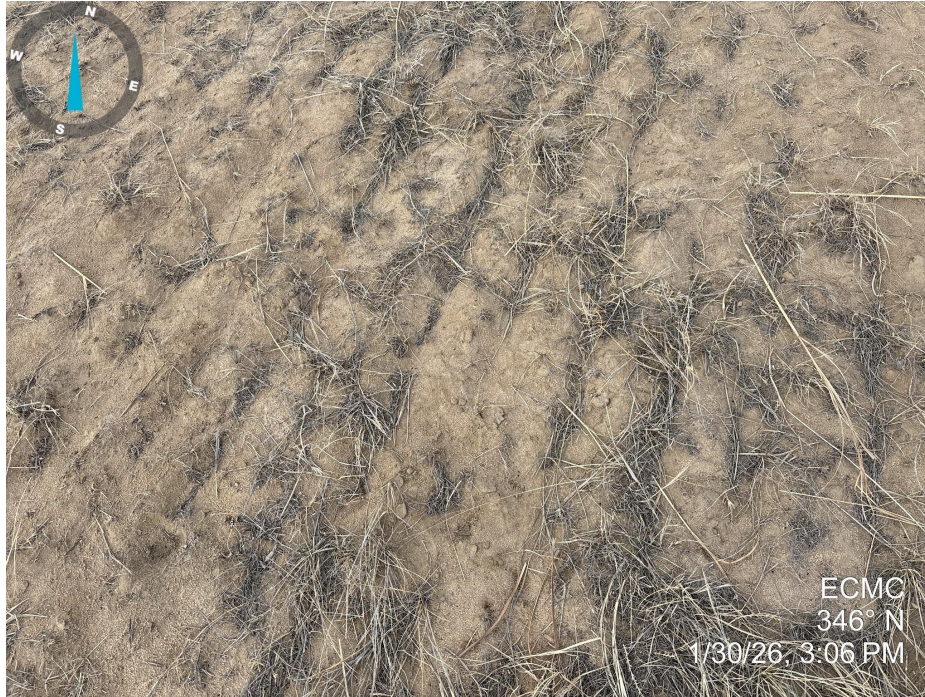
**Photo 5.** Photo taken of ground cover at the location. Photo illustrates drill rows from seeding and perennial grass.

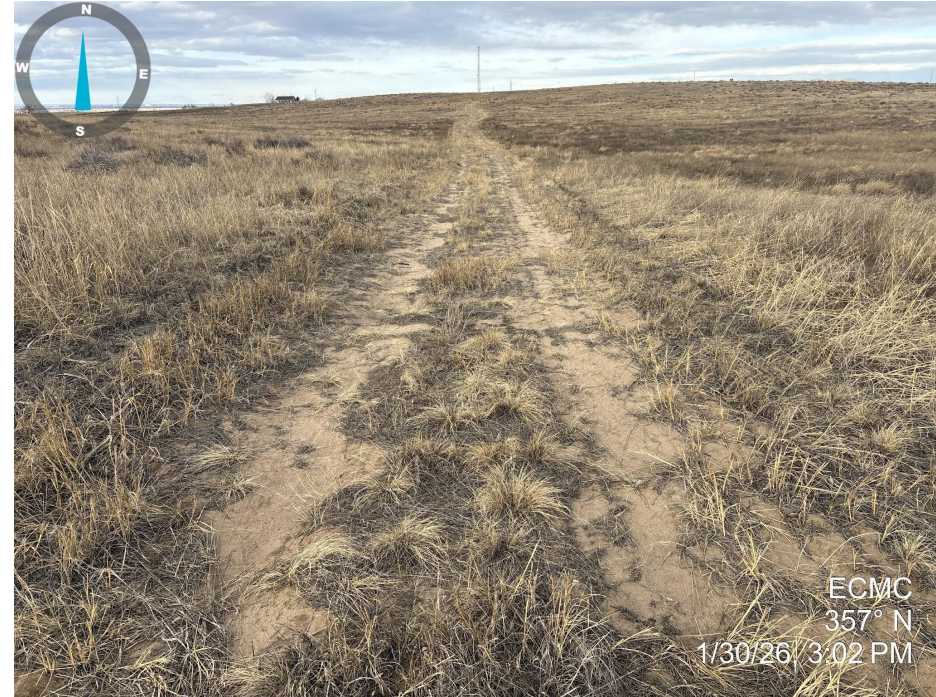
**Photo 6.** Photo taken of the access road to the location. Photo illustrates that final reclamation does not meet Rule 1004 standards along the road as bare ground remains.

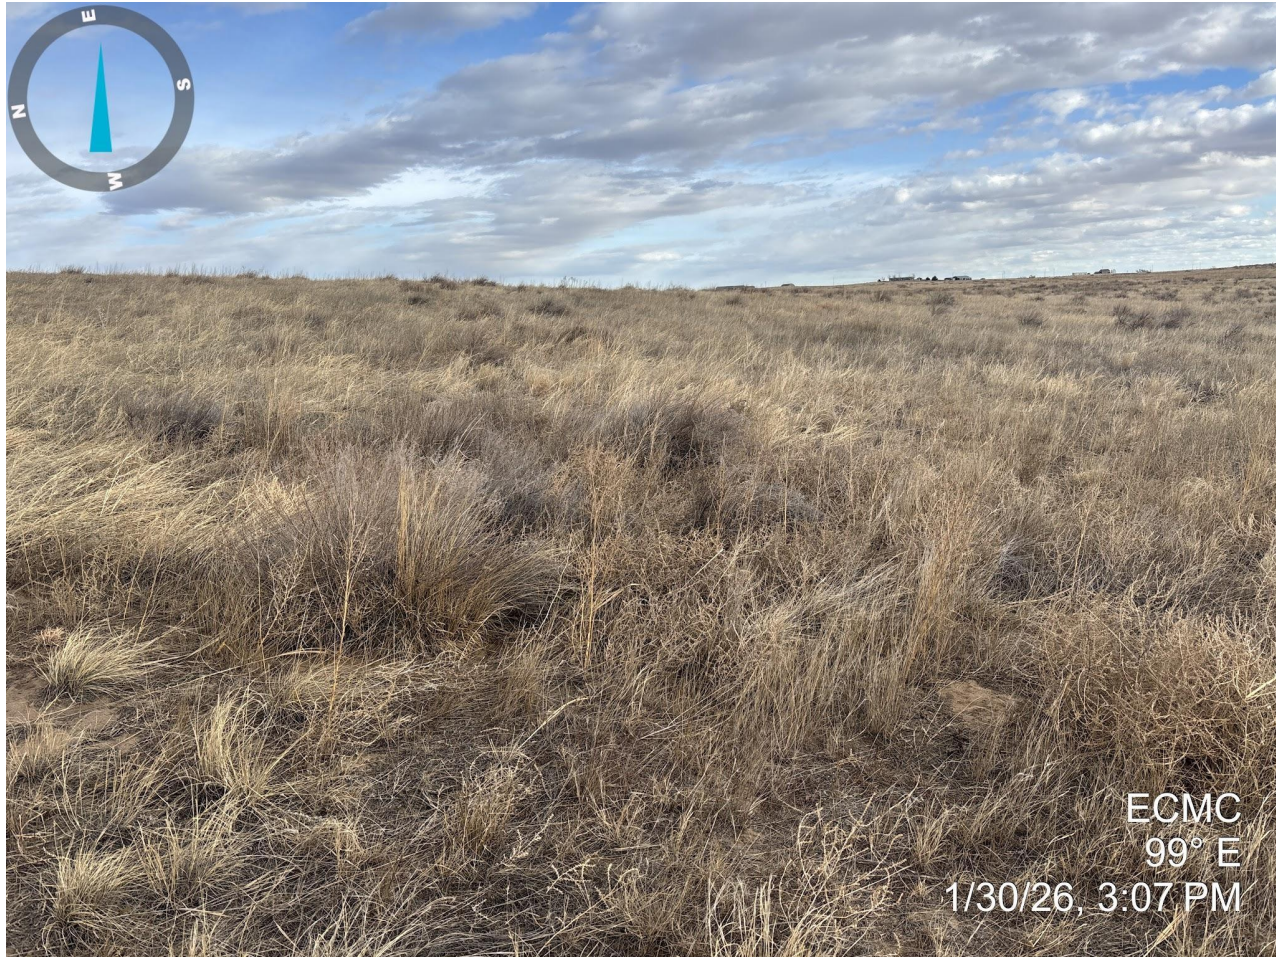
**Photo 7.** Photo taken of the reference area to the location, east of the location, facing east. Photo illustrates perennial grass and weedy annual vegetation.
