# Inspection Photos

Operator: QB Energy Operating LLC #10844

Location ID: 334927

Inspection Doc: 719200799

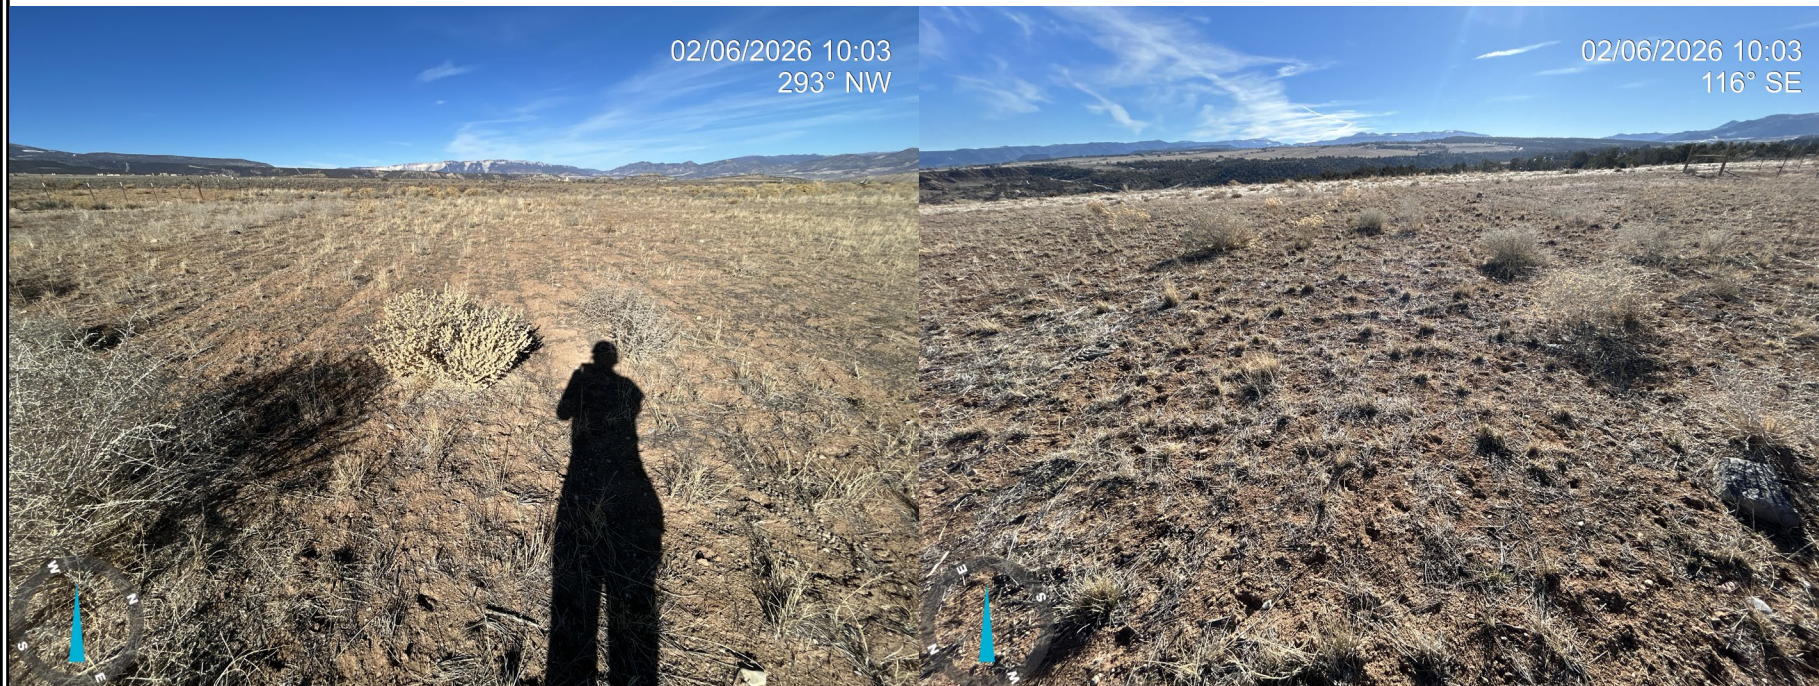
**Photo 1:** Photos showing an overview of the location looking northwest and southeast, respectively. The northern and northwestern portions of the location appear to be progressing towards 1004 final reclamation requirements.

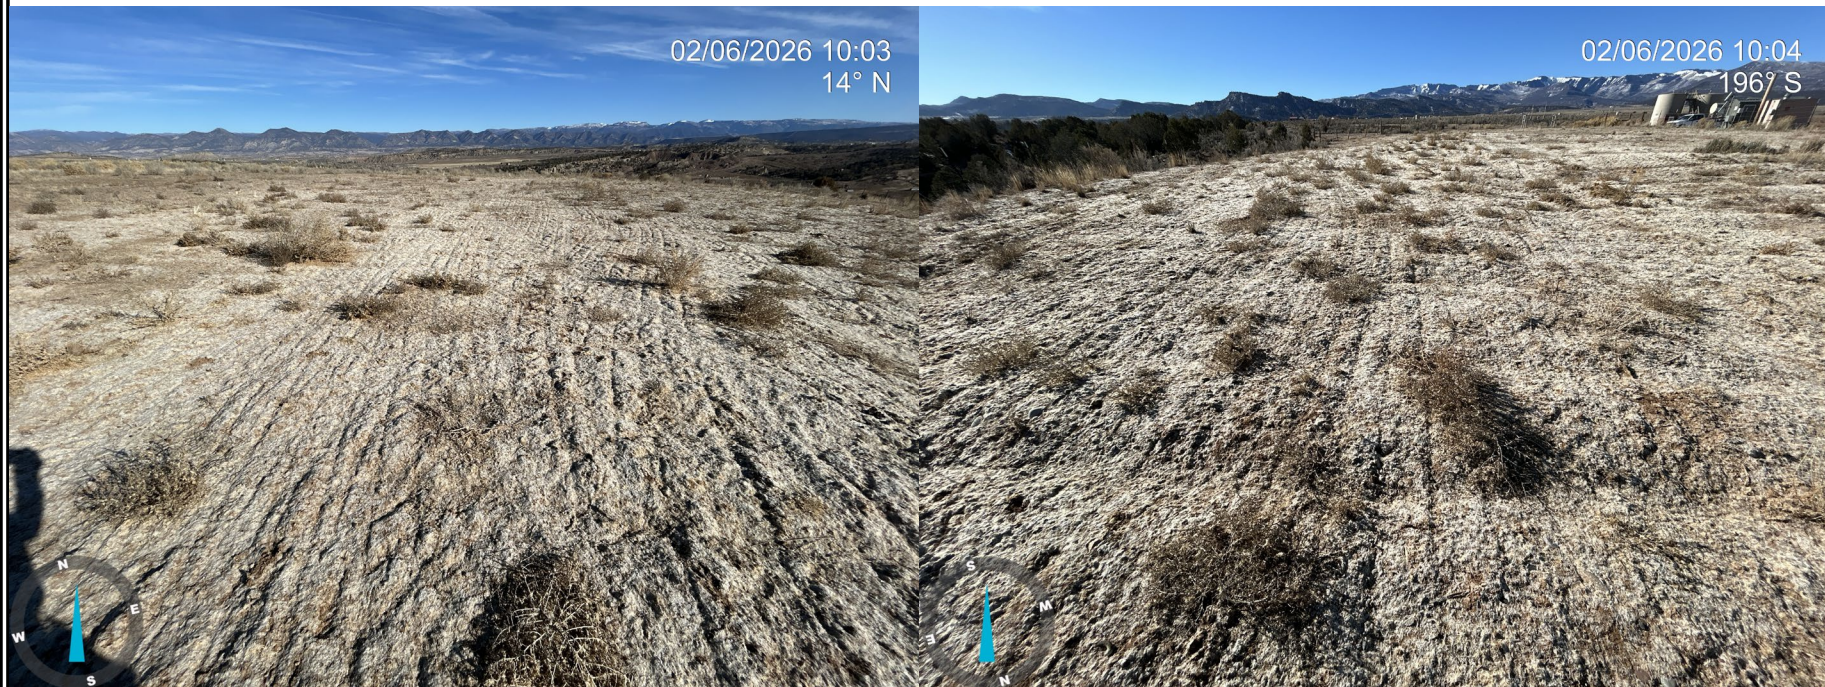
**Photo 2:** Photos showing an overview of the southern/southeastern portions of the location looking north and south, respectively. These portions of the location are predominantly bare or populated by prickly Russian thistle, an undesirable annual plant species, and do not appear to be progressing towards 1004 final reclamation requirements.

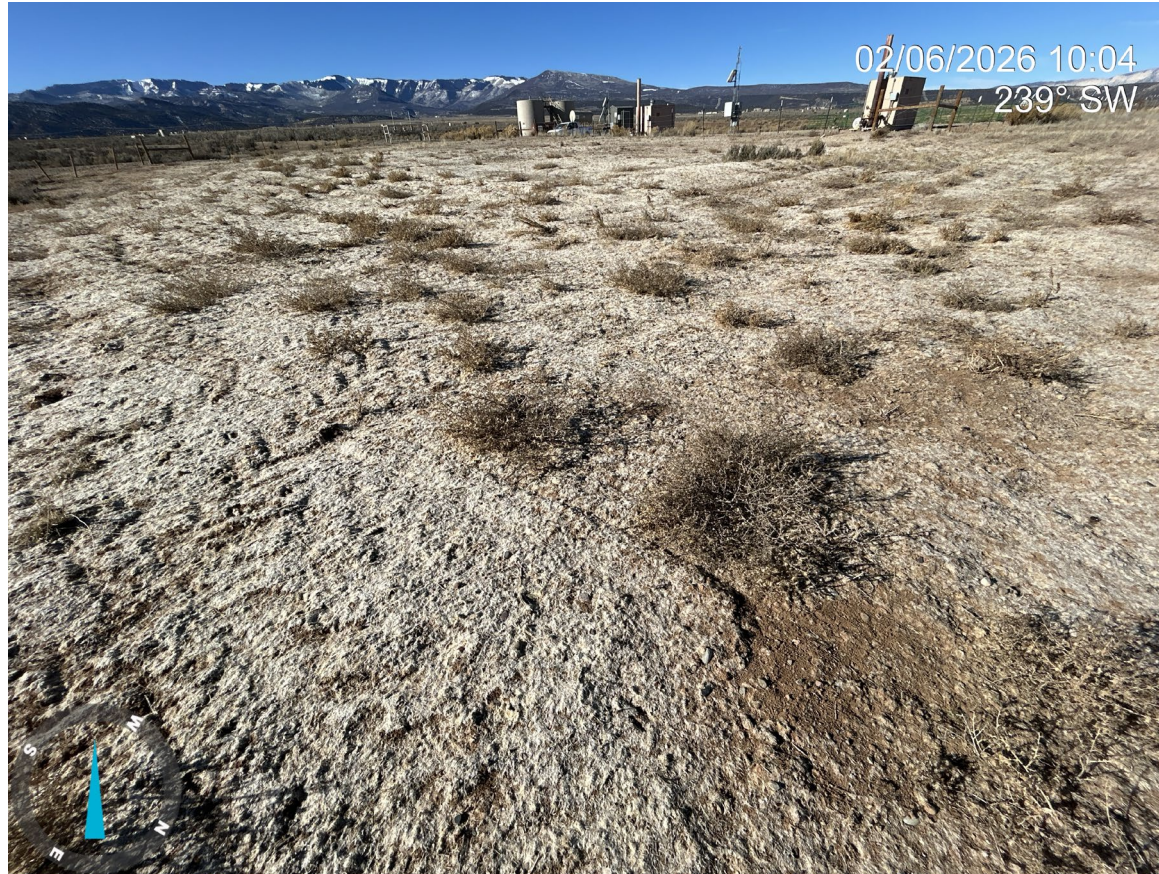
**Photo 3:** Photos showing an overview of the southern/southeastern portion of the location. These portions do not appear to be progressing towards 1004 final reclamation requirements.
