# INSPECTION PHOTOS

Well: Golden Eagle 33-12

API #: 05-071-09487

INSPECTION DOC #: 716301950

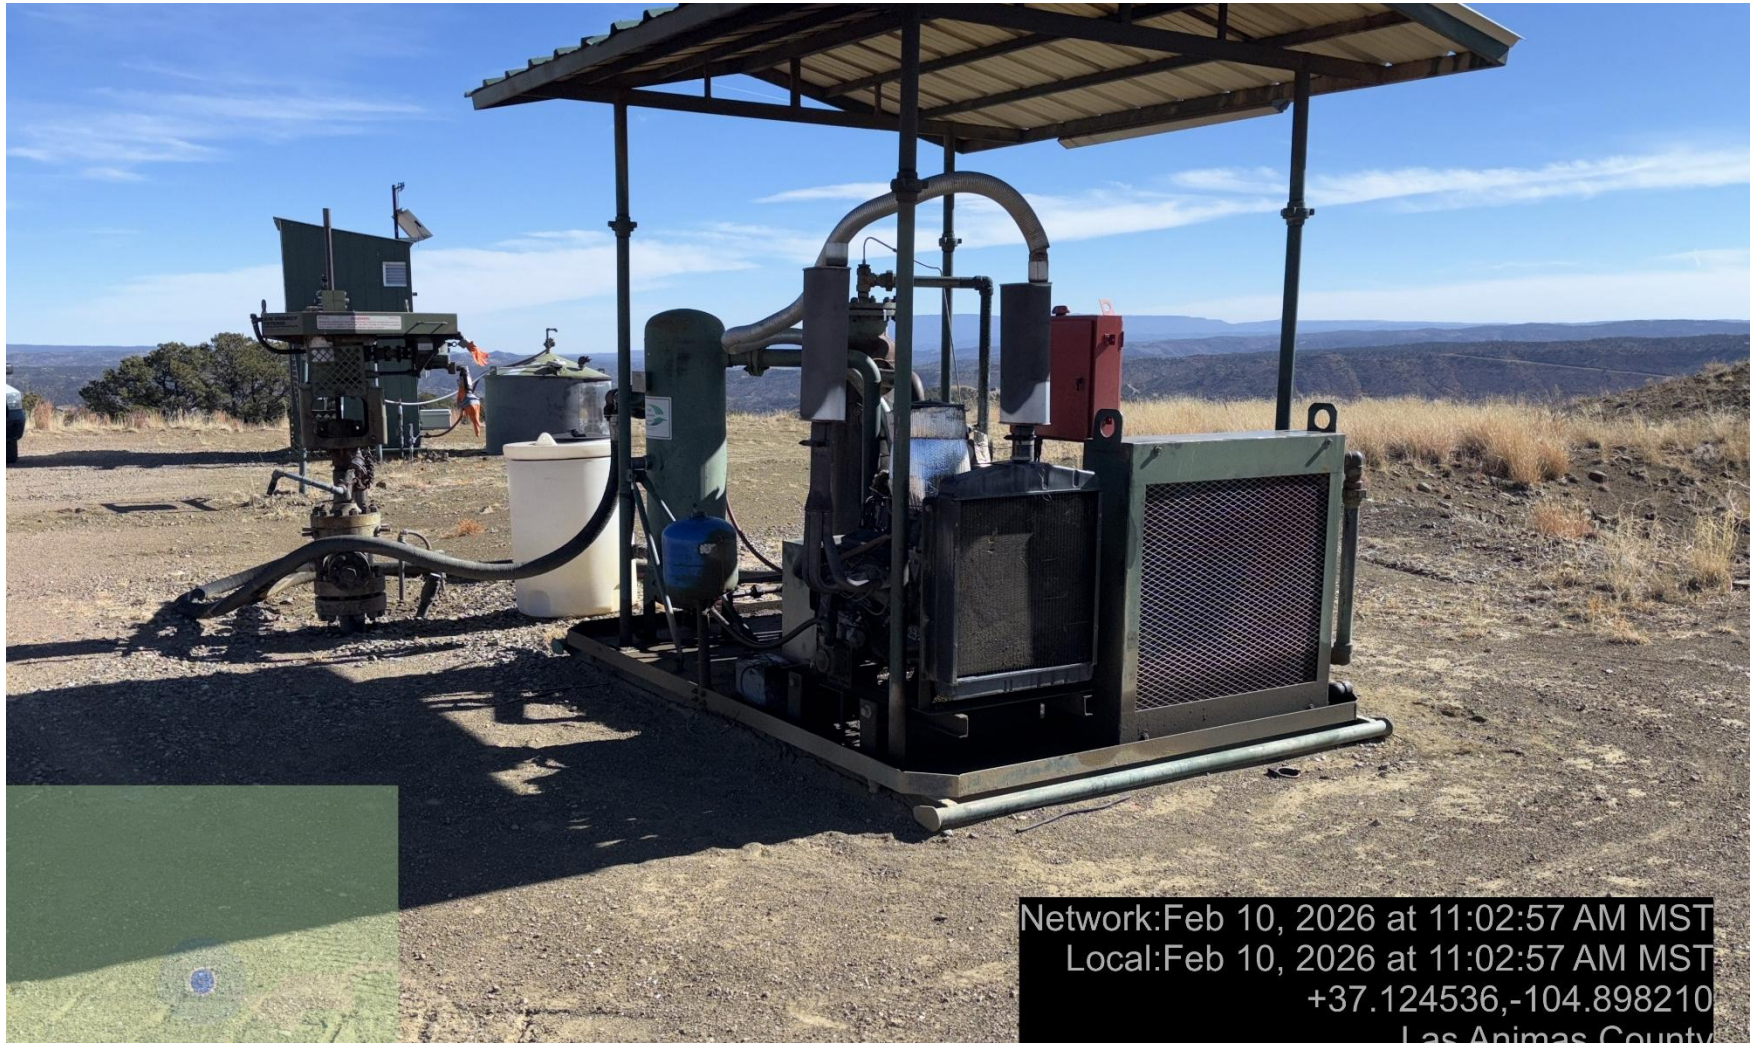
**PHOTO 4: Vacuum pump observed on well without ECMC approval. Provide ECMC with documentation showing approval of use of vacuum pump. Ca date 2-27-2026.**

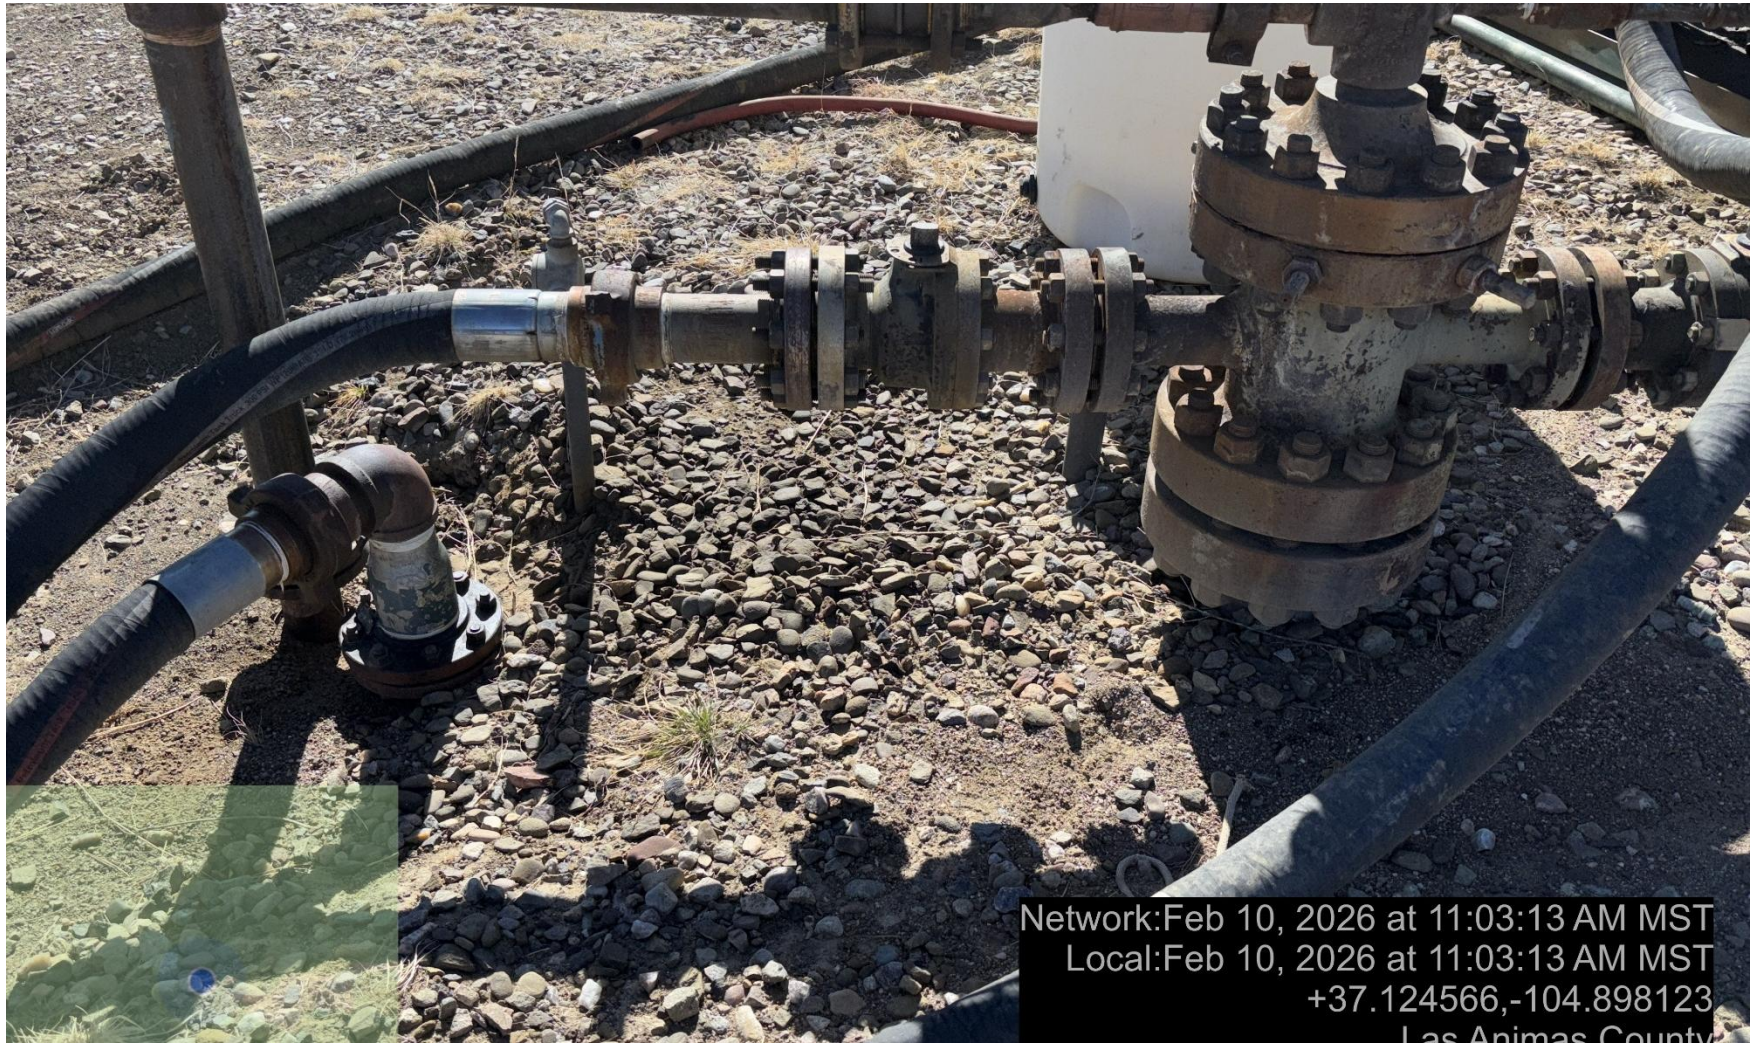
**PHOTO 5: Area of impacted soil near wellhead. Conduct maintenance on equipment, cleanup stained material and review self inspection processes. COMPLY WITH RULE 1002,(2).D. ca date 2-27-2026.**
