INSPECTION PHOTOS

Well: Golden Eagle 33-15

INSPECTION DOC #: 716301957

Operator: OGRIS OPERATING LLC 10758

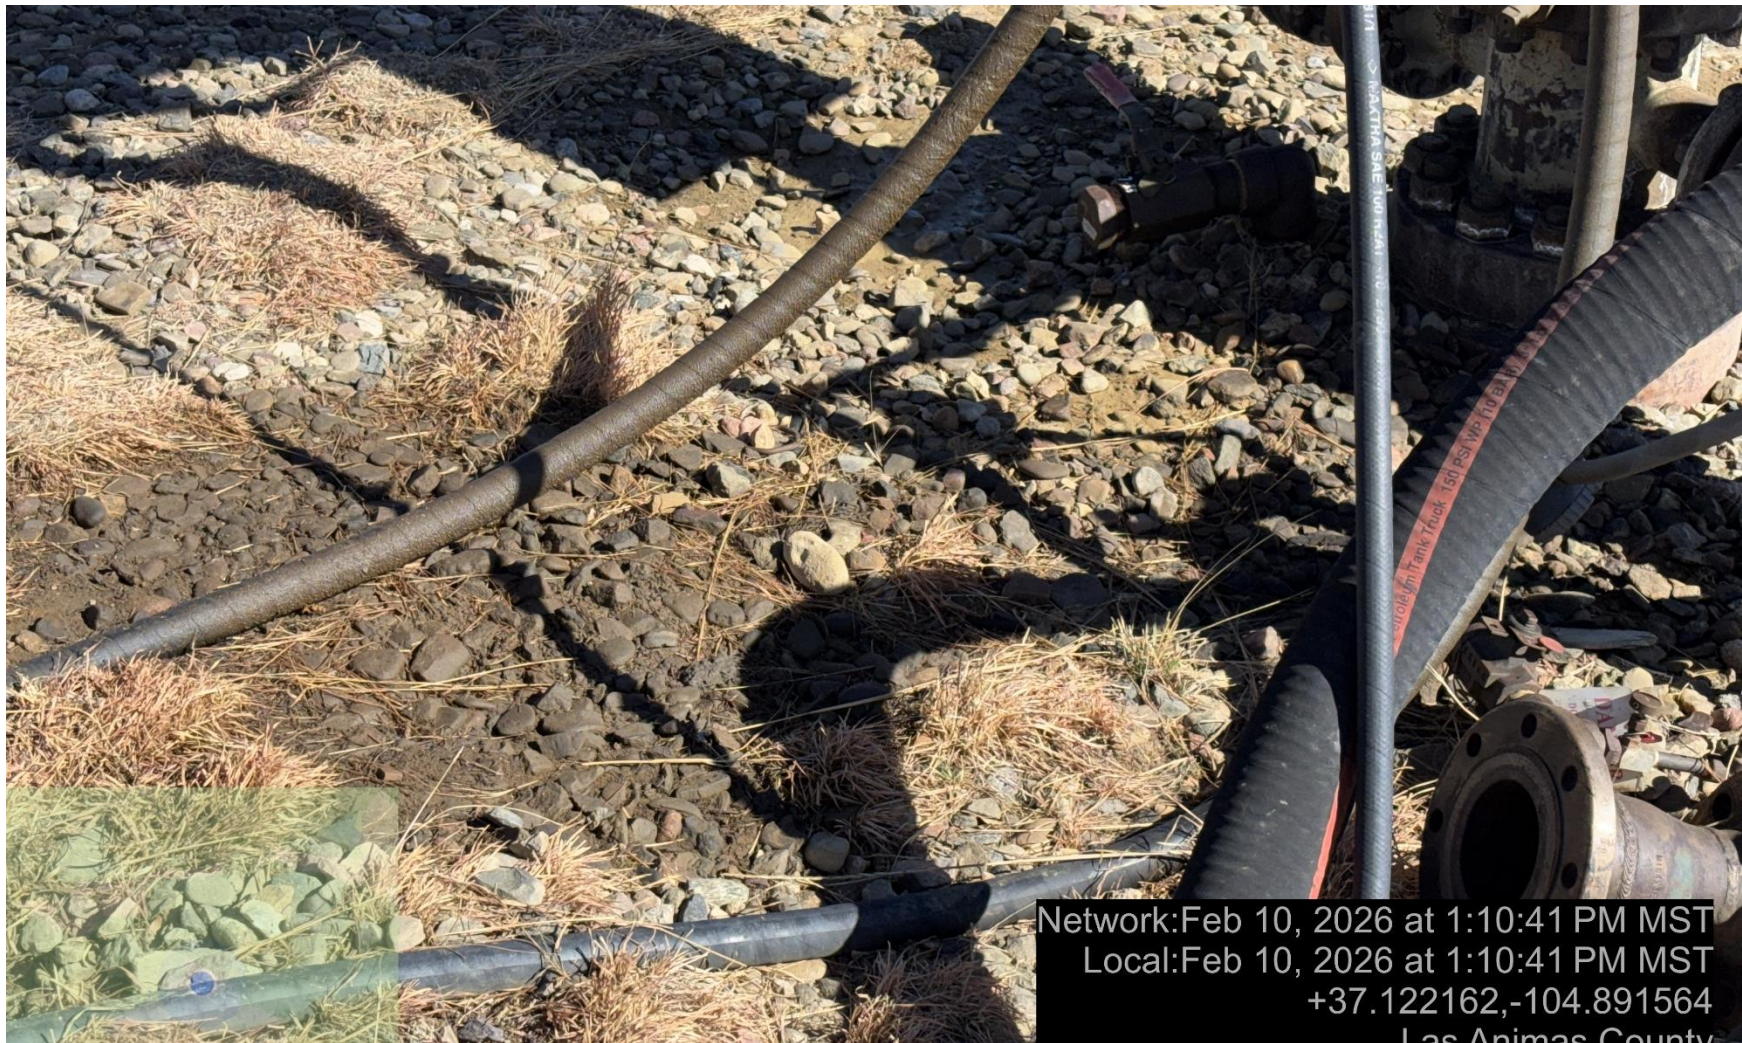
PHOTO 4: Vacuum pump observed on well without ECMC approval. Provide ECMC with documentation showing approval of use of vacuum pump. Ca date 2/23/2026.

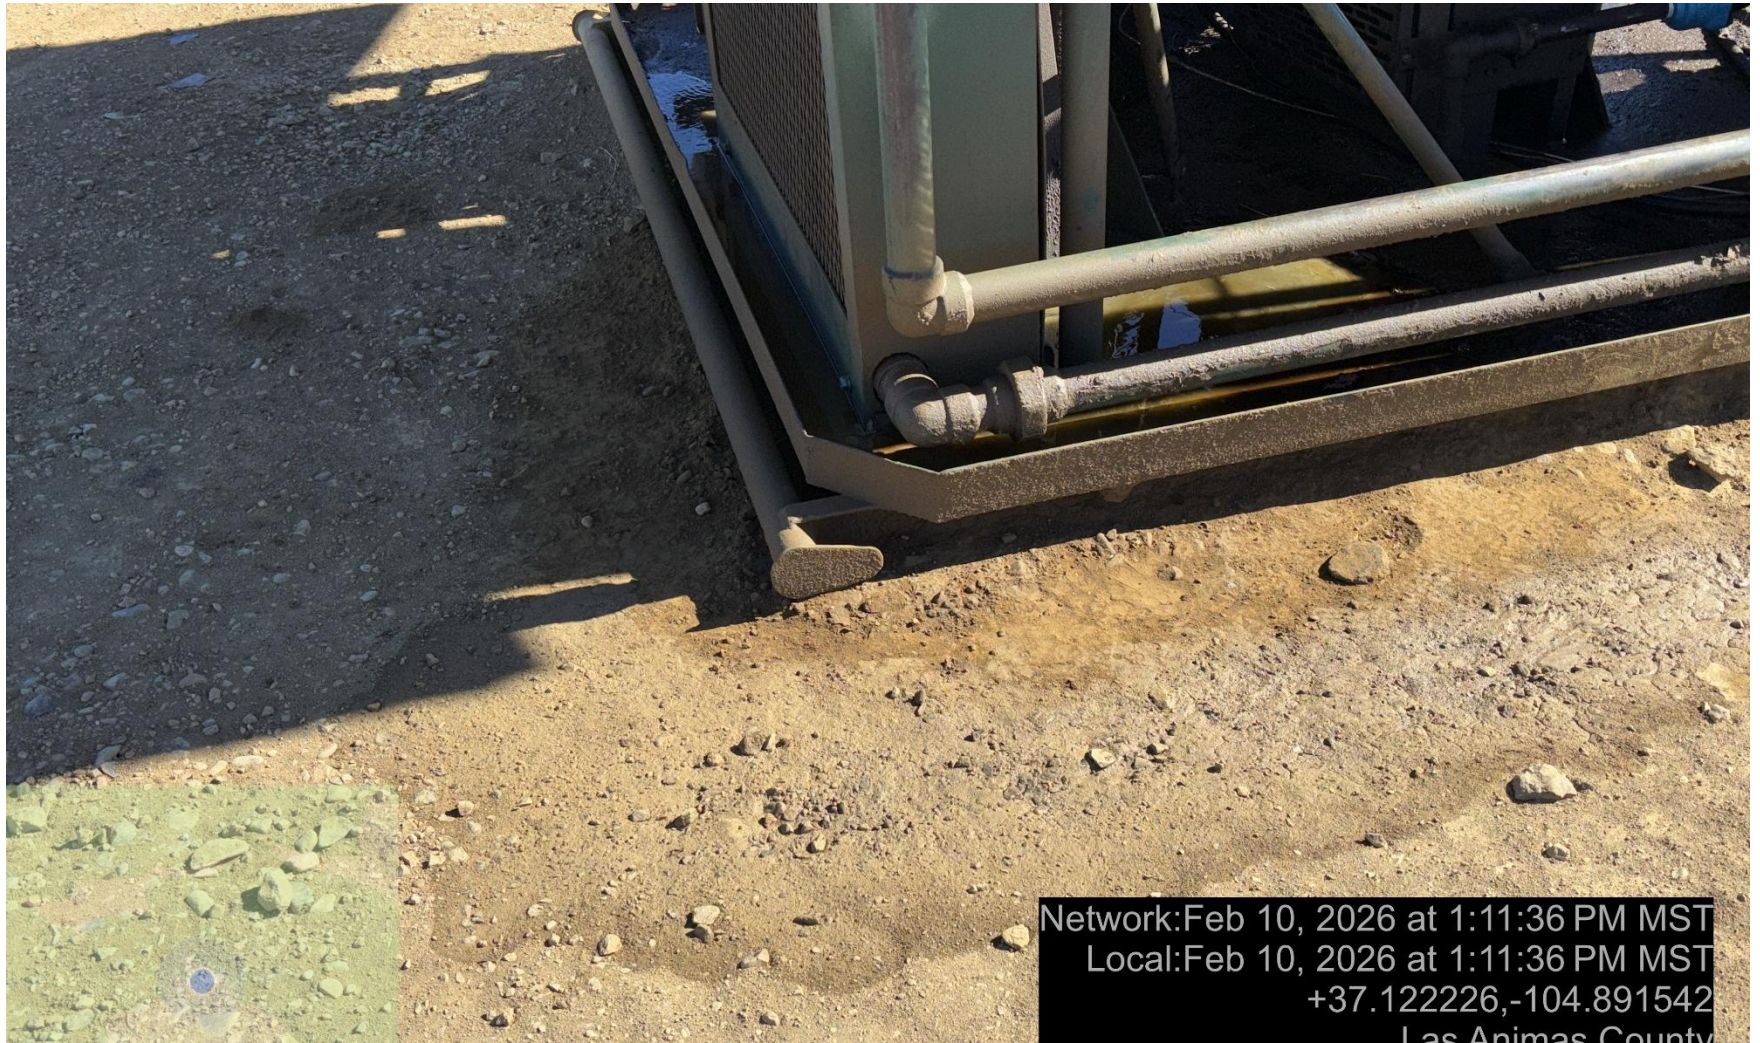
PHOTO 5: area of impacted soil near wellhead appears to be from leaking hydraulic hose. Conduct maintenance on equipment, cleanup stained material and review self inspection processes. COMPLY WITH RULE 1002,(2).D. ca date 2/23/2026.

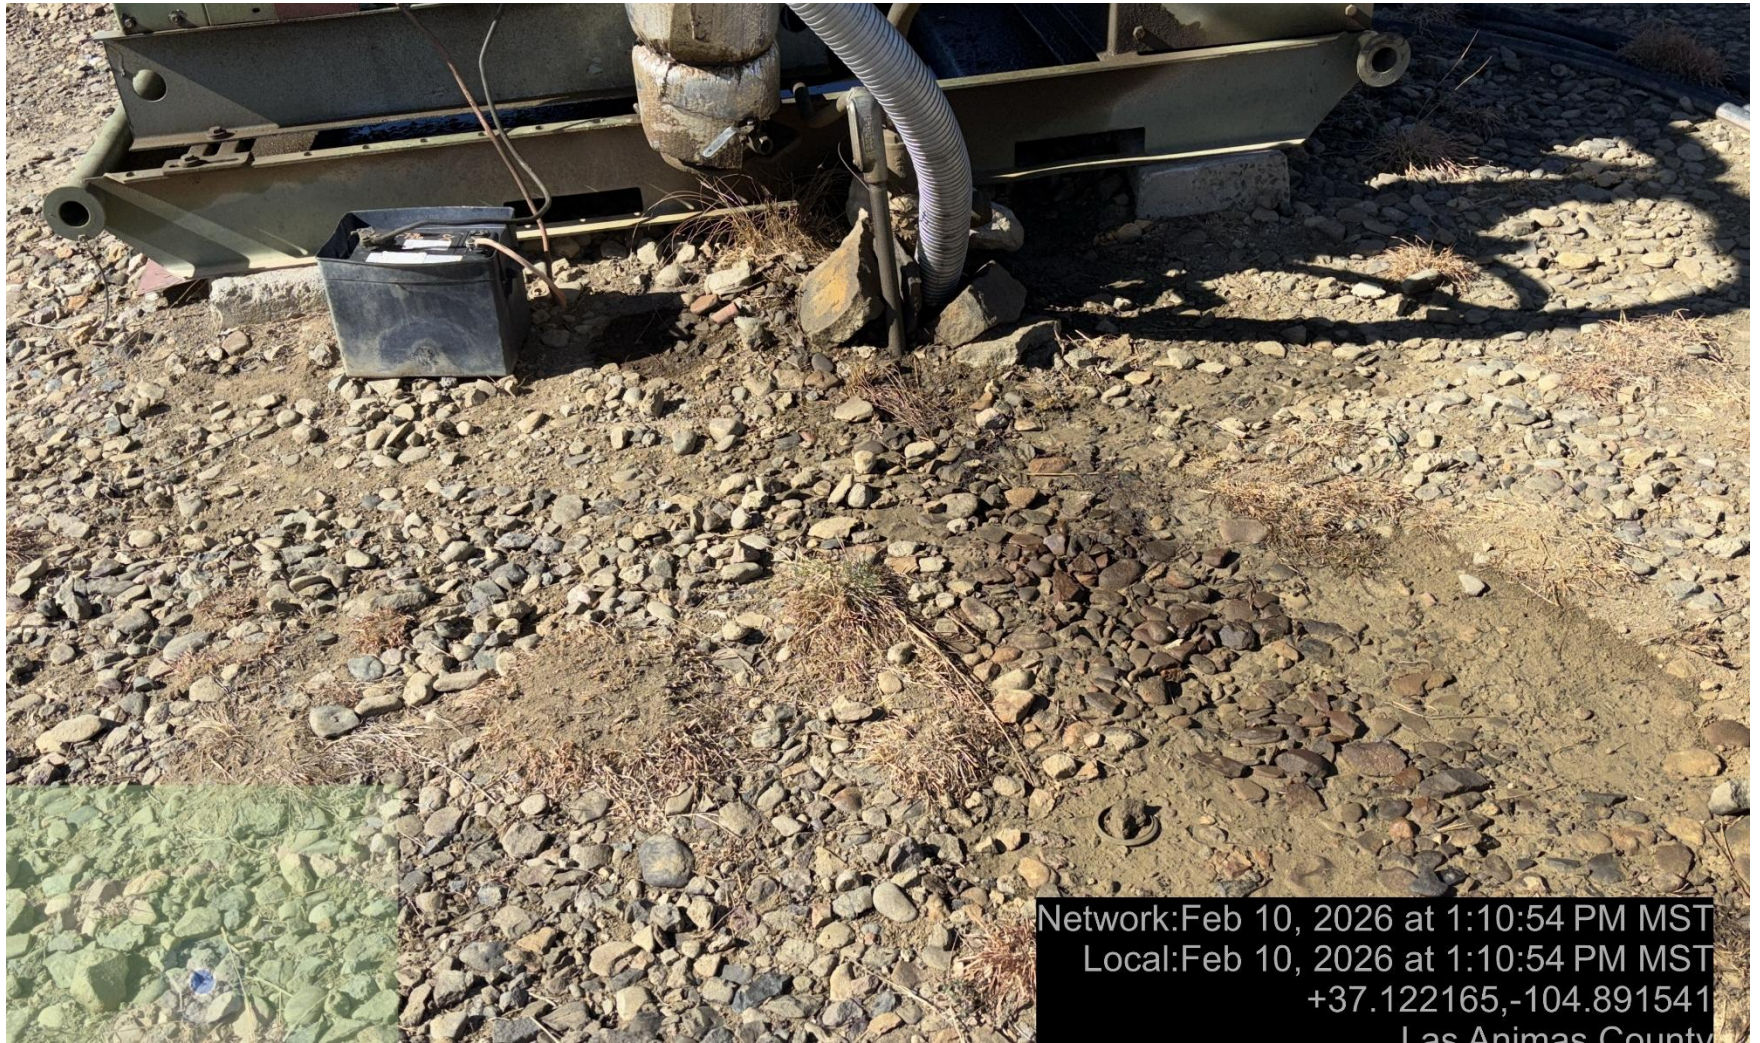
PHOTO 6: area of impacted soil near compressor skid. Conduct maintenance on equipment, cleanup stained material and review self inspection processes. COMPLY WITH RULE 1002,.(2).D. ca date 2/23/2026.

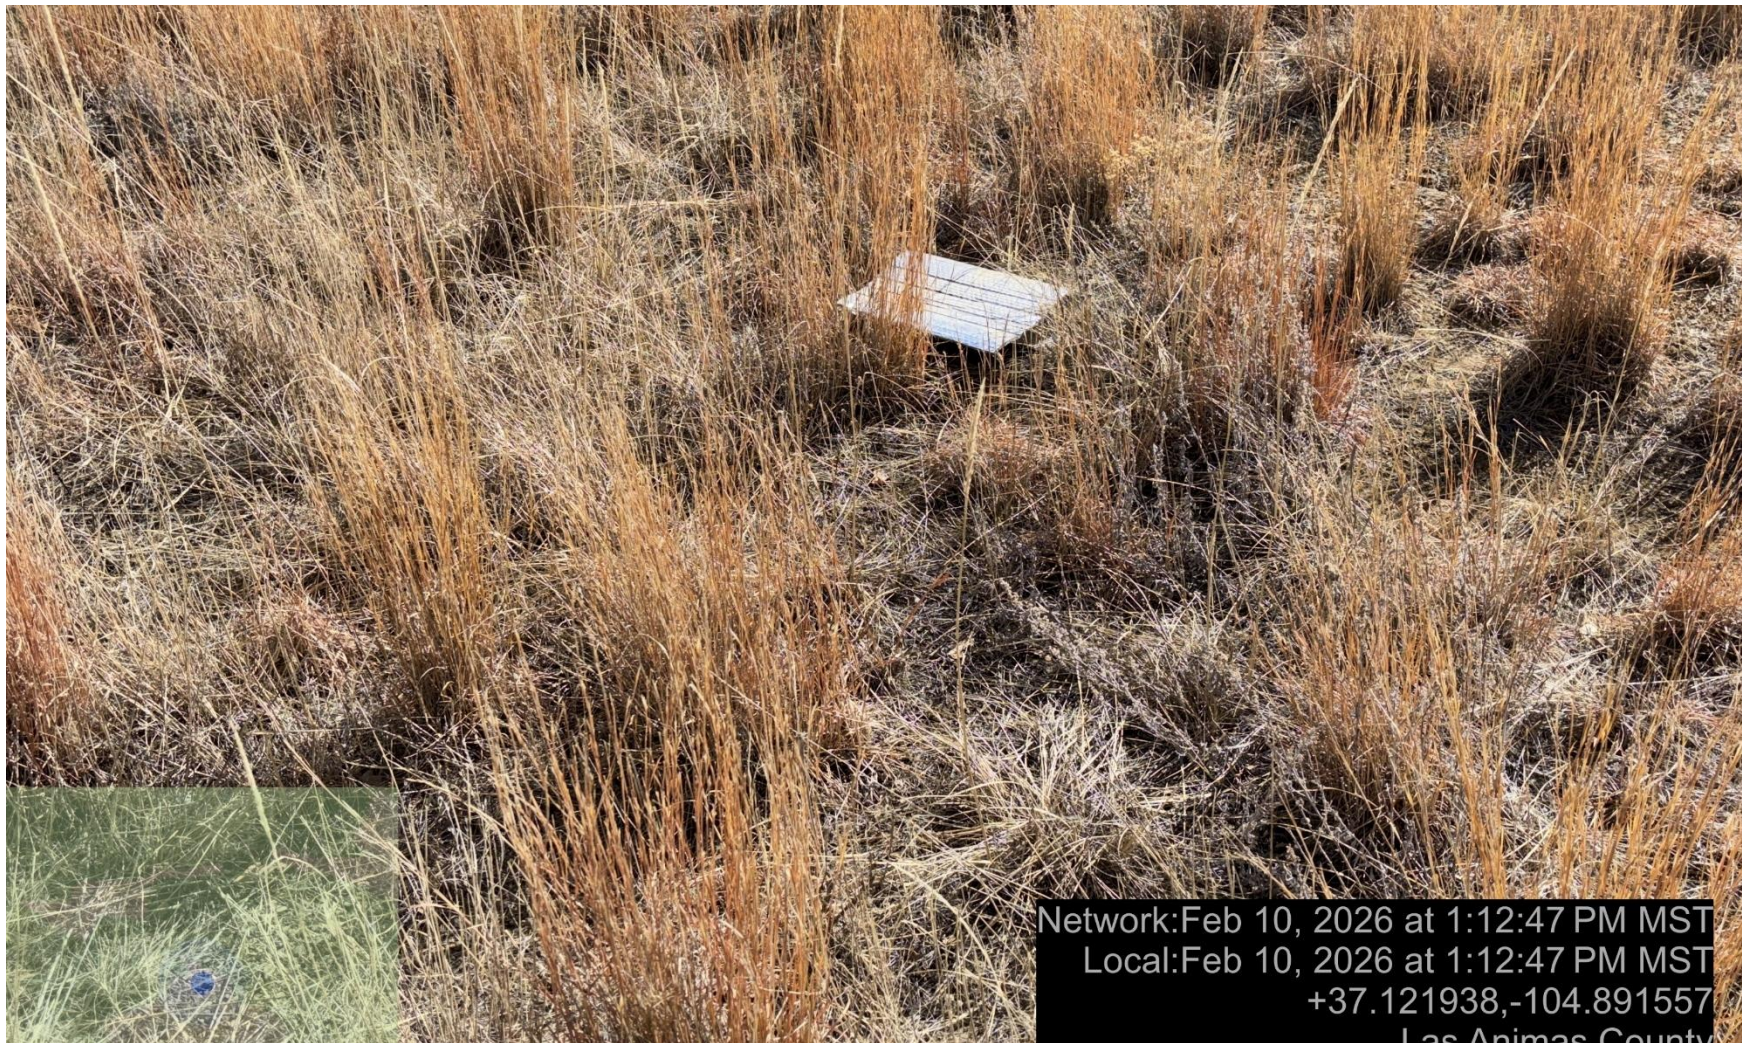
PHOTO 7: area of impacted soil near prime mover engine skid. Conduct maintenance on equipment, cleanup stained material and review self inspection processes. COMPLY WITH RULE 1002,(2).D. ca date 2/23/2026.

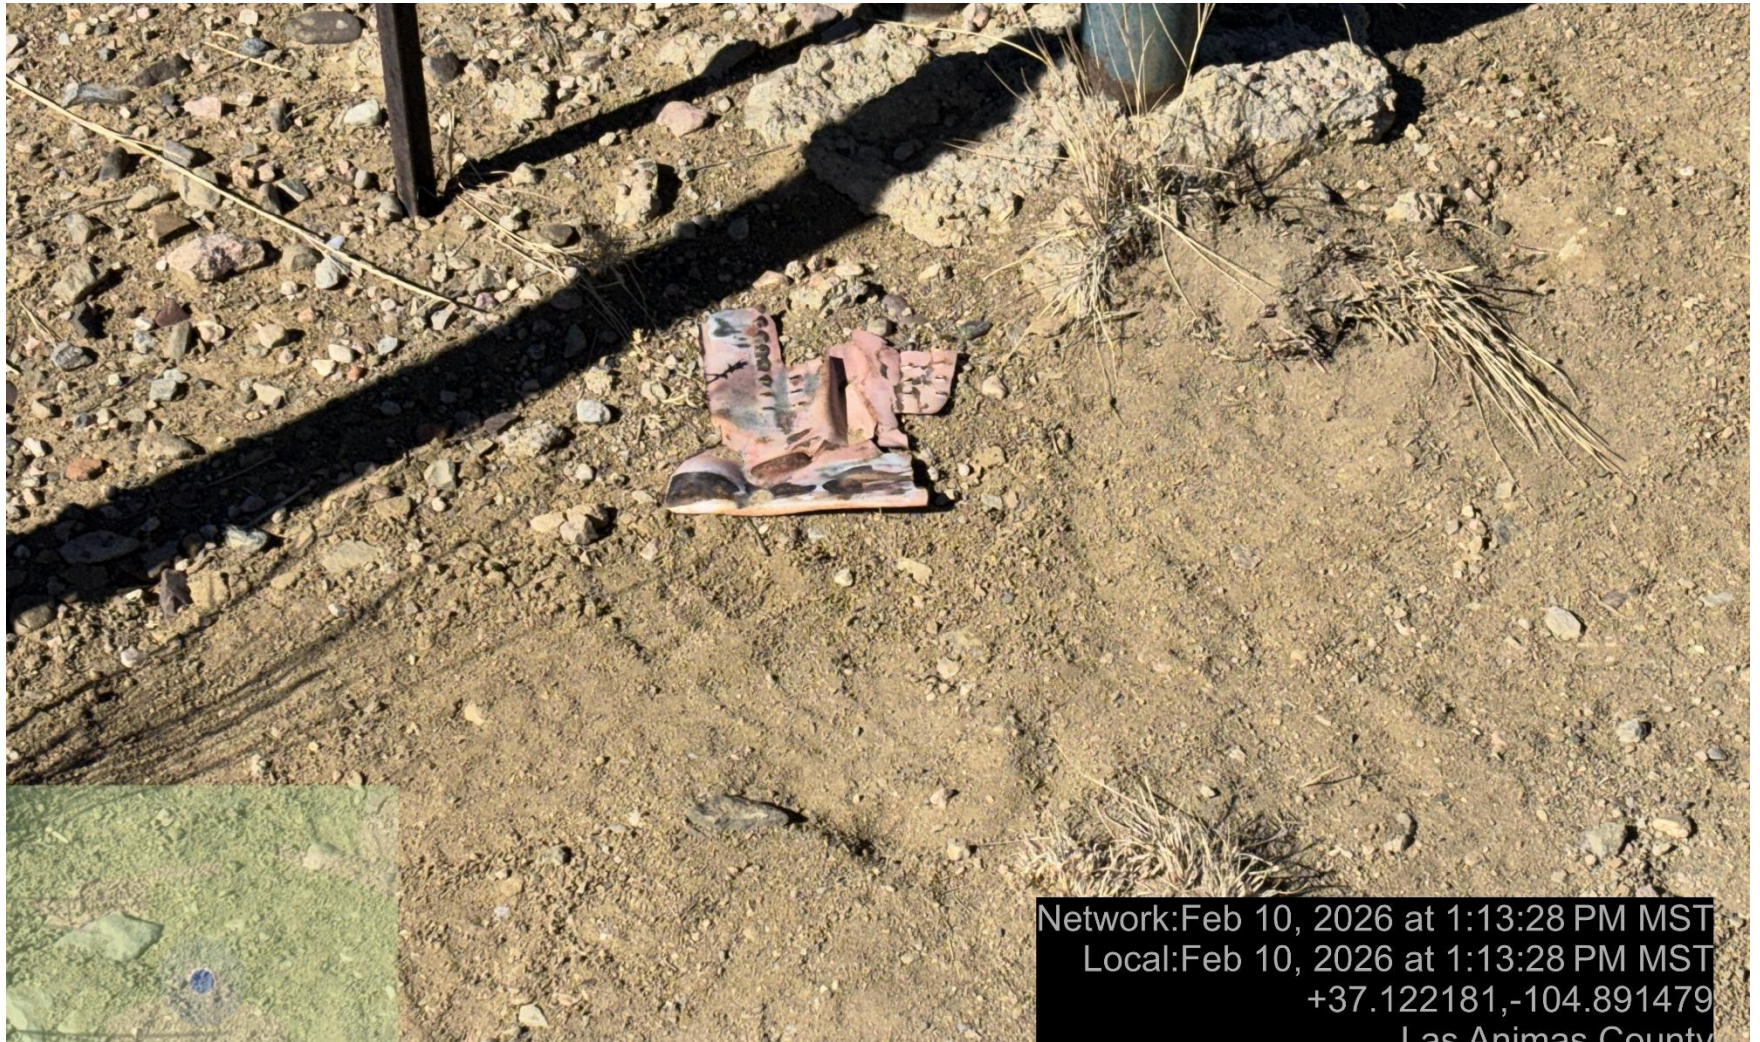
PHOTO 8: trash on south side of location. **Remove all trash on and around location per rule 606. ca date 2/23/2026.**

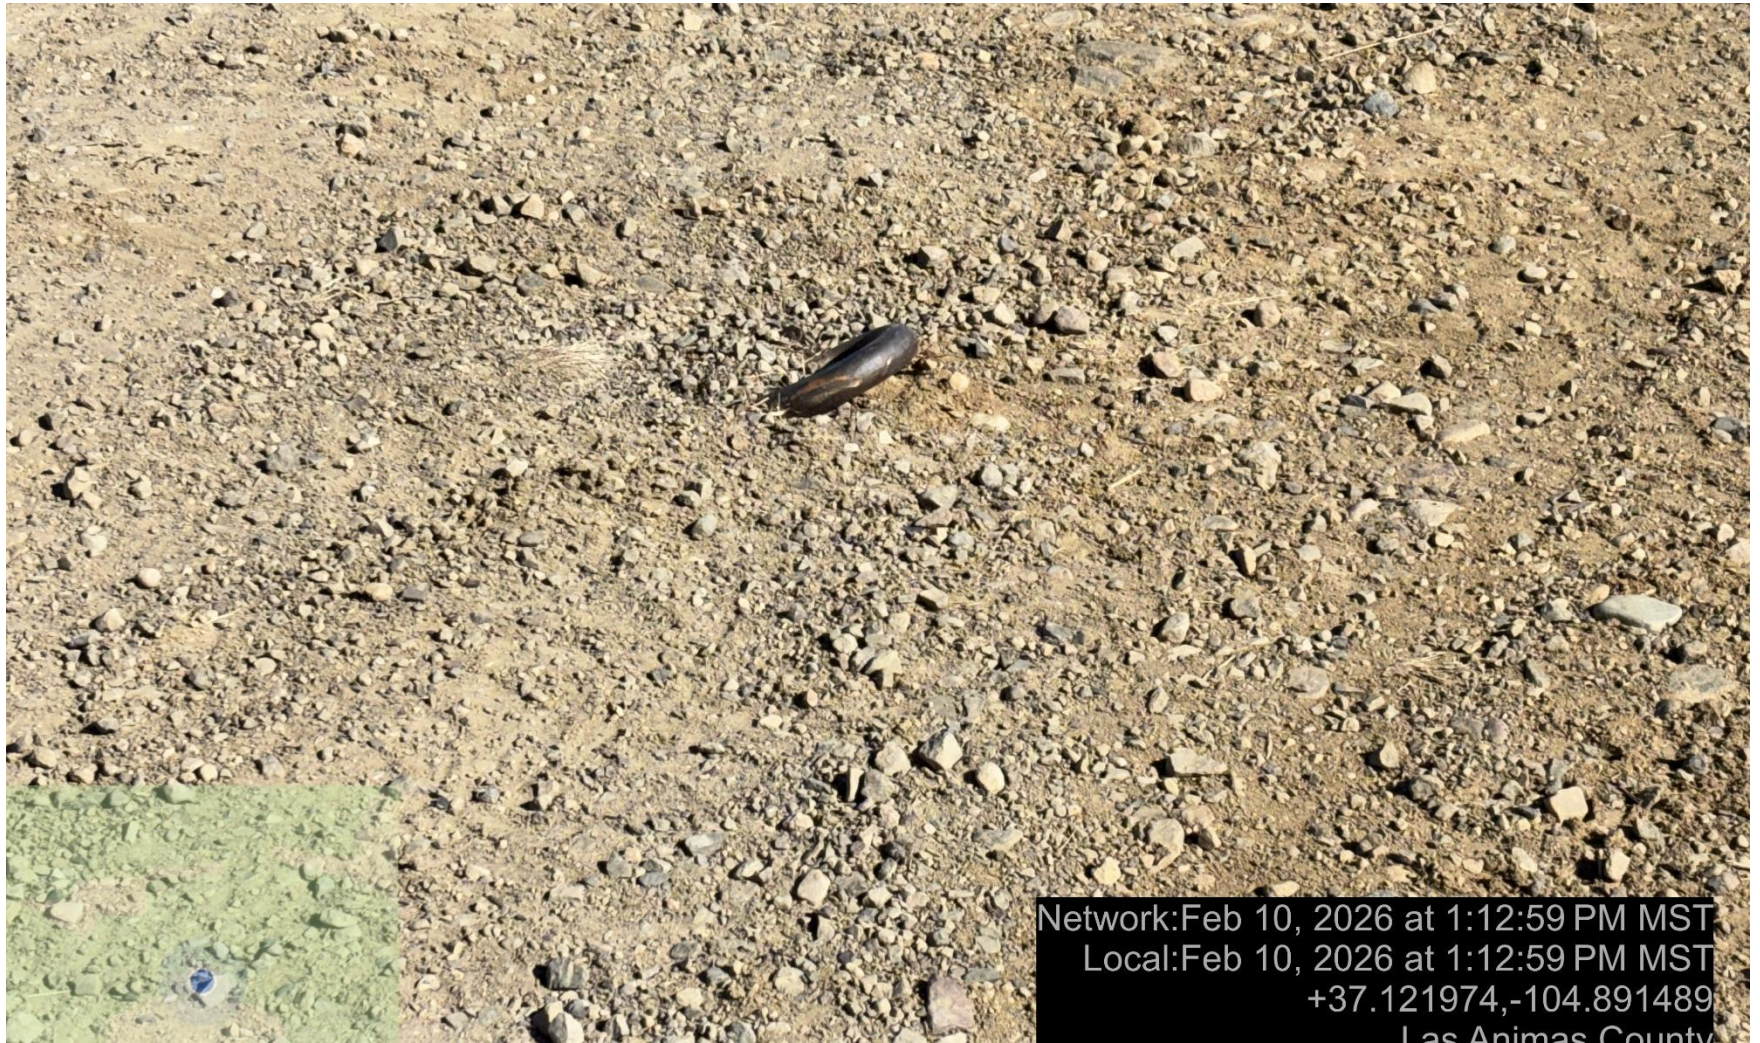
PHOTO 9: trash near compressor skid. Remove all trash on and around location per rule 606. ca date 2/23/2026.

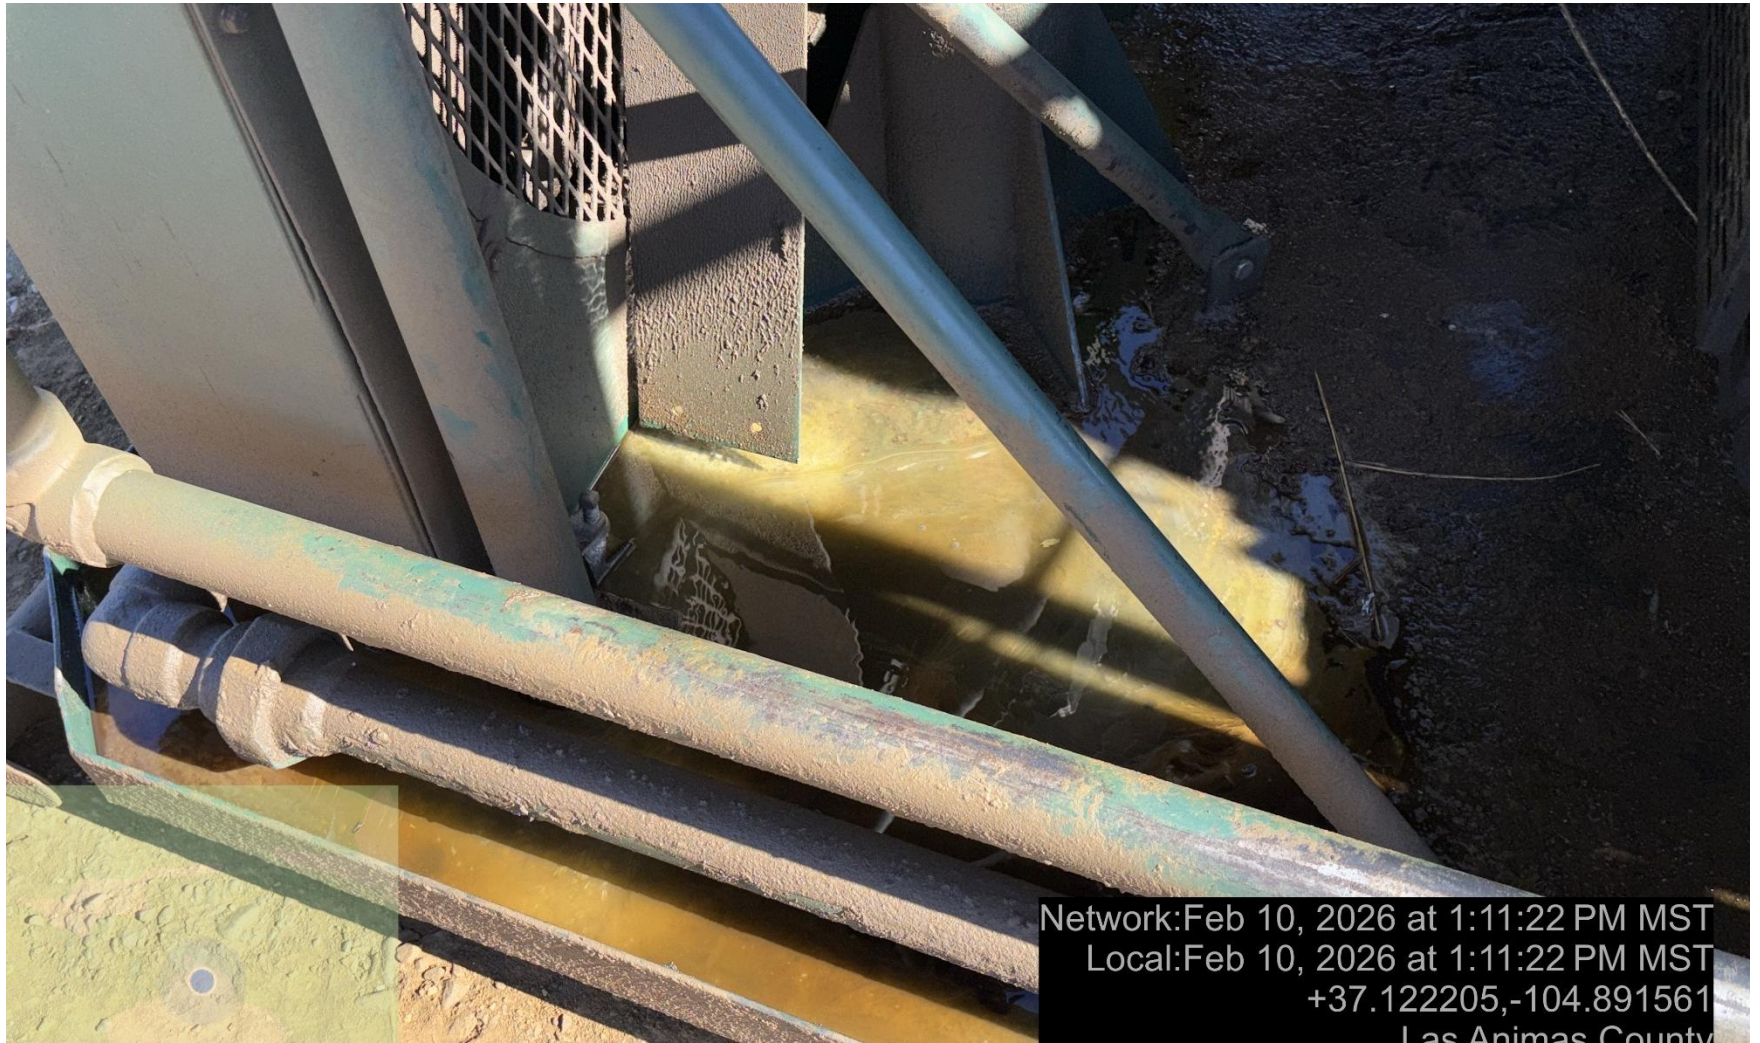
PHOTO 10: no guy line marker on southeast anchor. **Install proper guy line markers per Rule 1003.a. ca date 2/23/2026.**

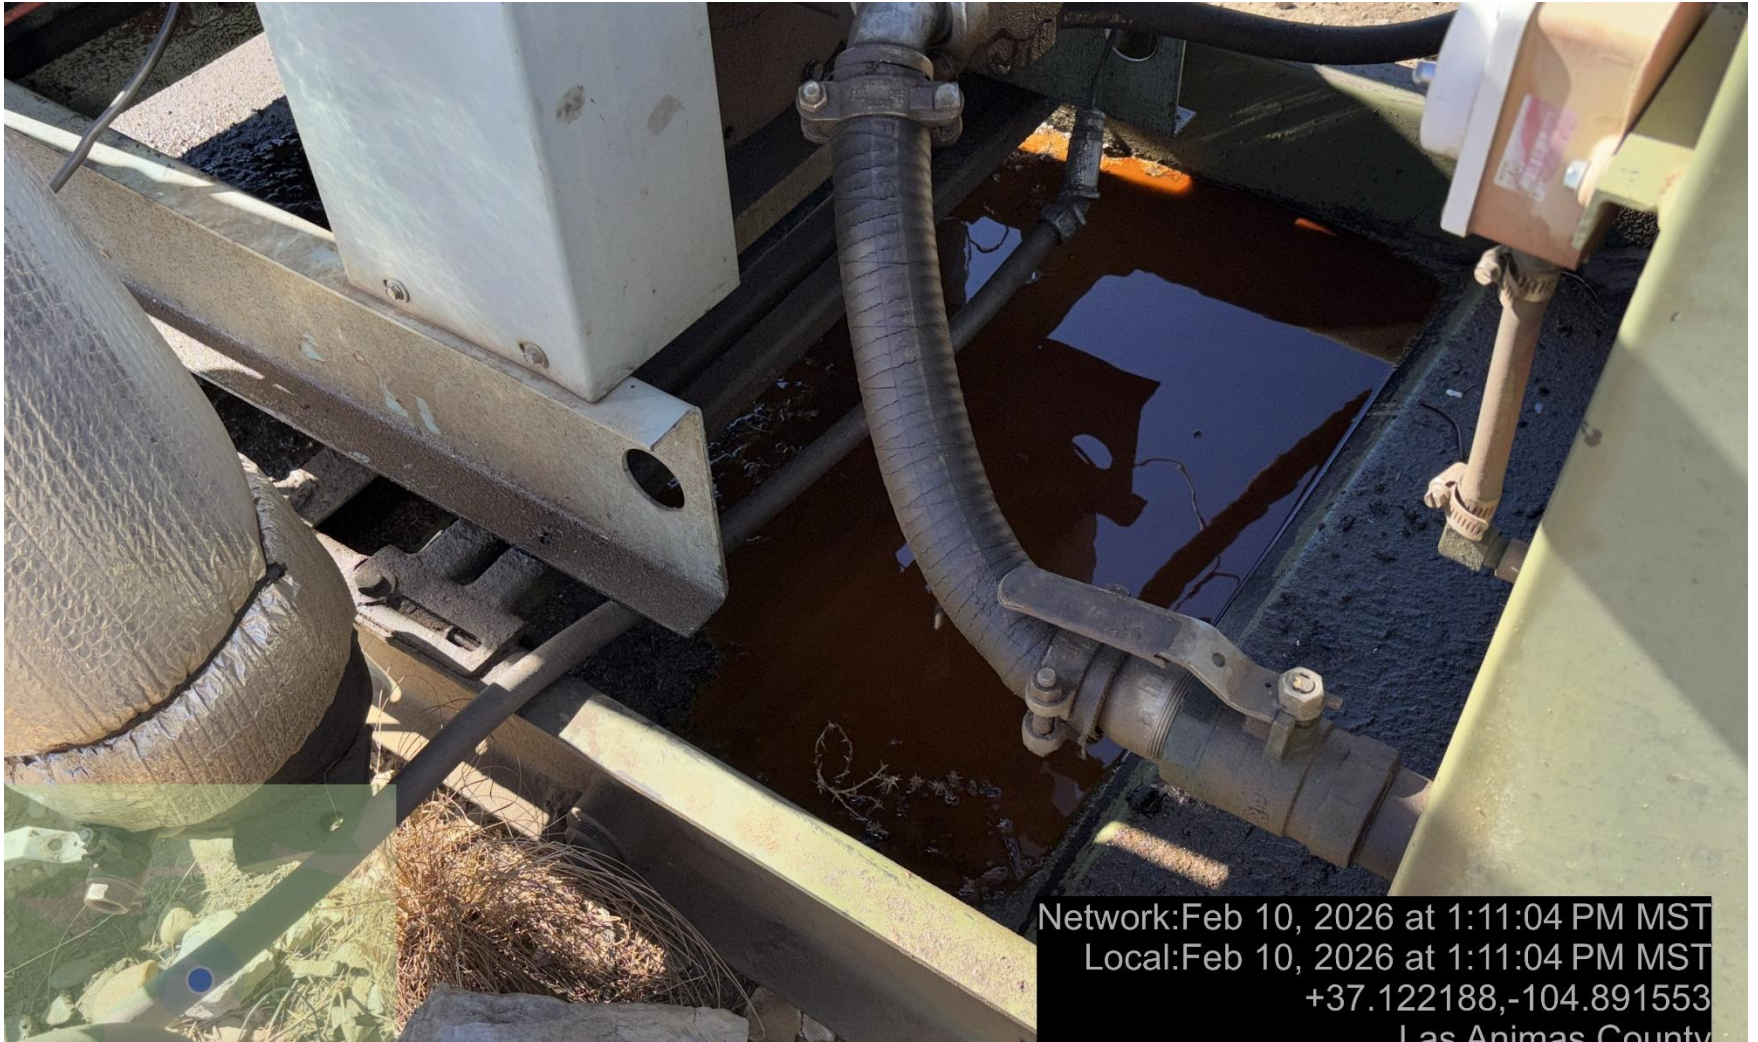
PHOTO 12: OILY WASTE IN COMPRESSOR SKID WITHOUT WILDLIFE PROTECTION SCREENS OR COVERS. DRAIN OILY WASTE REPAIR ALL LEAKS AND REMOVE IMPACTED SOIL PER RULE 1002..(2).D & 1002.f.(2)B, Comply with general provisions of the oil and gas act for wildlife protection AND SB-181. IMMEDIATE ACTION IS REQUIRED. CA DATE 2/11/2026.
