INSPECTION PHOTOS

Well: Apache Canyon 04-01

INSPECTION DOC #: 716301959

Operator: OGRIS OPERATING LLC 10758

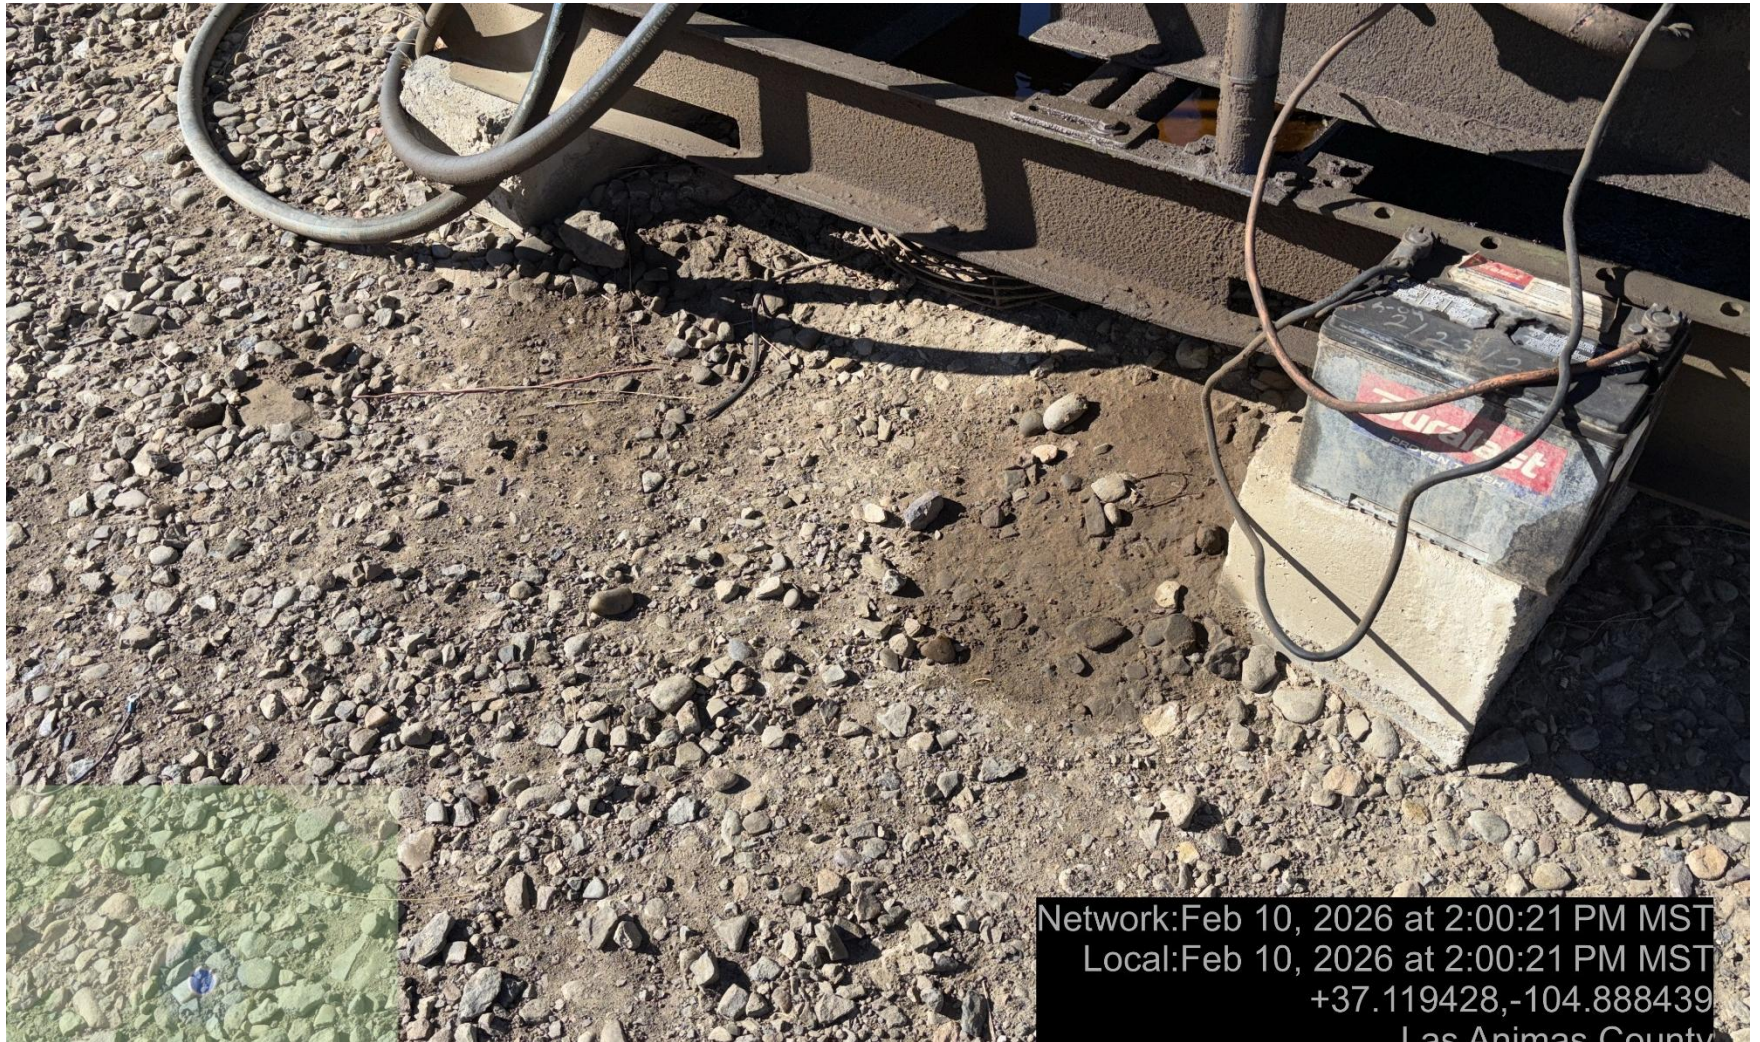
PHOTO 5: Area of impacted soil near wellhead appears to be from leaking hydraulic hose. Conduct maintenance on equipment, cleanup stained material and review self inspection processes. COMPLY WITH RULE 1002,(2).D. ca date 2/23/2026.

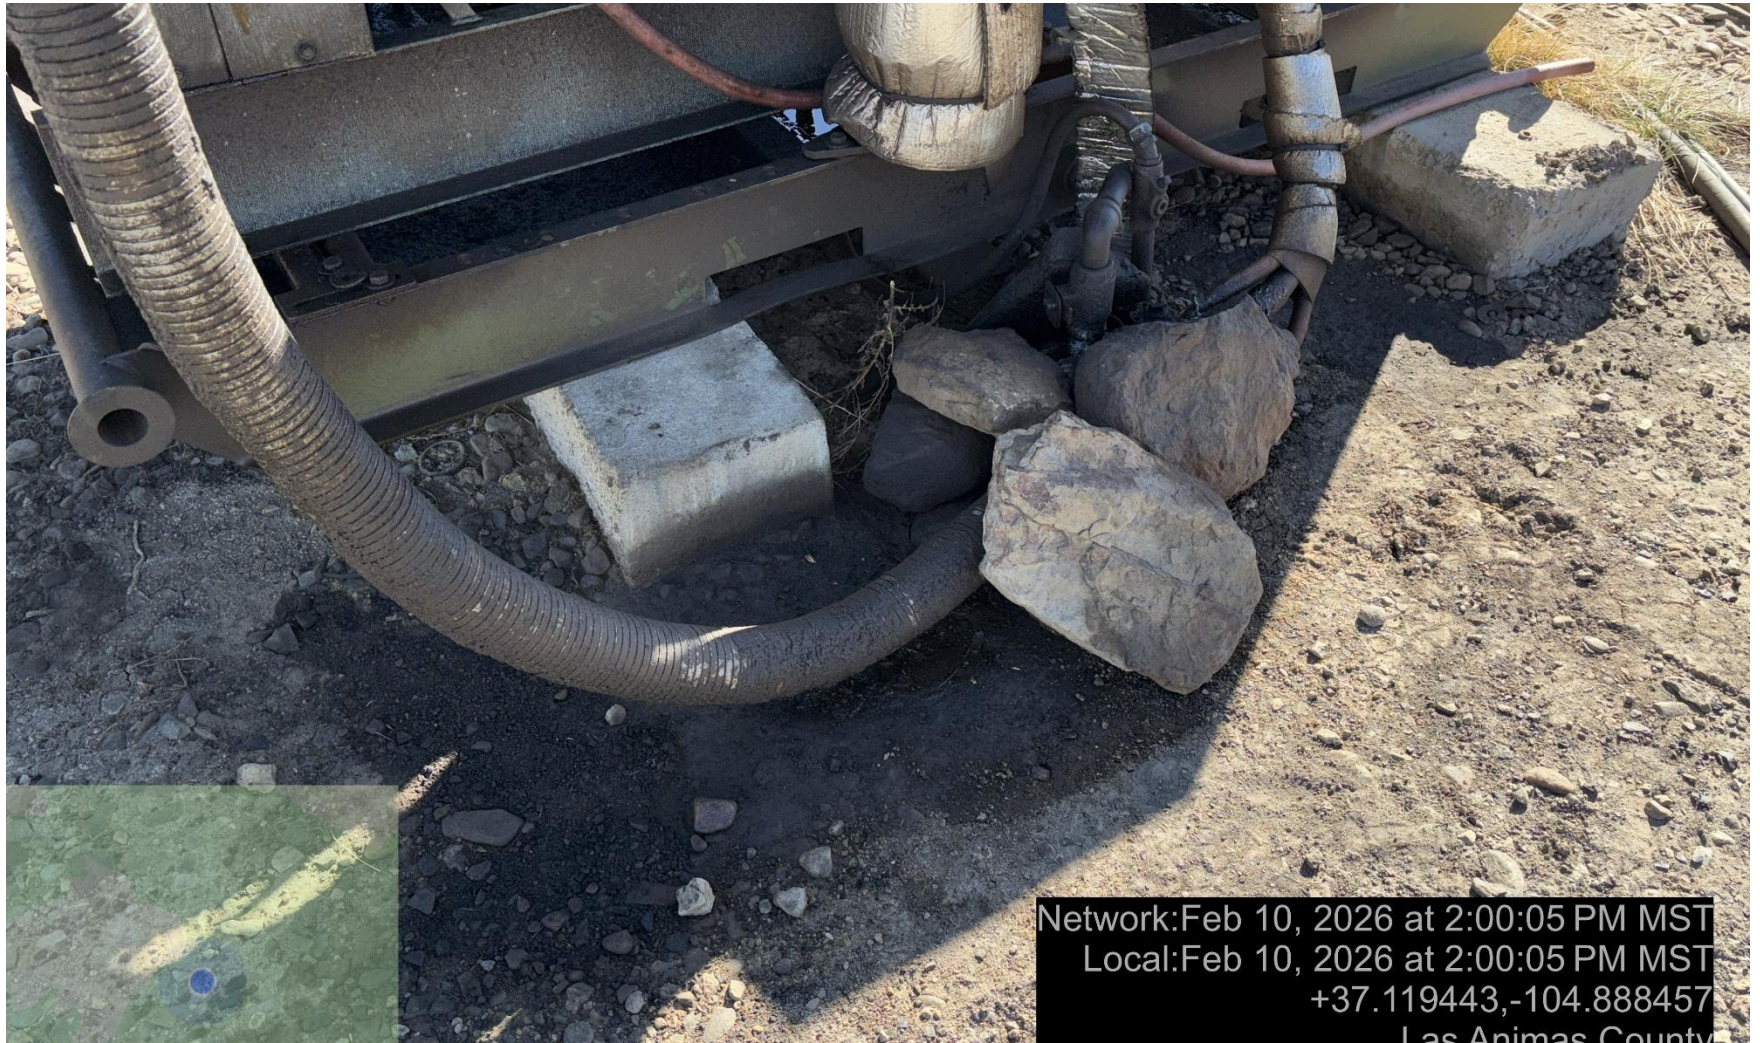
PHOTO 6: Area of impacted soil near prime mover engine skid. Conduct maintenance on equipment, cleanup stained material and review self inspection processes. COMPLY WITH RULE 1002,(2).D. ca date 2/23/2026.

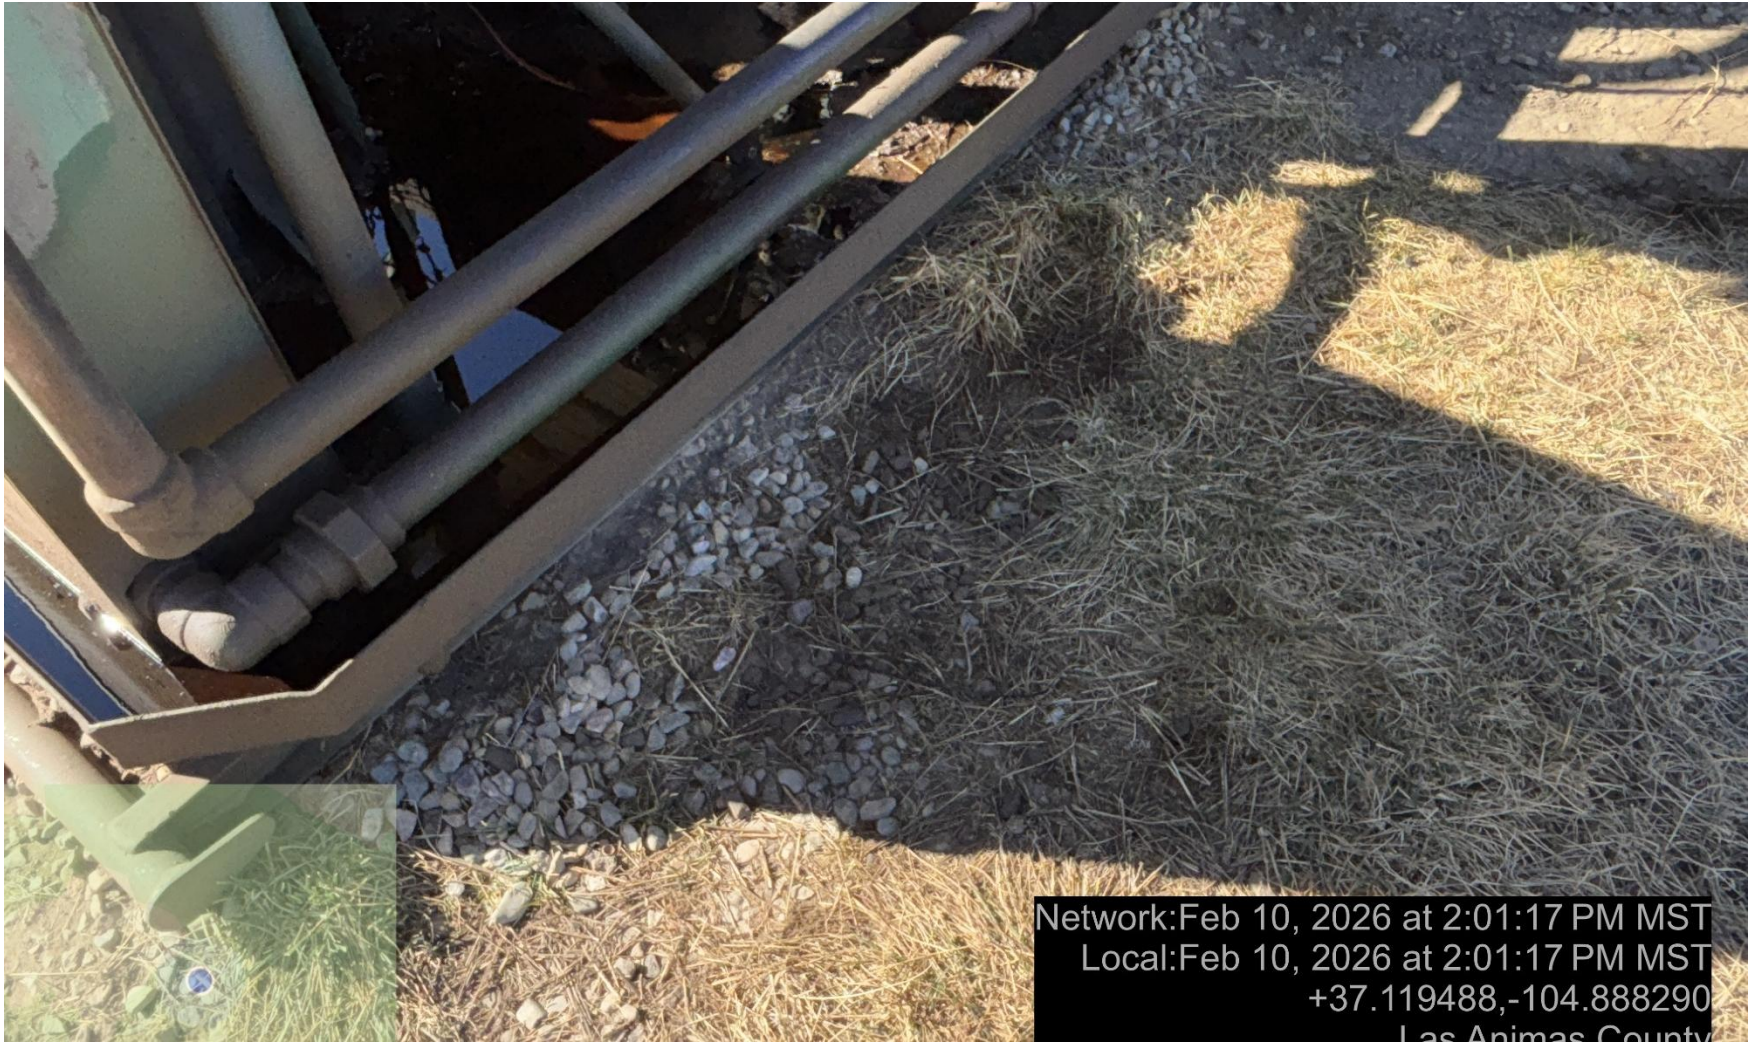
PHOTO 7: Area of impacted soil near prime mover engine skid. Conduct maintenance on equipment, cleanup stained material and review self inspection processes. COMPLY WITH RULE 1002,(2).D. ca date 2/23/2026.

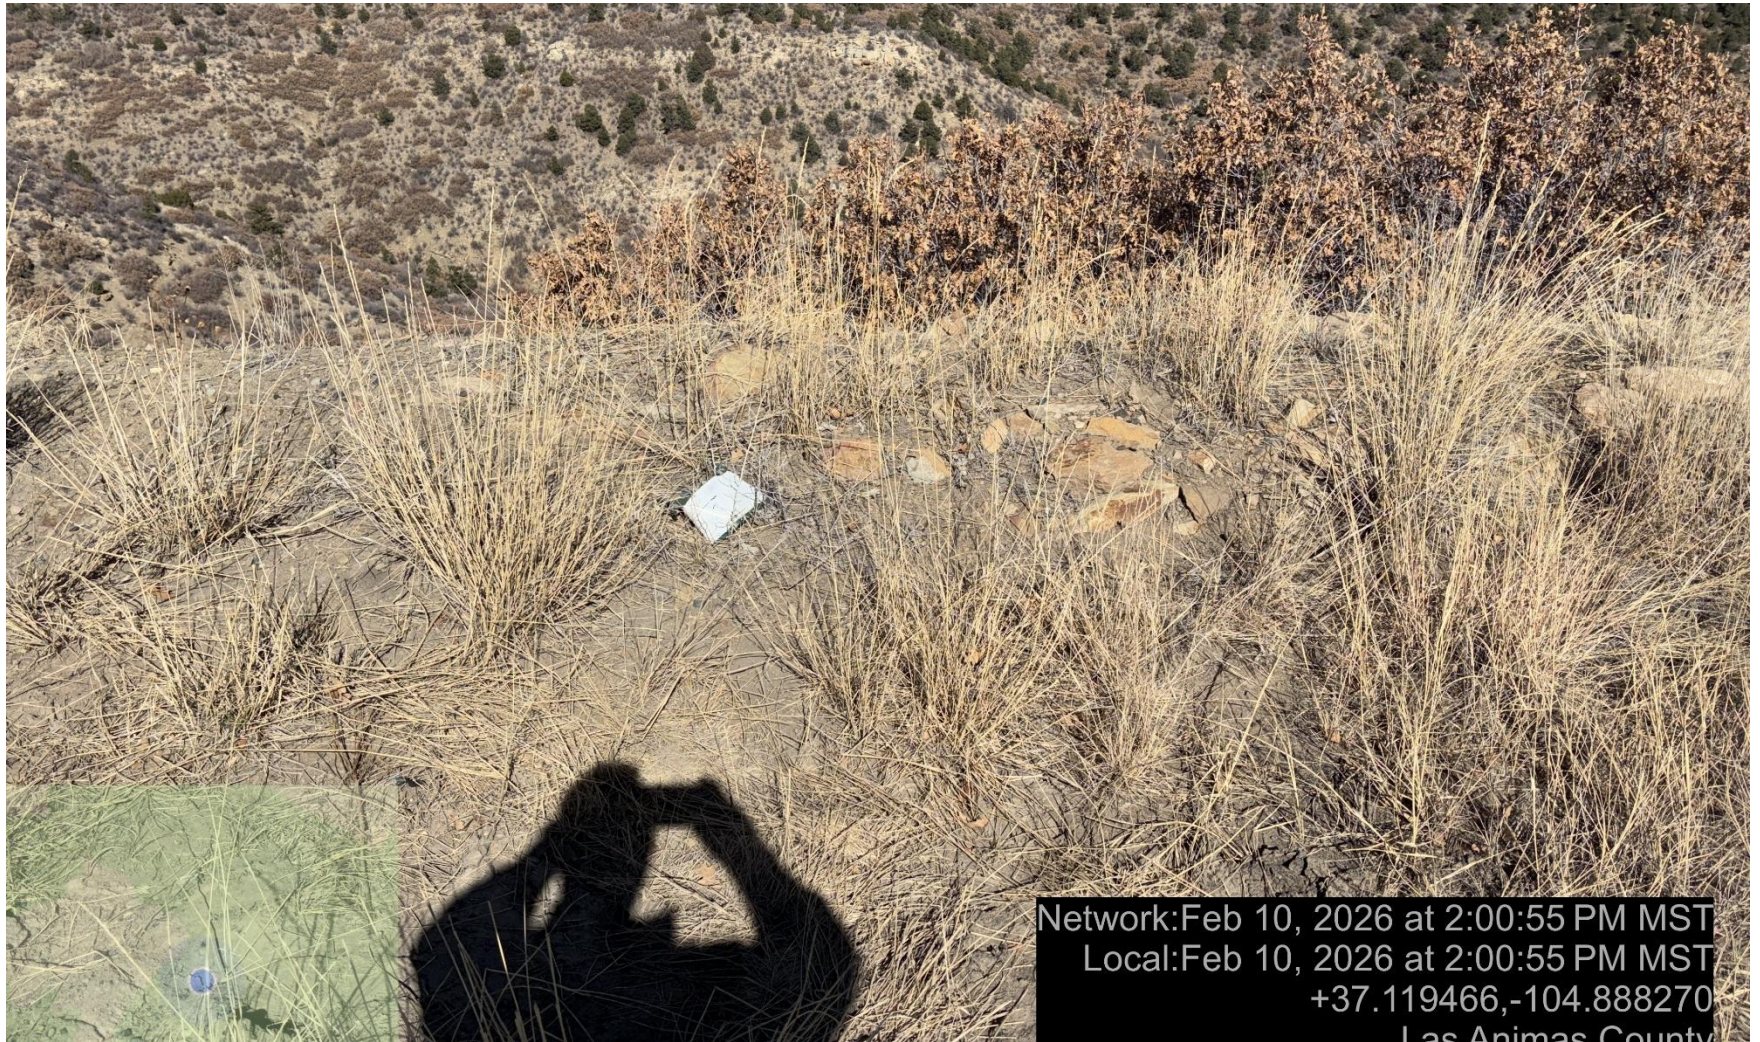
PHOTO 8: Area of impacted soil near compressor skid. Conduct maintenance on equipment, cleanup stained material and review self inspection processes. COMPLY WITH RULE 1002,.(2).D. ca date 2/23/2026.

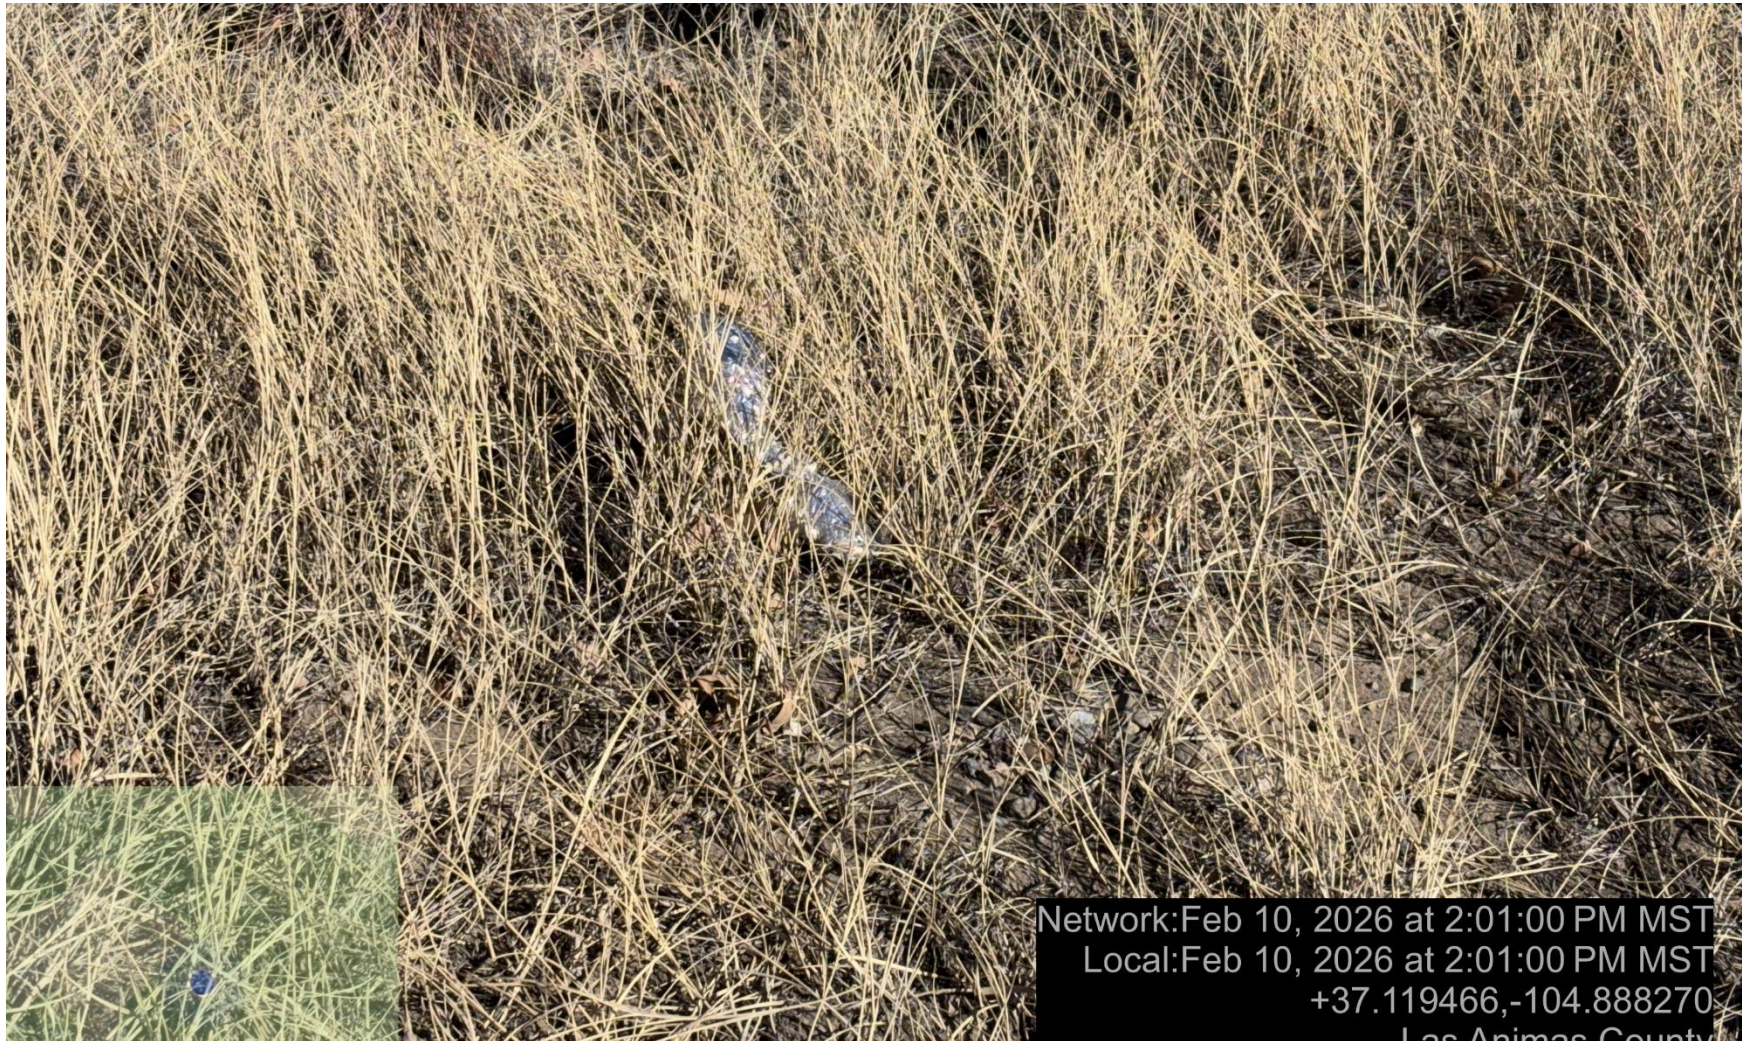
PHOTO 9: trash on location near compressor skid. Remove all trash from on and around location per rule 606. ca date 2/23/2026.

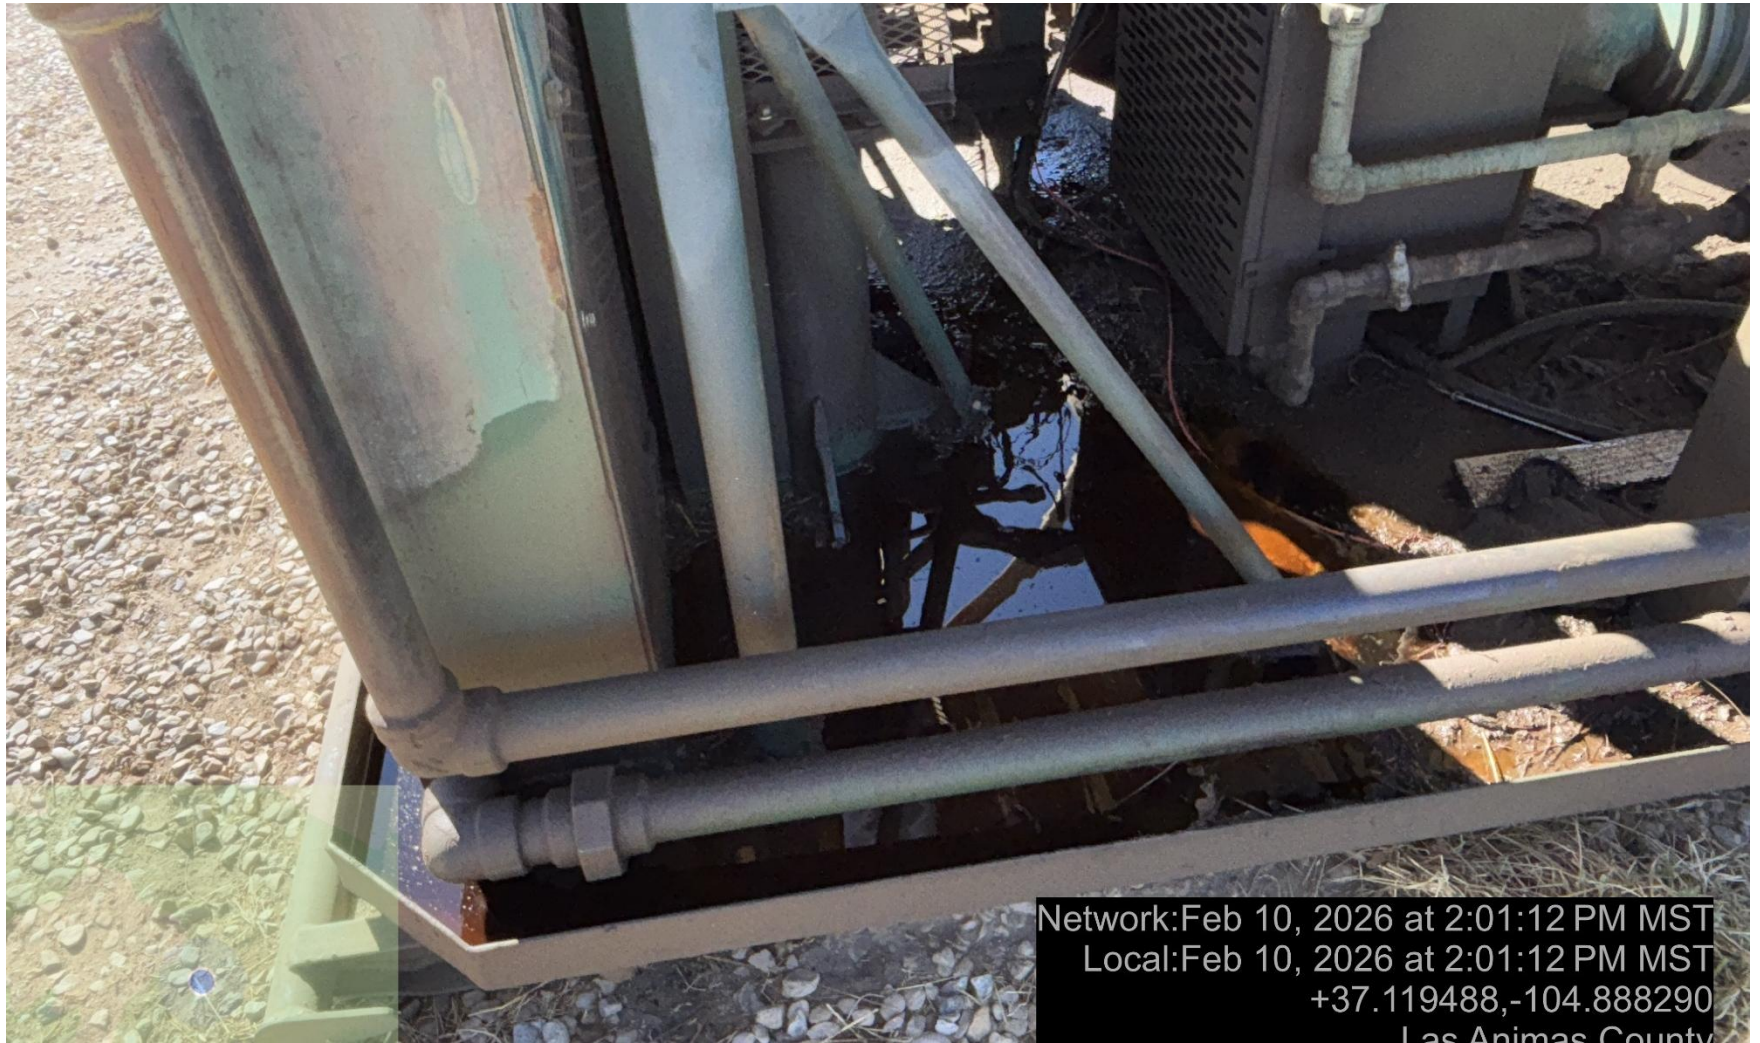
PHOTO 10: trash on location near compressor skid. **Remove all trash from on and around location per rule 606. ca date 2/23/2026.**

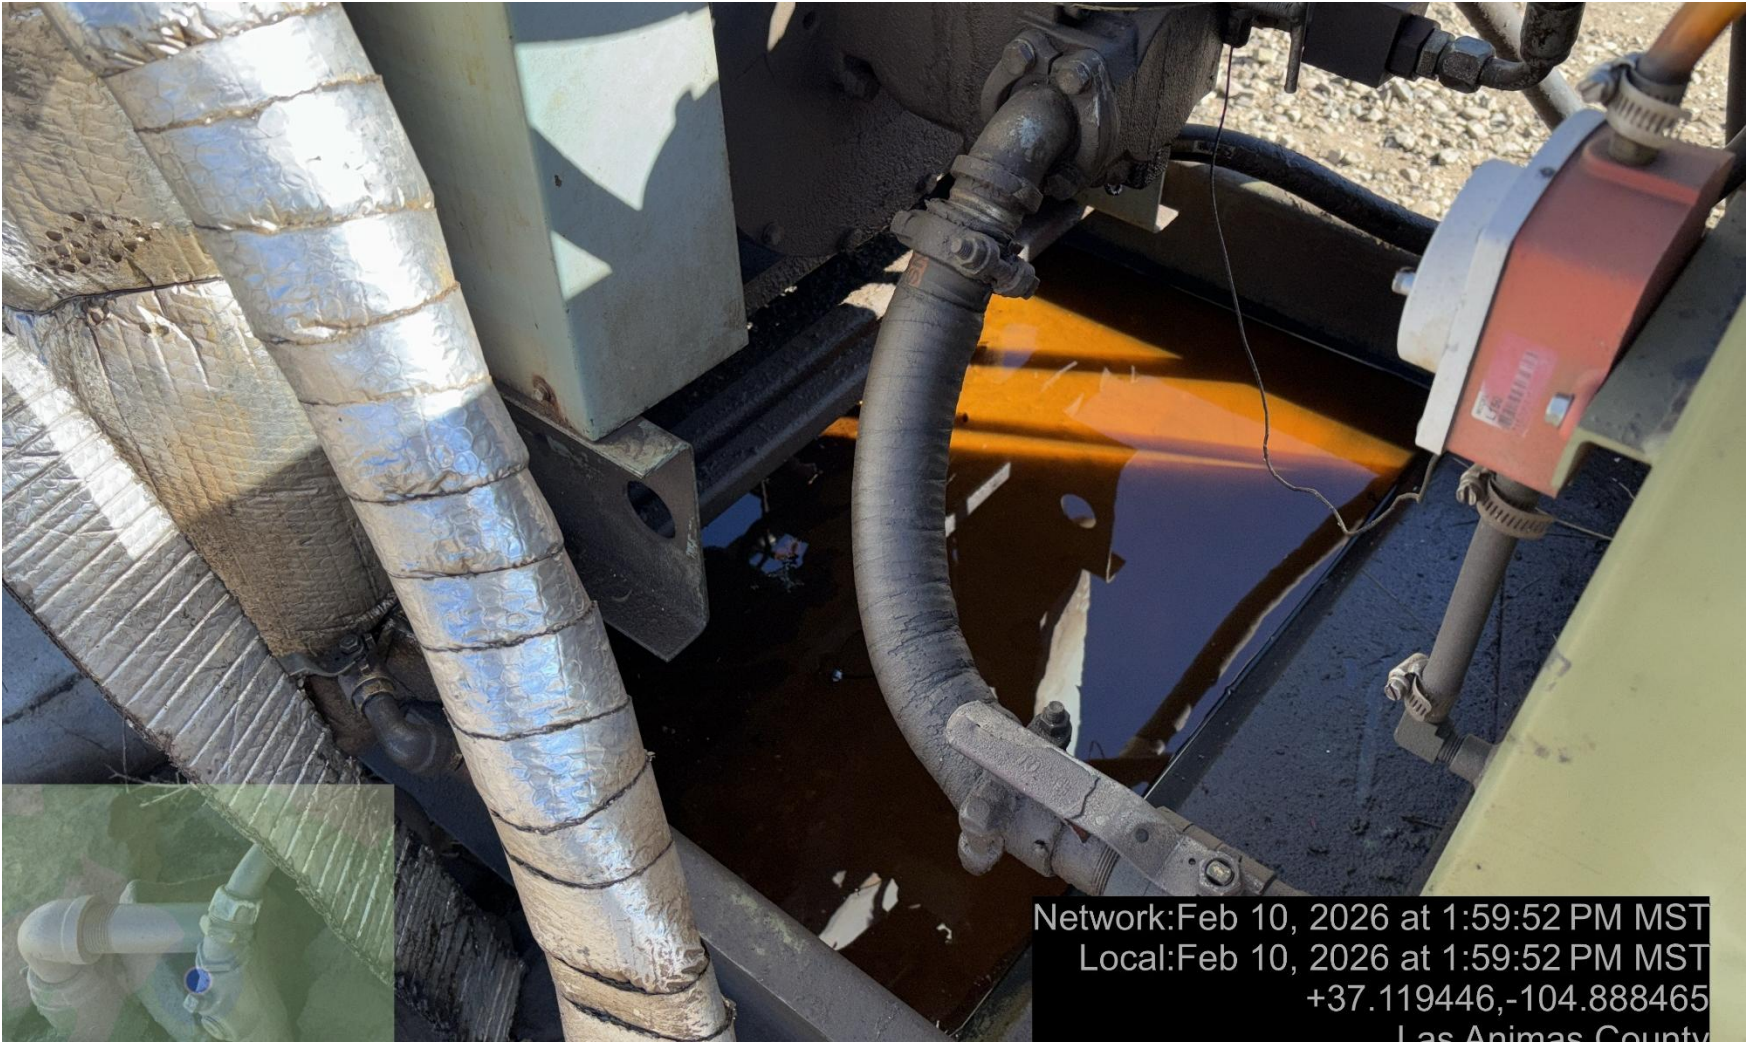
PHOTO 11: OILY WASTE IN COMPRESSOR SKID WITHOUT WILDLIFE PROTECTION SCREENS OR COVERS. DRAIN OILY WASTE REPAIR ALL LEAKS AND REMOVE IMPACTED SOIL PER RULE 1002..(2).D & 1002.f.(2)B, Comply with general provisions of the oil and gas act for wildlife protection AND SB-181. immediate action is required, ca date 2/11/2026.
