Inspection Photos

Operator: QB Energy Operating LLC #10844

Location ID: 334835

Inspection Doc: 719200805

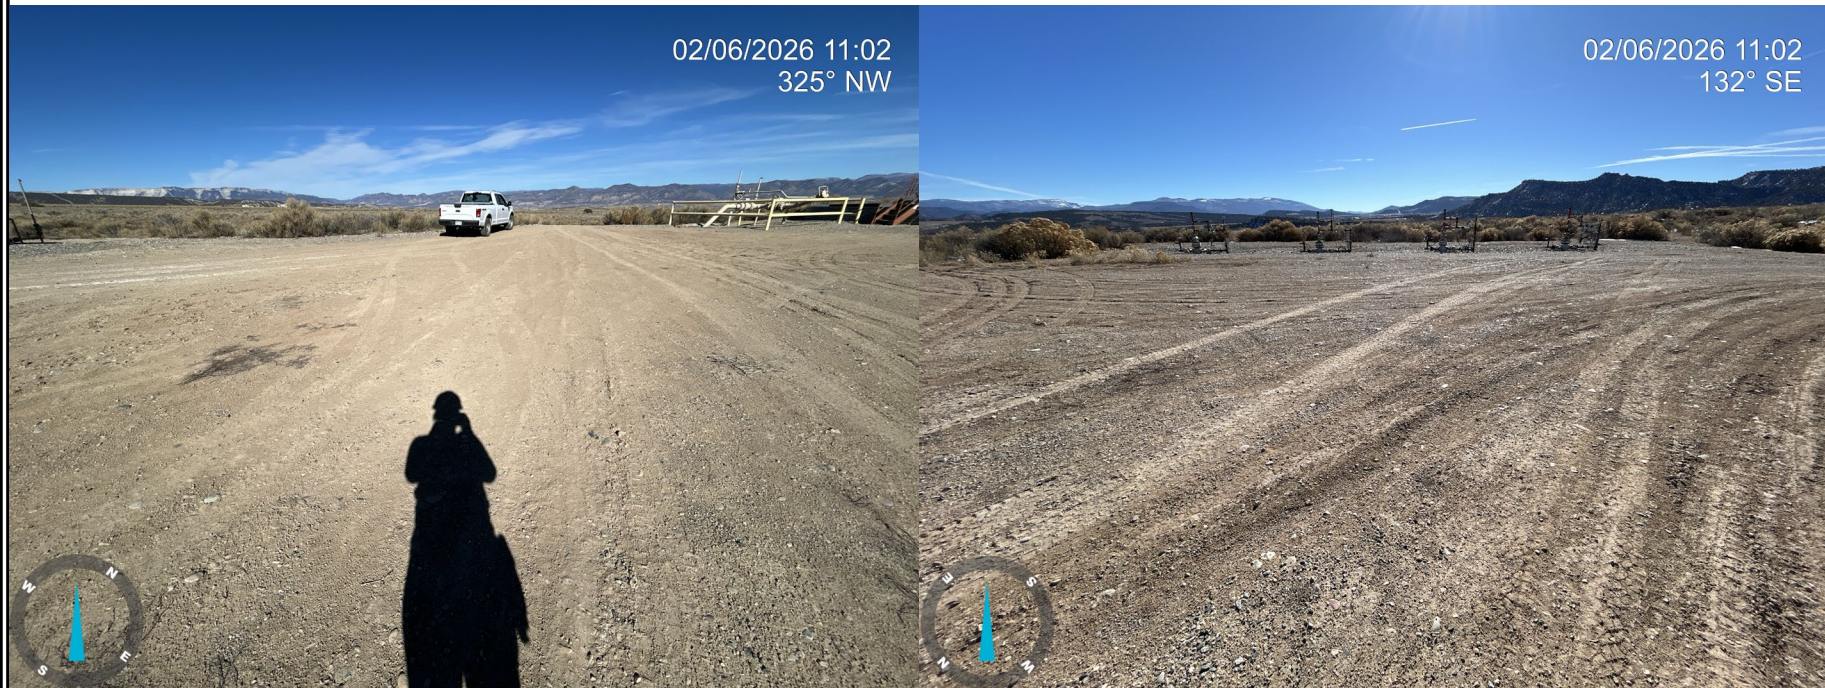
Photo 1: Photos showing an overview of the location looking northwest and southeast, respectively.

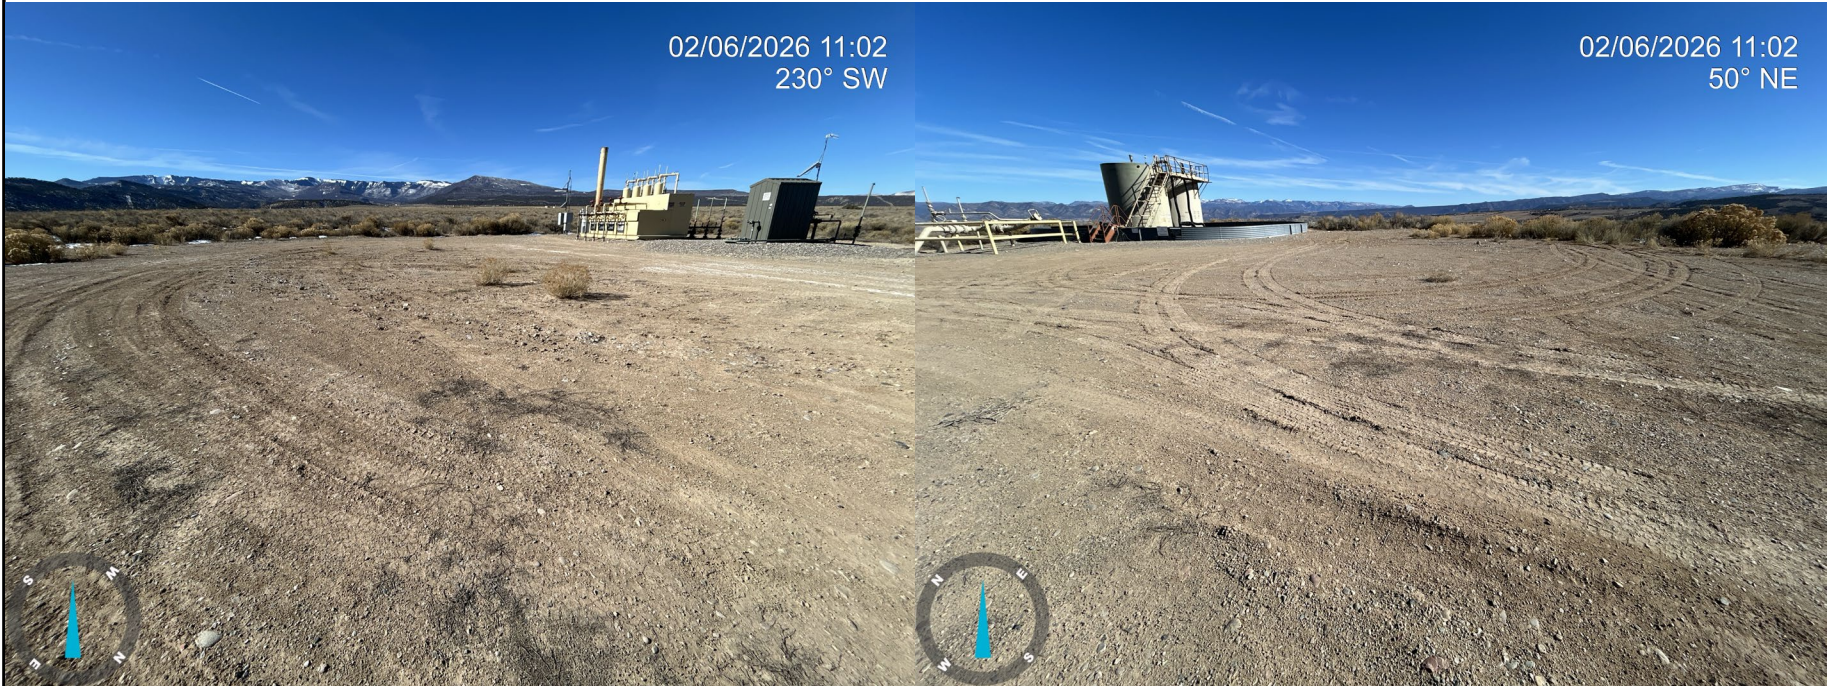
Photo 2: Photos showing an overview of the location looking southwest and northeast, respectively.

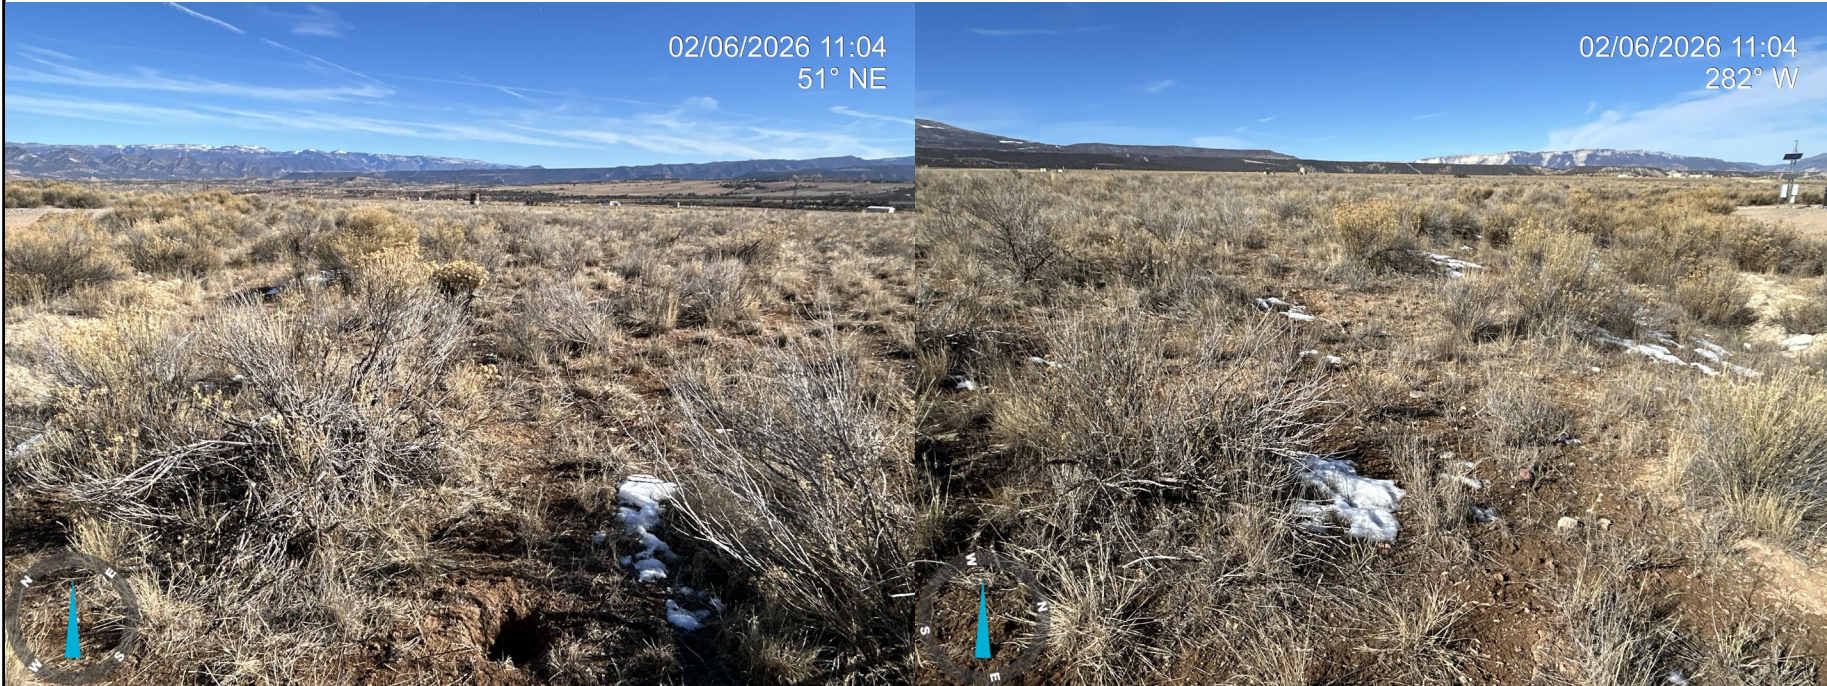
Photo 3: Photos showing an overview of the southern interim area. Perennial grasses and shrubs are present and interim areas are well-established; interim areas are progressing towards 1003 reclamation standards.

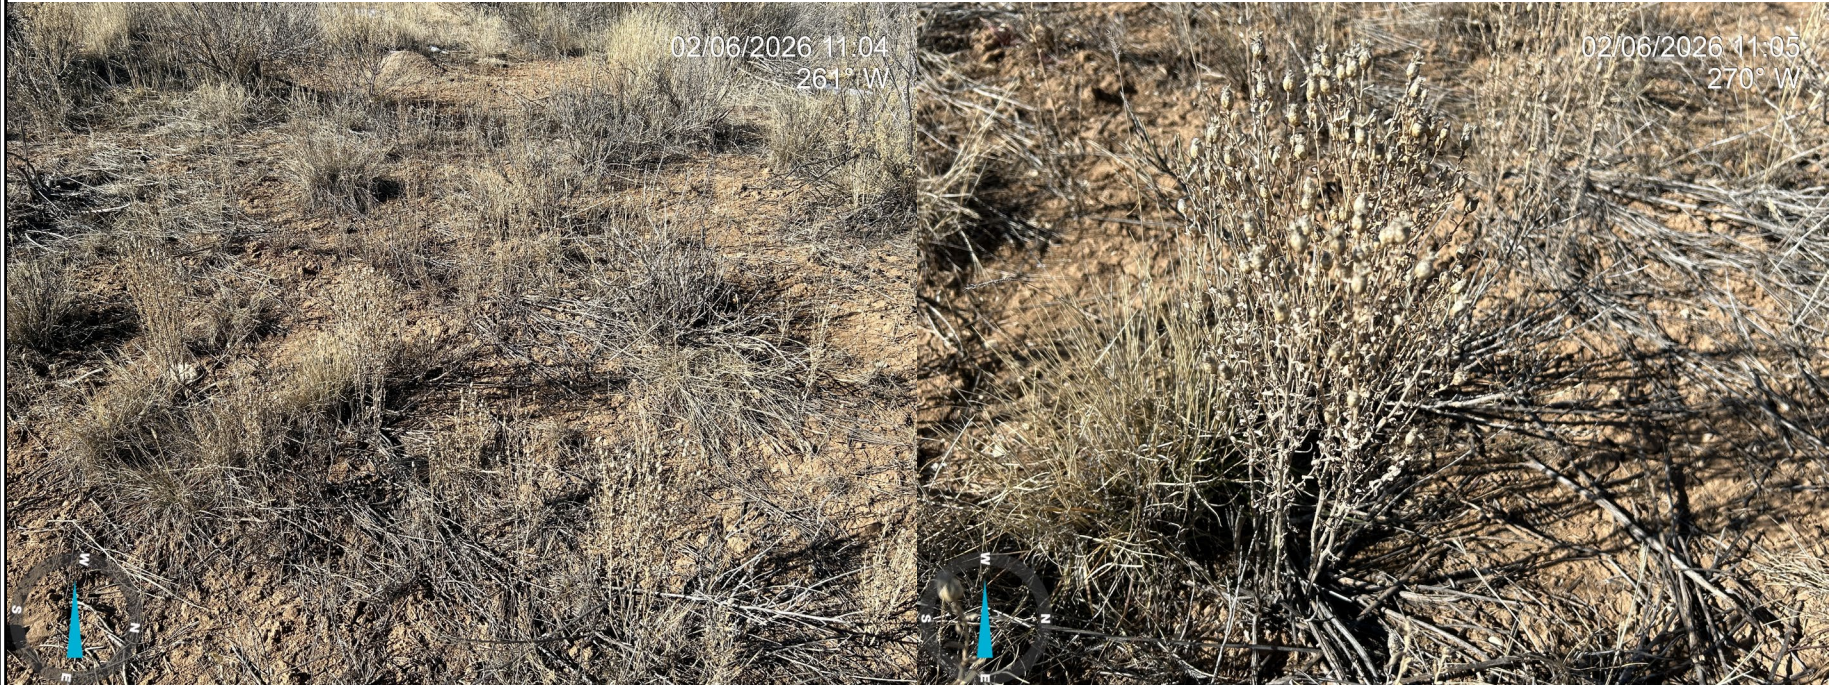
Photo 4: Photos showing a patch of Russian knapweed, a List B noxious weed species, is present in the southern interim area. Weed control is required; a follow-up inspection will be conducted during the 2026 growing season to evaluate weed control efforts at the location.

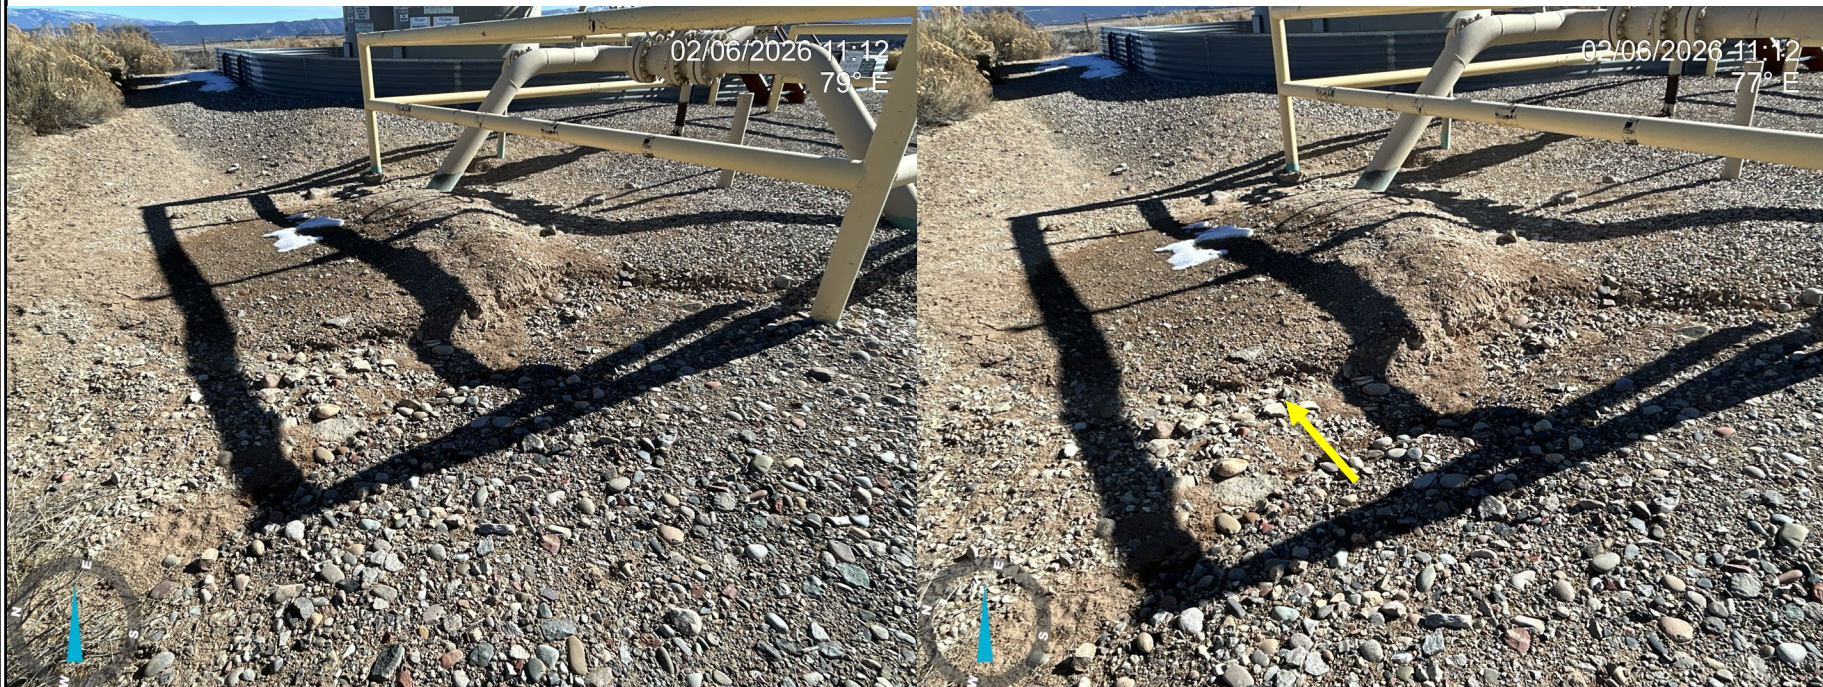
Photo 5: Photos showing erosion and rilling that has begun to occur on the northern edge of the working pad surface; maintenance is advised.

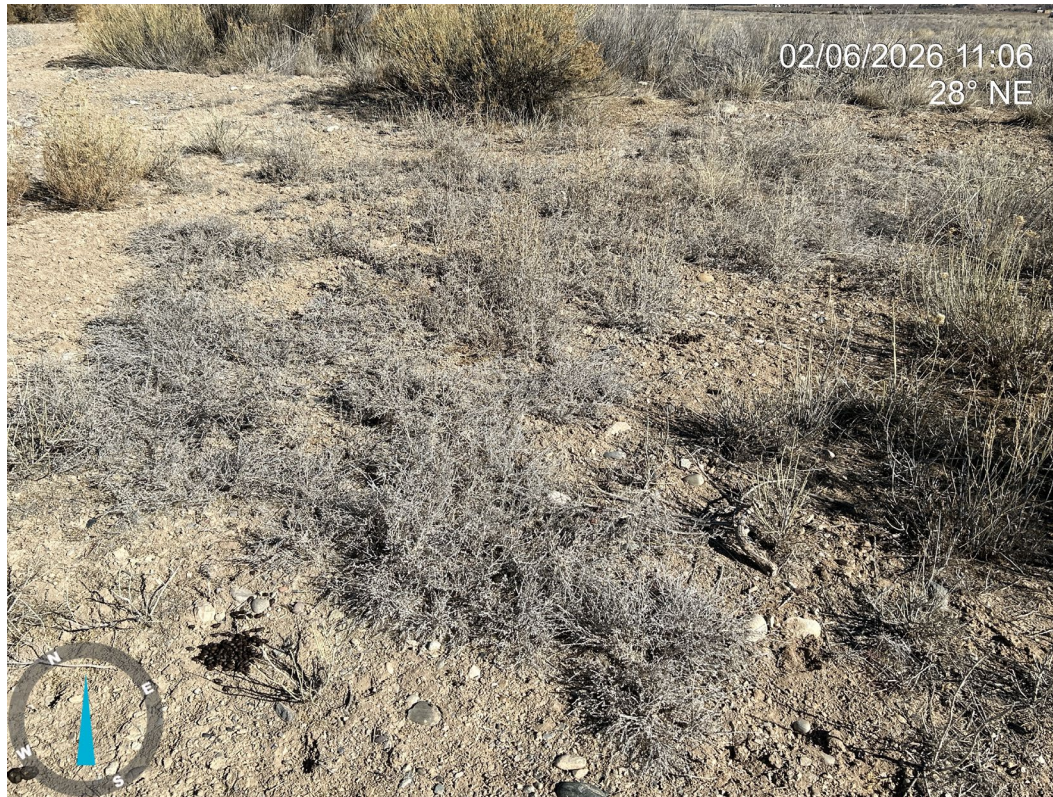
Photo 6: Photos showing an example of prickly Russian thistle, an undesirable plant species, is present on the eastern edge of the working pad surface. Weed control is required; a follow-up inspection will be conducted during the 2026 growing season to evaluate weed control efforts at the location.

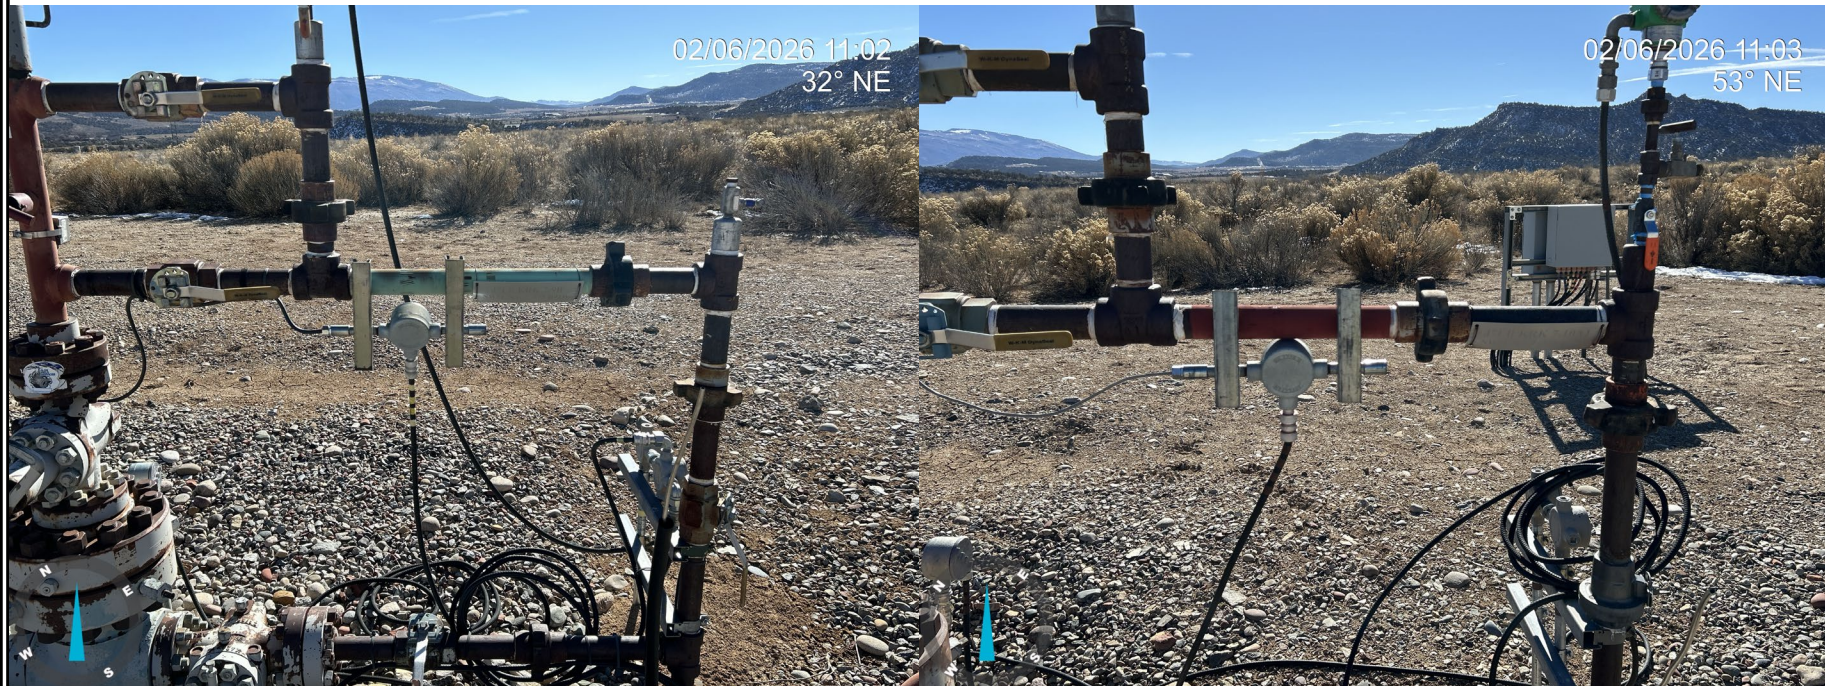
Photo 7: Photos showing examples of wellhead signage that is beginning to slip out of place; maintenance to secure signage in place is advised.
