Final Reclamation and Stormwater Inspection

Operator: KP KAUFFMAN COMPANY INC

Location ID: 482899

Location Name: 33-2N-68W NENE Tank Battery Loc/

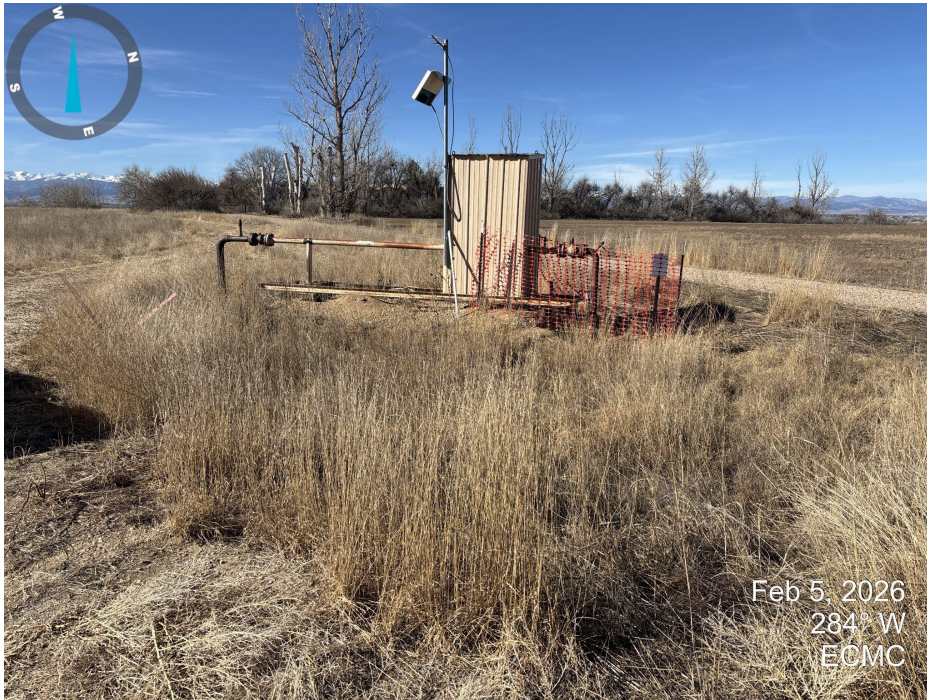
Photo 1. Looking west across the north part of the tank battery location. Meter shed and riser remains. Desirable perennial vegetation is present on the location. Undesirable weeds such as kochia are also present on the location.

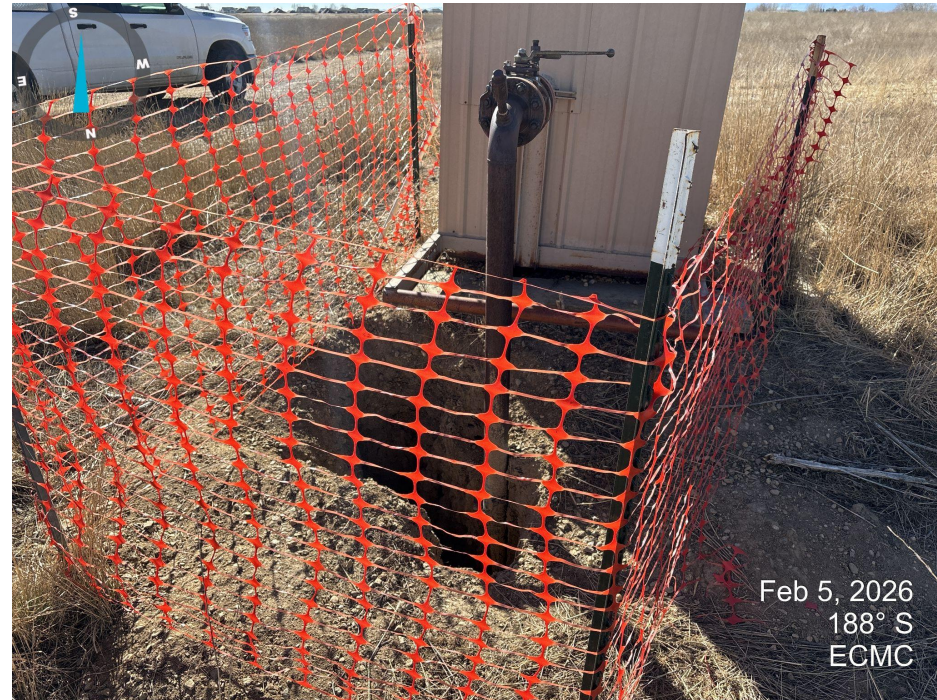
Photo 2. An excavation was present on the north side of the meter shed. A flowline was exposed below ground. Excavation was fenced. Several flags and markers were present around the location at appear to mark flowlines.

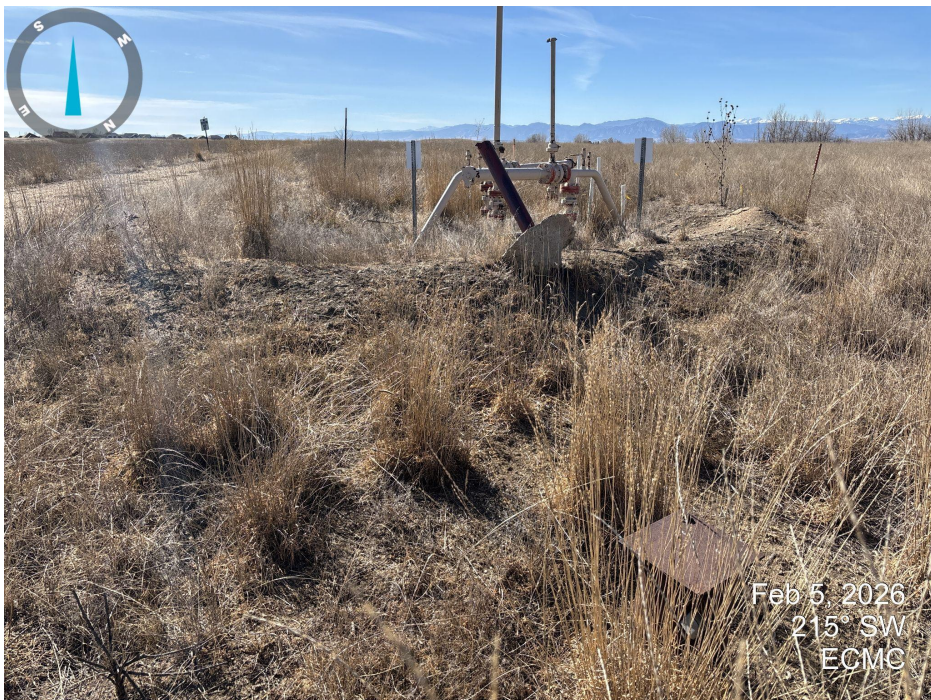
Photo 3. Looking south across the southern storage tank area. The large storage tank has been removed from the location. Pipe risers, pvc, and metal pipe remain on location.

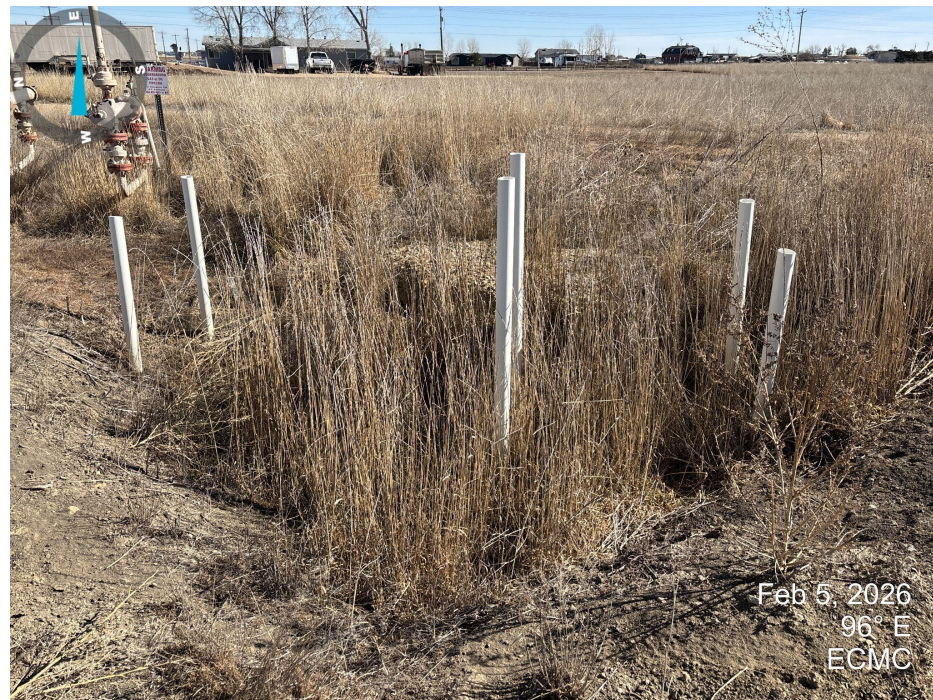
Photo 4. Looking east across the tank/ flowline reiser area. PVC pipes are present. A depression is present in the tank area.

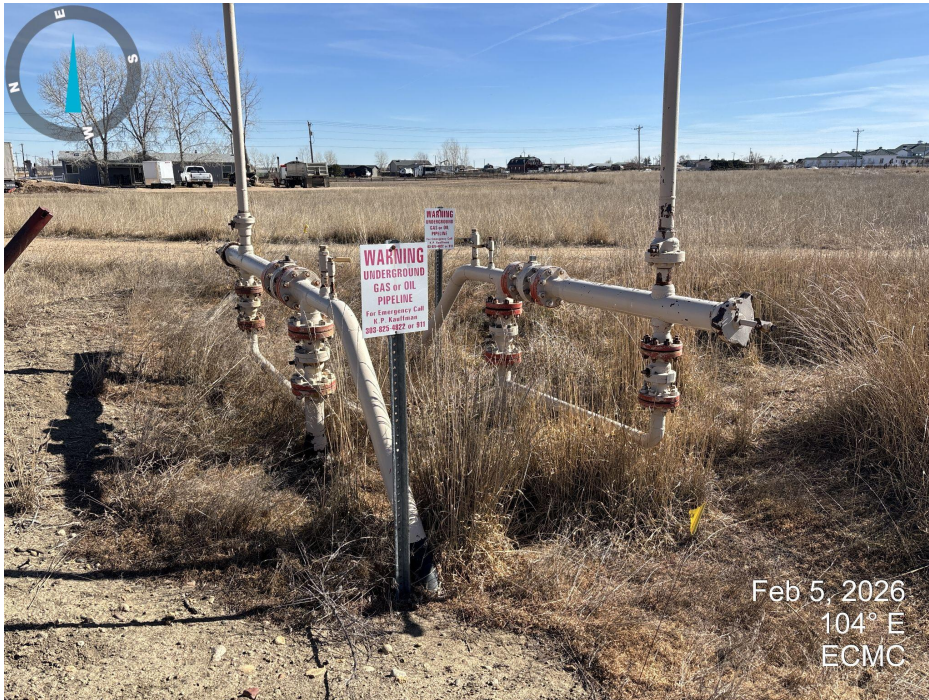
Photo 5. Flowline risers at the tank battery.

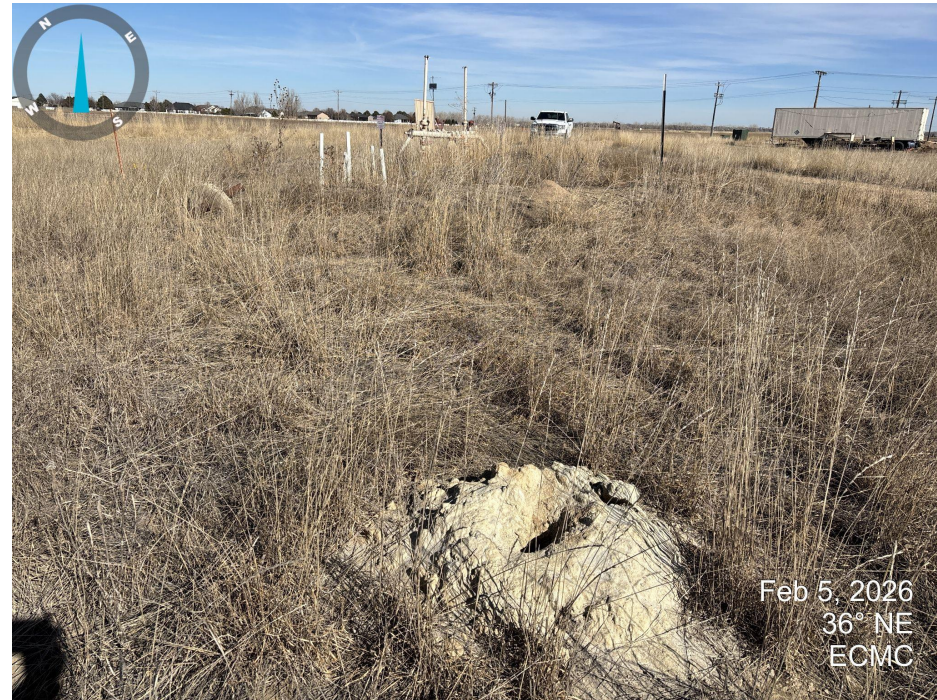
Photo 6. It appears that boreholes are present and open south of the tank battery location.

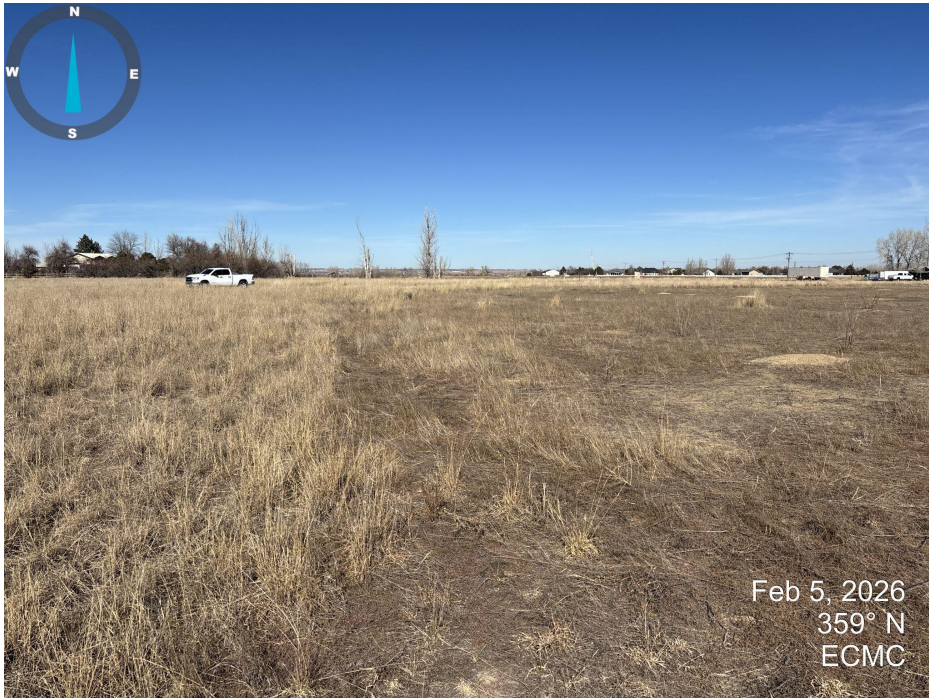
Photo 7. The electric utility mentioned in the previous inspection located near well API 123-08631 appears to have been removed.

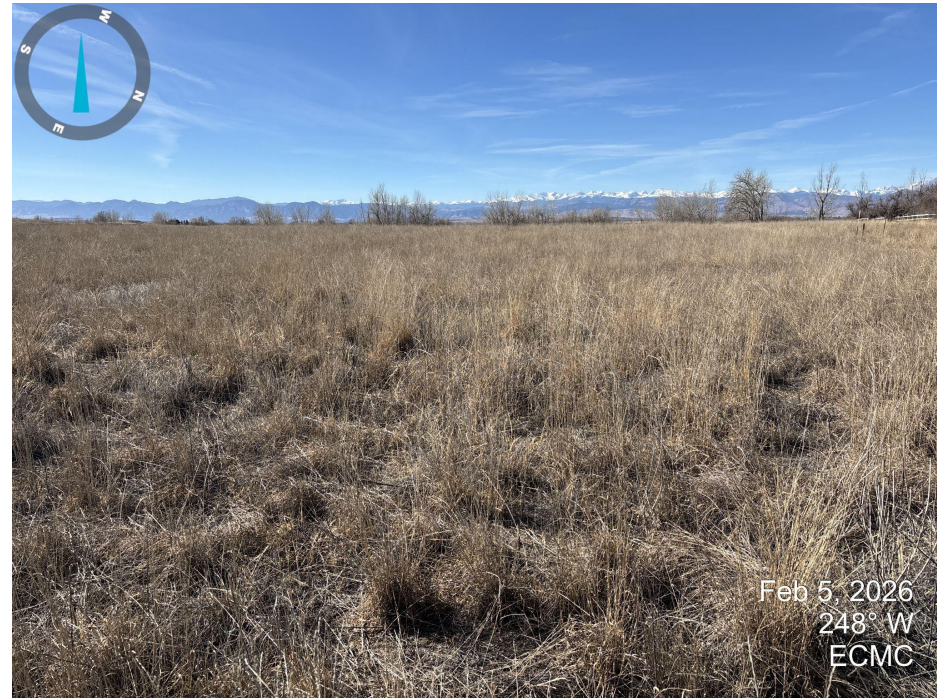
Photo 8. Reference vegetation to the west of the tank battery location.
