Final Reclamation and Stormwater Inspection

Location ID: 328530

Well Name: UPRC #33-1M

Inspection Document #: 718601363

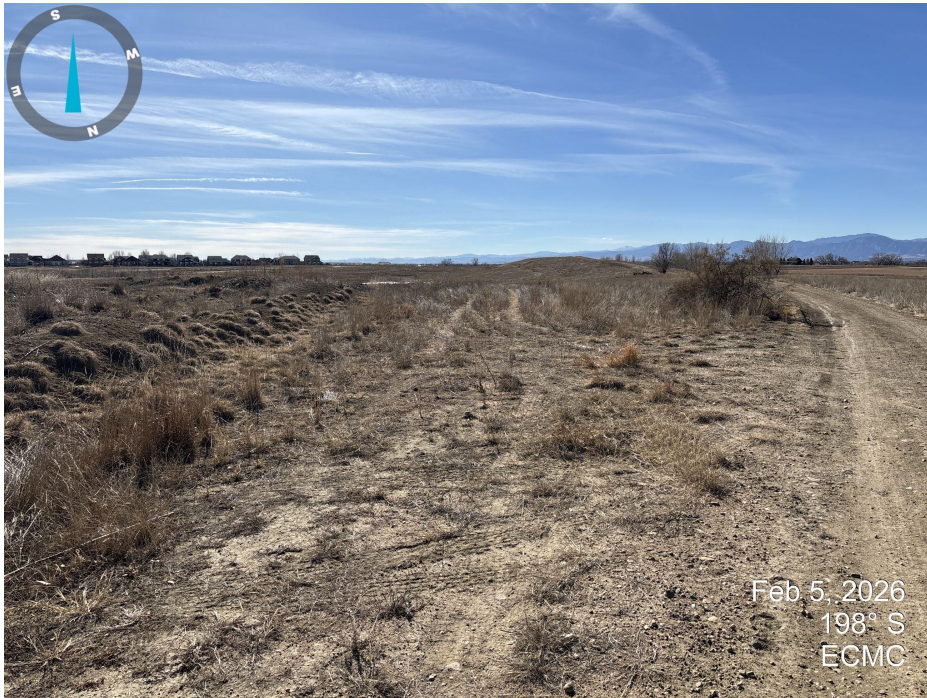
Photo 1. Looking south down the former access road. A new access road was constructed here unrelated to oil and gas operations. See FIR 697504154 for more info.

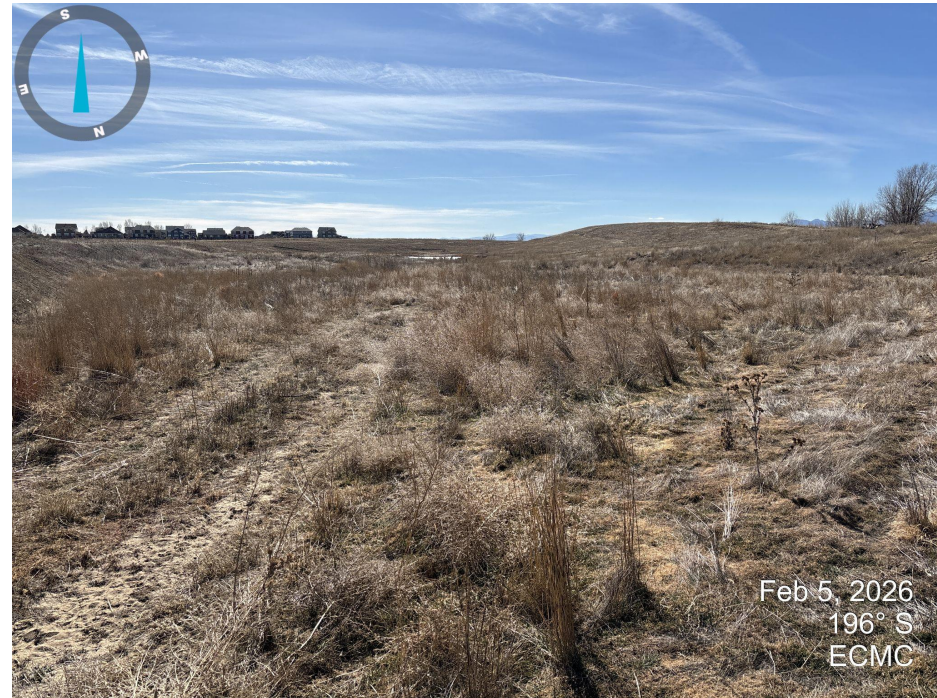
Photo 2. Looking south across the well and tank battery location. No oil and gas equipment remains on the location.

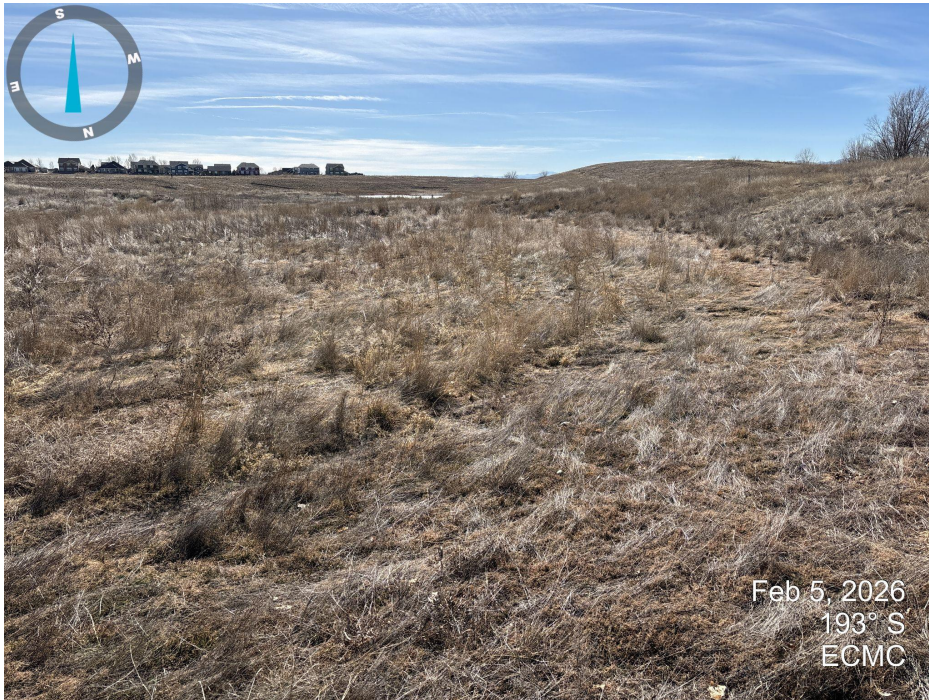
Photo 3. Looking south across the tank battery portion of the location. Desirable vegetation is present on the location and appears to be progressing towards 80% coverage of the reference are. Undesirable weeds such as kochia, ragweed, and cheatgrass are also present on the location. This area appears to have less desirable vegetation than other parts of the location.

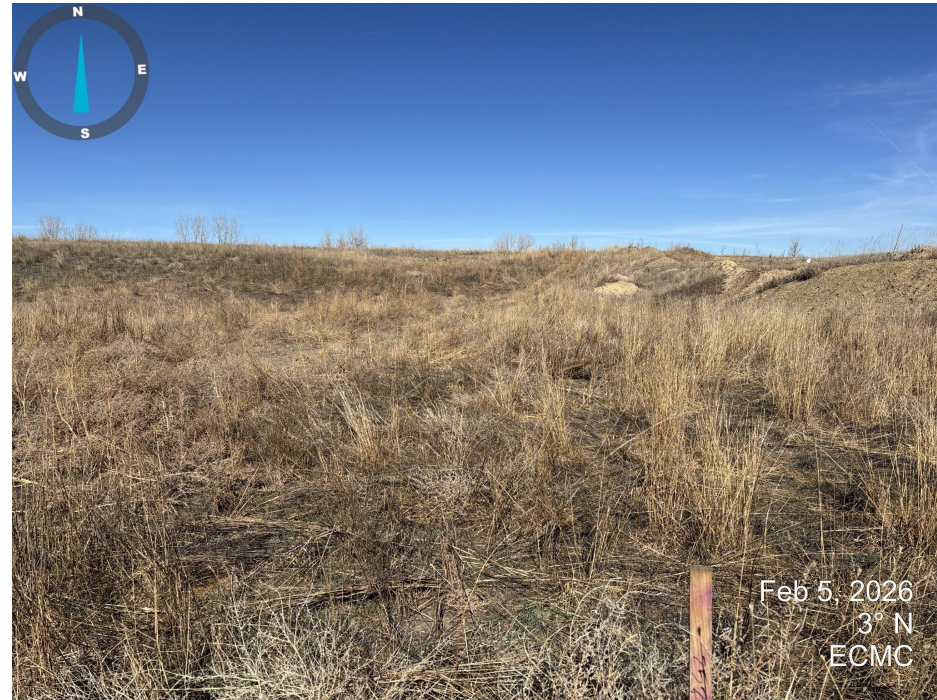
Photo 4. Looking north from the wellbore area. Desirable vegetation is present on the location and appears to be progressing towards 80% coverage of the reference are. Undesirable weeds such as kochia, ragweed, and cheatgrass are also present on the location.

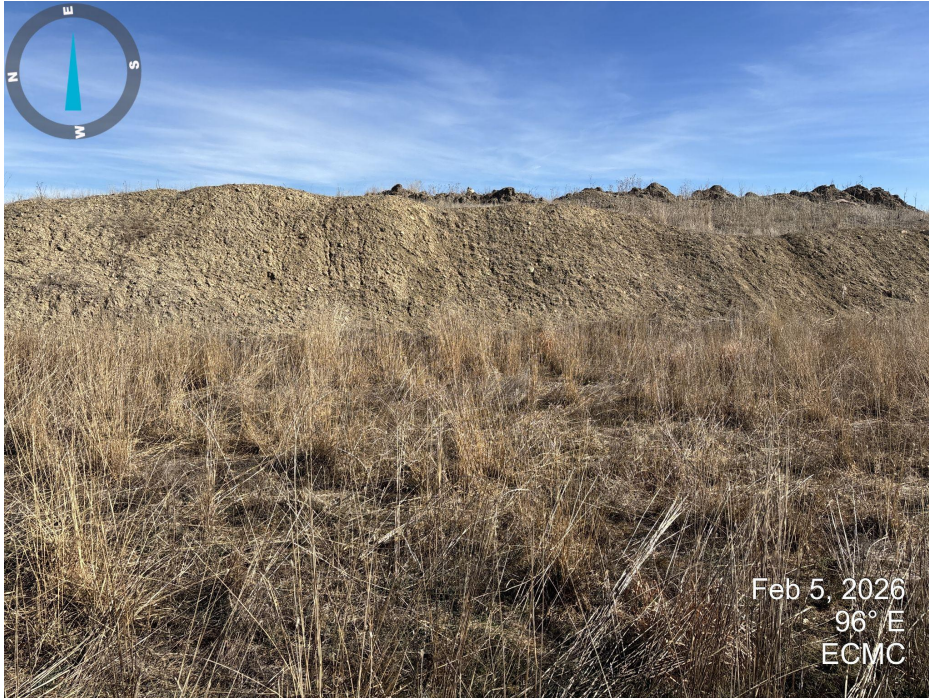
Photo 5. Looking east from the wellbore area. See photo 4 comments.

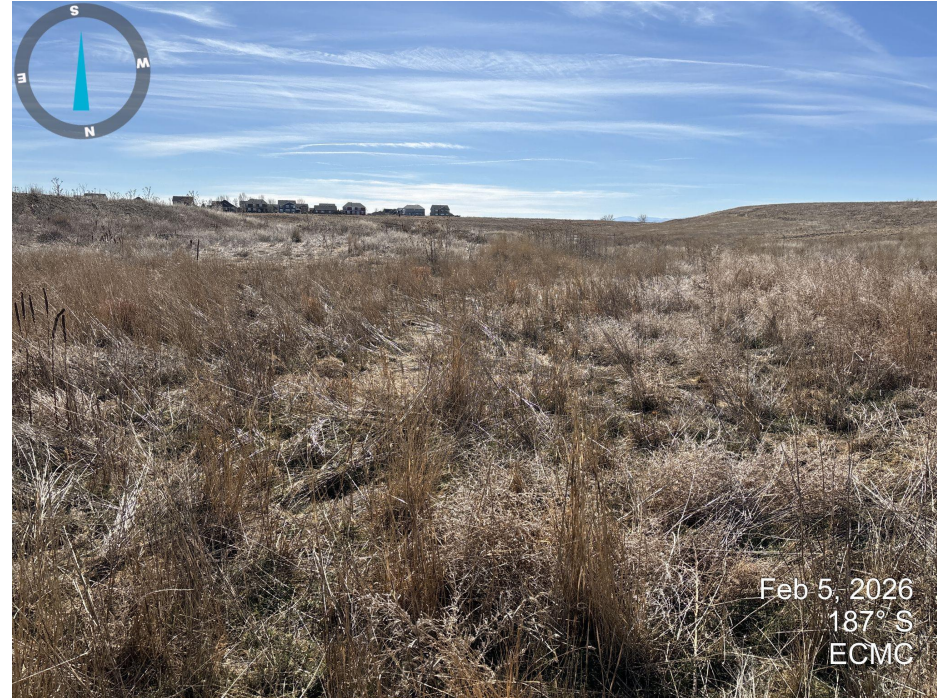
Photo 6. Looking south from the wellbore area. See photo 4 comments.

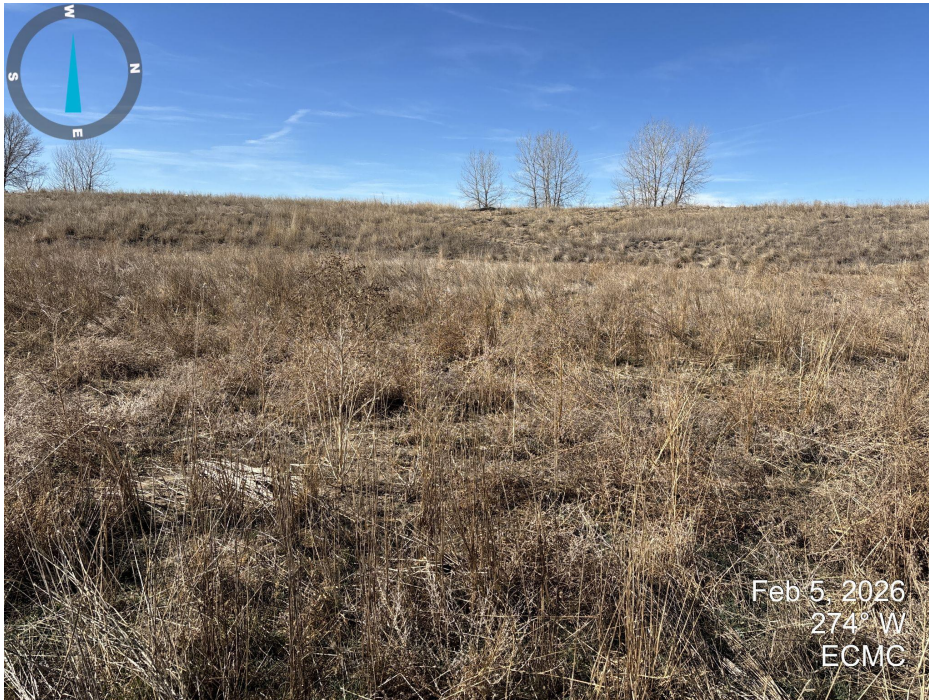
Photo 5. Looking west from the wellbore area. See photo 4 comments.

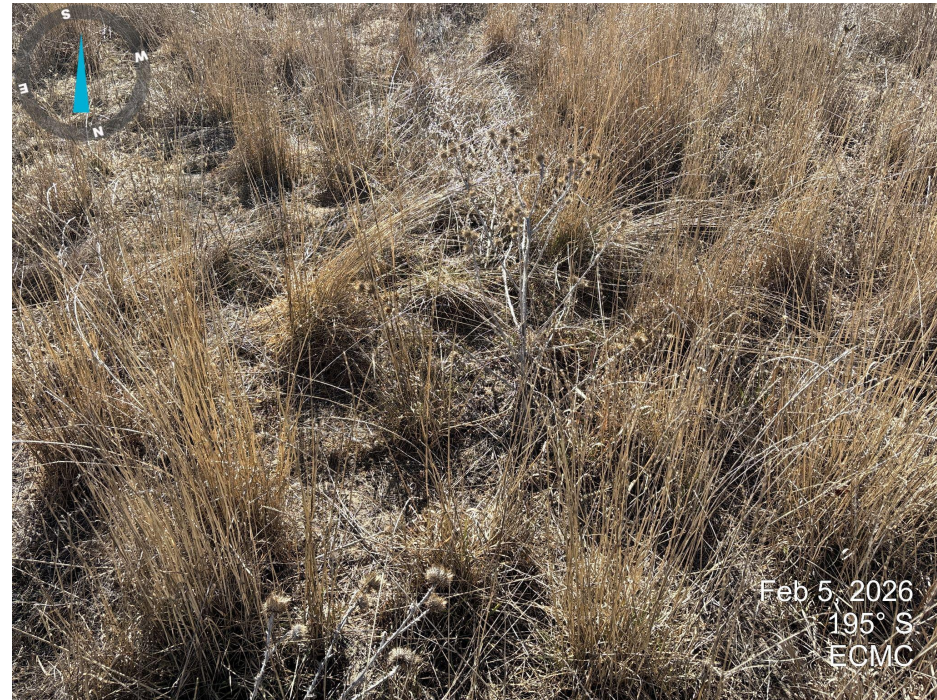
Photo 6. photo taken on the south side of the location. Some dead and knocked down scotch thistles were observed on location. Thistles appeared to be controlled at the time of inspection.

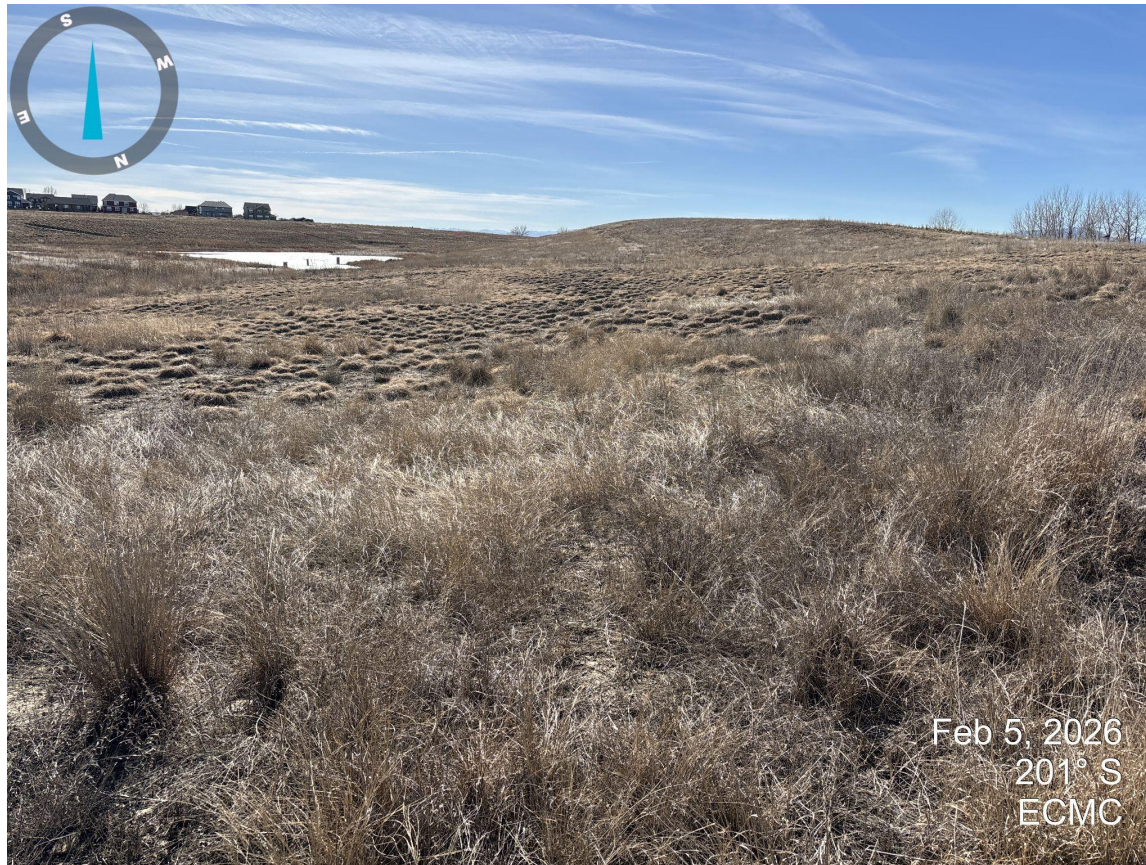
Photo 7. Reference vegetation to the south of the well location.

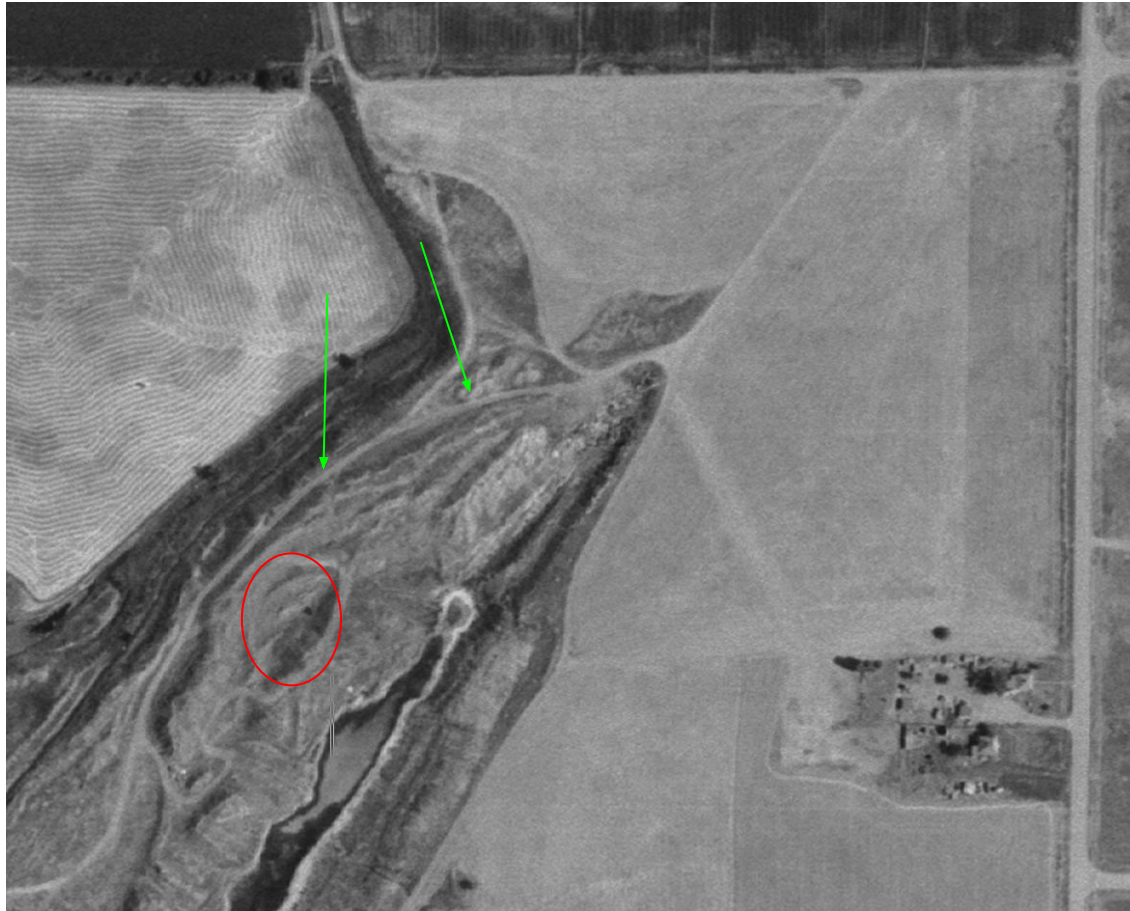
Photo 8. Historical aerial imagery taken 08/1971. The main access road (green arrows) appears to be preexisting to oil and gas. Red circle approximate location of well and tank battery.
