Inspection Photos

Operator: QB Energy Operating LLC #10844

Location ID: 324066

Inspection Doc: 719200825

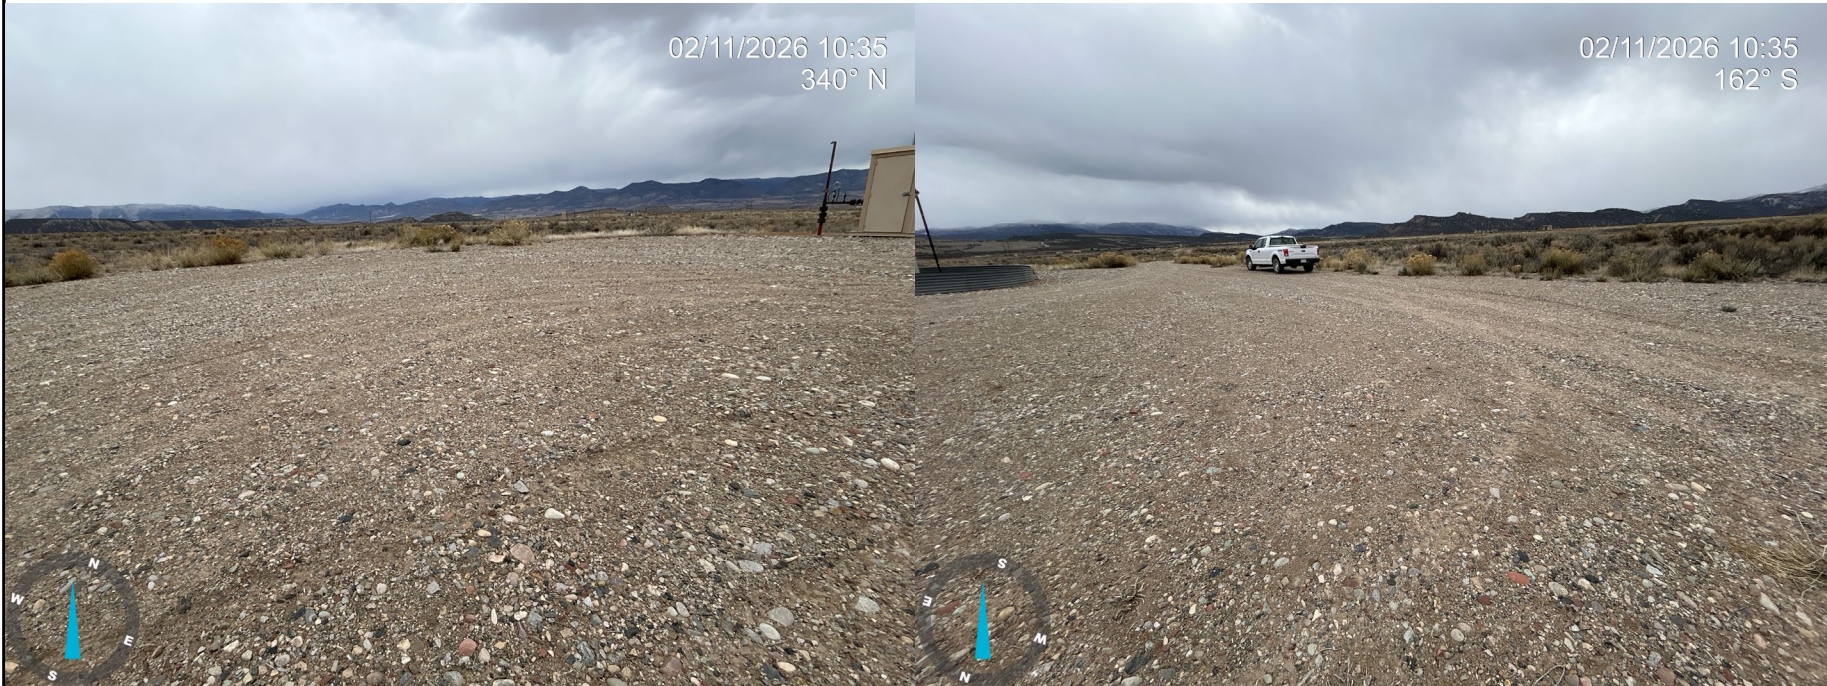
Photo 1: Photos showing an overview of the location looking north and south, respectively.

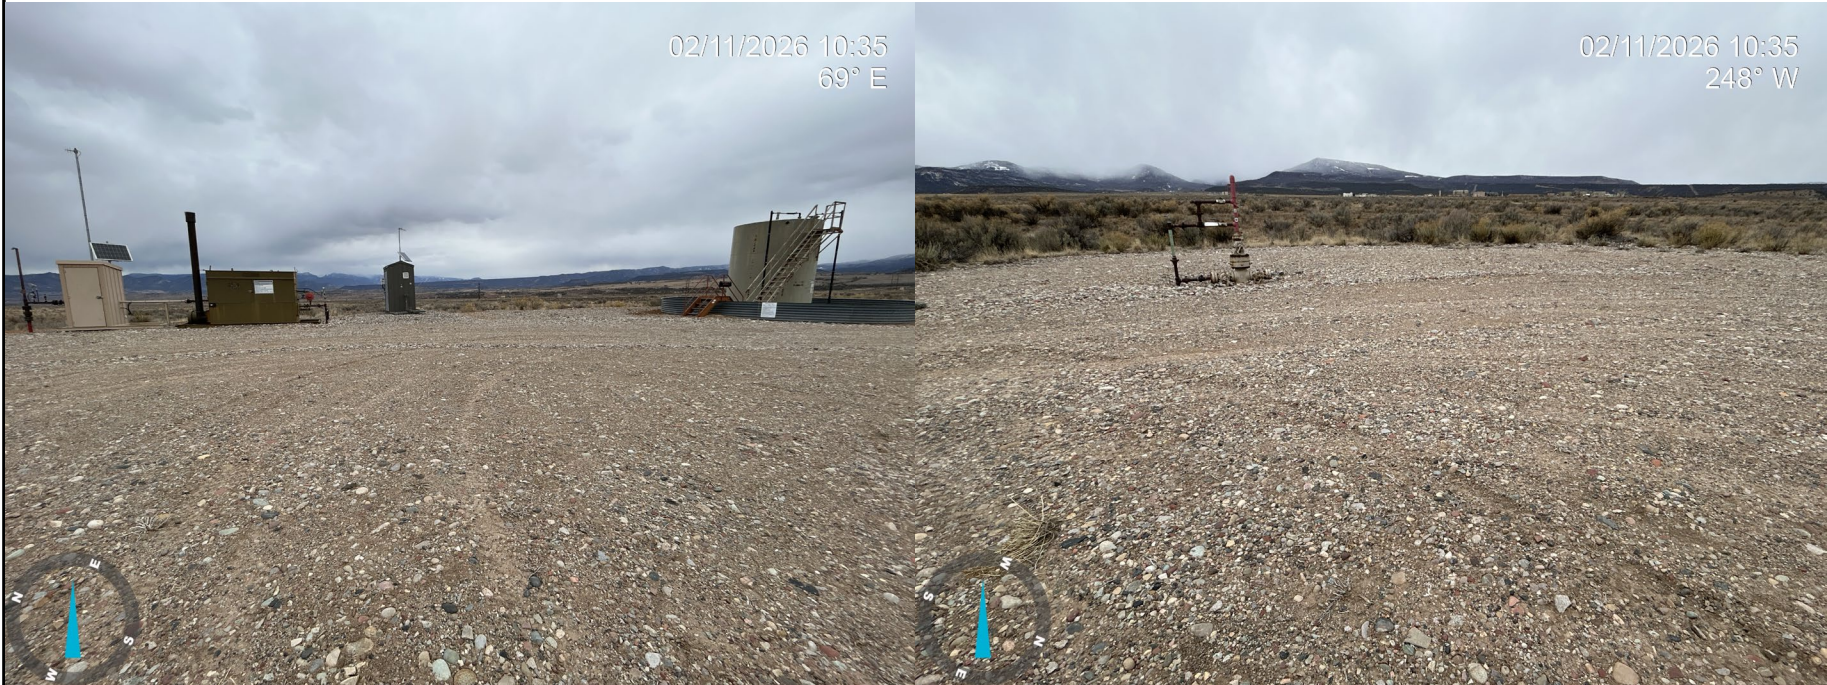
Photo 2: Photos showing an overview of the location looking east and west, respectively.

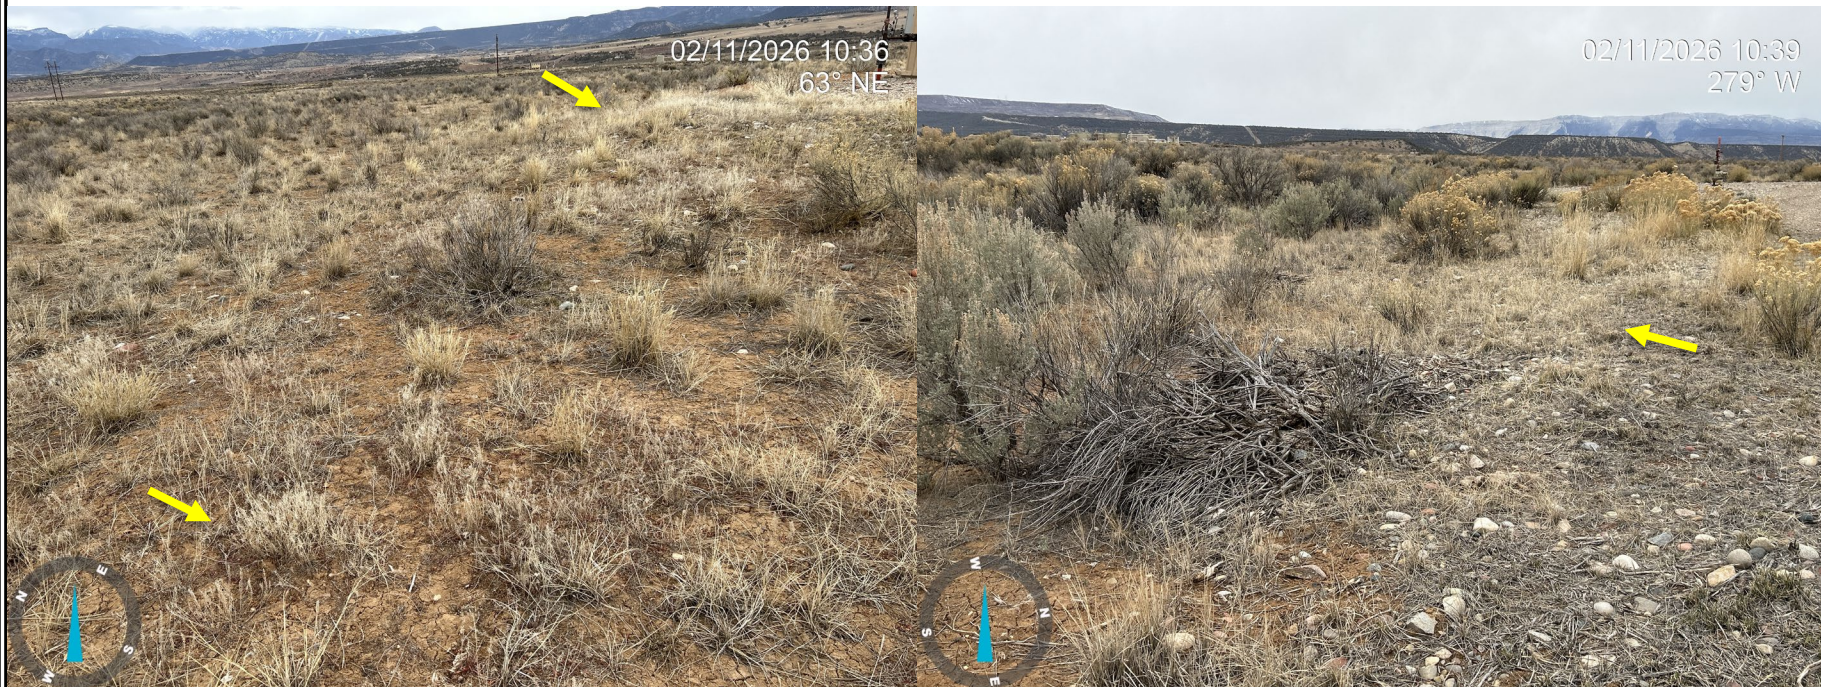
Photo 3: Photos showing an overview of the northwestern and northern interim areas, respectively. Cheatgrass (yellow arrow) and weedy annual species are present throughout.

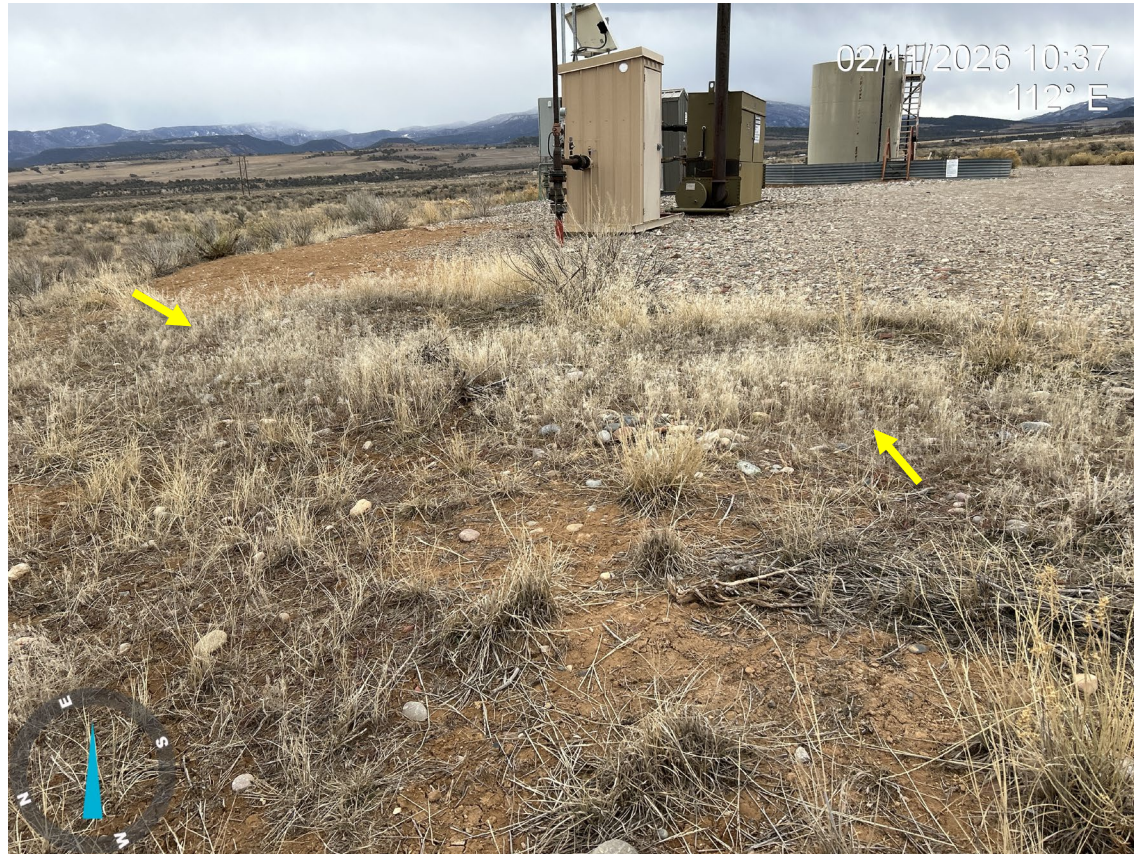
Photo 4: Photos showing cheatgrass (yellow arrow) is present around the margins of the working pad surface.

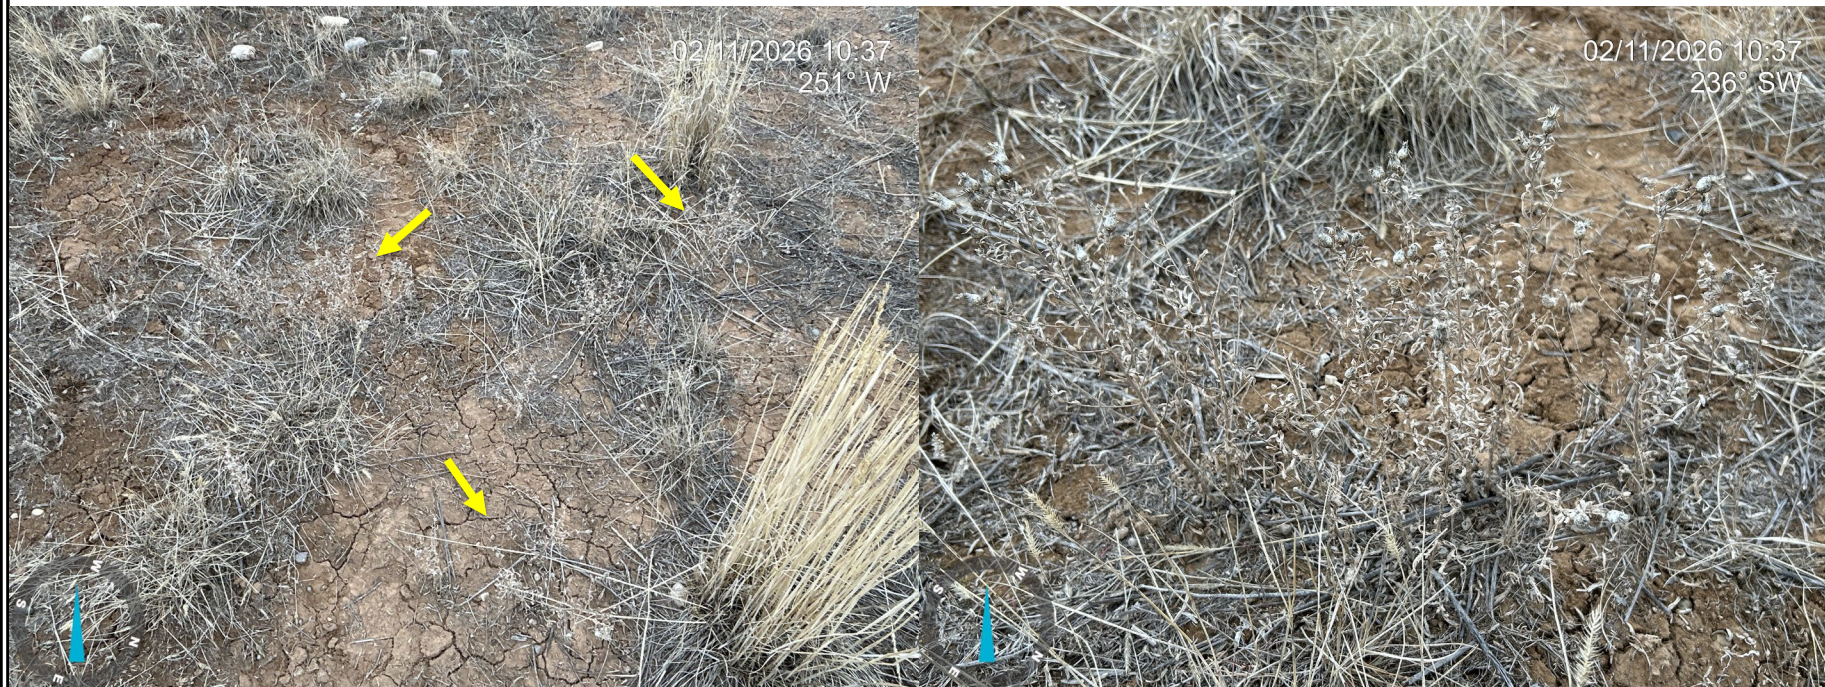
Photo 5: Photos showing an example of Russian knapweed, a List B noxious weed, that is present in tertiary amounts within the northern interim area. Weed management is required at the location; comply with Rule 606.c. and 1003.f.

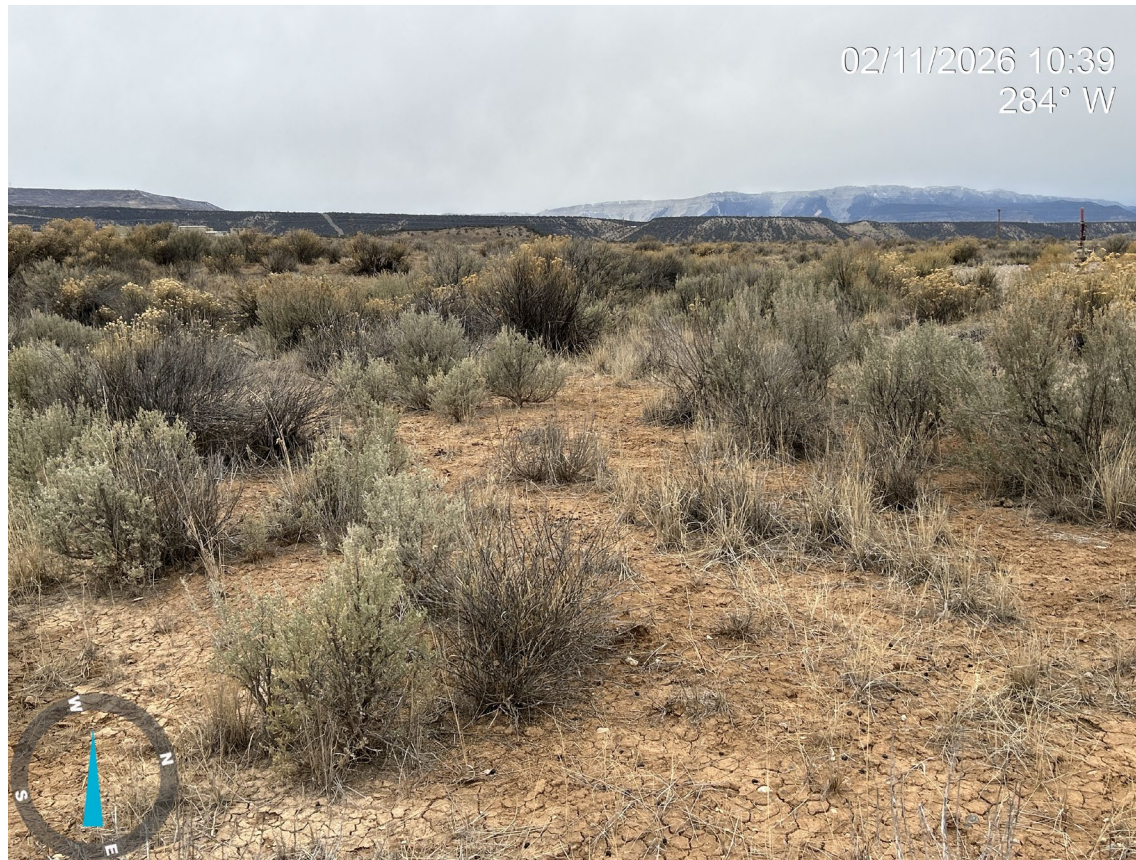
Photo 6: Photos showing an overview of the western interim area. Overall, interim areas are progressing towards 1003 reclamation requirements.

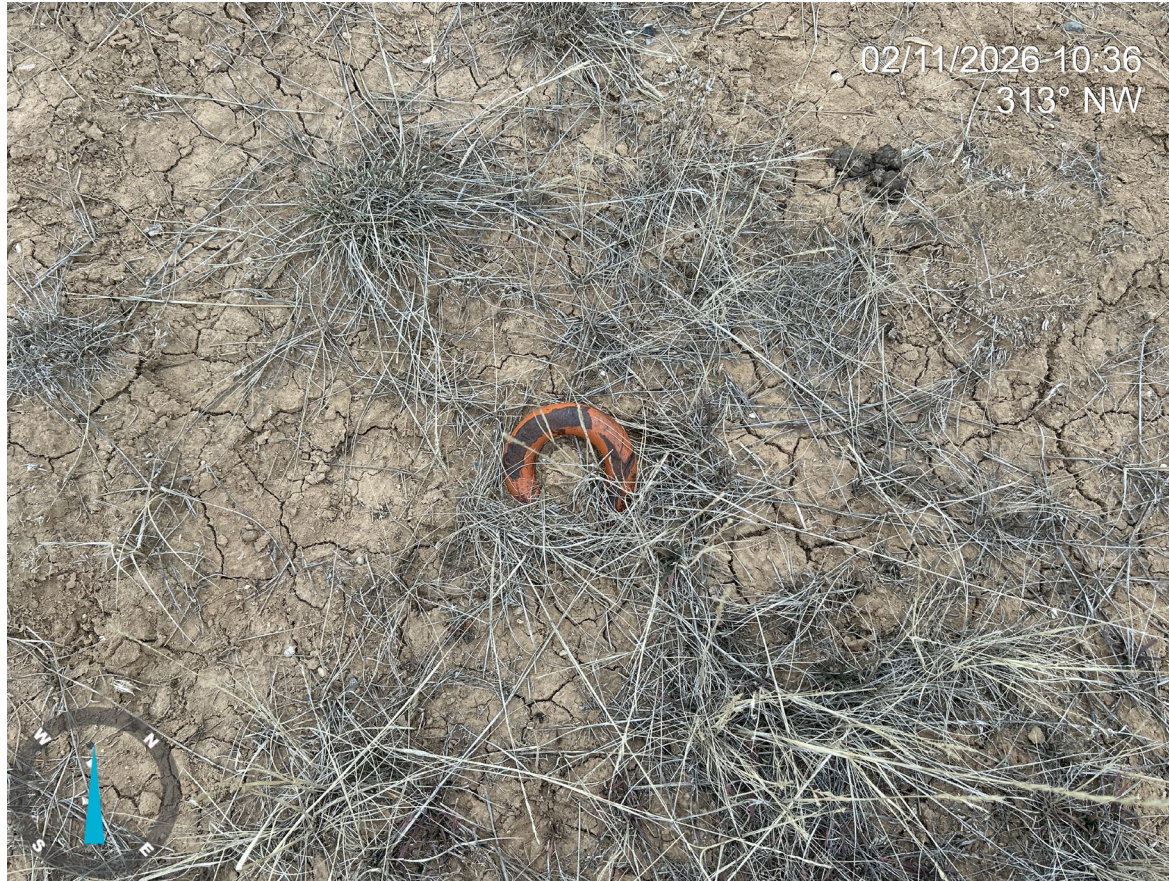
Photo 7: Photos showing an unmarked guy line anchor that is present in the northern interim area. Comply with Rule 1003.a.
