Inspection Photos

Operator: QB Energy Operating LLC #10844

Location ID: 383131

Inspection Doc: 719200830

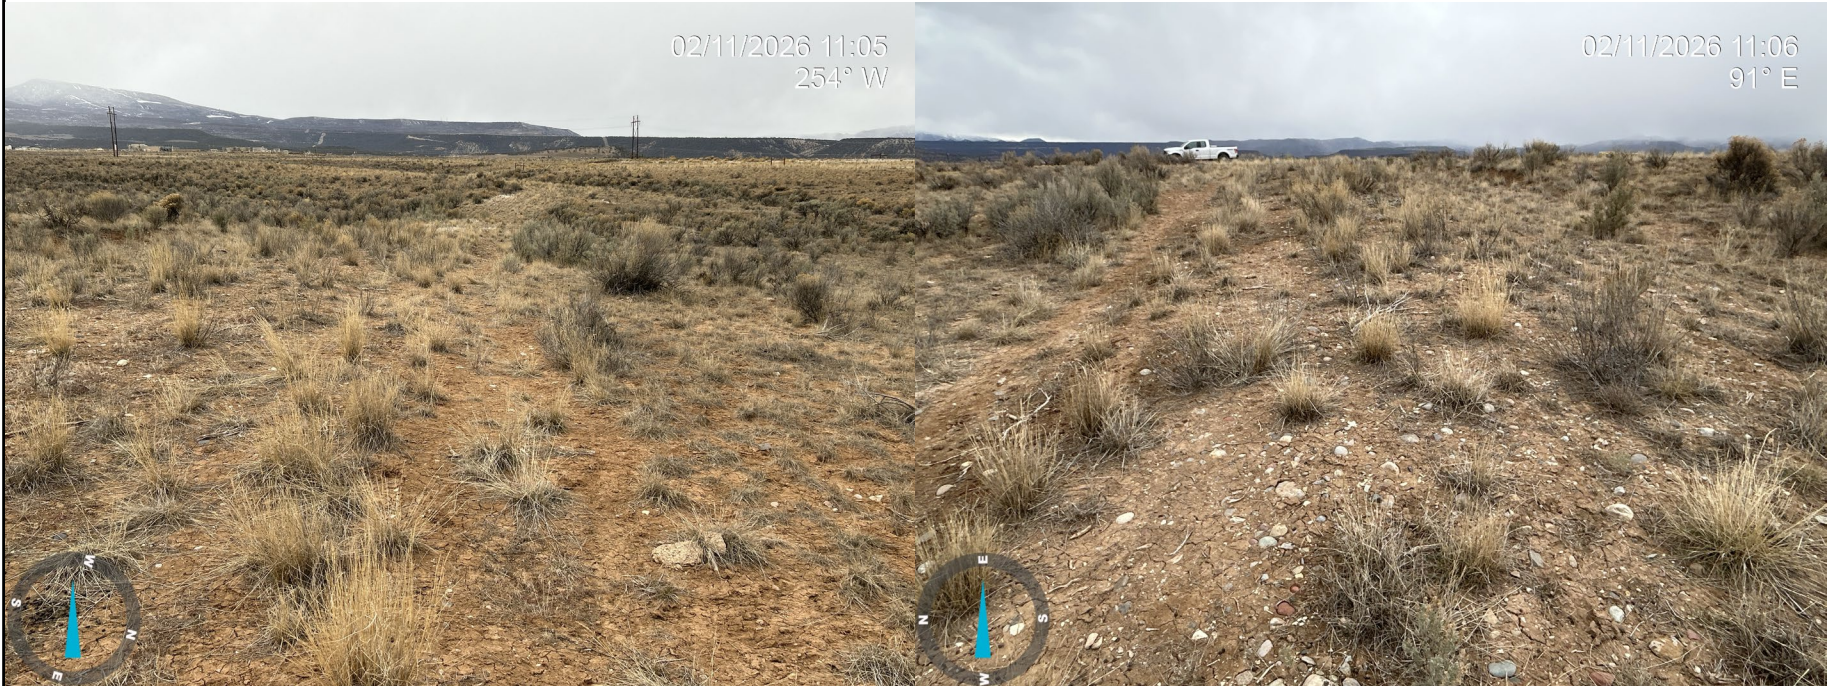
Photo 1: Photos showing an overview of the reclaimed access road leading to the location. The access road is progressing towards 1004 reclamation requirements.

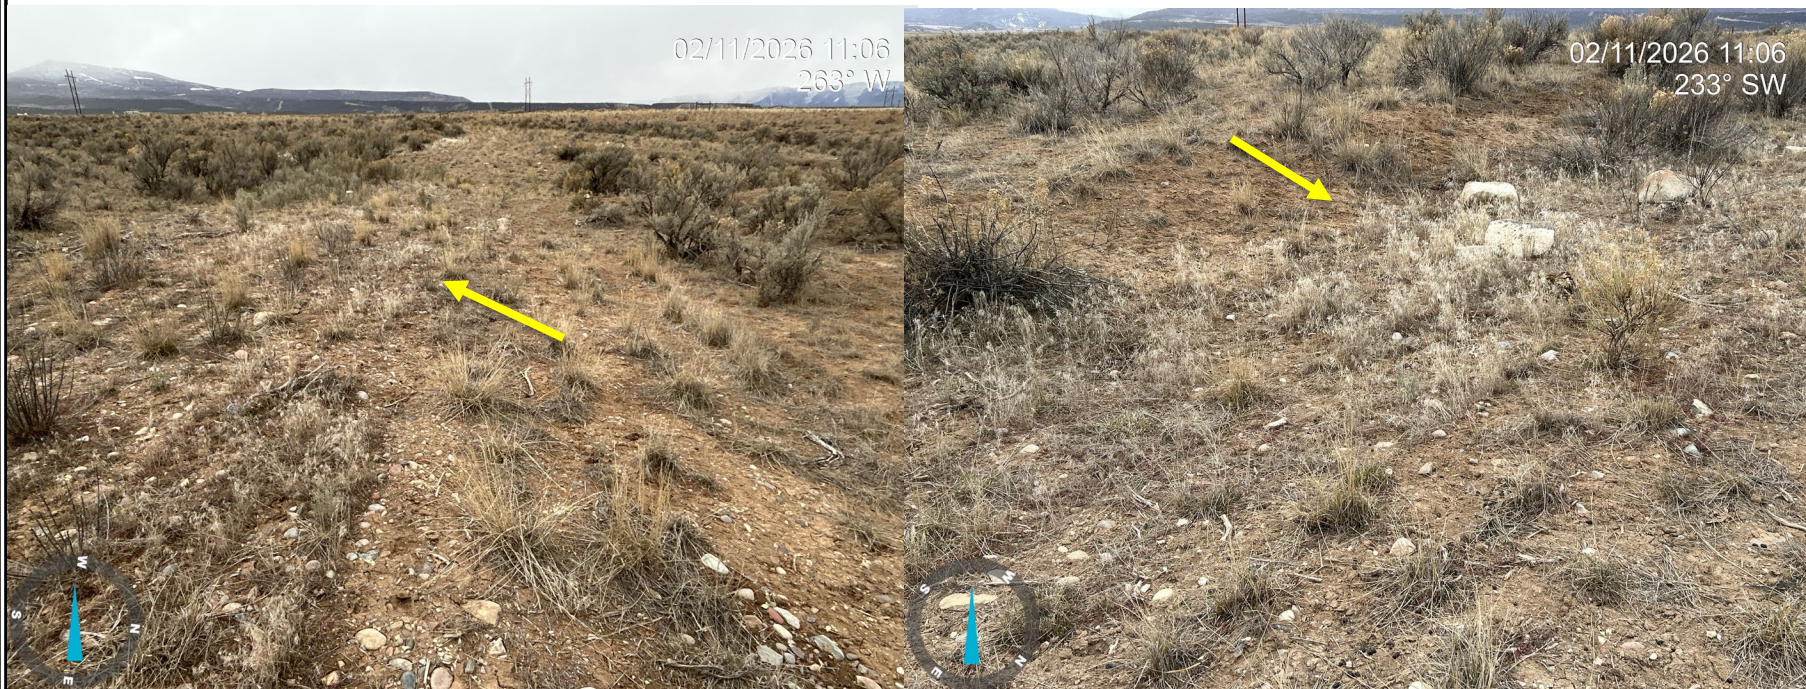
Photo 2: Photos showing examples of cheatgrass patches that are present along the reclaimed access road.

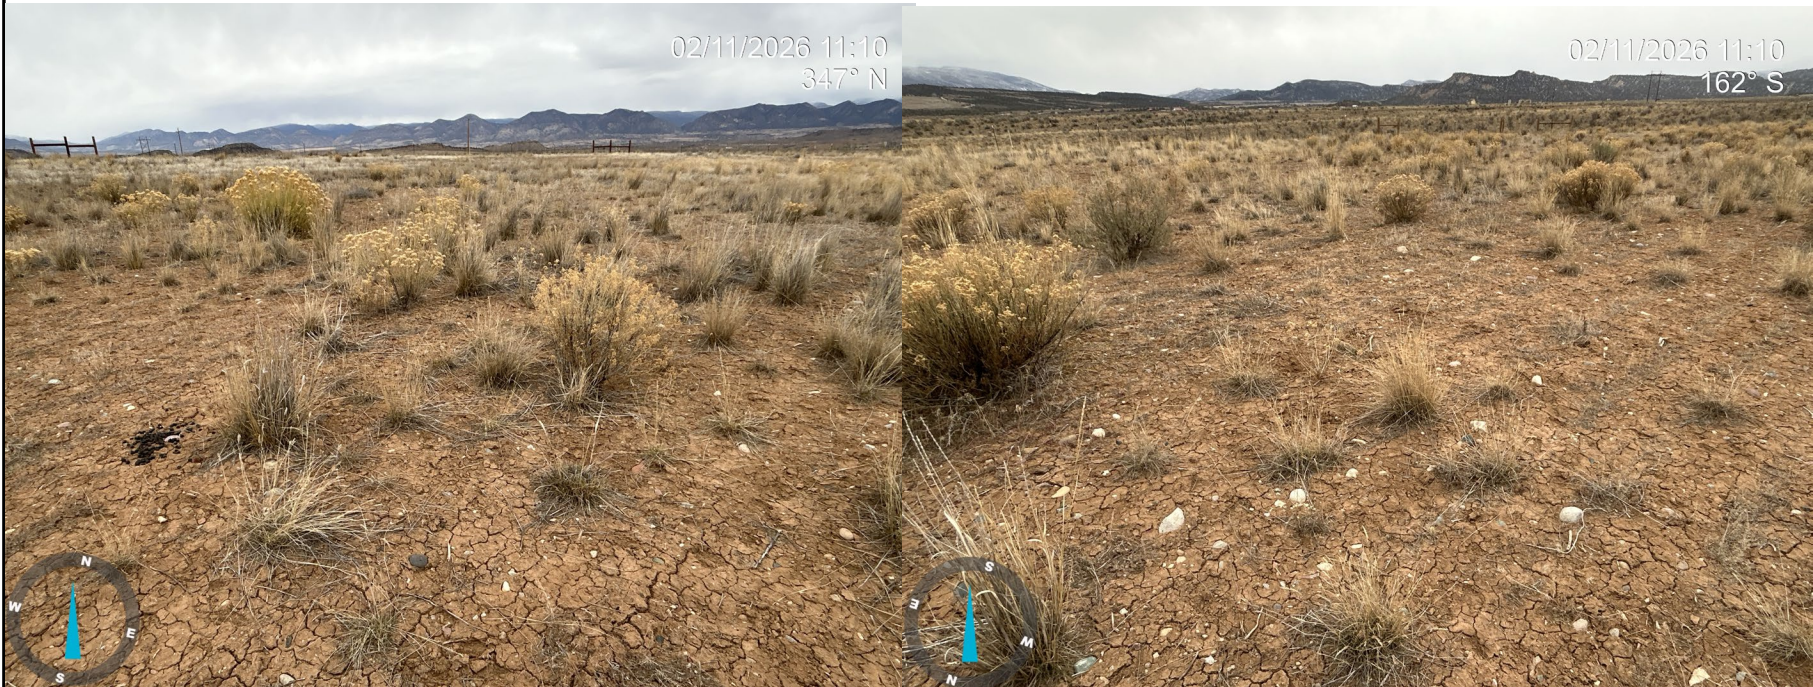
Photo 3: Photos showing an overview of the location looking north and south, respectively. Vegetation is sparse in some central areas of the location; these portions may need more time to develop.

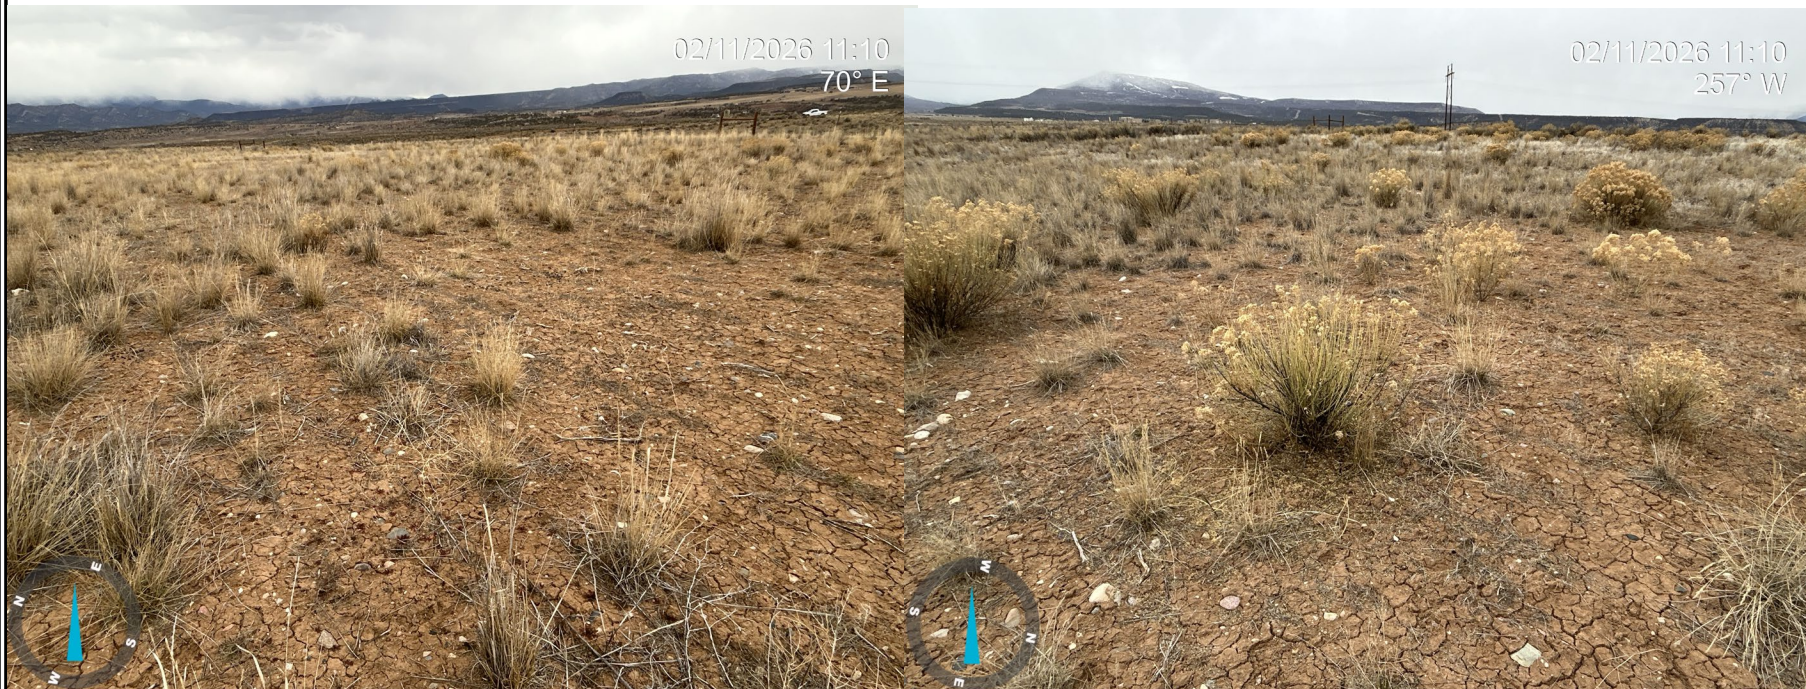
Photo 4: Photos showing an overview of the location looking east and west, respectively. Vegetation is sparse in some central areas of the location; these portions may need more time to develop.

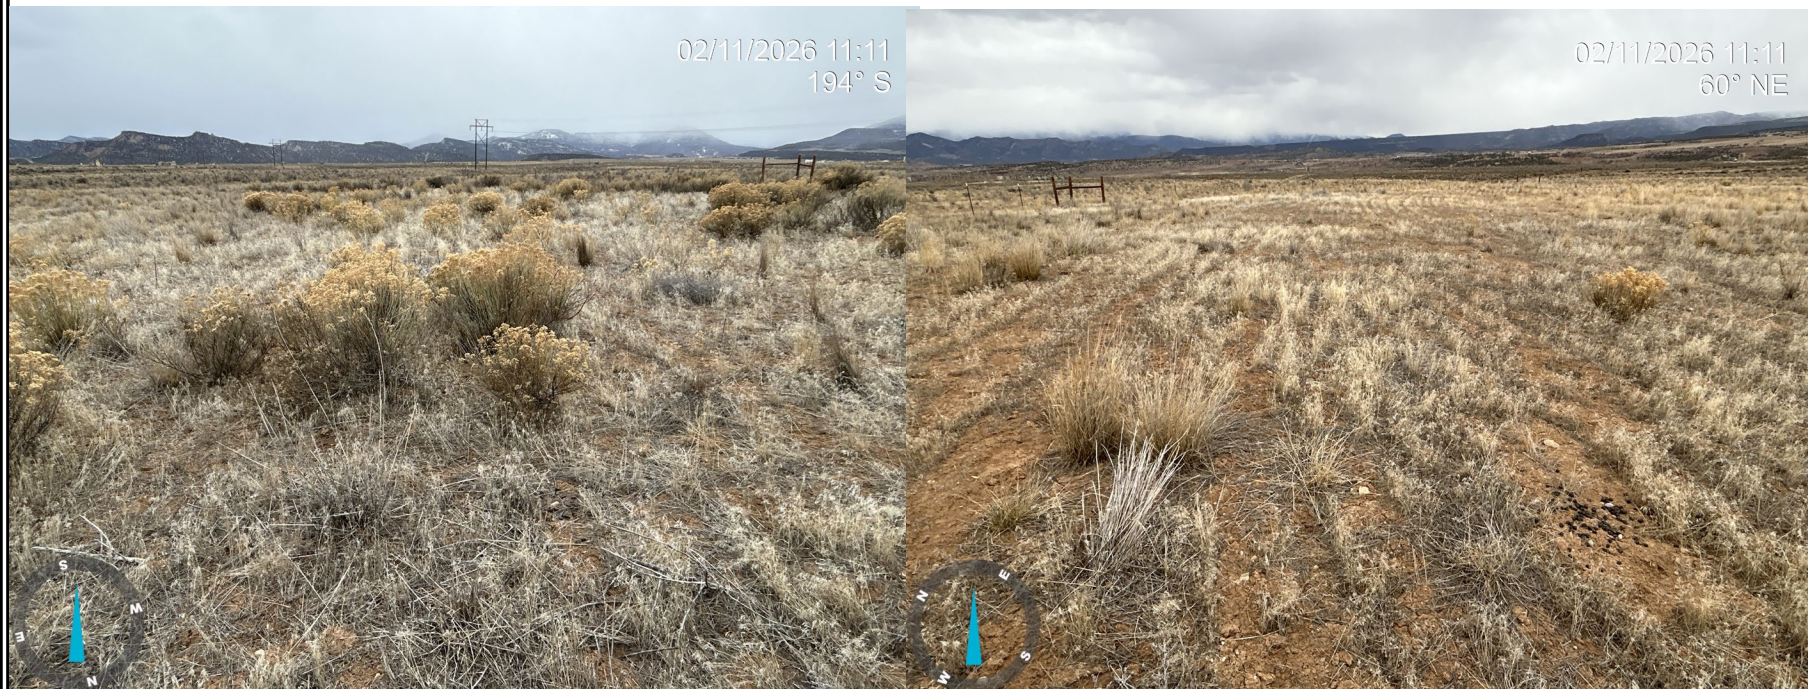
Photo 5: Photos showing an overview of the northwestern and northern portions of the location, respectively. Cheatgrass dominates these portions of the location. Ongoing weed management is required until the location receives a passing final inspection.

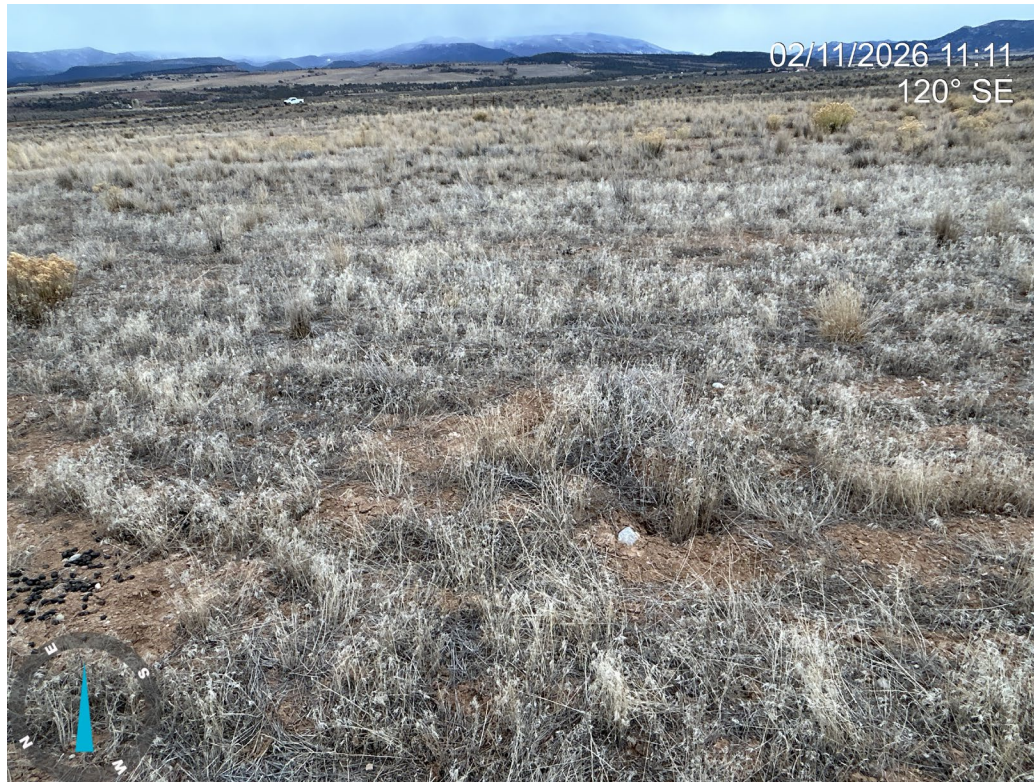
Photo 6: Photos showing an overview of the northern portions of the location. Cheatgrass dominates this portion of the location. Ongoing weed management is required until the location receives a passing final inspection.

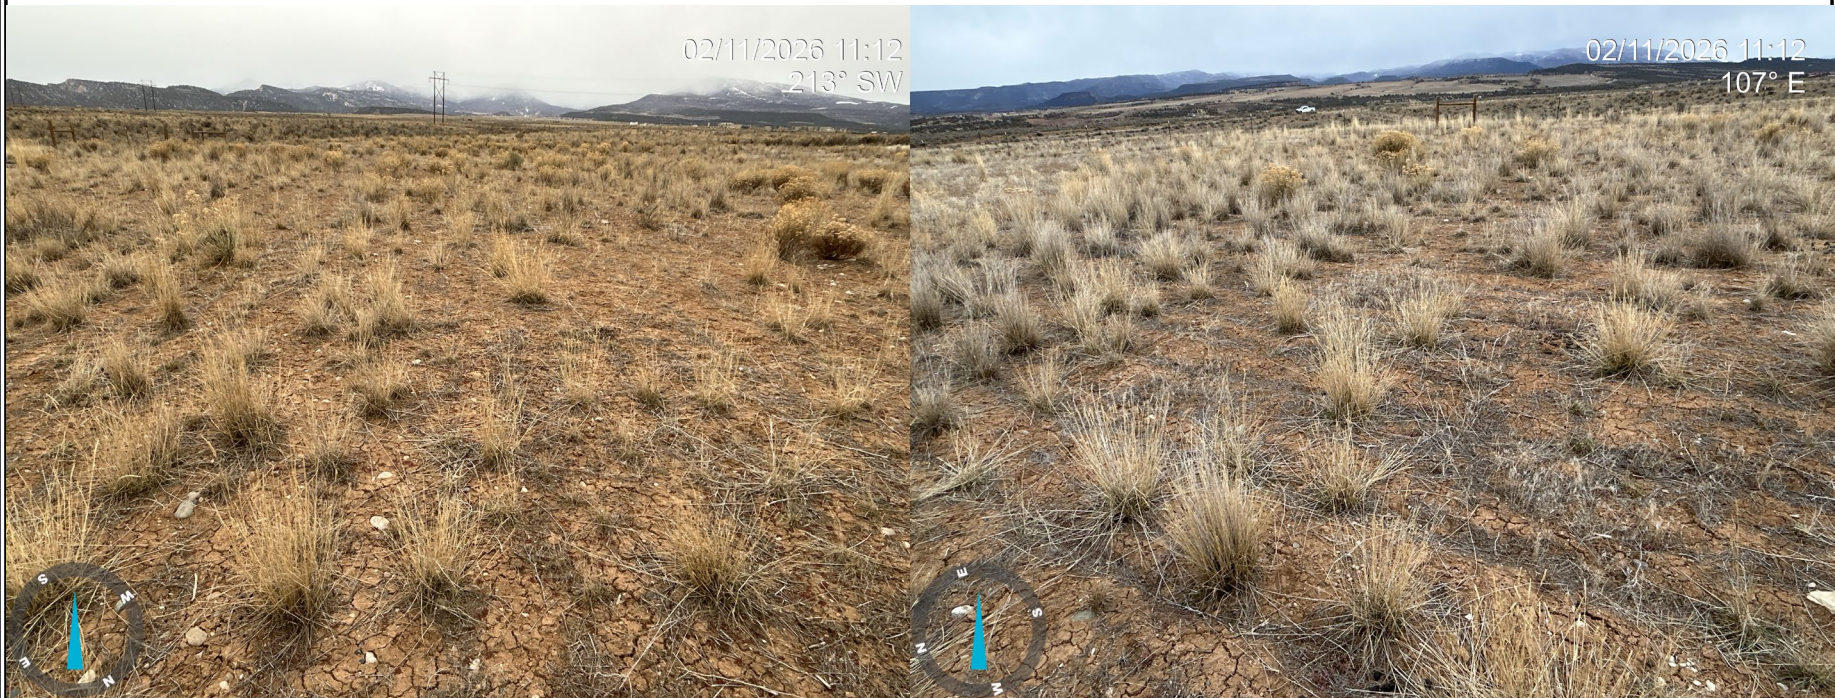
Photo 7: Photos showing an overview of the southwestern and southeastern portions of the location, respectively. These portions of the location are progressing towards 1004 reclamation requirements. Cheatgrass is beginning to establish in some portions of the southern area.

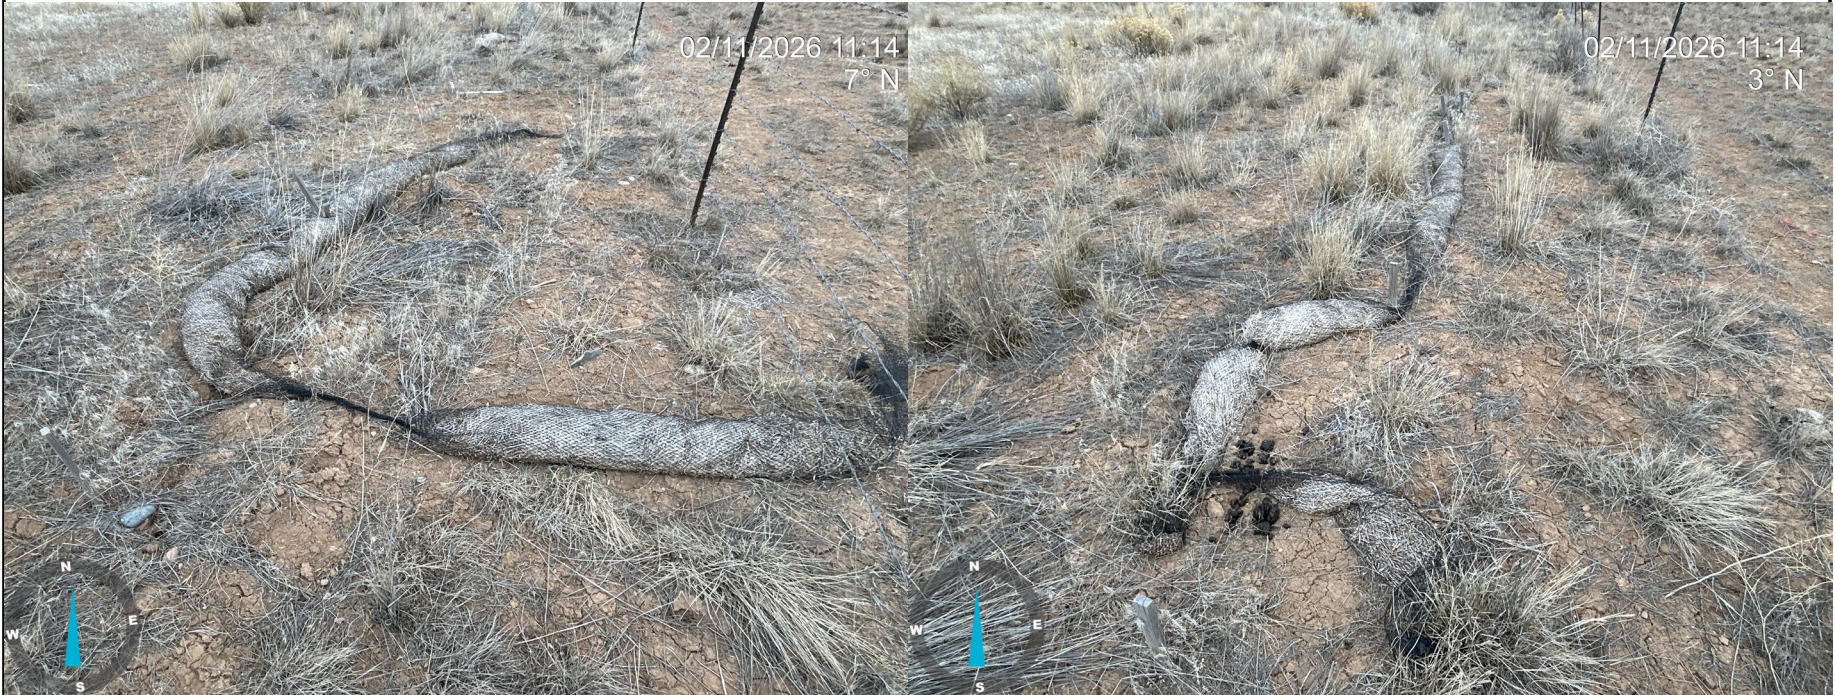
Photo 8: Photos showing an example of straw wattles that are present on the southern/southeastern portion of the location and appear to be in disrepair. Removal is required before the location receives a passing final reclamation inspection.

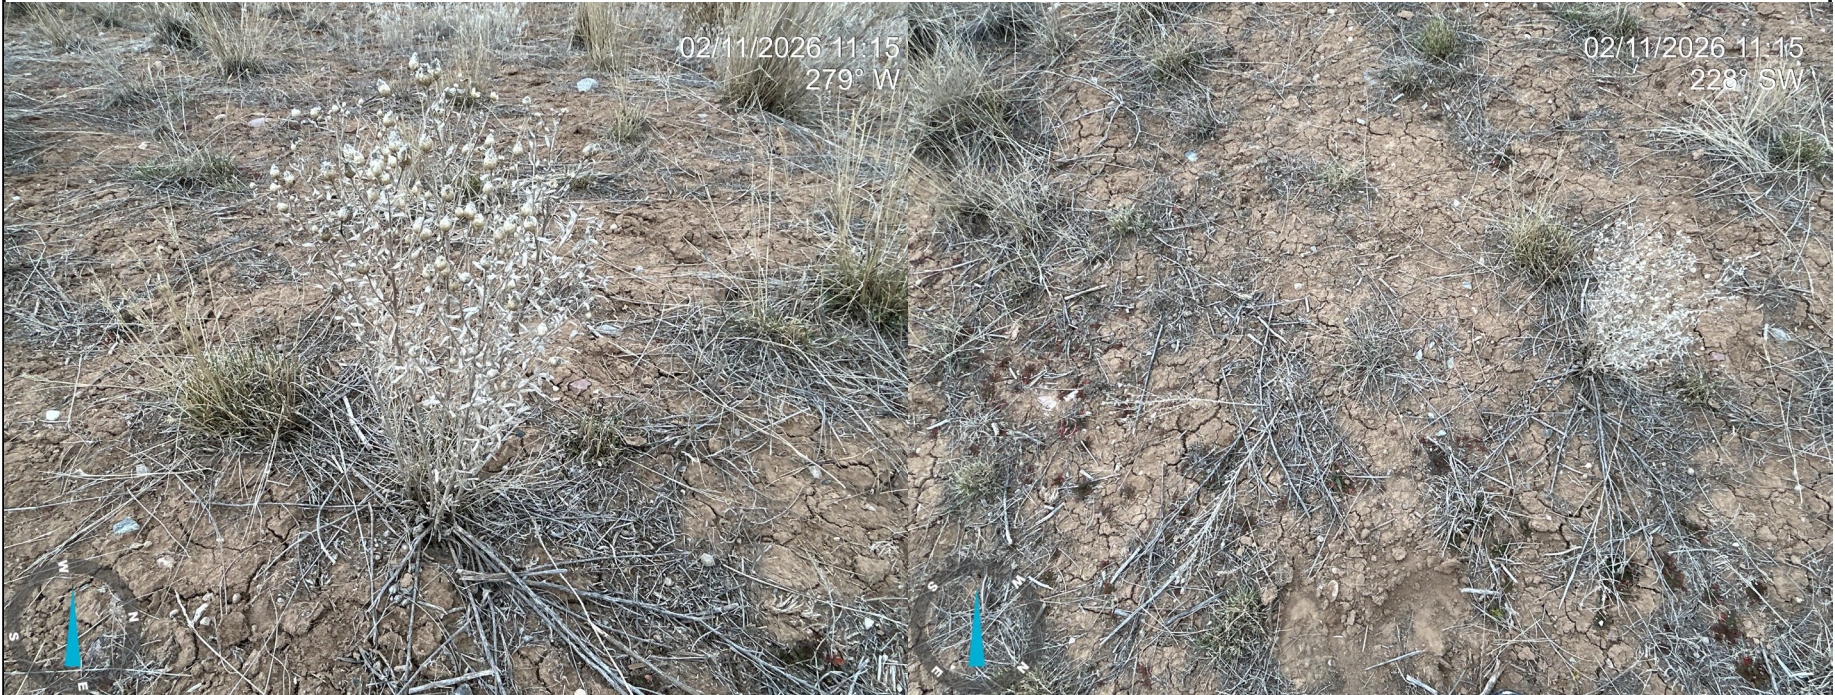
Photo 9: Photos showing trace amounts of Russian knapweed, a List B noxious weed species, is present on the southern portion of the location. Ongoing weed management is required until the location receives a passing final inspection.

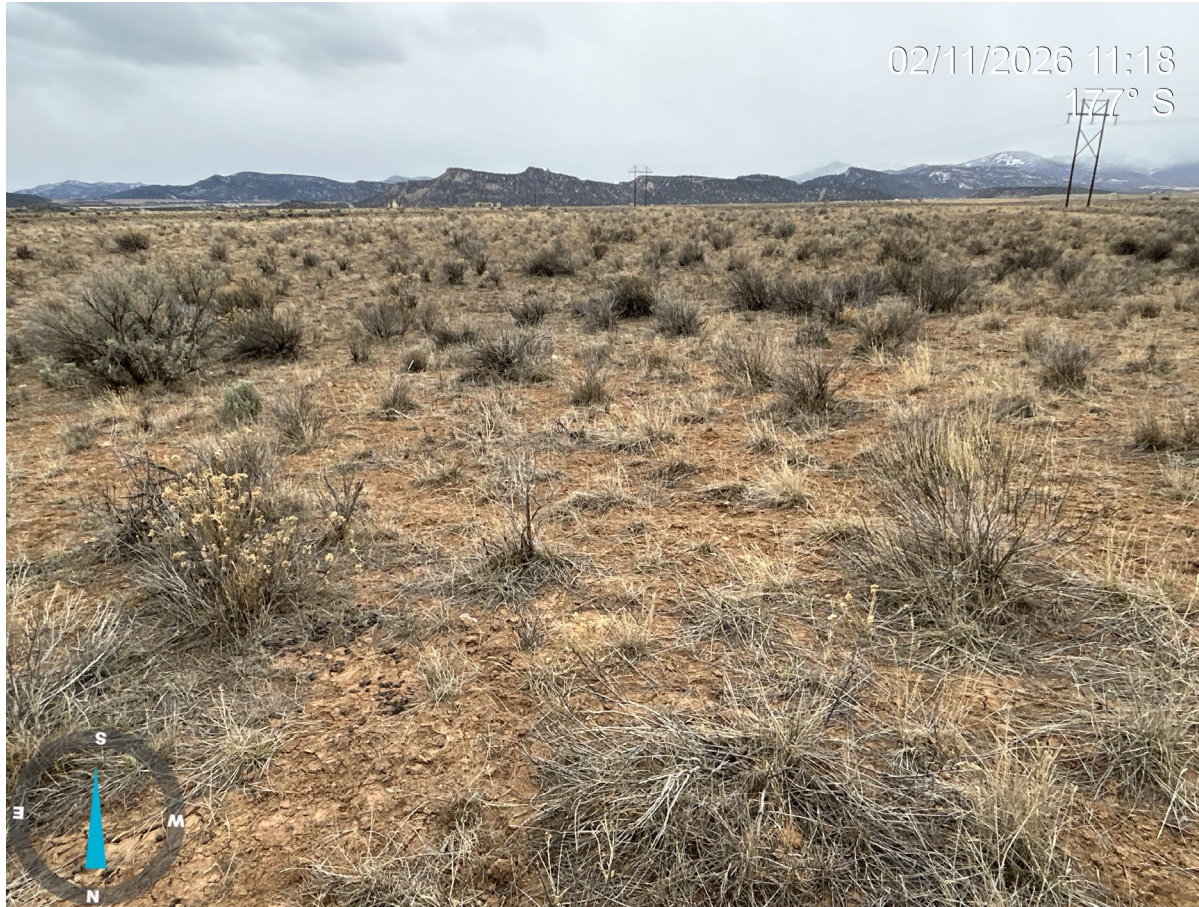
Photo 10: Photos showing an example of vegetation on the adjacent reference area during the dormant season.
