INSPECTION PHOTOS

Well: PIONEER 34-27 & TR

API #: 05-071-07617

INSPECTION DOC #: 716302000

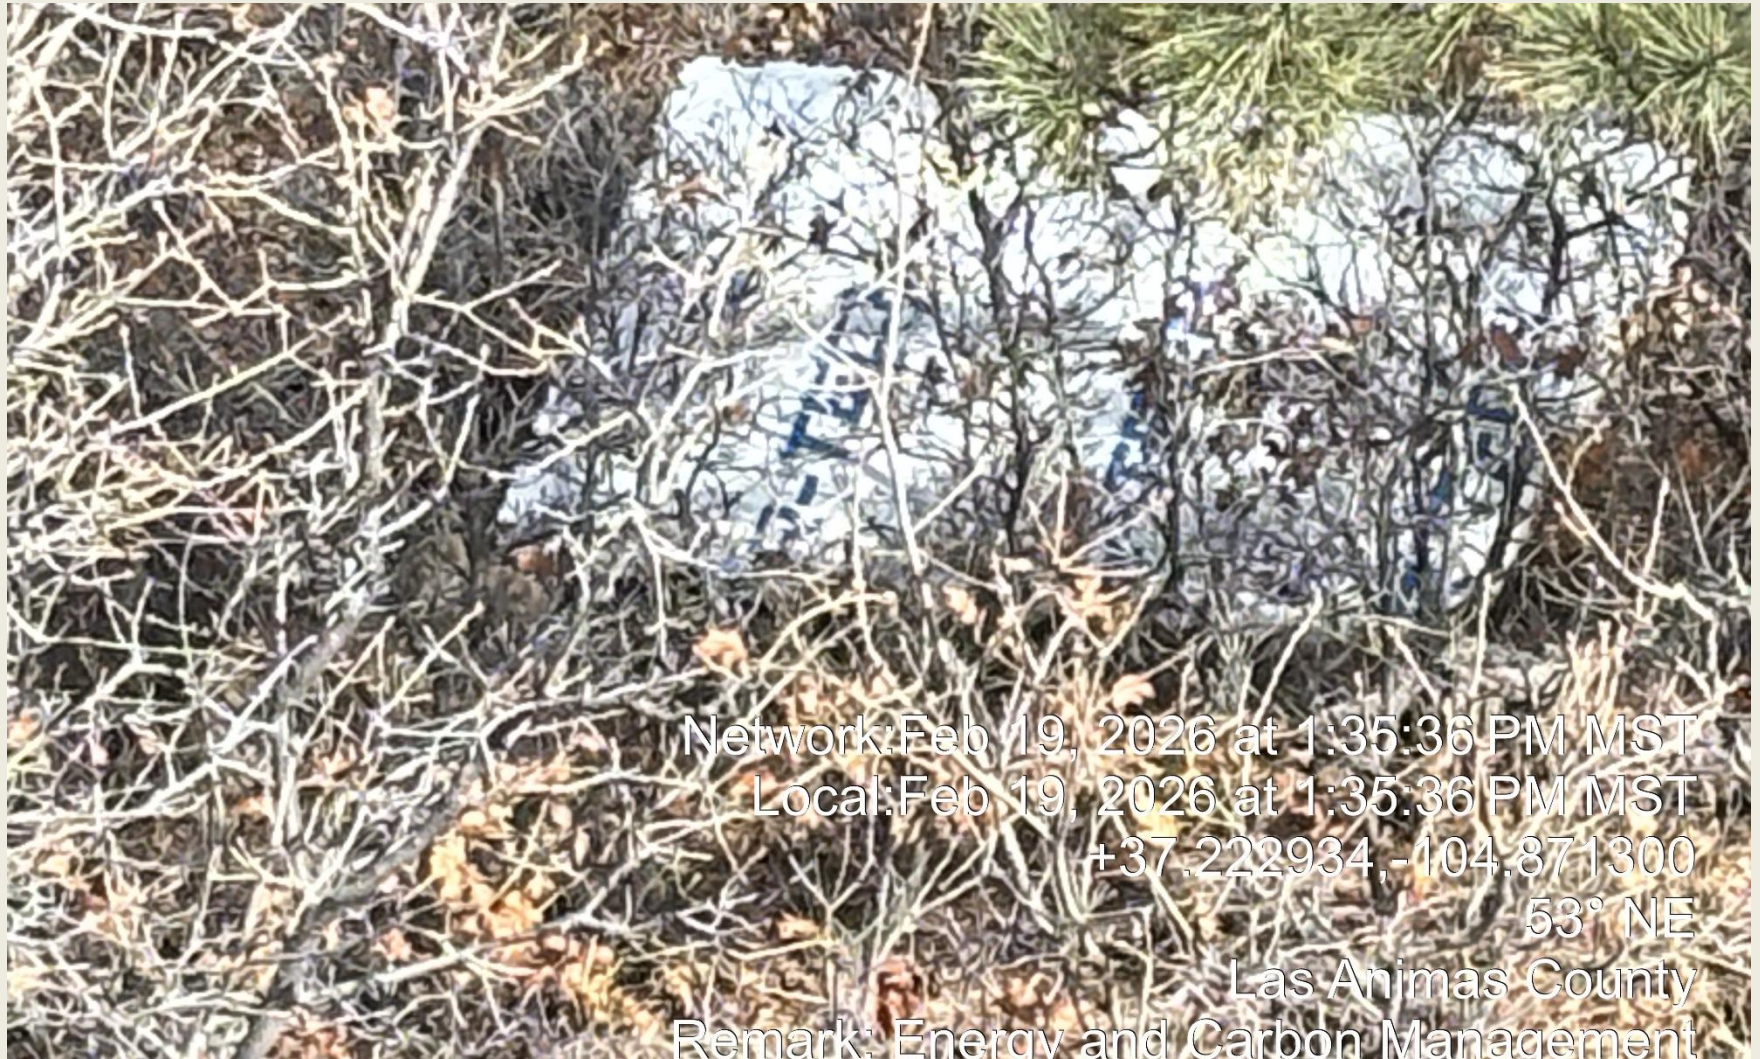
PHOTO 6: TRASH OFF THE NORTH SIDE OF LOCATION APPEARS TO BE INSULATION FROM SOUND WALLS. **REMOVE TRASH ON AND AROUND LOCATION PER RULE 606. CA DATE 2/25/2026.**

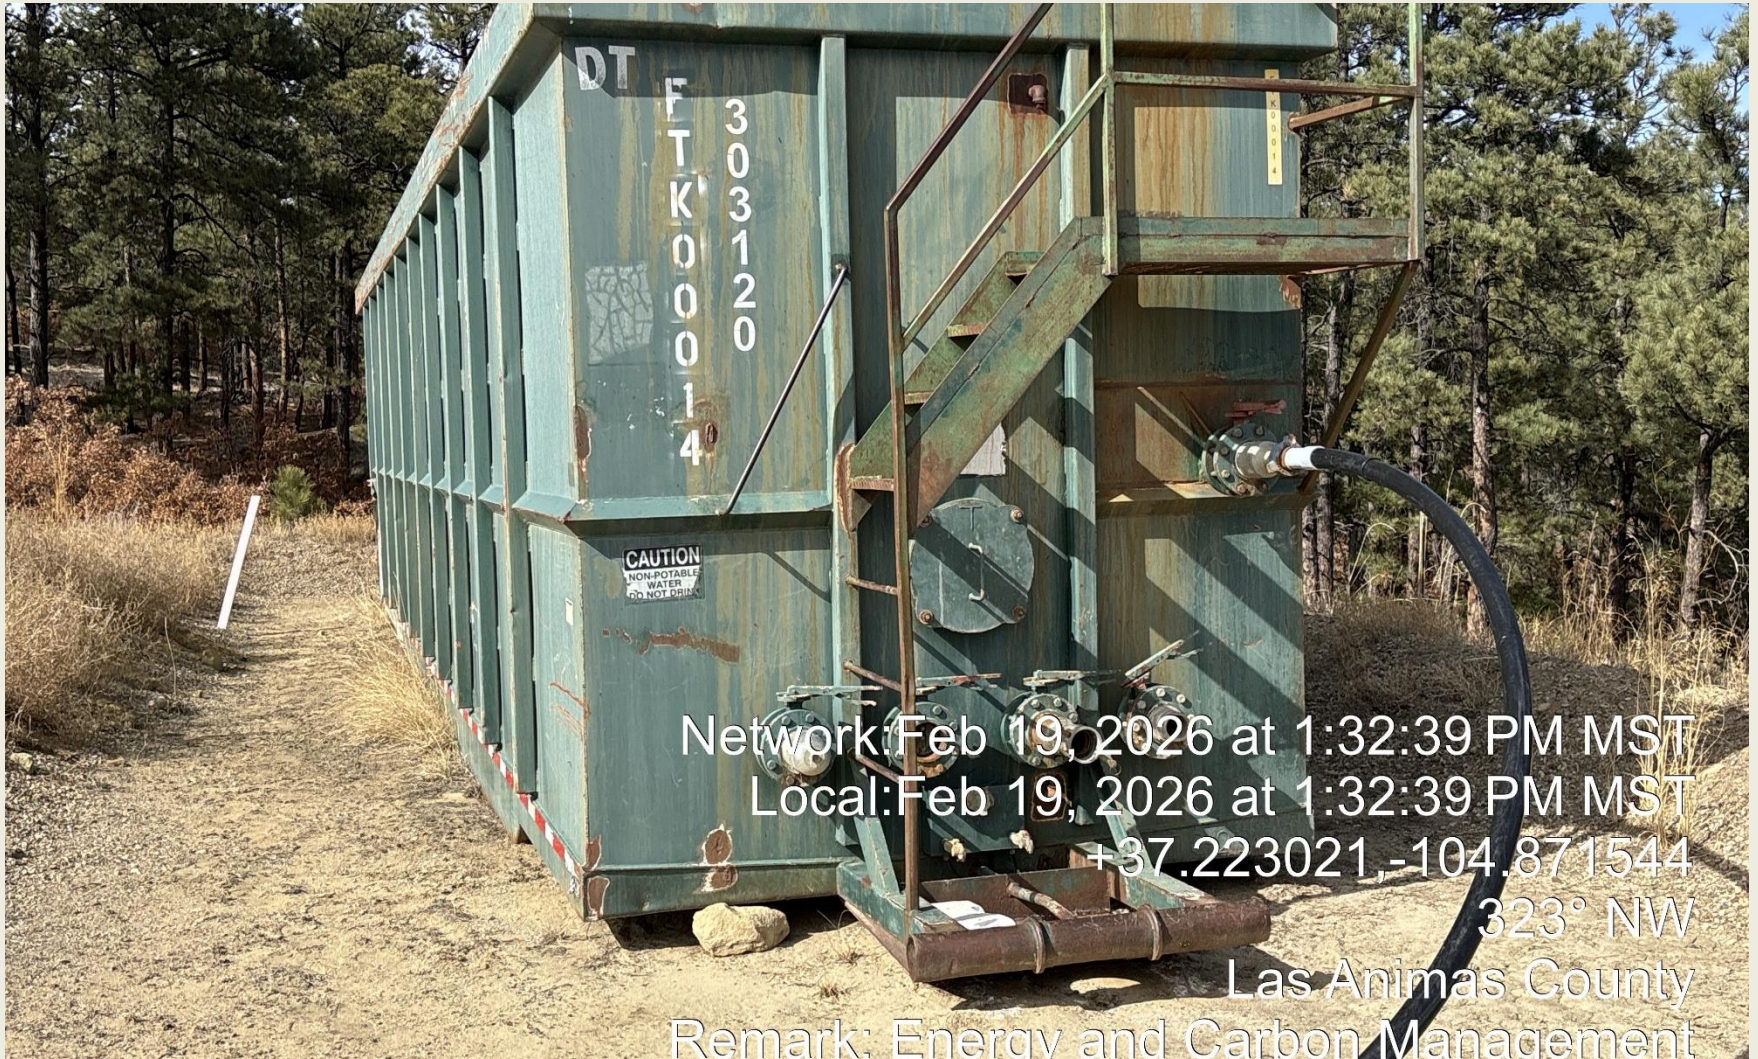
PHOTO 7: NO NFPA STICKER POSTED, NO CAPACITY POSTED AND CONTENTS IS PRODUCED WATER NOT NONE POTABLE WATER.
REMOVE OR COVER NONE POTABLE WATER STICKER AND POST TANK BATTERY SIGHS PER RULE 605. CA DATE 3/3/2026.

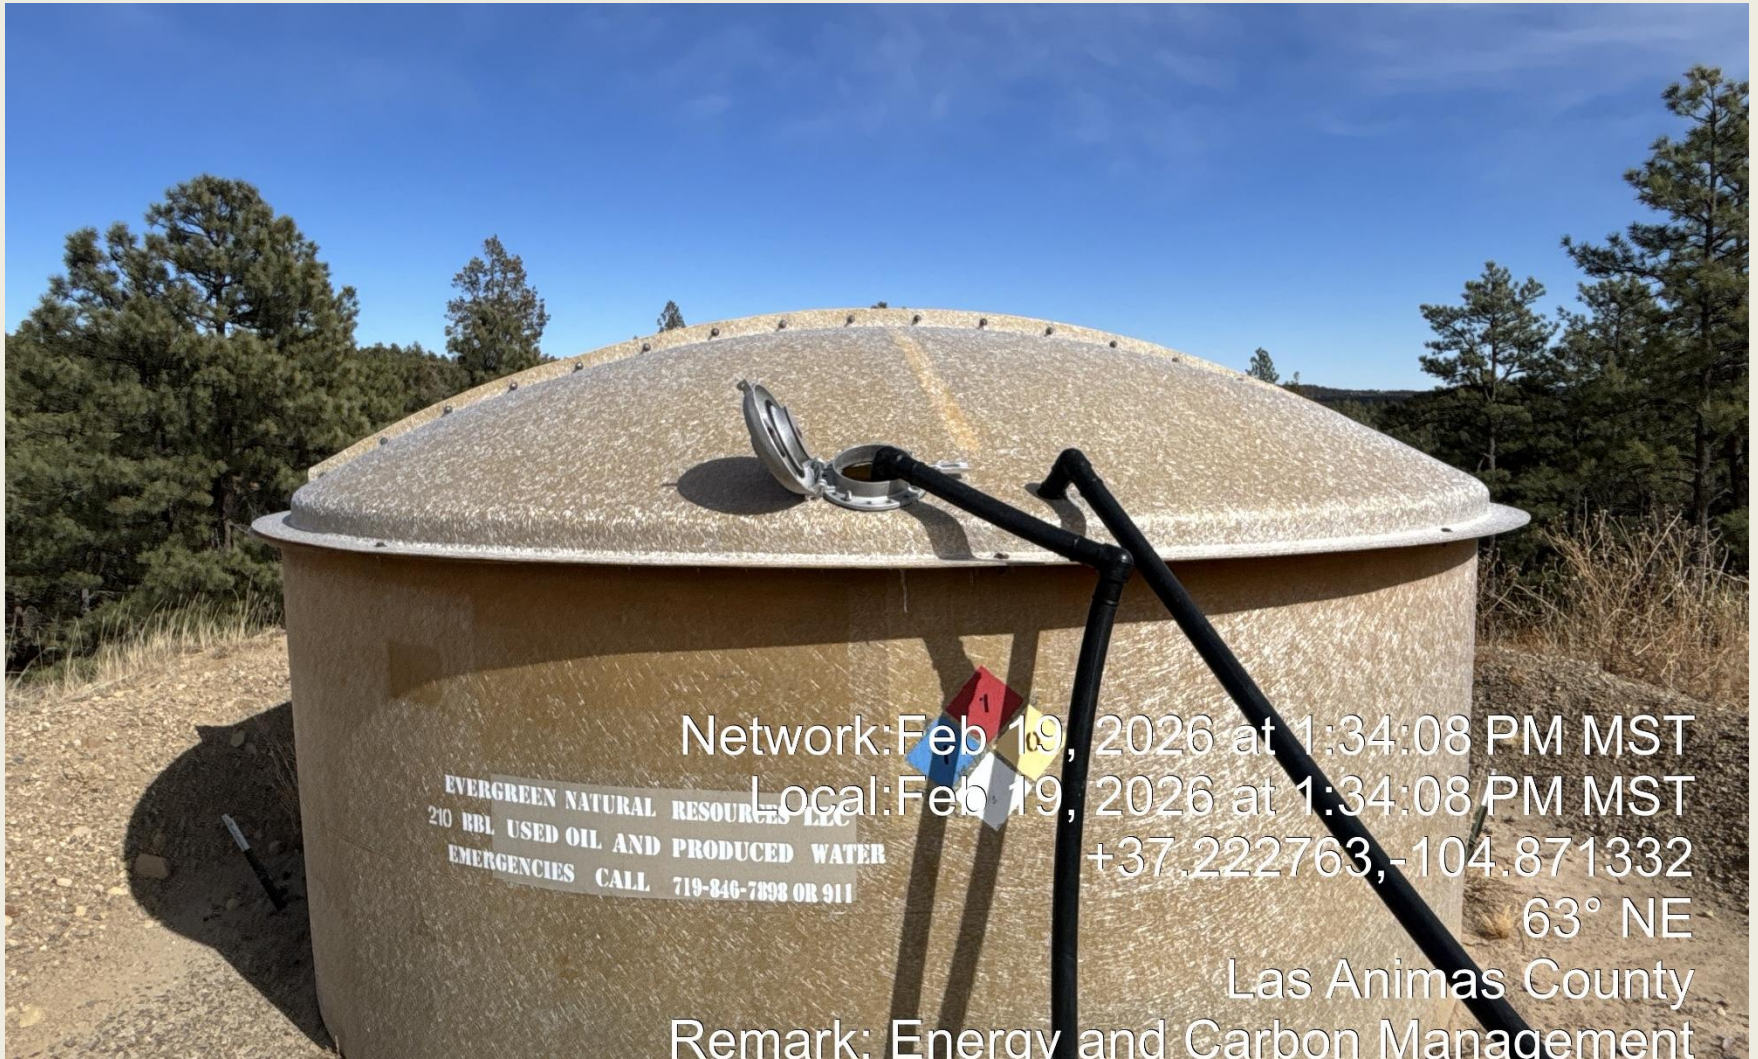
PHOTO 8: HATCH ON TANK IS OPEN WITH NO BIRD PROTECTION. PLUMB 2" PIPE SO HATCH CAN BE CLOSED OR INSTALL BIRD PROTECTORS PER RULE 608. CA DATE 3/3/2026.
