Inspection Photos

Operator: QB Energy Operating LLC #10844

Location ID: 334967

Inspection Doc: 719200852

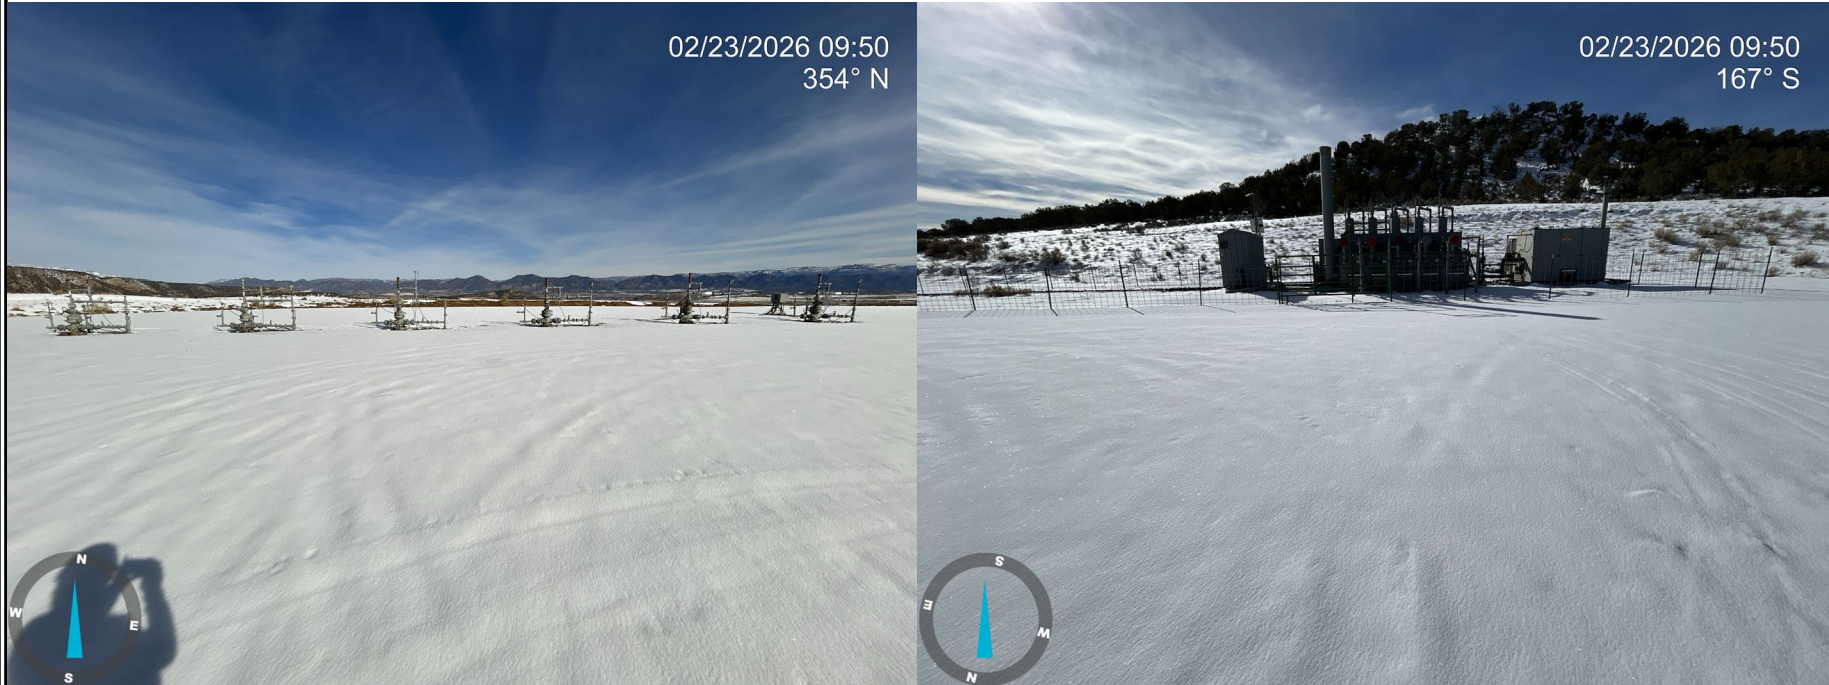
Photo 1: Photos showing an overview of the location looking north and south, respectively.

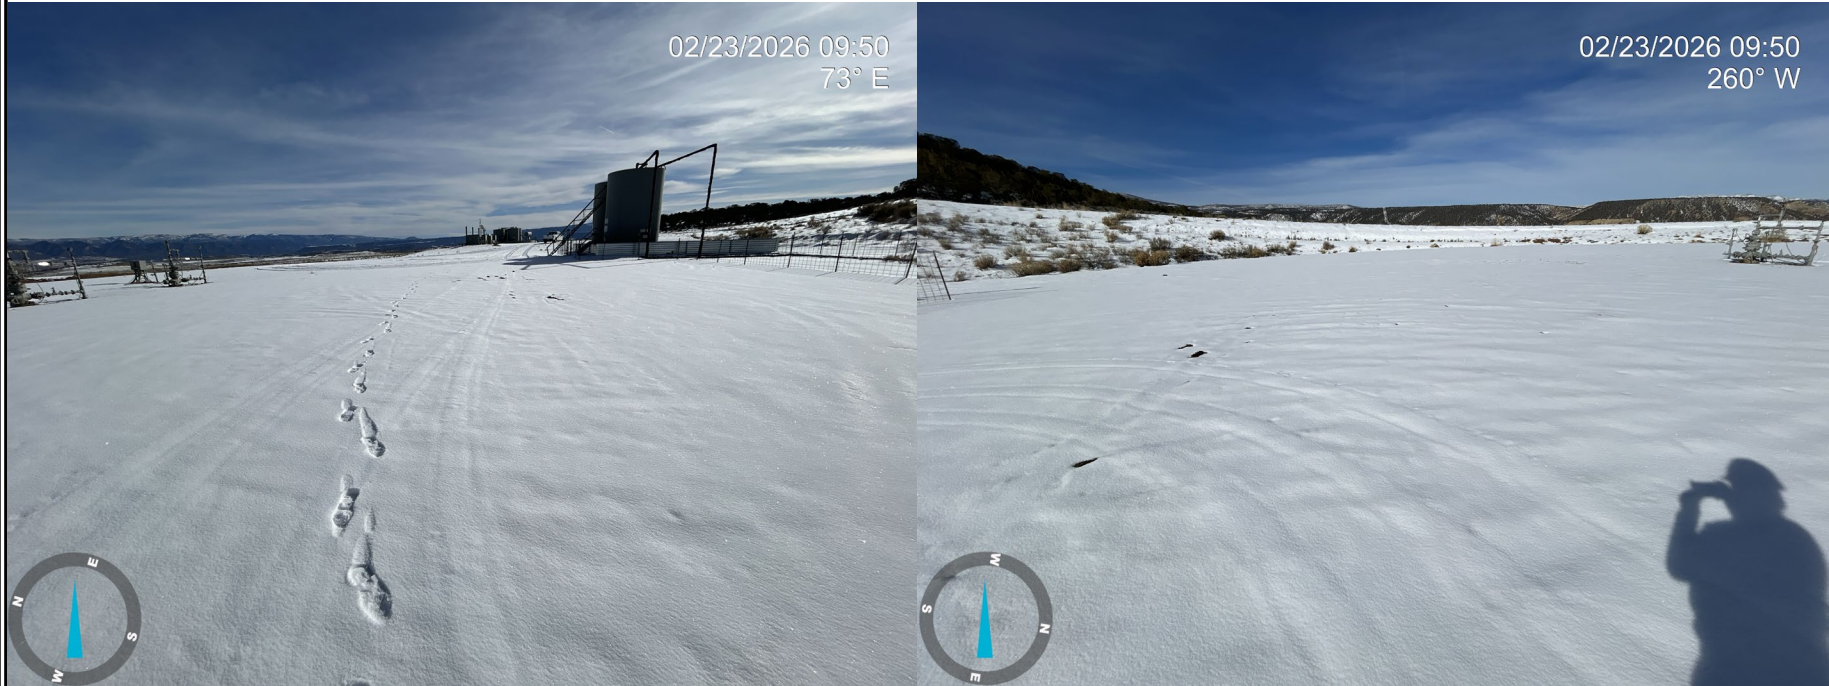
Photo 2: Photos showing an overview of the location looking east and west, respectively.

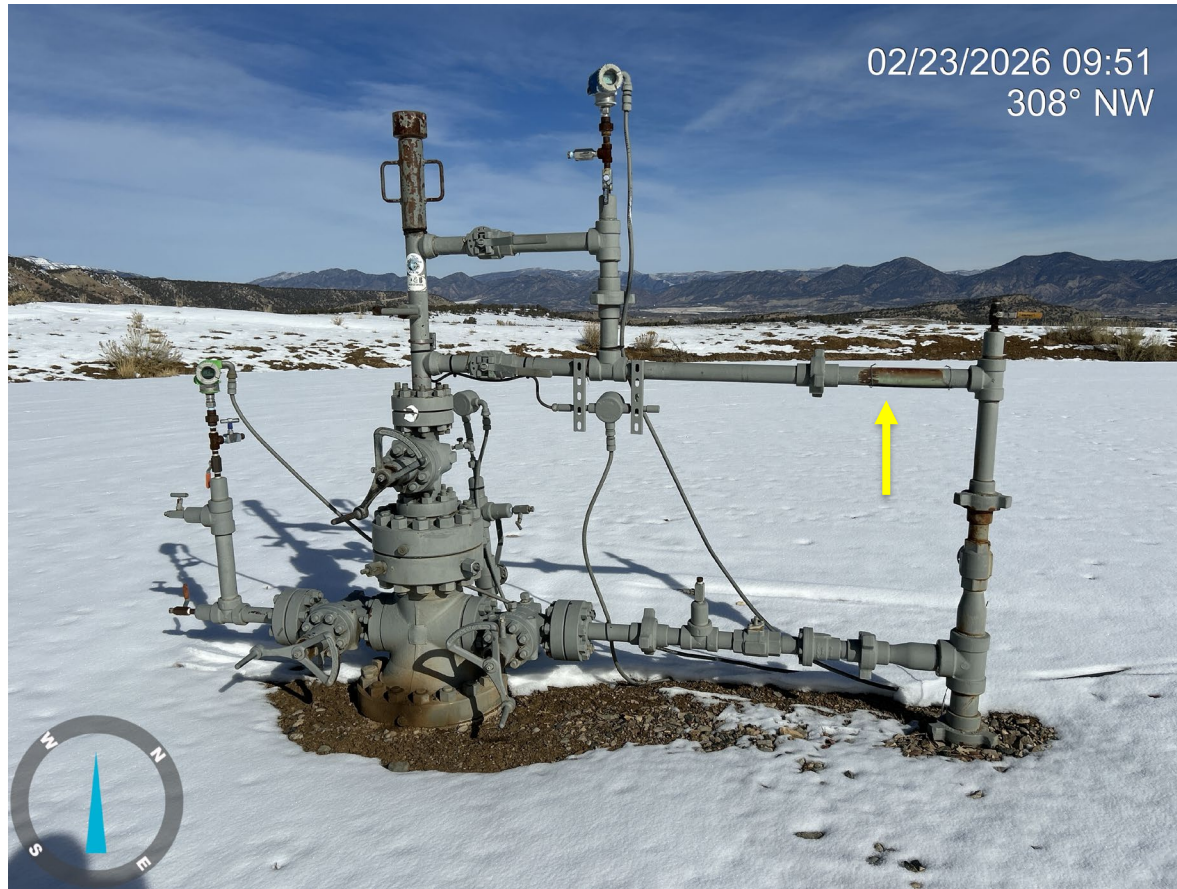
Photo 3: Photo showing wellhead signage has slipped downwards, rendering it inconspicuous and difficult to read. Comply with Rule 605.d.

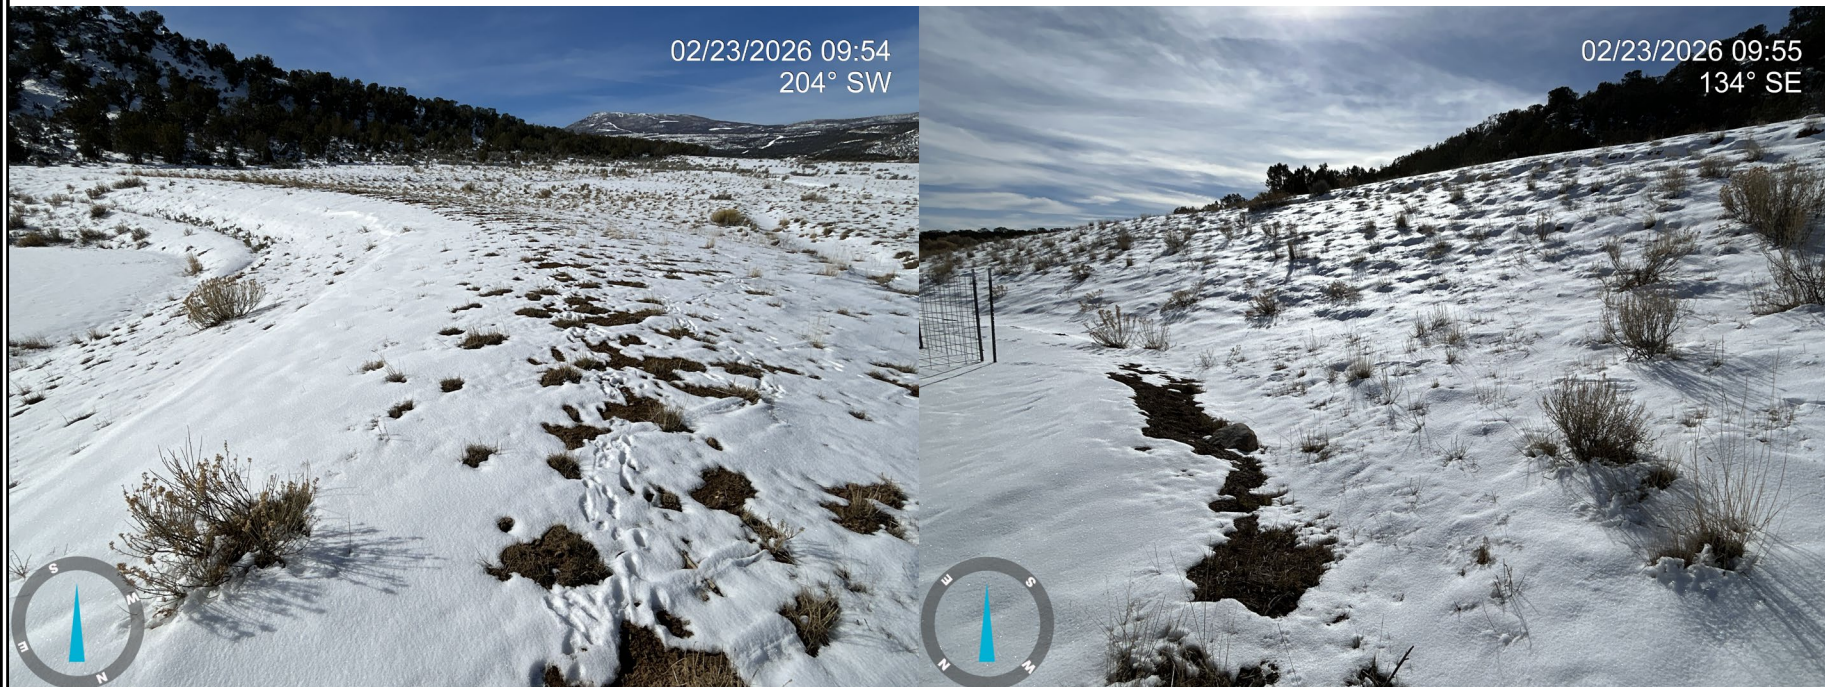
Photo 4: Photos showing an overview of the northwestern and southwestern interim areas, respectively. Snow cover prevented a full interim inspection; a follow-up inspection will be conducted during future growing seasons to determine 1003 compliance.
