**INITIAL DECOMMISSIONING REPORT**  
**WELLS RANCH USX AE21-14**  
**ECMC REMEDIATION # 42501**

**Noble Energy, Inc – 100322 – DJ Basin**  
**Wells Ranch USX AE21-14**  
 NWSW, Section 21, Township 6 North, Range 62 West  
 Weld County, Colorado

**SOIL SAMPLE  
 LOCATION MAP  
 (TANK BATTERY)**

**BACKGROUND SAMPLE LOCATION MAP**

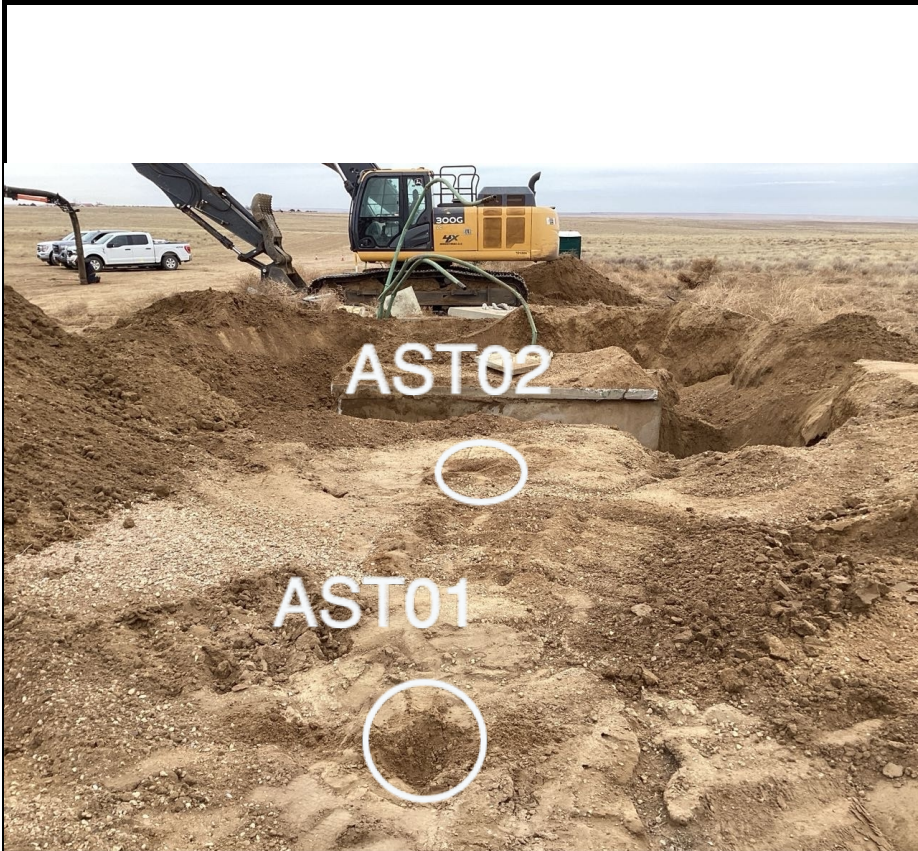
<b>Equipment ID:</b> AST01 & AST02		<b>Equipment Type:</b>	
<b>Material:</b>	<b>Volume:</b>	<b>Contents:</b>	
<b>Notes/Conditions:</b> Facing East

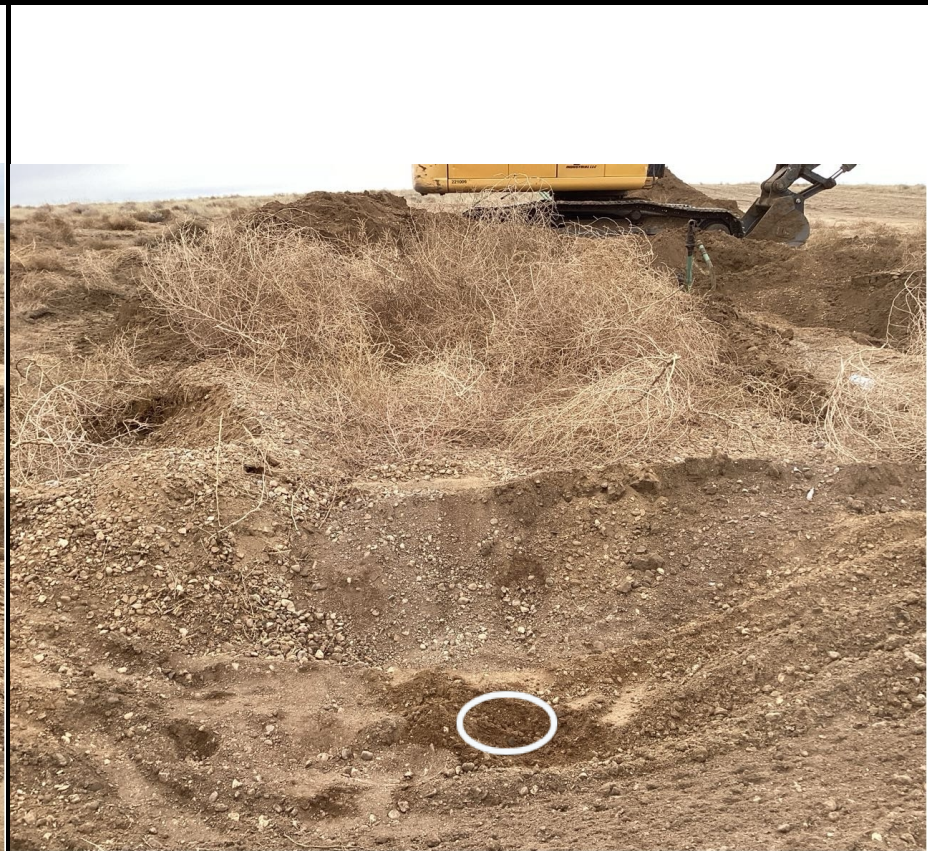
<b>Equipment ID:</b> FLARE01		<b>Equipment Type:</b>	
<b>Material:</b>	<b>Volume:</b>	<b>Contents:</b>	
<b>Notes/Conditions:</b> West

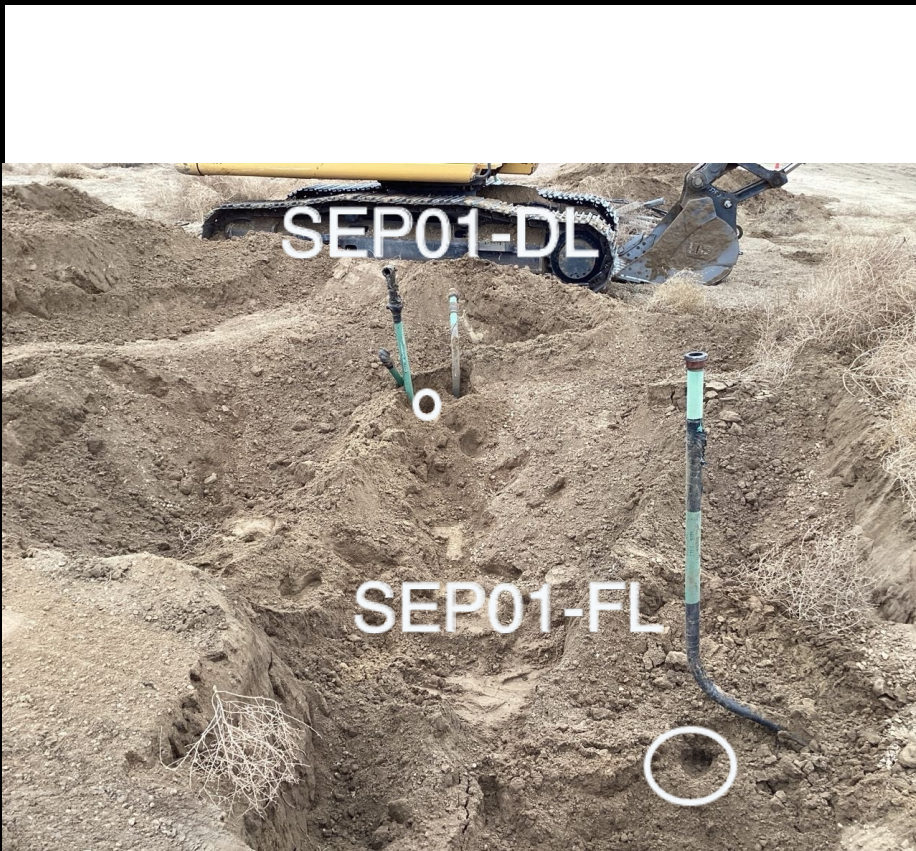
<b>Equipment ID:</b> SEP01-DL/FL		<b>Equipment Type:</b>	
<b>Material:</b>	<b>Volume:</b>	<b>Contents:</b>	
<b>Notes/Conditions:</b> West

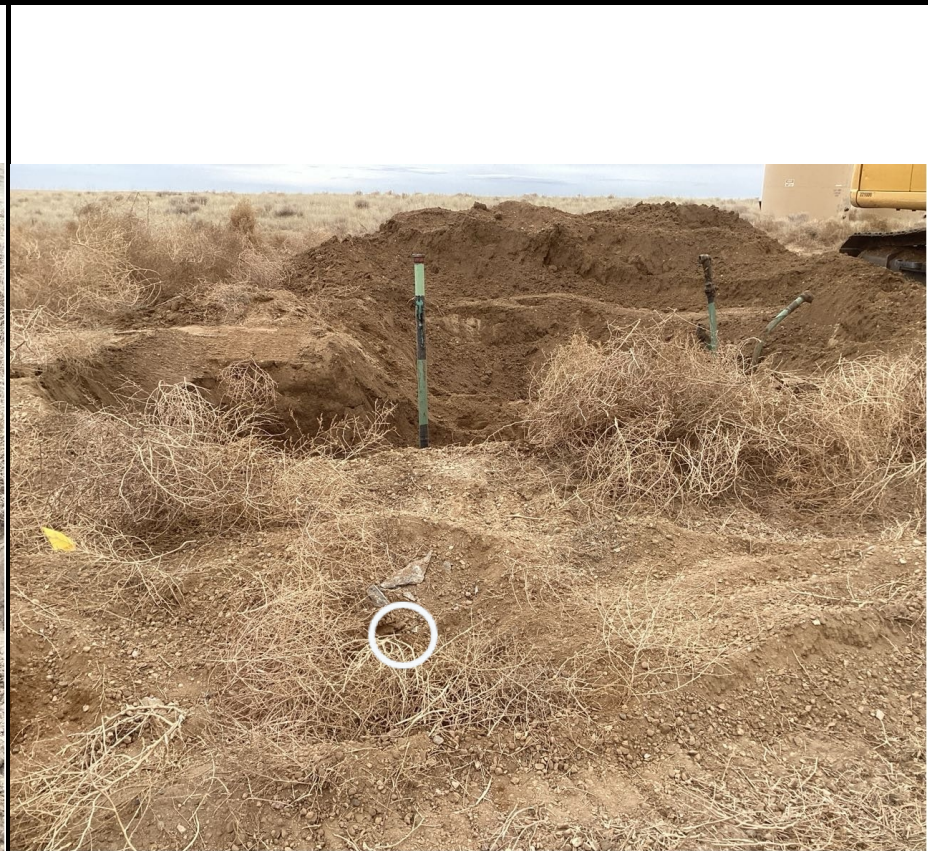
<b>Equipment ID:</b> MH01 @0-0.5'		<b>Equipment Type:</b>	
<b>Material:</b>	<b>Volume:</b>	<b>Contents:</b>	
<b>Notes/Conditions:</b> South

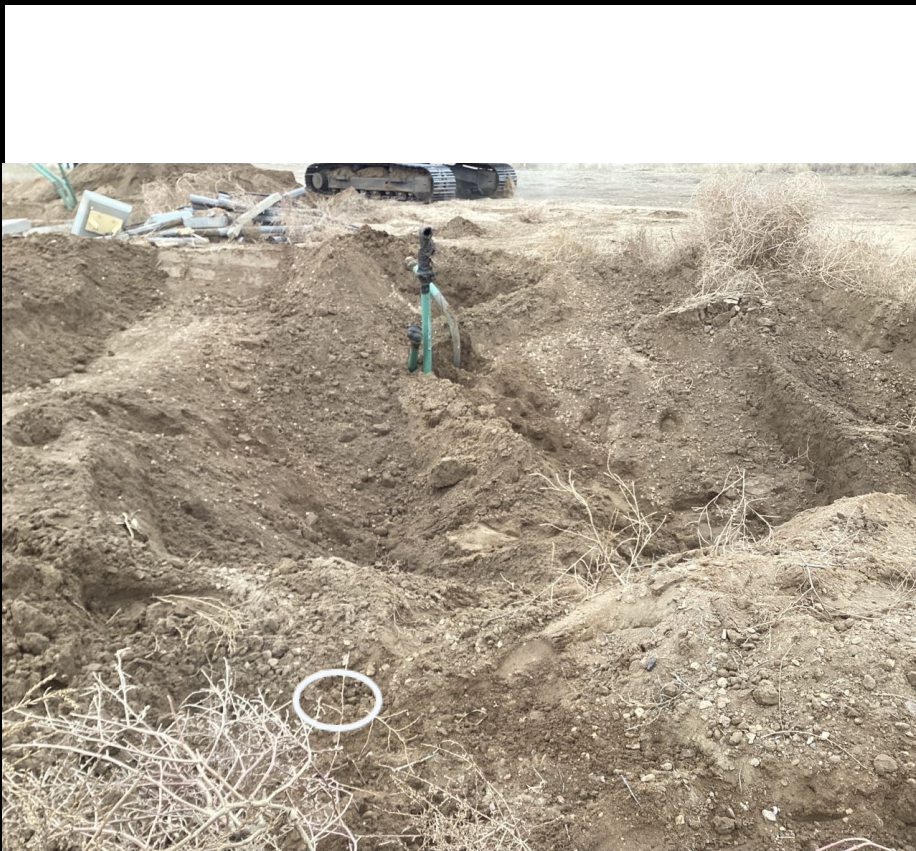
<b>Equipment ID:</b> MISC01		<b>Equipment Type:</b>	
<b>Material:</b>	<b>Volume:</b>	<b>Contents:</b>	
<b>Notes/Conditions:</b> North, South of SEP01

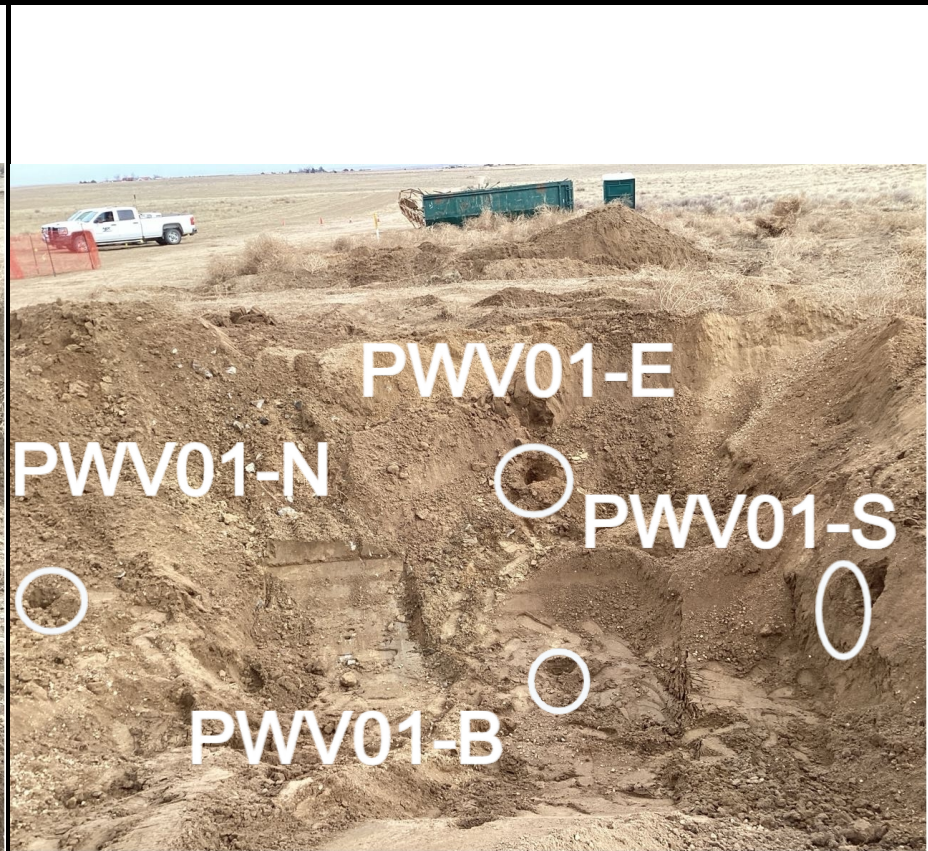
<b>Equipment ID:</b> PWV01		<b>Equipment Type:</b>	
<b>Material:</b>	<b>Volume:</b>	<b>Contents:</b>	
<b>Notes/Conditions:</b> PWV01N,S,E and B facing East

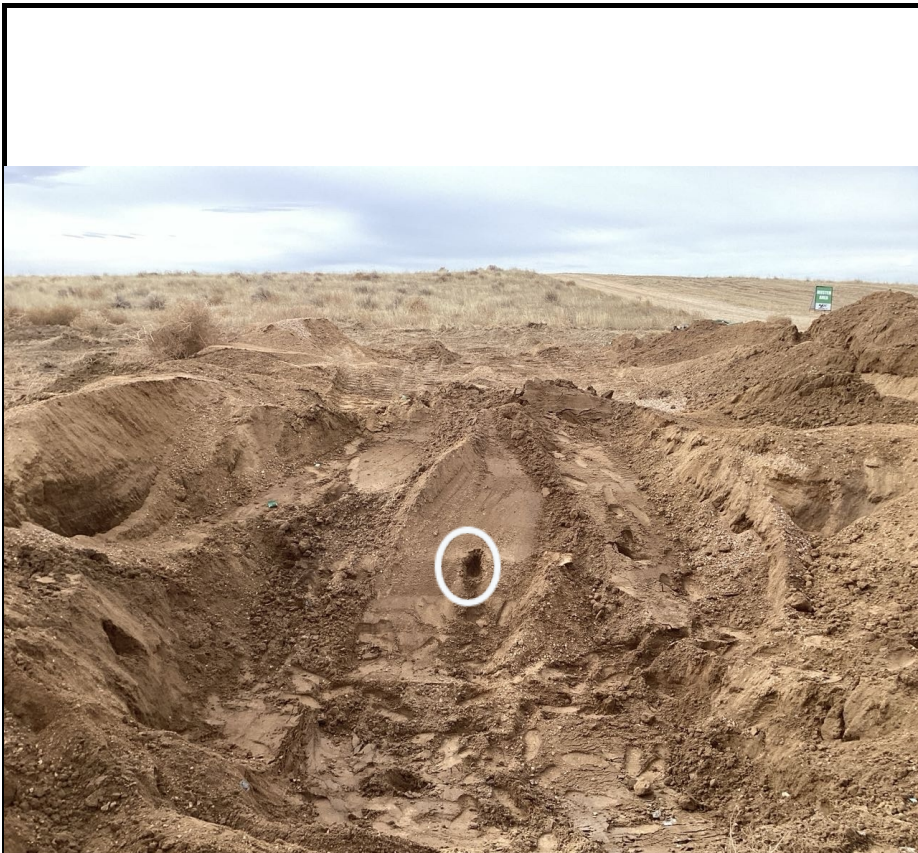
Equipment ID: PWV01-W

Notes/Conditions: West

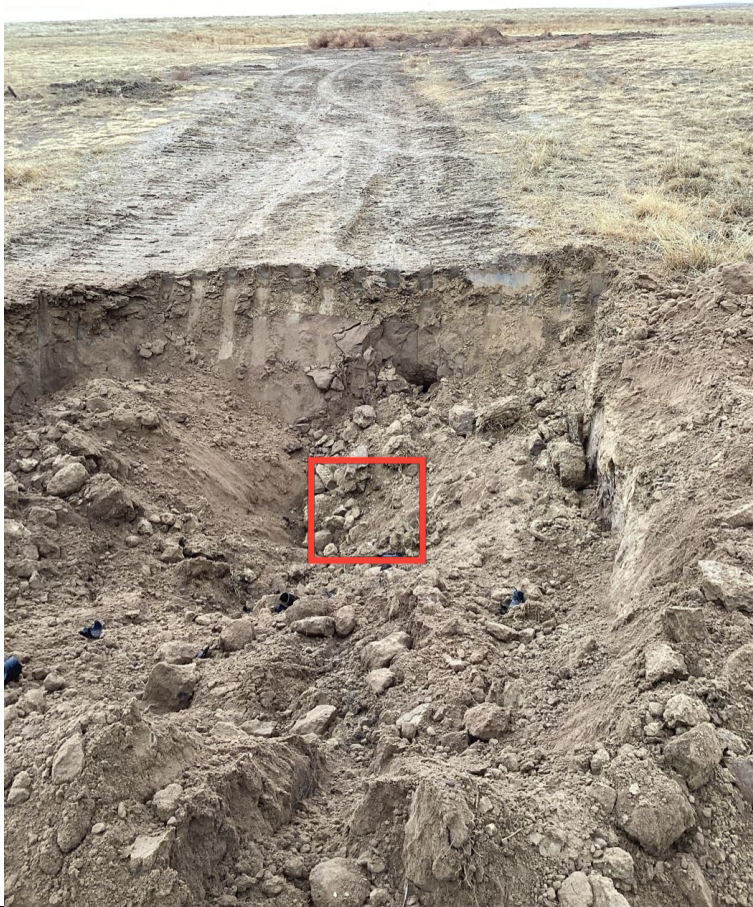
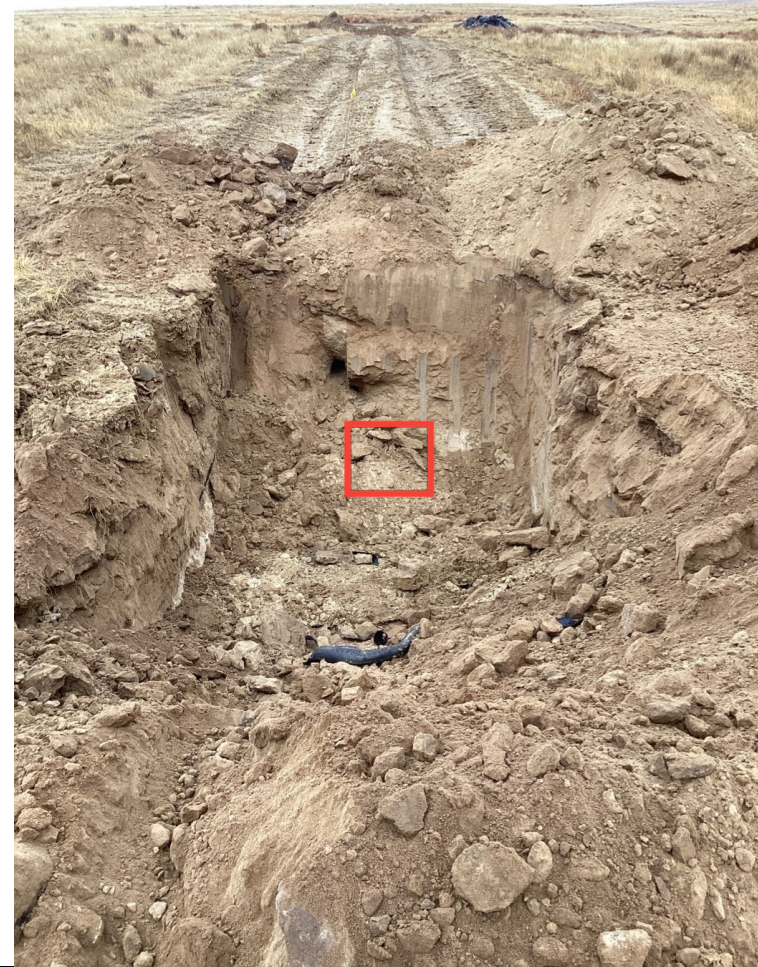
<b>Equipment ID:</b> FL01-01@3'		<b>Equipment Type:</b>		<b>Equipment ID:</b> FL01-02@3'		<b>Equipment Type:</b>	
<b>Material:</b>	<b>Volume:</b>	<b>Contents:</b>		<b>Material:</b>	<b>Volume:</b>	<b>Contents:</b>	
<b>Notes/Conditions:</b>				<b>Notes/Conditions:</b>

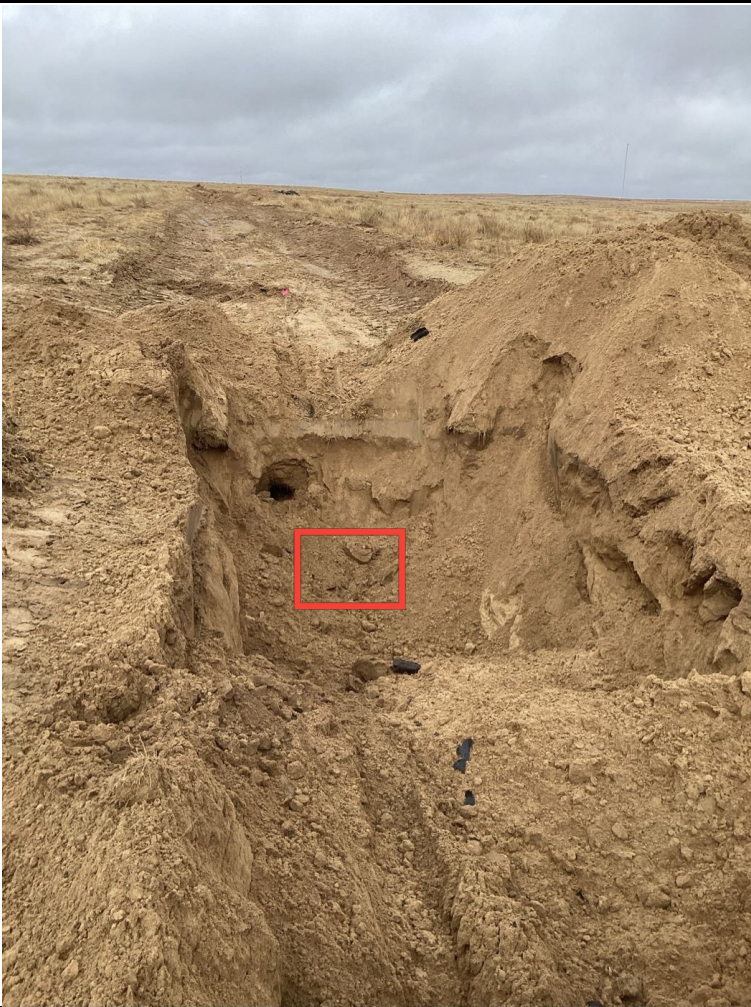
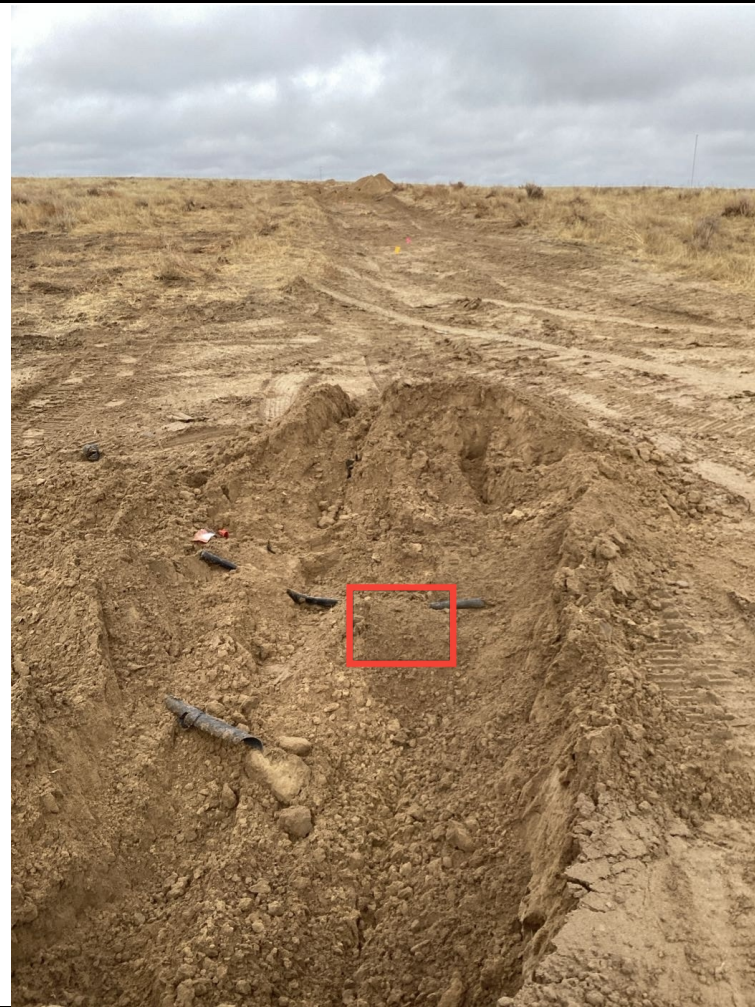
<b>Equipment ID:</b> FL01-03@3'		<b>Equipment Type:</b>		<b>Equipment ID:</b> FL01-04@3'		<b>Equipment Type:</b>	
<b>Material:</b>	<b>Volume:</b>	<b>Contents:</b>		<b>Material:</b>	<b>Volume:</b>	<b>Contents:</b>	
<b>Notes/Conditions:</b>				<b>Notes/Conditions:</b>

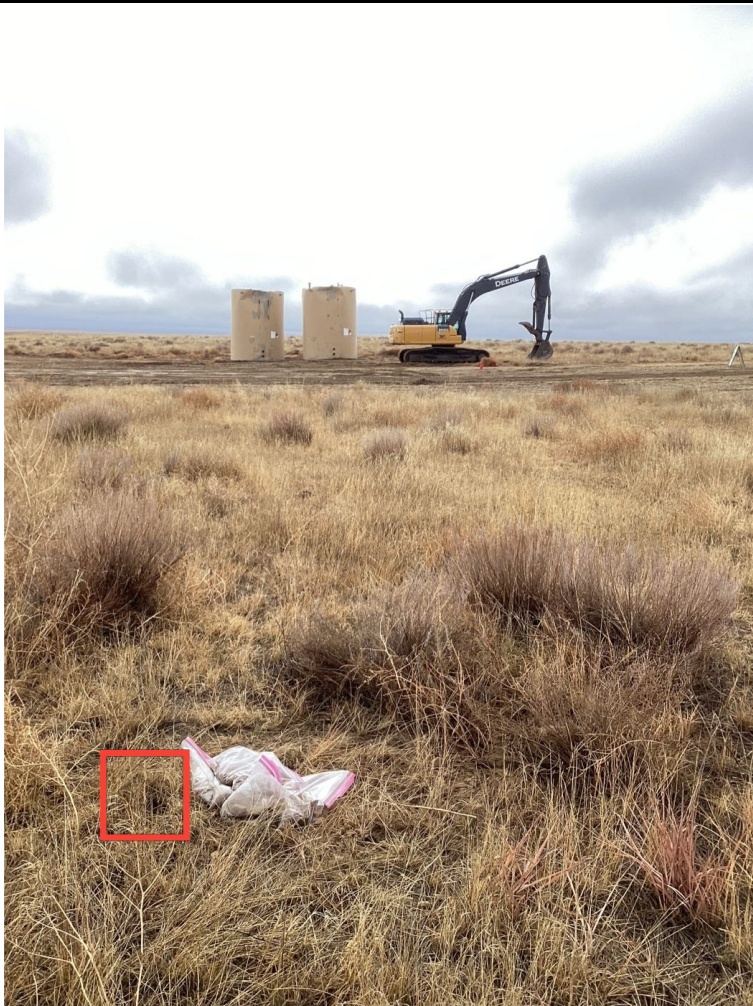
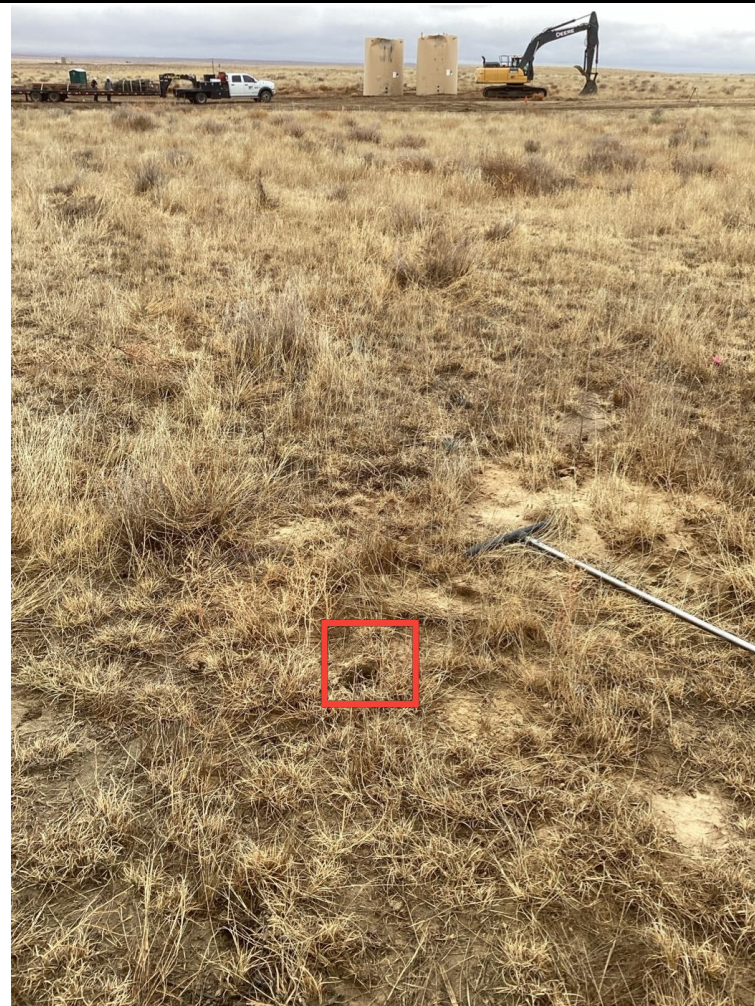
<b>Equipment ID:</b> BKG01		<b>Equipment Type:</b>		<b>Equipment ID:</b> BKG02		<b>Equipment Type:</b>	
<b>Material:</b>	<b>Volume:</b>	<b>Contents:</b>		<b>Material:</b>	<b>Volume:</b>	<b>Contents:</b>	
<b>Notes/Conditions:</b> BKG01 @ 1-2', BKG01 @ 3-4', BKG01 @ 4-5'				<b>Notes/Conditions:</b> BKG02 @ 1-2', BKG02 @ 3-4', BKG02 @ 4-5'
