Inspection Photos

Operator: QB Energy Operating LLC #10844

Location ID: 334900

Inspection Doc: 719200874

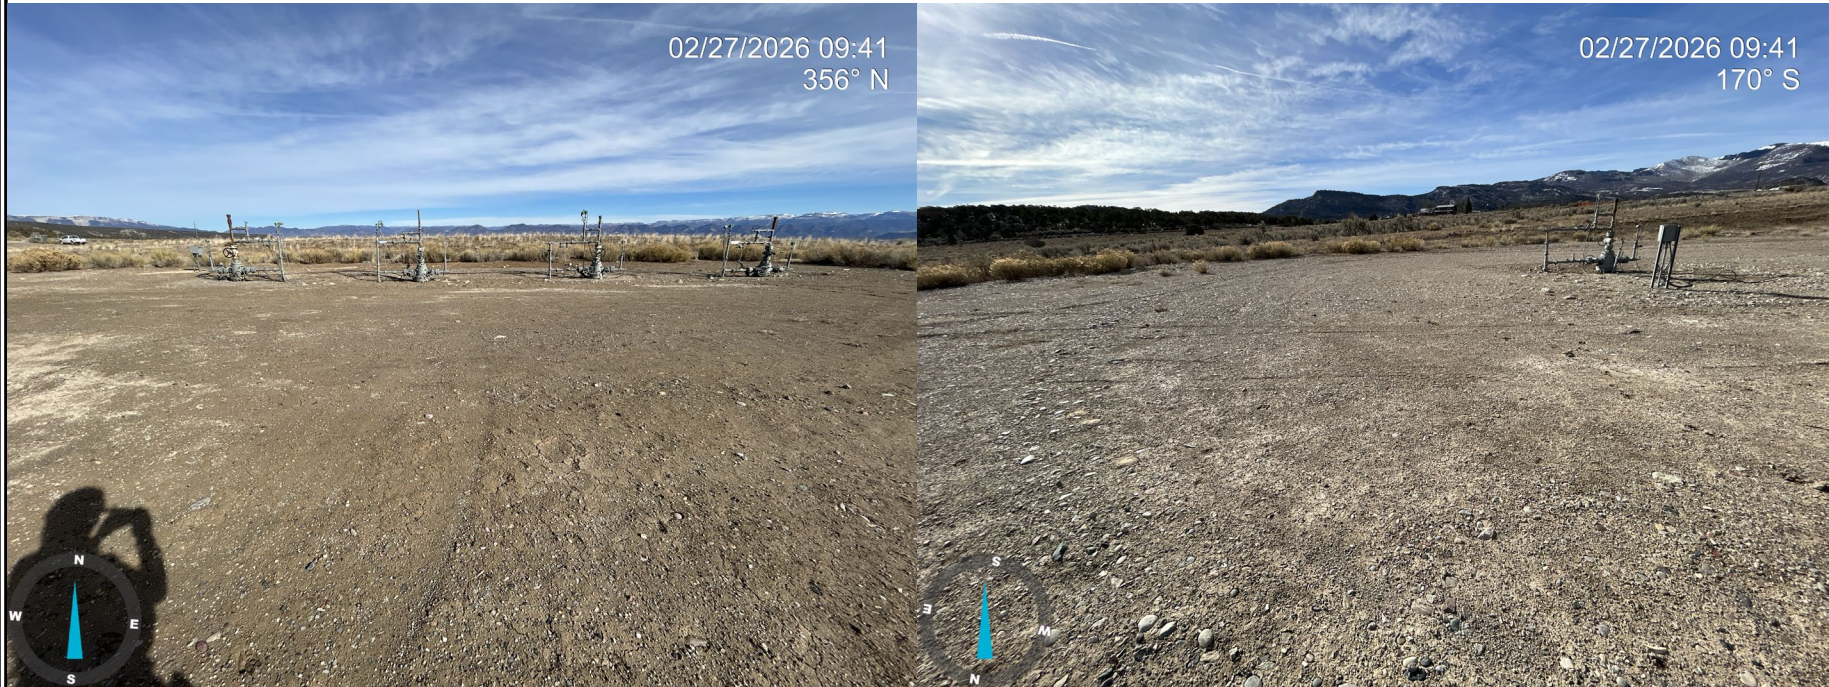
Photo 1: Photos showing an overview of the location looking north and south, respectively.

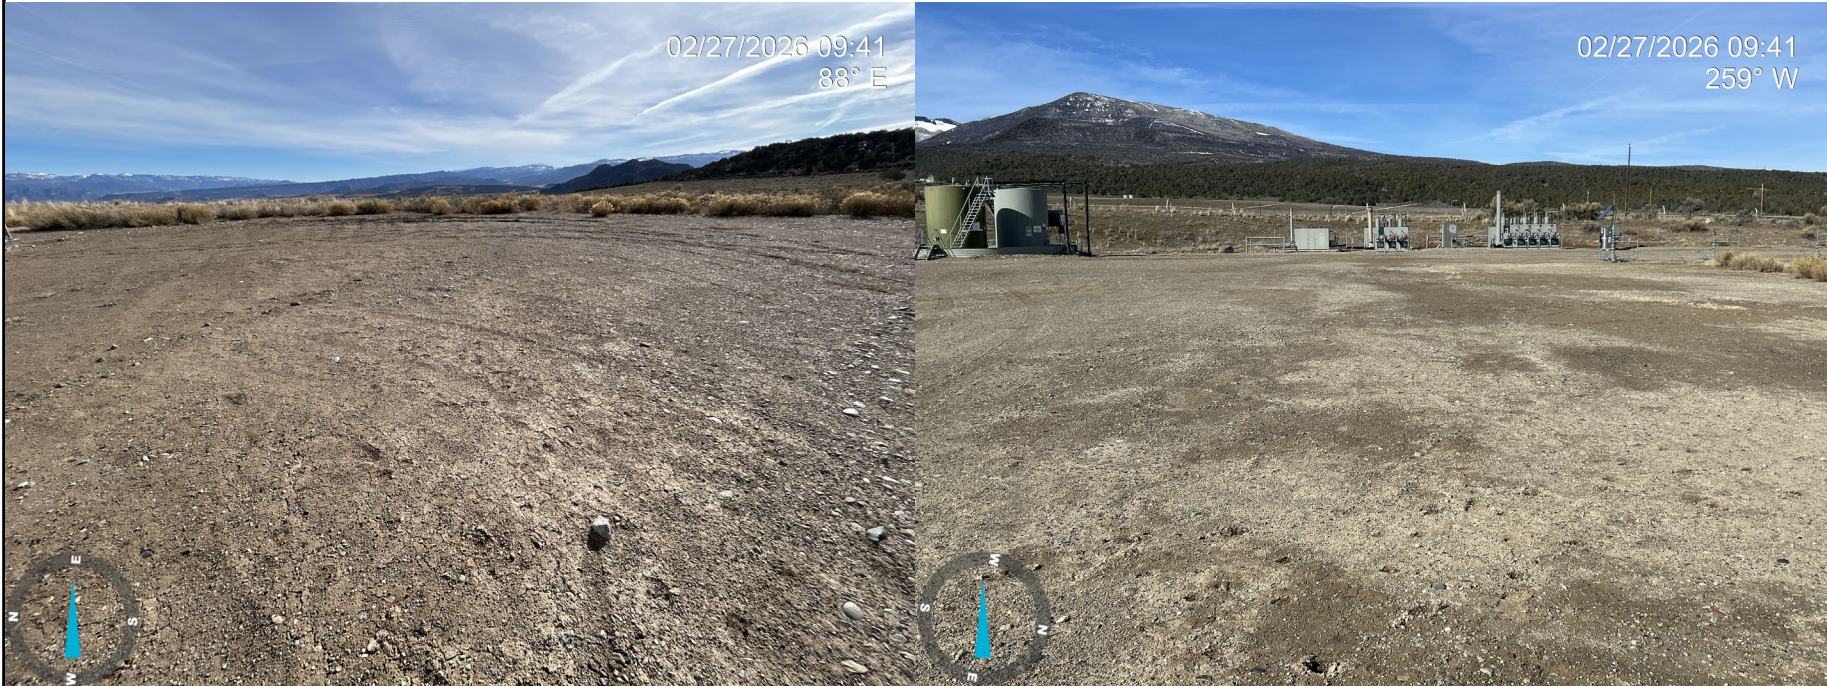
Photo 2: Photos showing an overview of the location looking east and west, respectively.

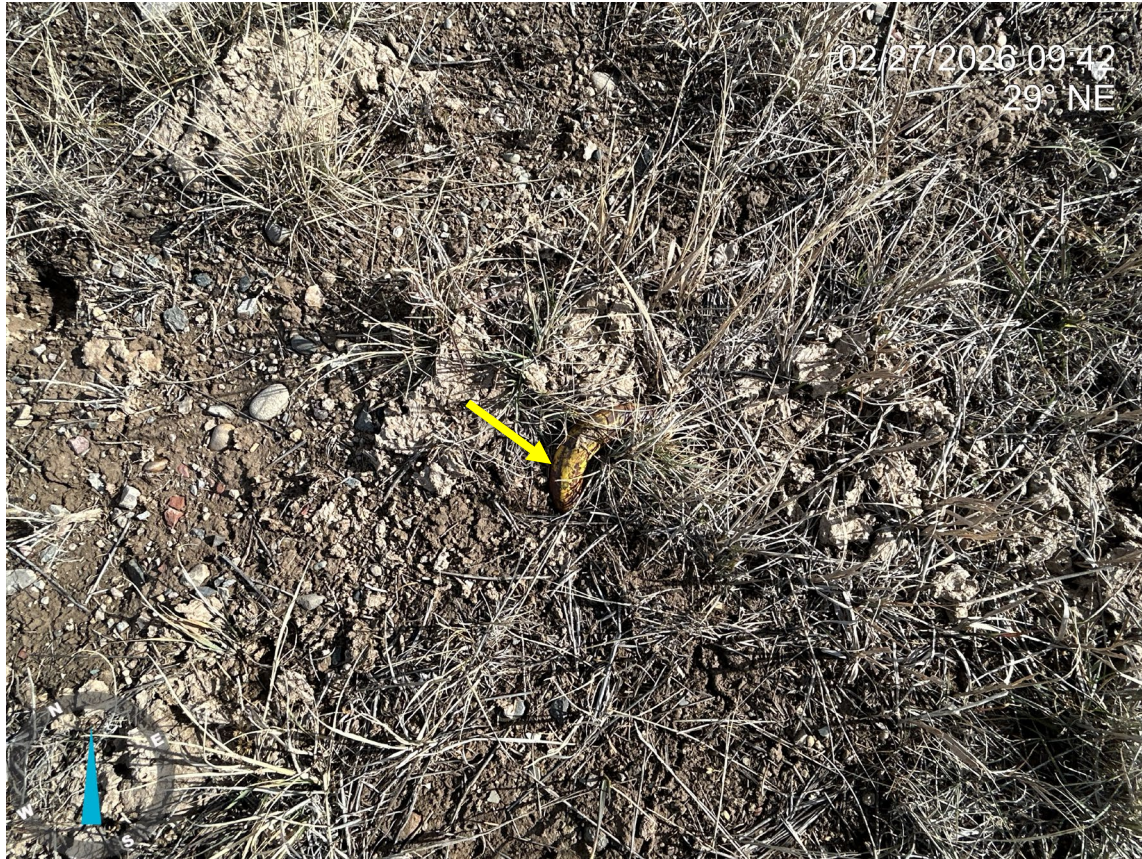
Photo 3: Photos showing an unmarked guy line anchor located in the southeastern interim area. Comply with Rule 1003.a. and mark or remove anchor.

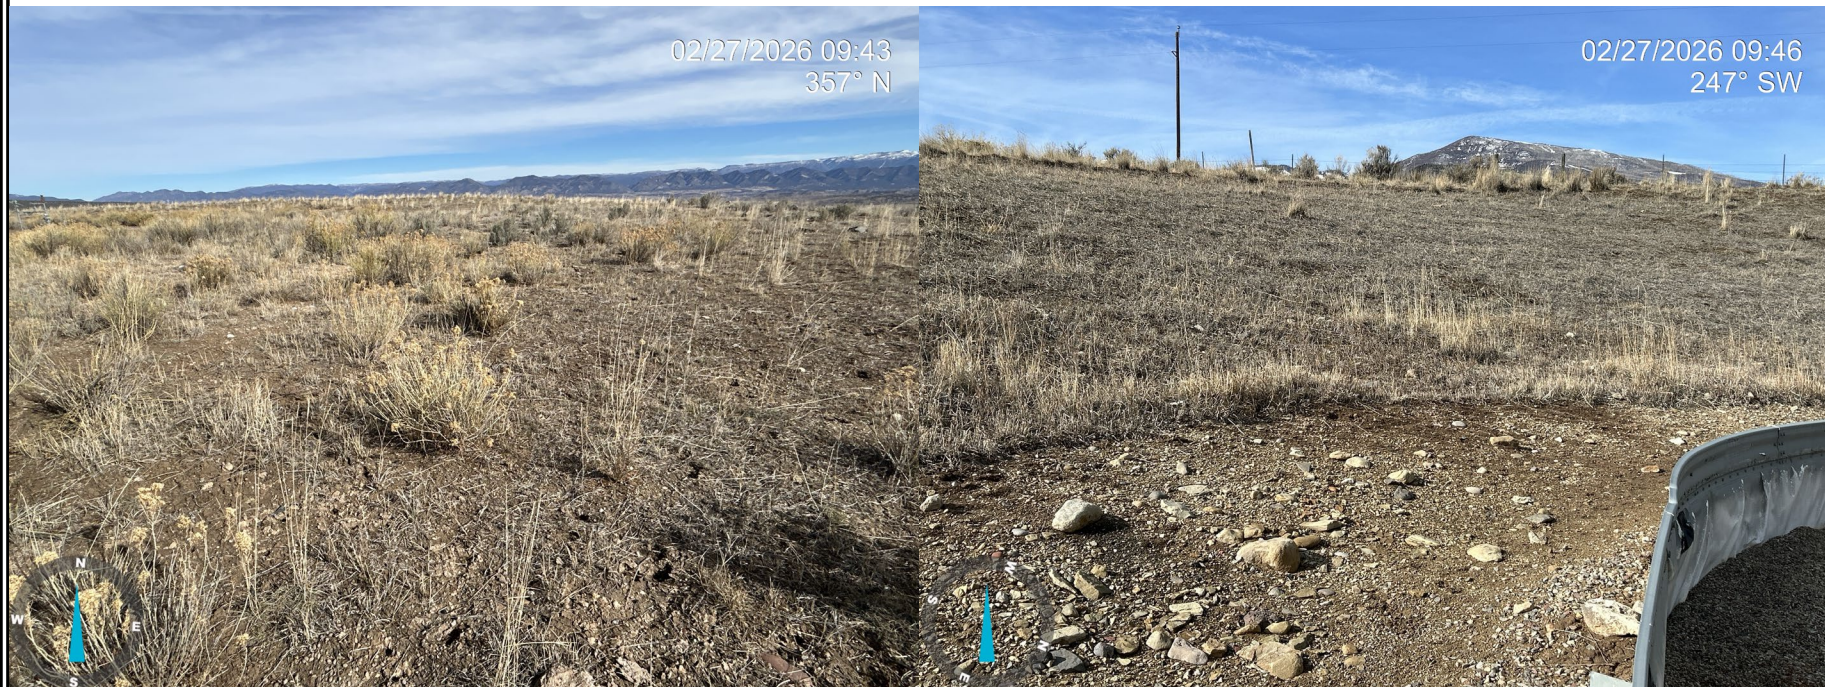
Photo 4: Photos showing an overview of the eastern interim area and southwestern cut slopes at the location, respectively. Interim areas are composed of perennial shrubs and grasses and appear to be progressing towards 1003 reclamation requirements.
