Final Reclamation Inspection

Operator: KERR MCGEE OIL & GAS ONSHORE LP - 47120

Location ID: 327118

Inspection Photos
Location Name: HSR-VANNEMAN #3-27A
Location ID: 327118

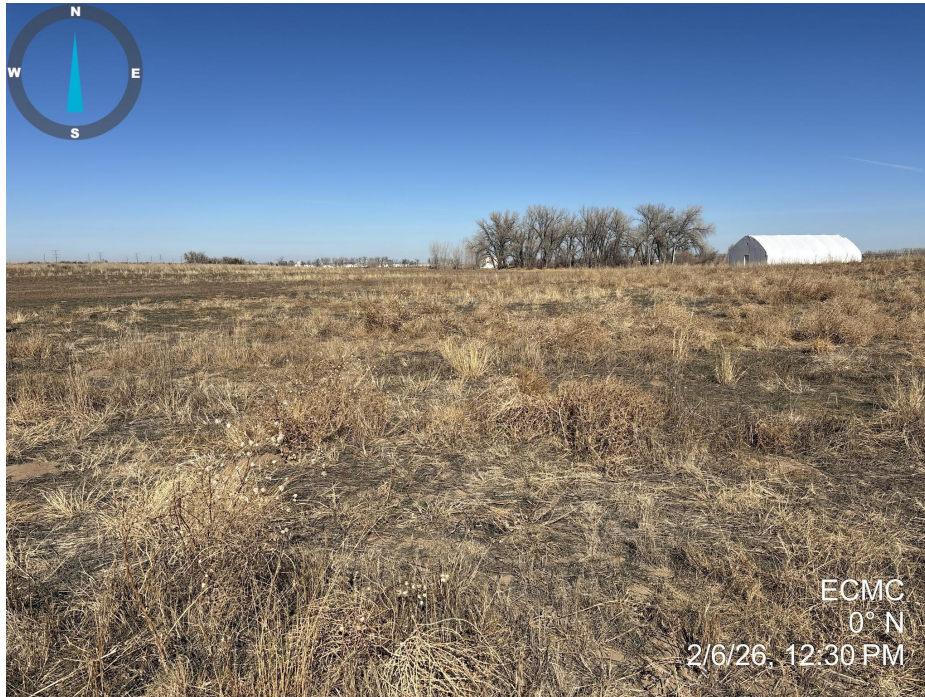
Photo 1. Photo taken of the well location, facing north. Photo illustrates that final reclamation activities appear to have taken place, but vegetation establishment does not meet Rule 1004 standards. Weedy annual vegetation including russian thistle (*Salsola tragus*) was observed across the location.

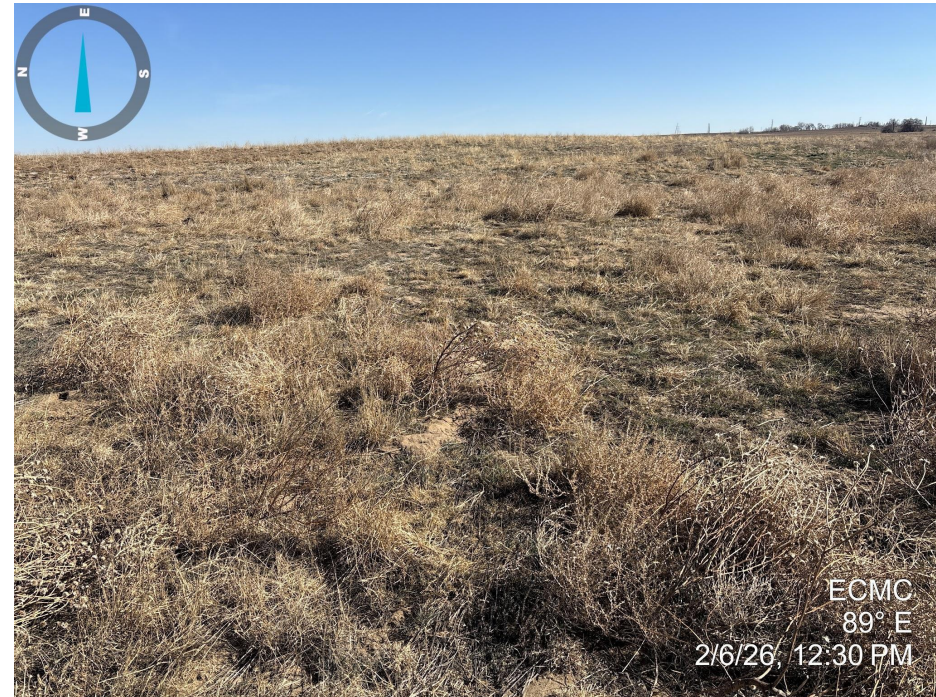
Photo 2. Photo taken of the well location, facing east. See comments under Photo 1.

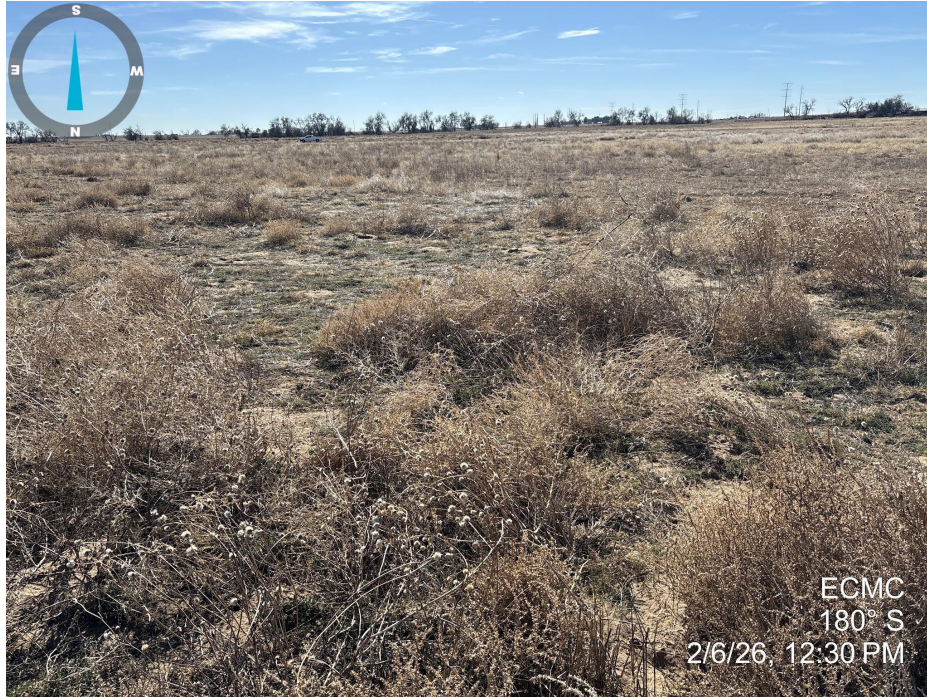
Photo 3. Photo taken of the well location, facing south. See comments under Photo 1.

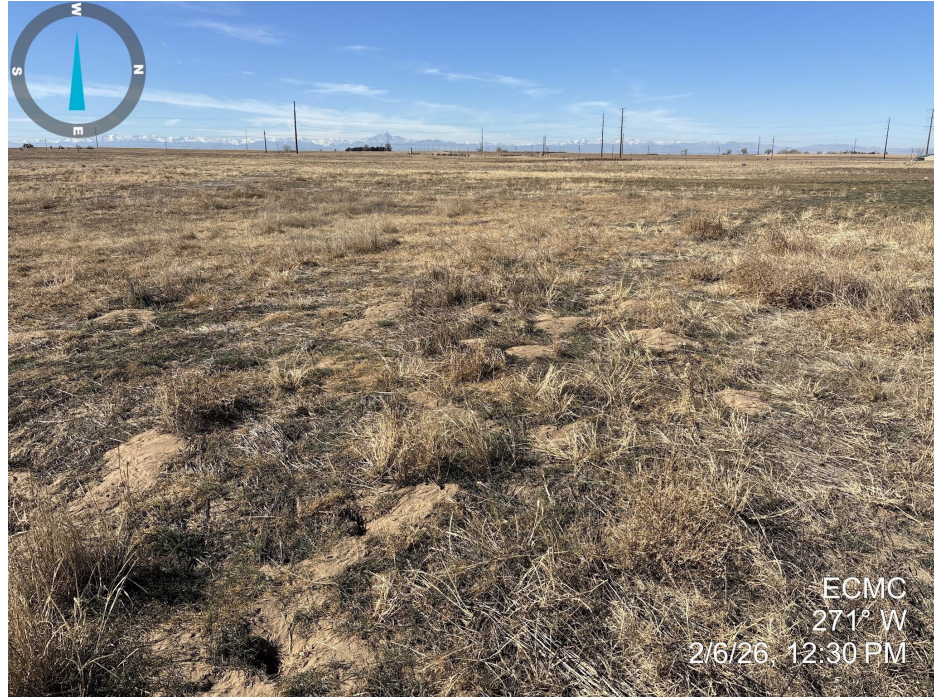
Photo 4. Photo taken of the well location, facing west. See comments under Photo 1.

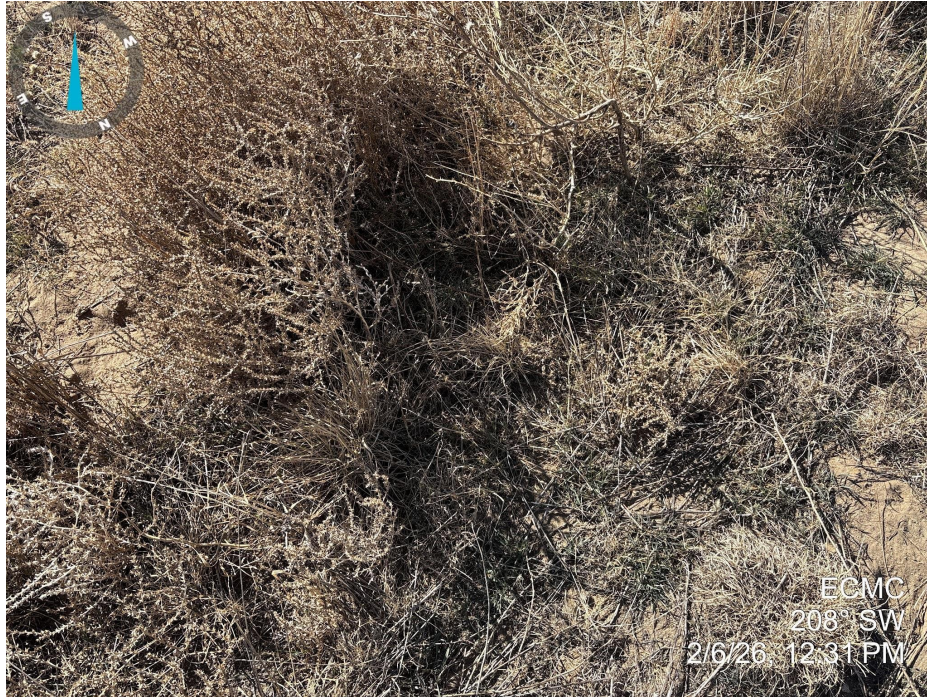
Photo 5. Photo taken of ground cover at the well location. Photo illustrates weedy annual vegetation including russian thistle (*Salsola tragus*).

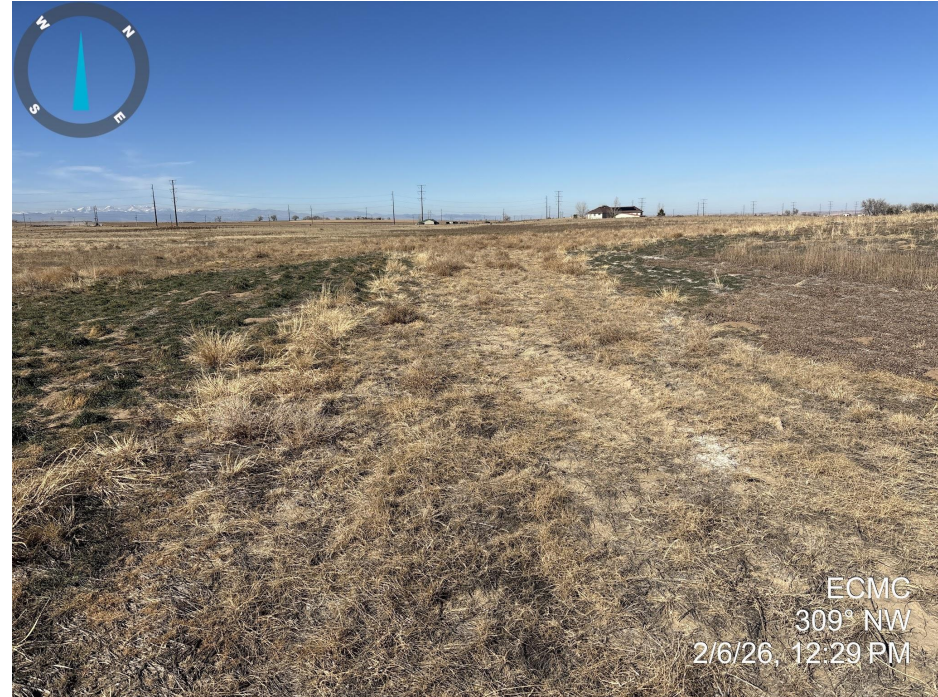
Photo 6. Photo taken of the access road to the location, facing northwest. Photo illustrates that final reclamation activities have taken place along the access road, but vegetation establishment does not meet Rule 1004 standards.

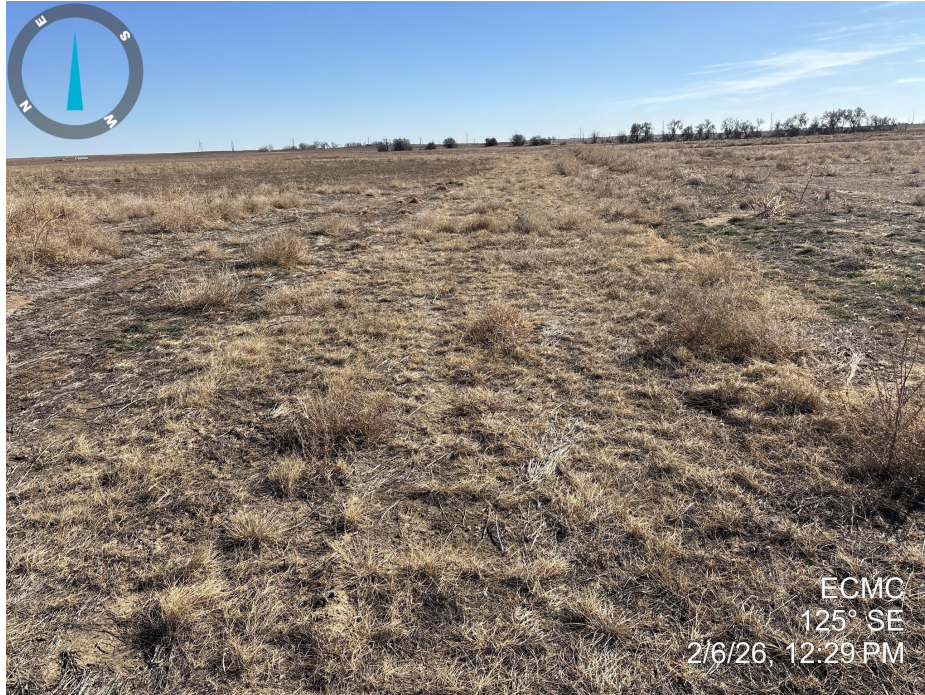
Photo 7. Photo taken of the access road the well location, facing southeast. See comments under Photo 6.

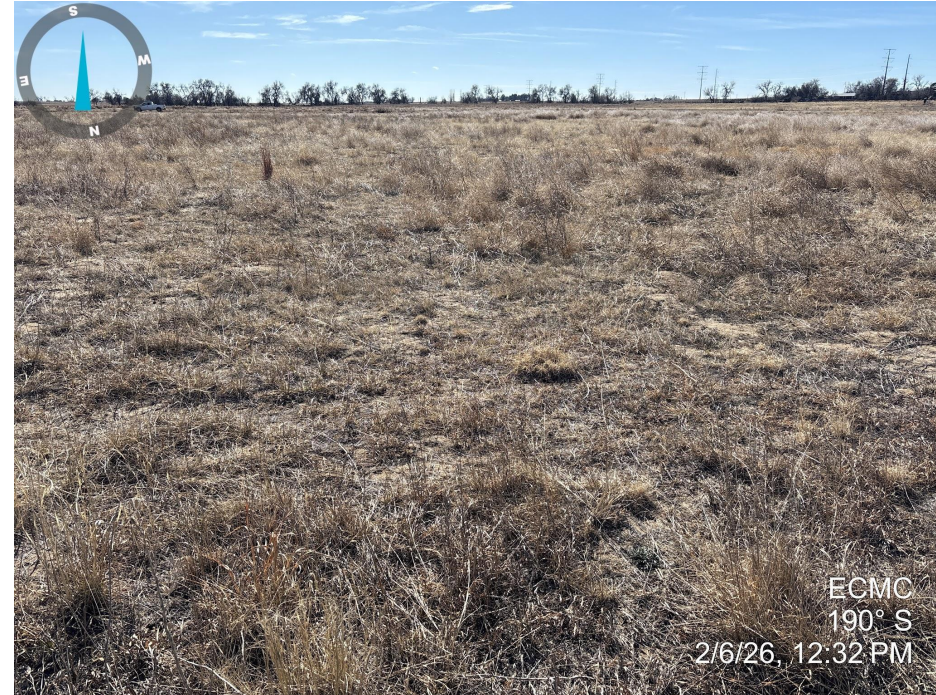
Photo 8. Photo taken of the reference area to the location, south of the location, facing south. Photo illustrates perennial grass and weedy annual vegetation.
