Final Reclamation Inspection

Operator: KERR MCGEE OIL & GAS ONSHORE LP - 47120

Location ID: 446413

Location Name: LORENZ L30-3, 5#2-30 O SA

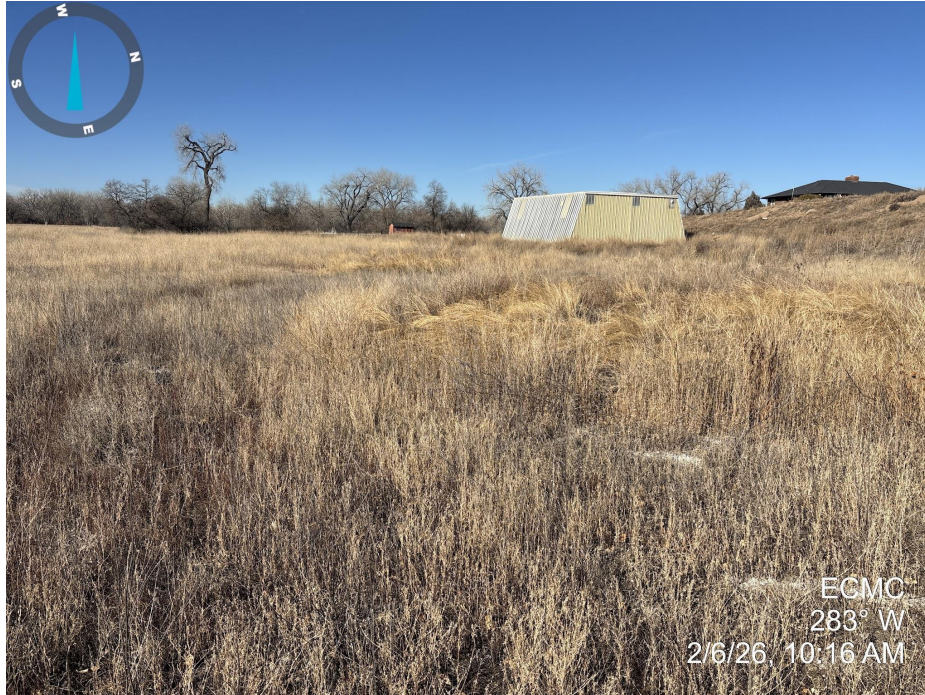
Photo 1. Photo taken of the tank battery location, facing west. Photo illustrates that final reclamation activities appear to have taken place, but vegetation establishment does not meet Rule 1004 standards. Weedy annual vegetation was observed at the location including kochia (*Bassia scoparia*) and scotch thistle (*Onopordum acanthium*), a List B Noxious Weed species.

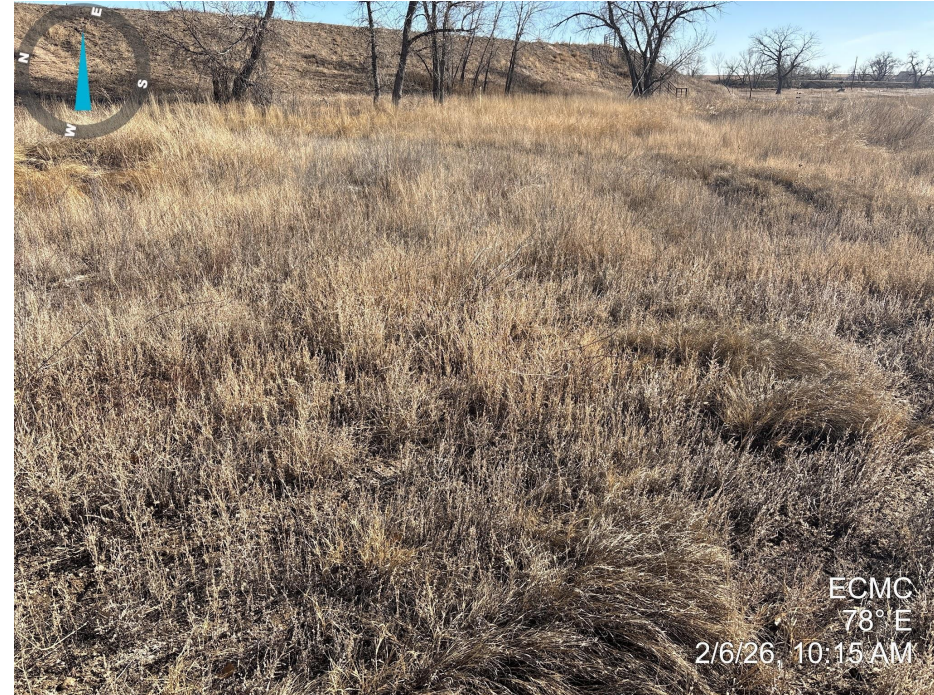
Photo 2. Photo taken of the tank battery location, facing east. See comments under Photo 1.

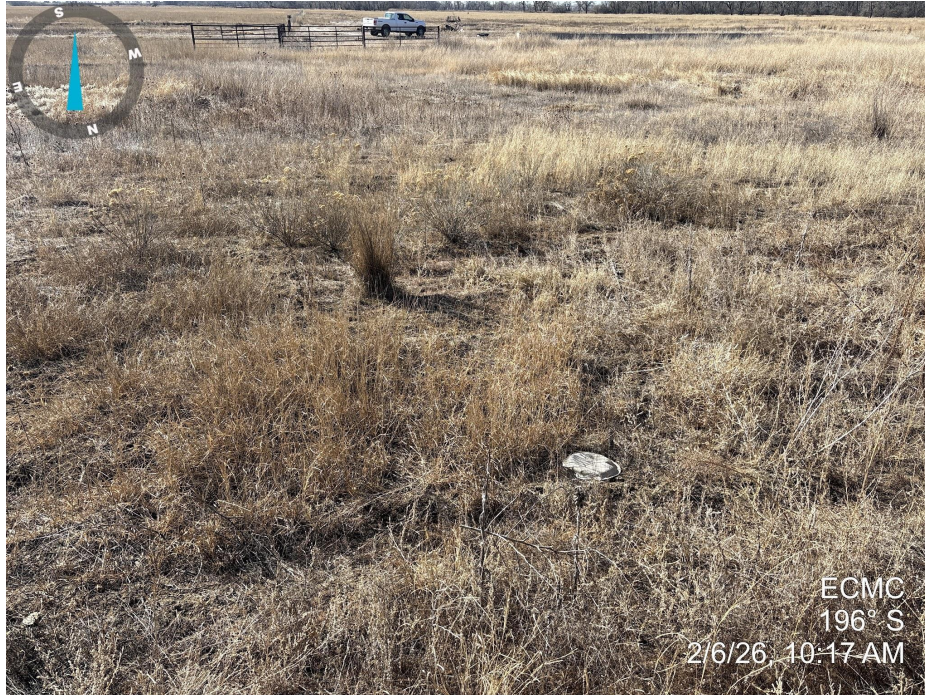
Photo 3. Photo taken of the tank battery location, facing south. See comments under Photo 1.

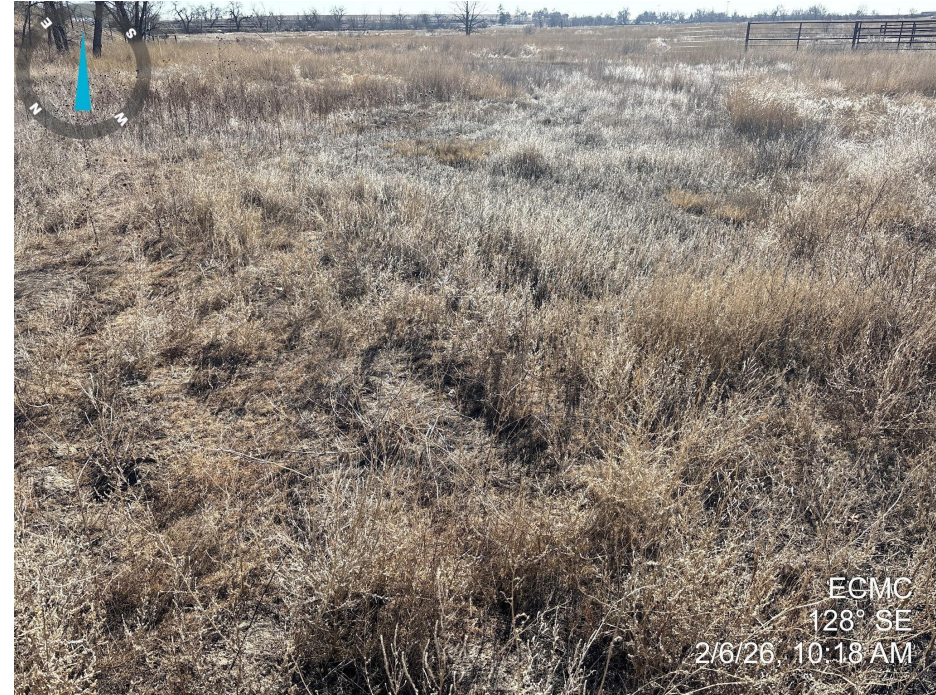
Photo 4. Photo taken of the tank battery location, facing southeast. See comments under Photo 1.

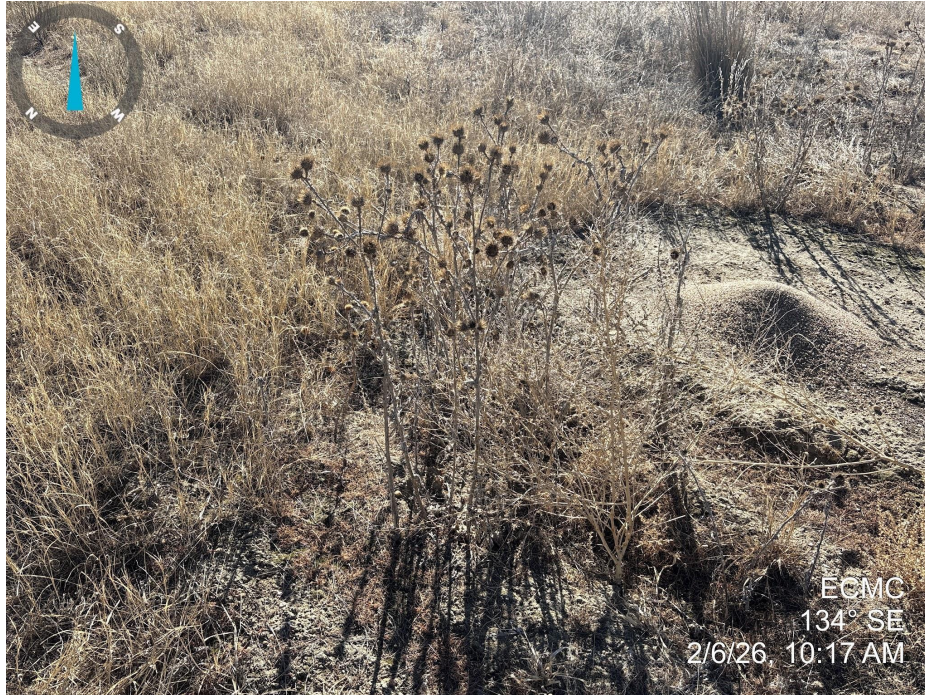
Photo 5. Photo taken of vegetation on the location, facing southeast. Photo illustrates perennial grass and weedy annual vegetation including scotch thistle (*Onopordum acanthium*), a List B Noxious Weed species.

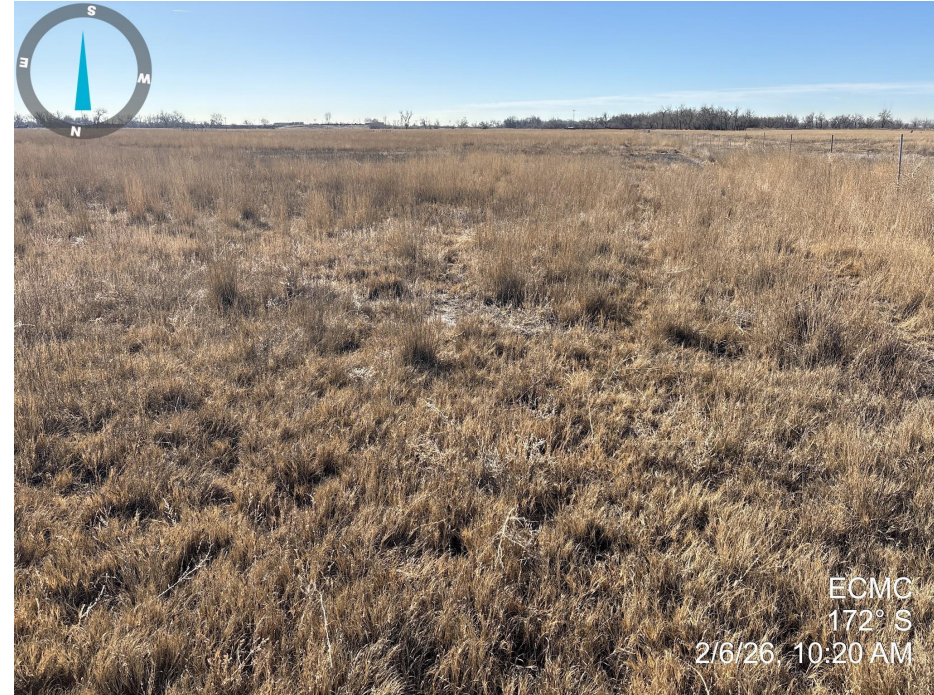
Photo 6. Photo taken of the reference area to the location, south of the location, facing south. Photo illustrates perennial grass and weedy annual vegetation.
