Inspection Photos

Operator: QB Energy Operating LLC #10844

Location ID: 334834

Inspection Doc: 719200893

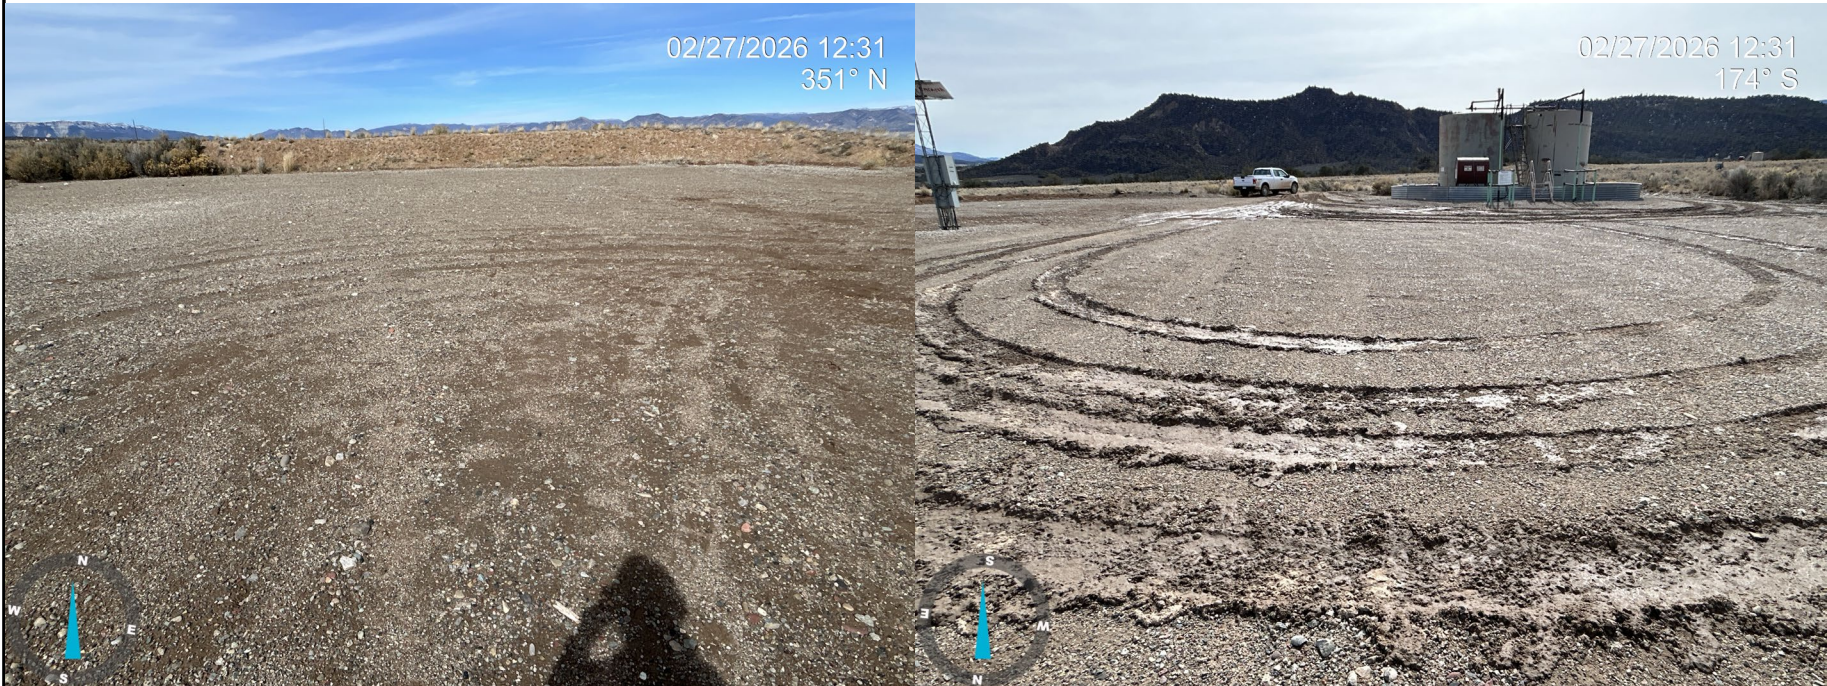
Photo 1: Photos showing an overview of the location looking north and south, respectively.

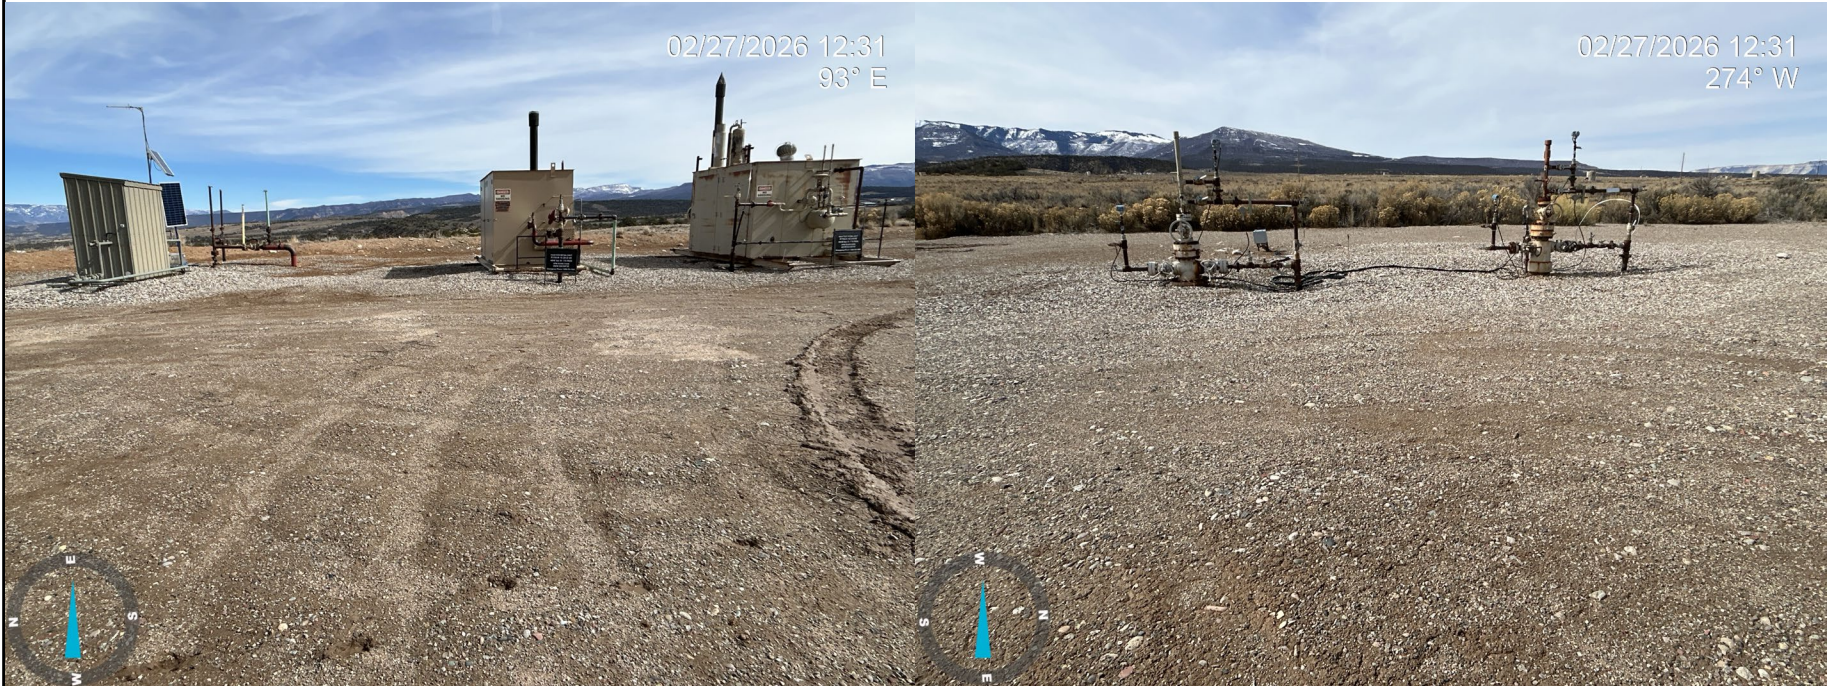
Photo 2: Photos showing an overview of the location looking east and west, respectively.

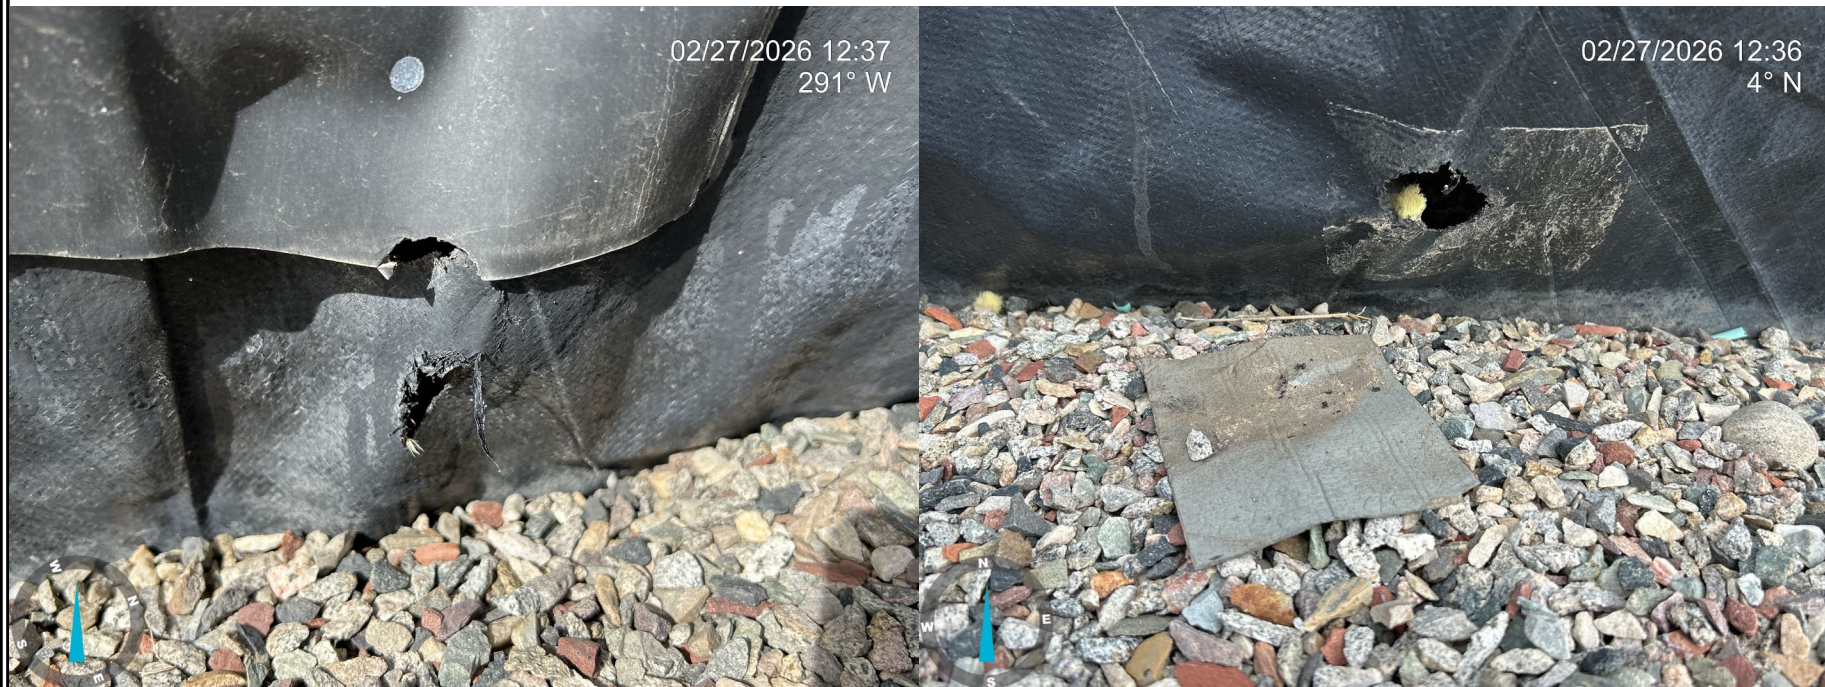
Photo 3: Photos showing an example of rips/tears that are occurring at the tank's black geotextile liner. Maintenance is required; comply with Rule 603.o.

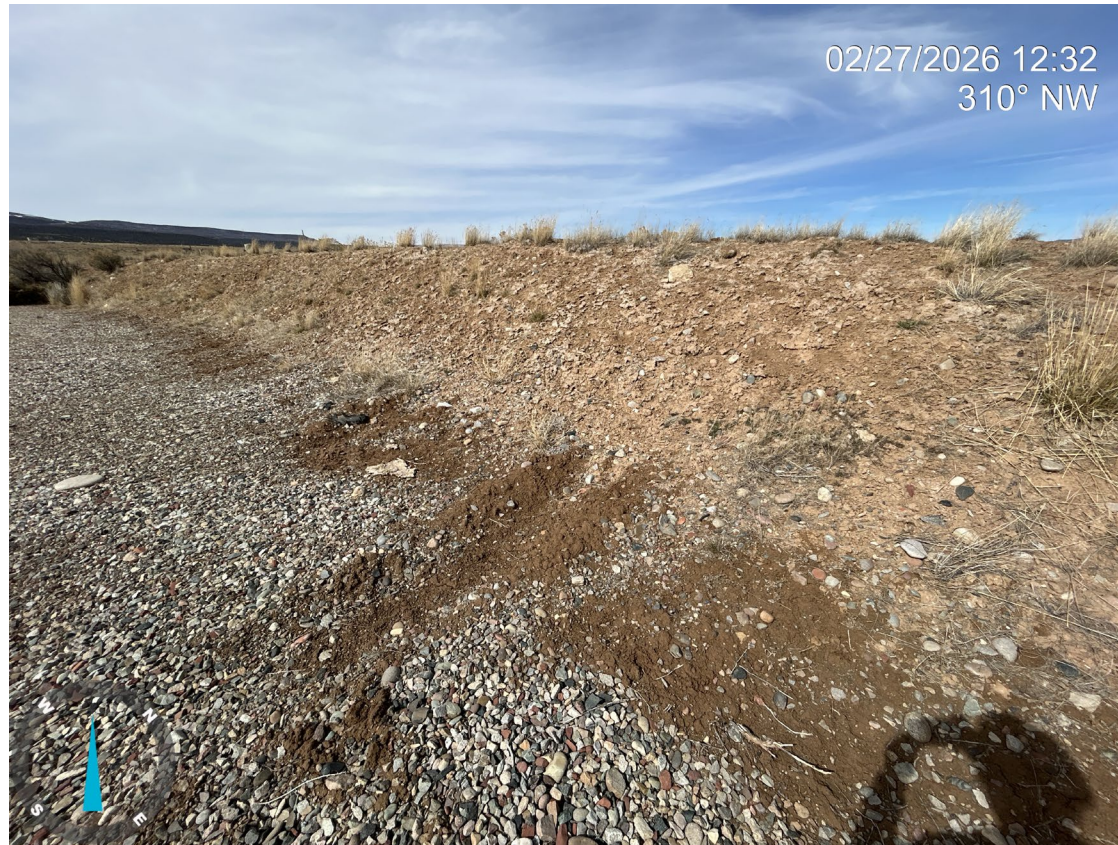
Photo 4: Photo showing an example of the northern cut slope; vegetation may need more time to develop. A follow-up inspection will be conducted during future growing seasons to determine compliance with 1003.

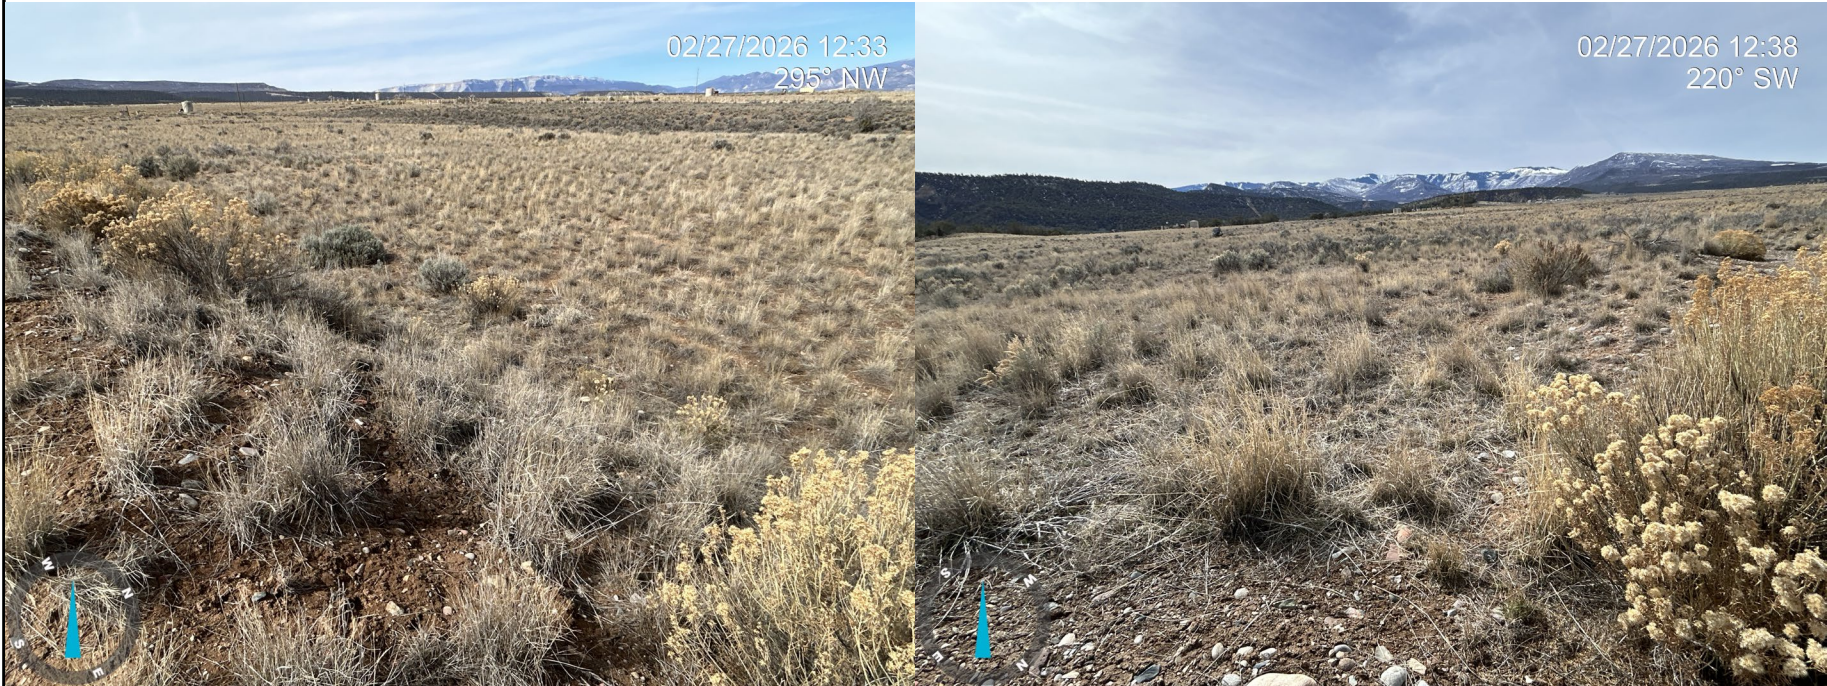
Photo 5: Photos showing an overview of the northern and western interim areas, respectively. Overall, interim areas are progressing towards 1003 reclamation requirements.

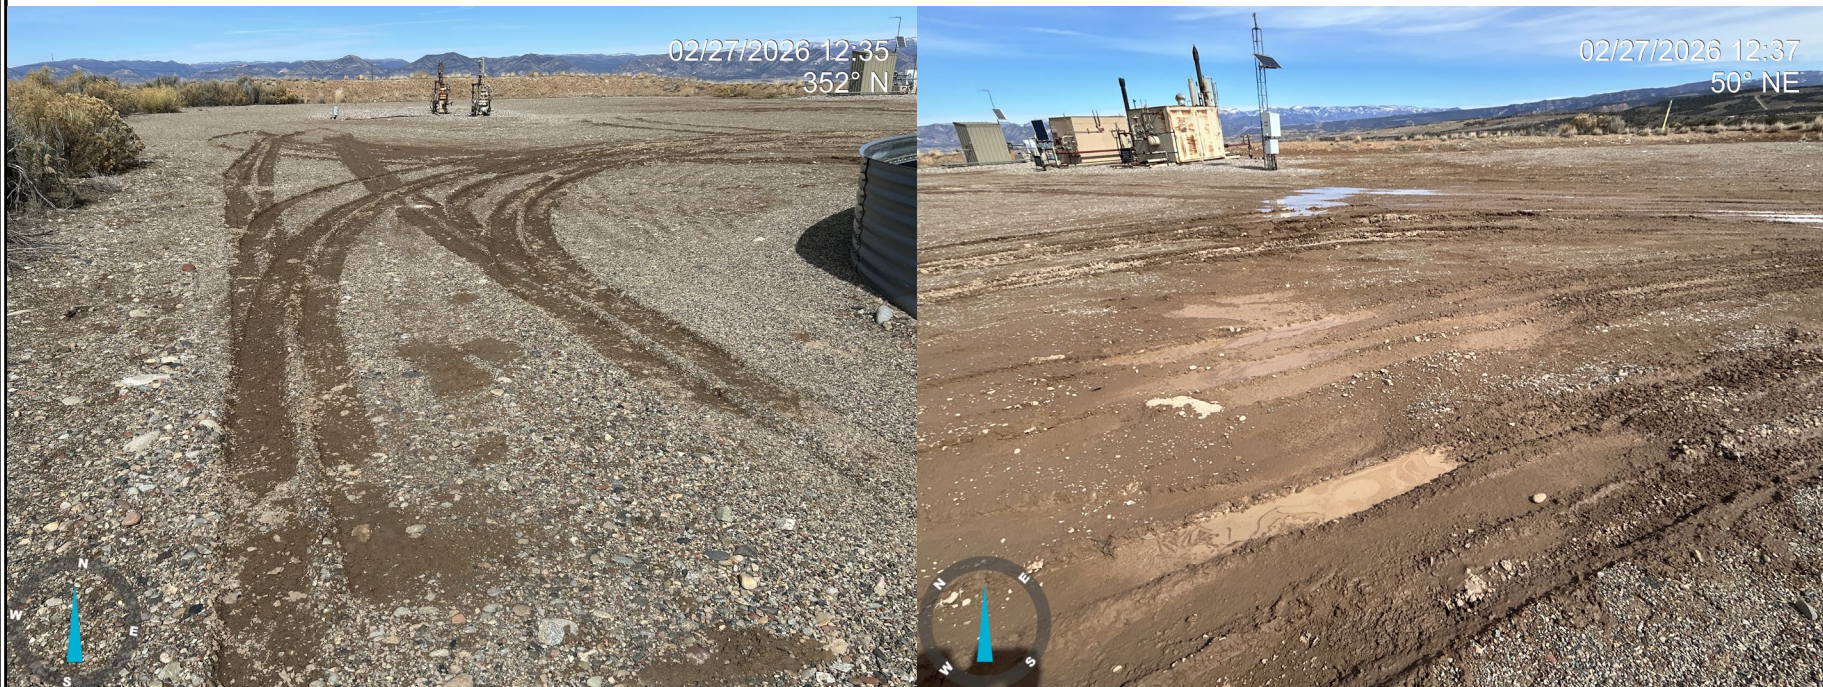
Photo 6: Photos showing examples of vehicle tracking and rutting that is occurring on the working pad surface; gravel appears to be sparse in some places. Comply with Rule 1002.f.
