Final Reclamation and Stormwater Inspection

Operator: MARLIN OIL CO* THE - 53800

Location ID: 382176

Well Name: STATE #1-2

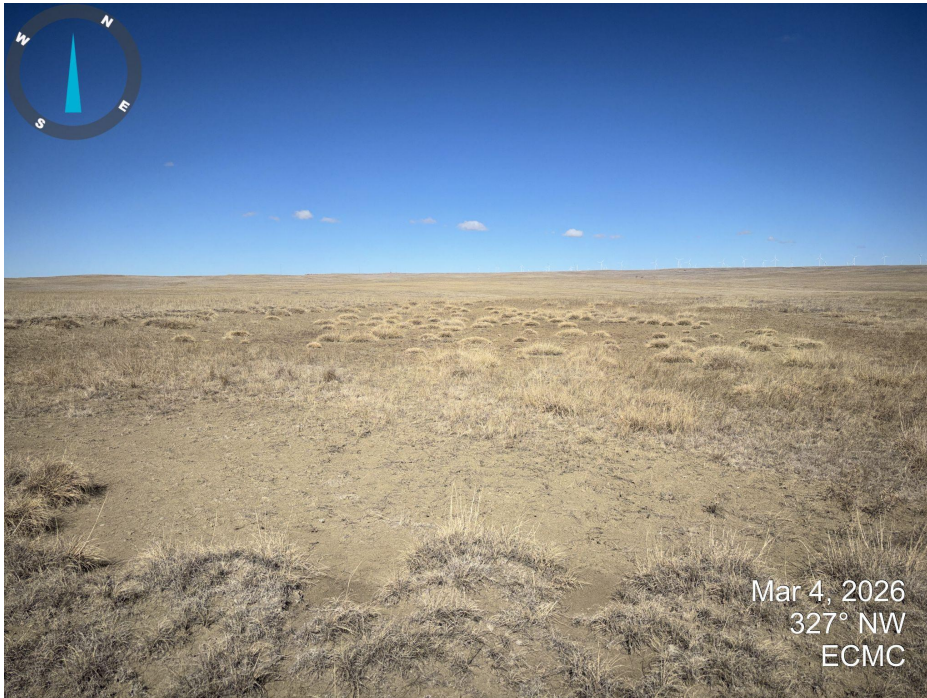
Photo 1. Looking north across the pad. The pad is primarily bare soil. Some desirable perennial vegetation establishment is present on the location. The location is not reflective of the surrounding reference area. No oil and gas equipment is present on the location.

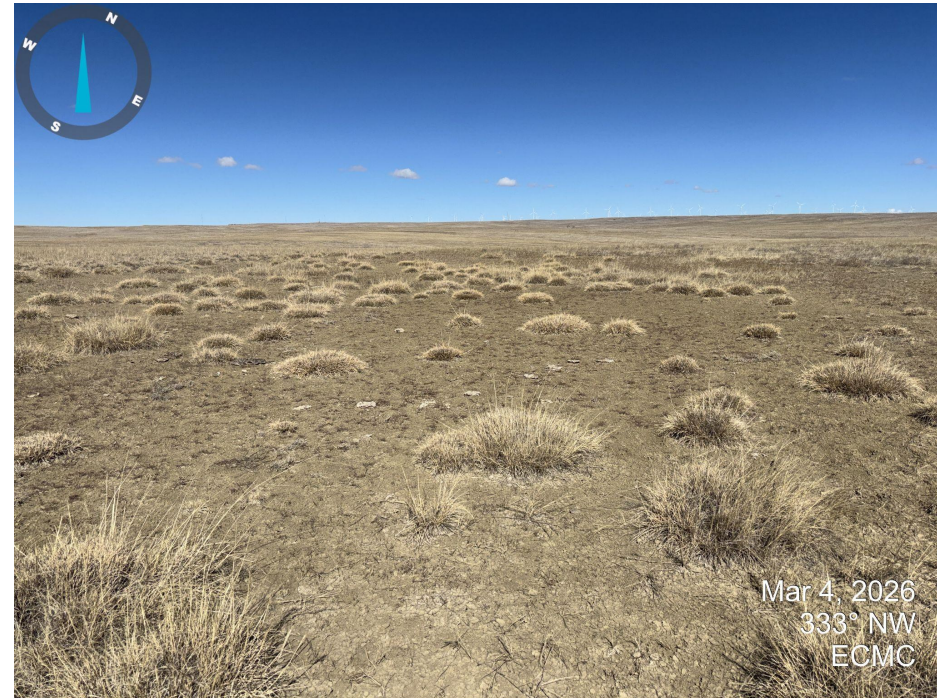
Photo 2. Photo taken in the center of the location near the wellbore gps coordinates. Photo illustrates ground cover.

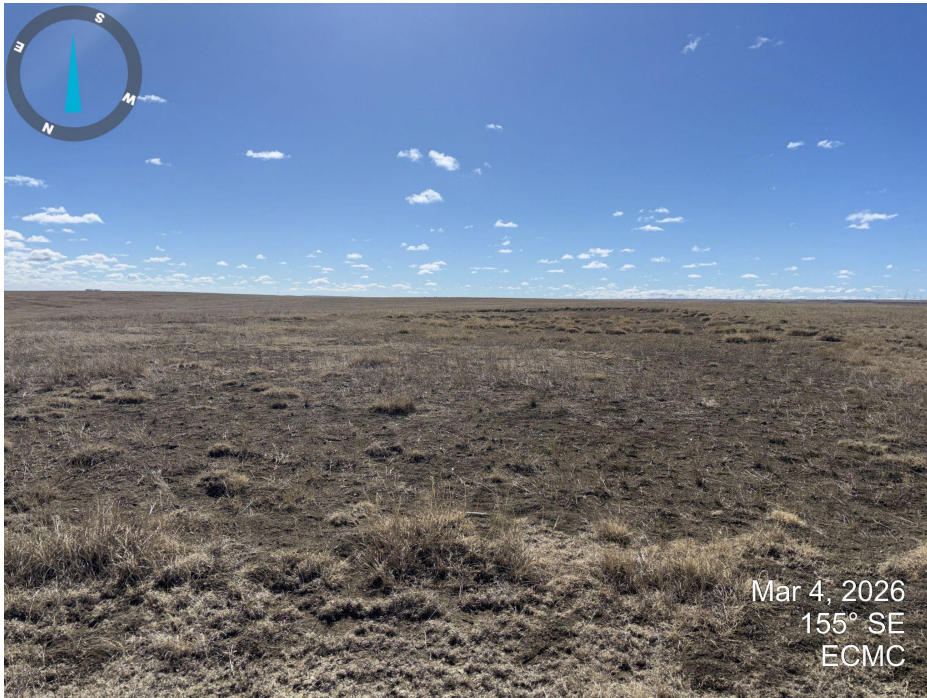
Photo 3. Looking south across the location. See photo 1 comments.

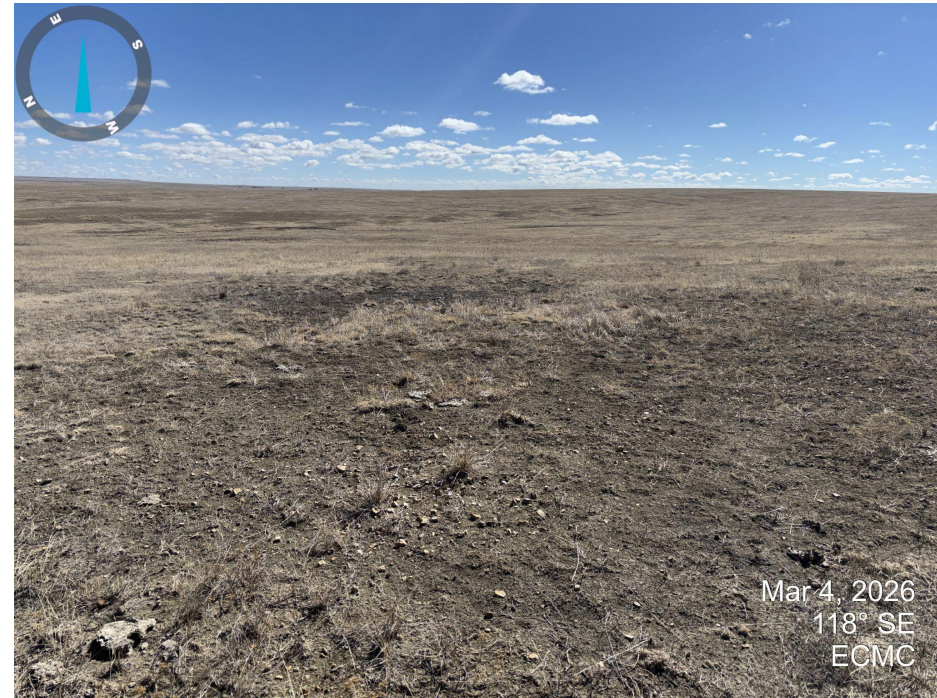
Photo 4. Photo taken looking east from the center of the location. Bare areas of soil are present extending east from the pad. This area is not reflective of the surrounding reference area. This area also does not appear to have been contoured and may have been pit/ equipment area.

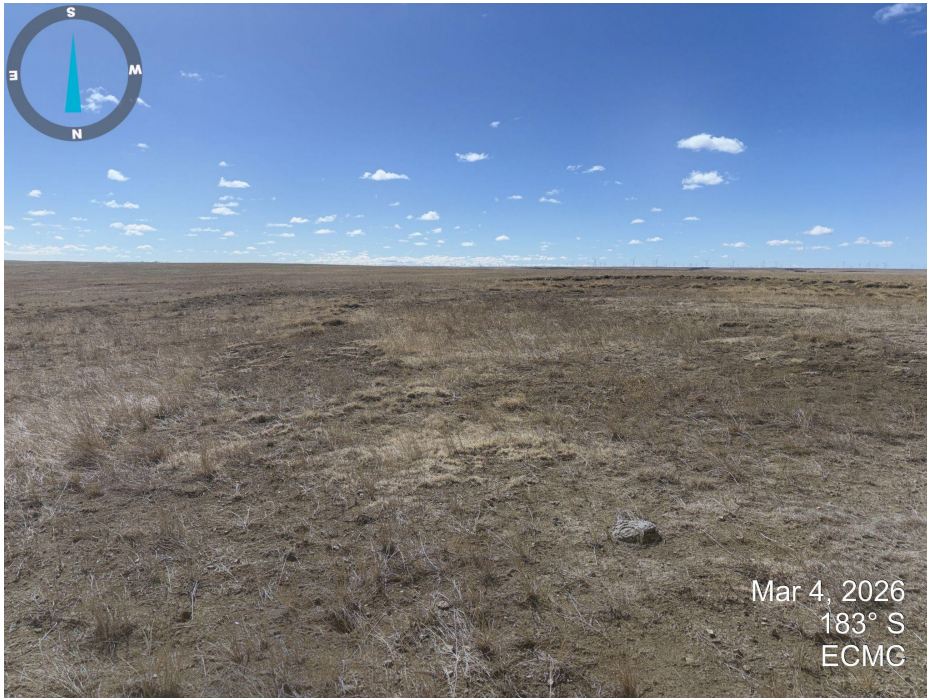
Photo 5. Looking South across the eastern portion of the location. See photo 4 comments. Berms and depressions are present in this area.

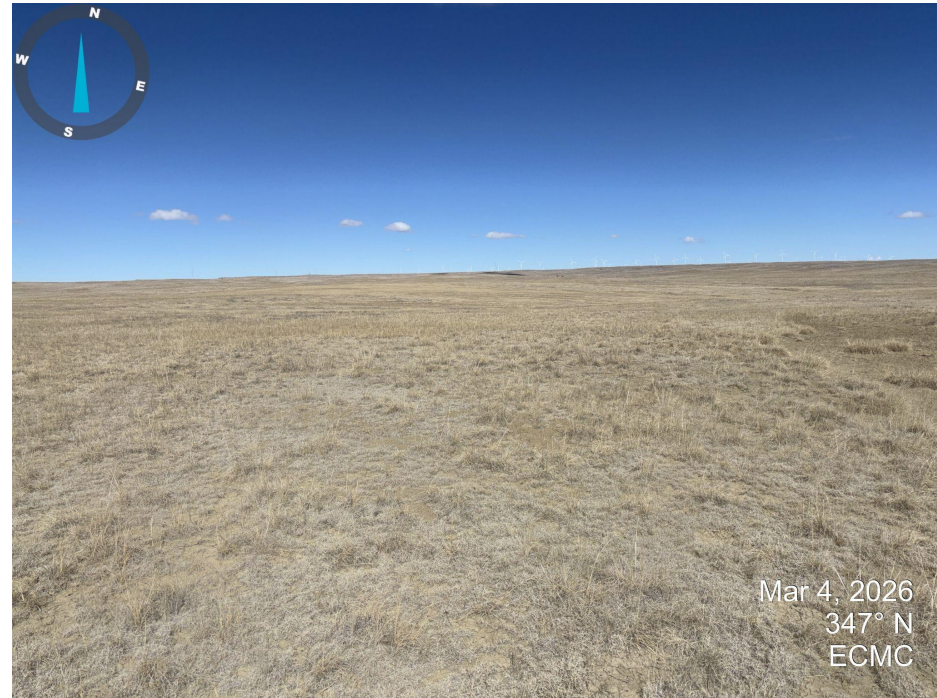
Photo 6. Looking northwest from the west side of the location along the former access road. Vegetation on the access road is reflective of the surrounding area.

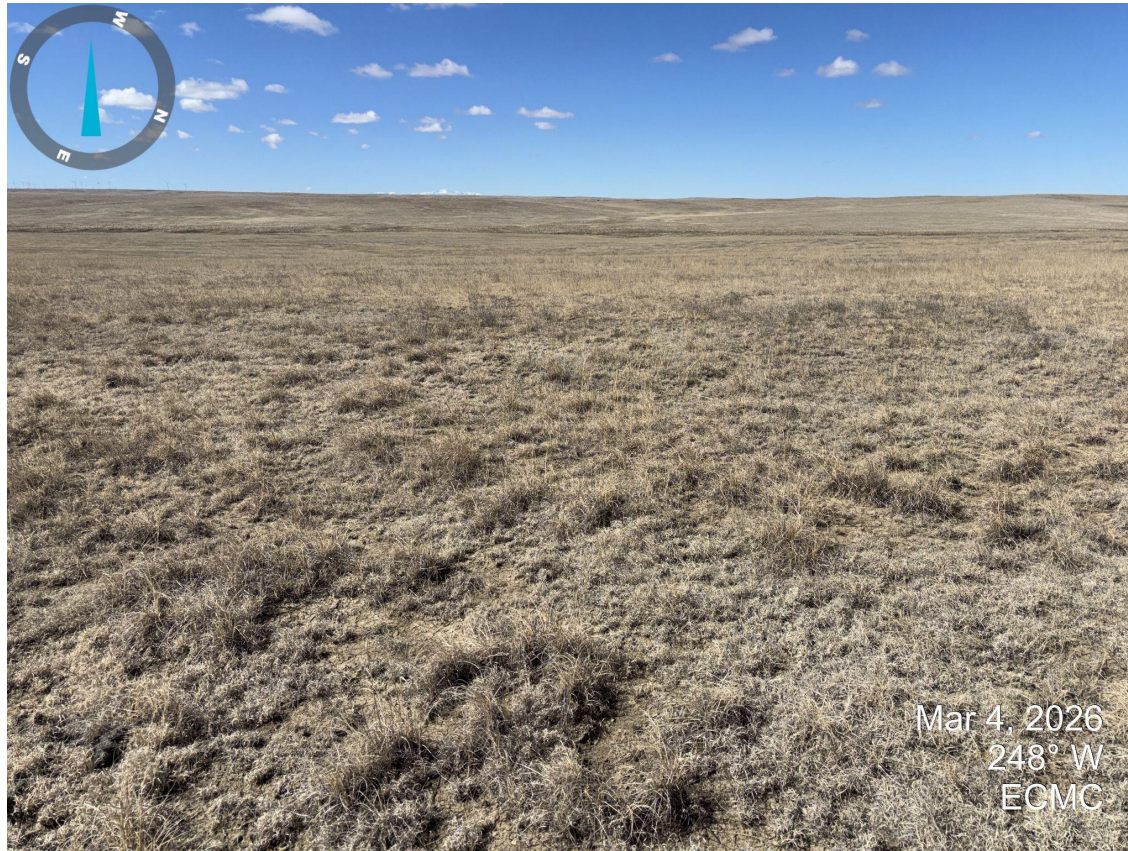
Photo 6. Reference vegetation to the west of the well location.
