Looking at the meter house from which Spill ID 493289 originated.

Lat 40.181825, Long -104.677714  
03/03/2026 14:43 GMT-07:00  
ECMC : Environmental Inspection

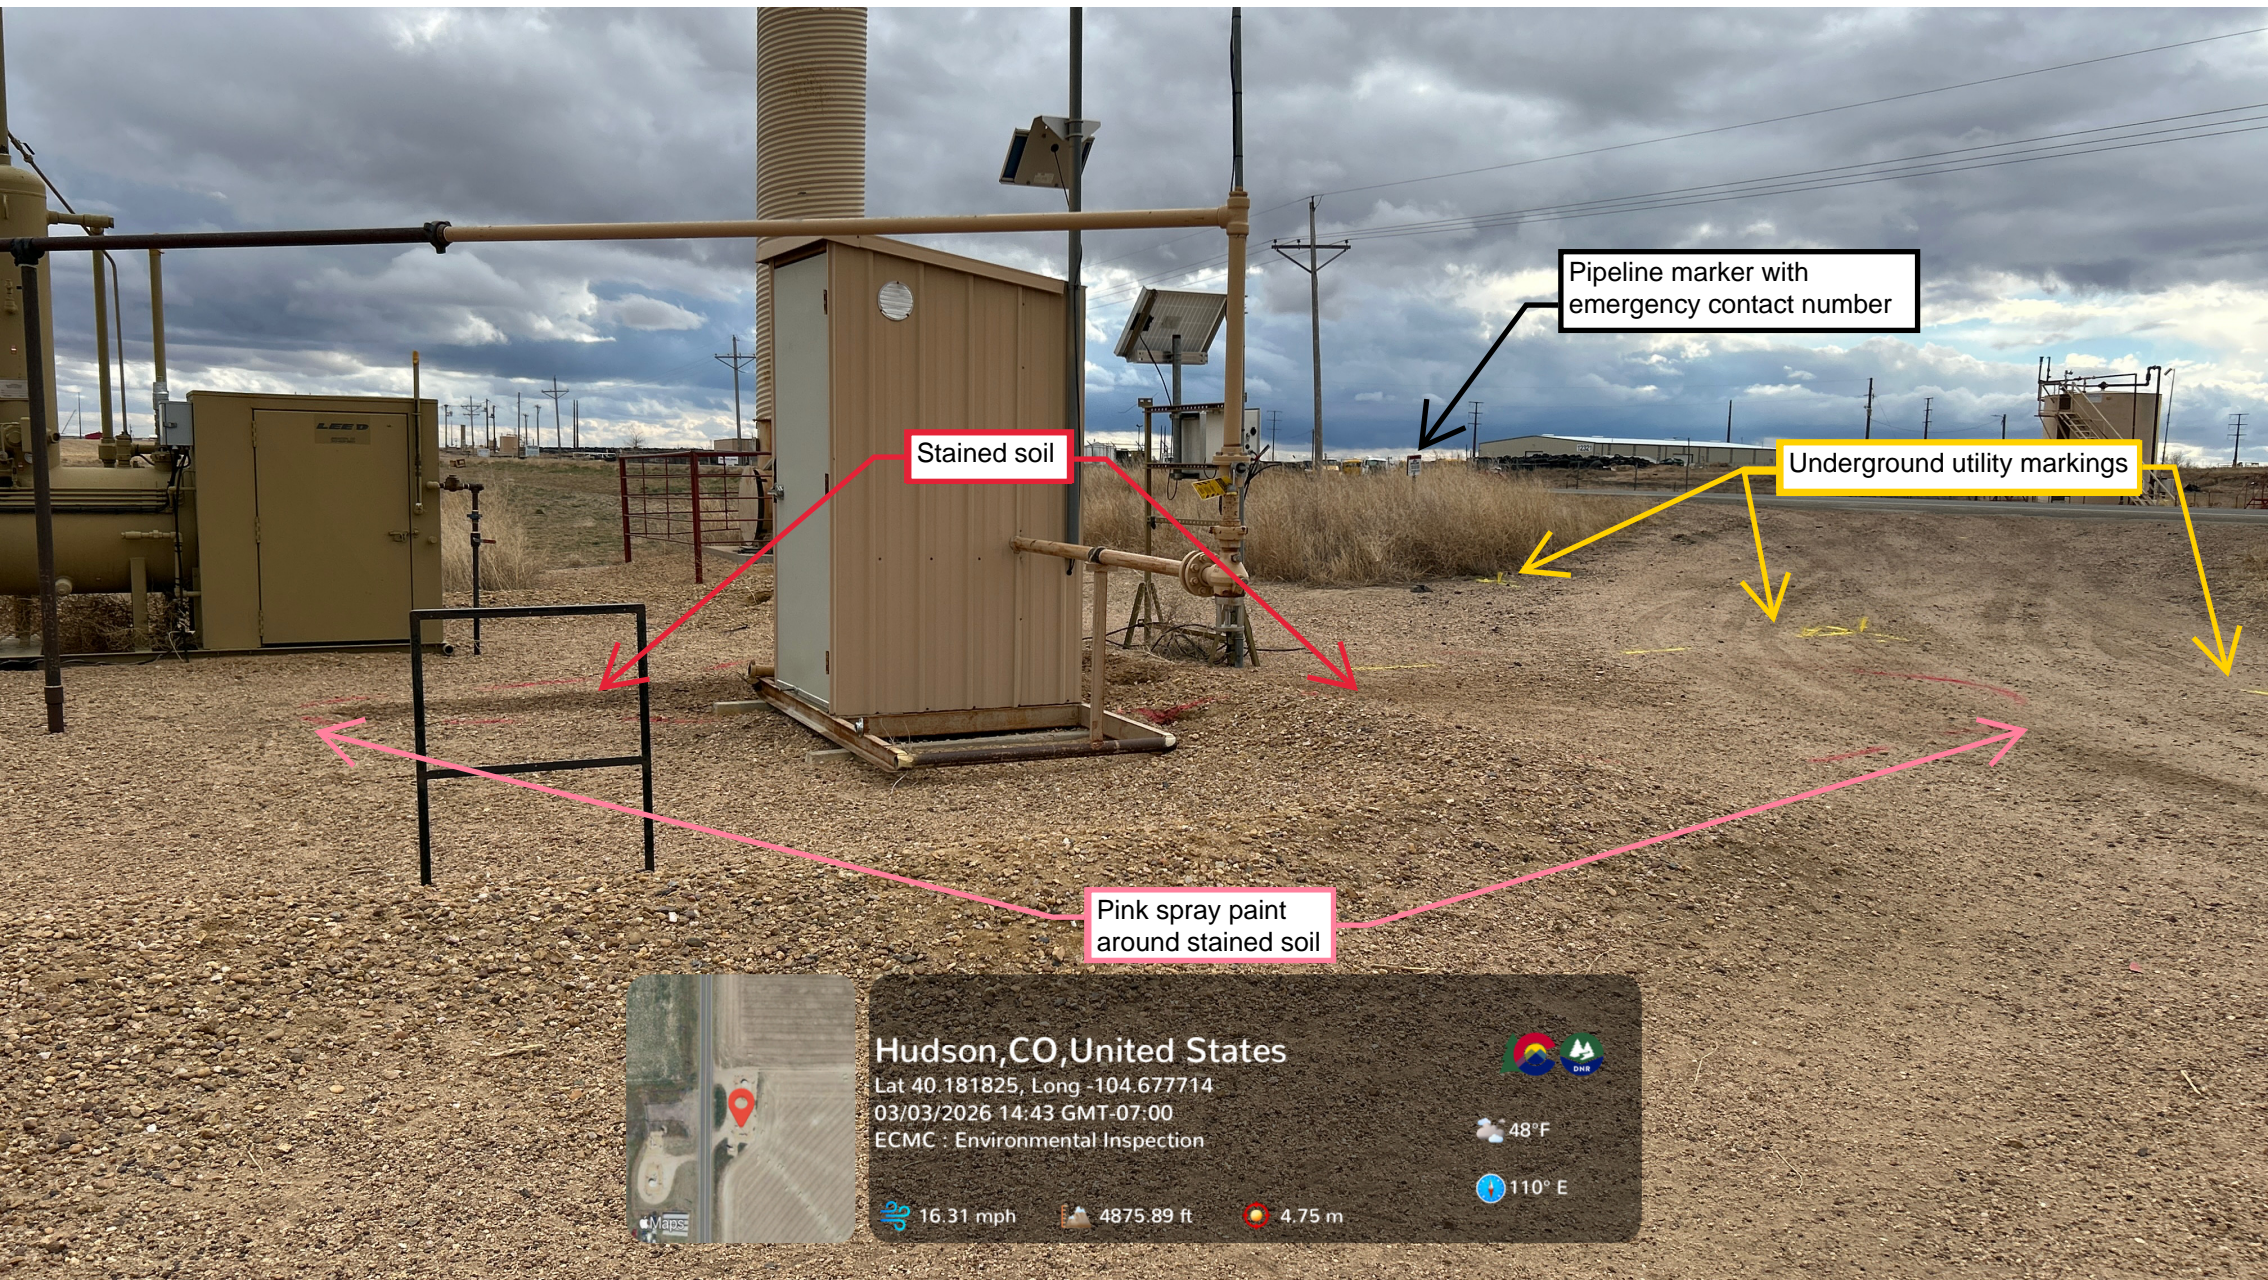
Pipeline marker with emergency contact number

Stained soil

Underground utility markings

Pink spray paint around stained soil

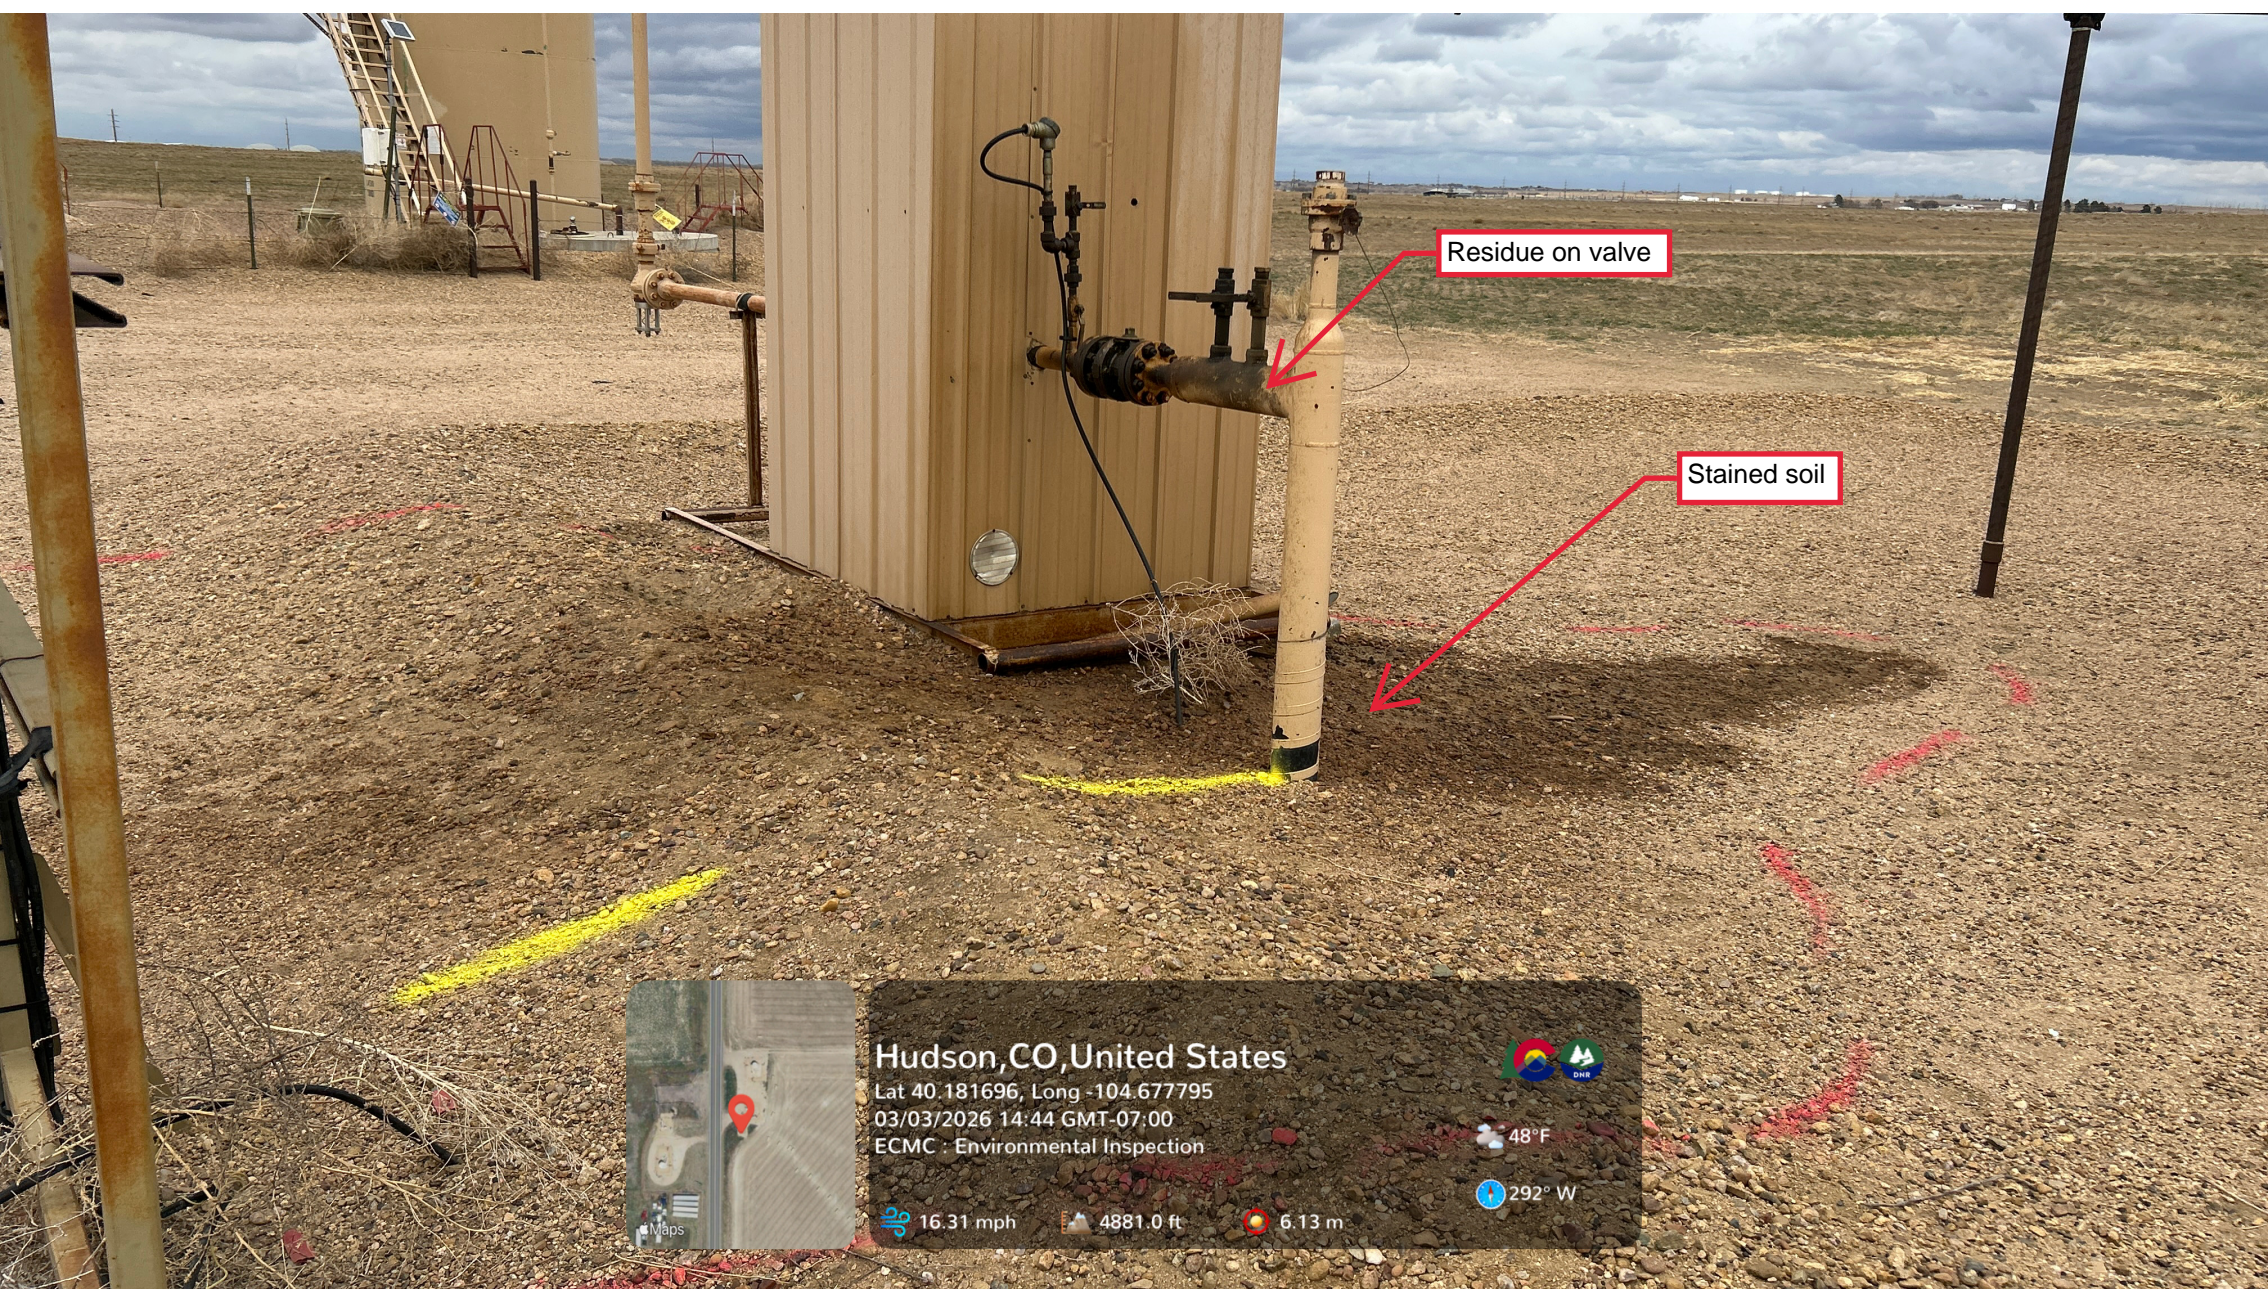
Looking at the stained soil at the Spill location. No indication of remedial activities present. Residue is visible on the valve on the south side of the meter house. A hissing noise was observed at the valve; see attached video.

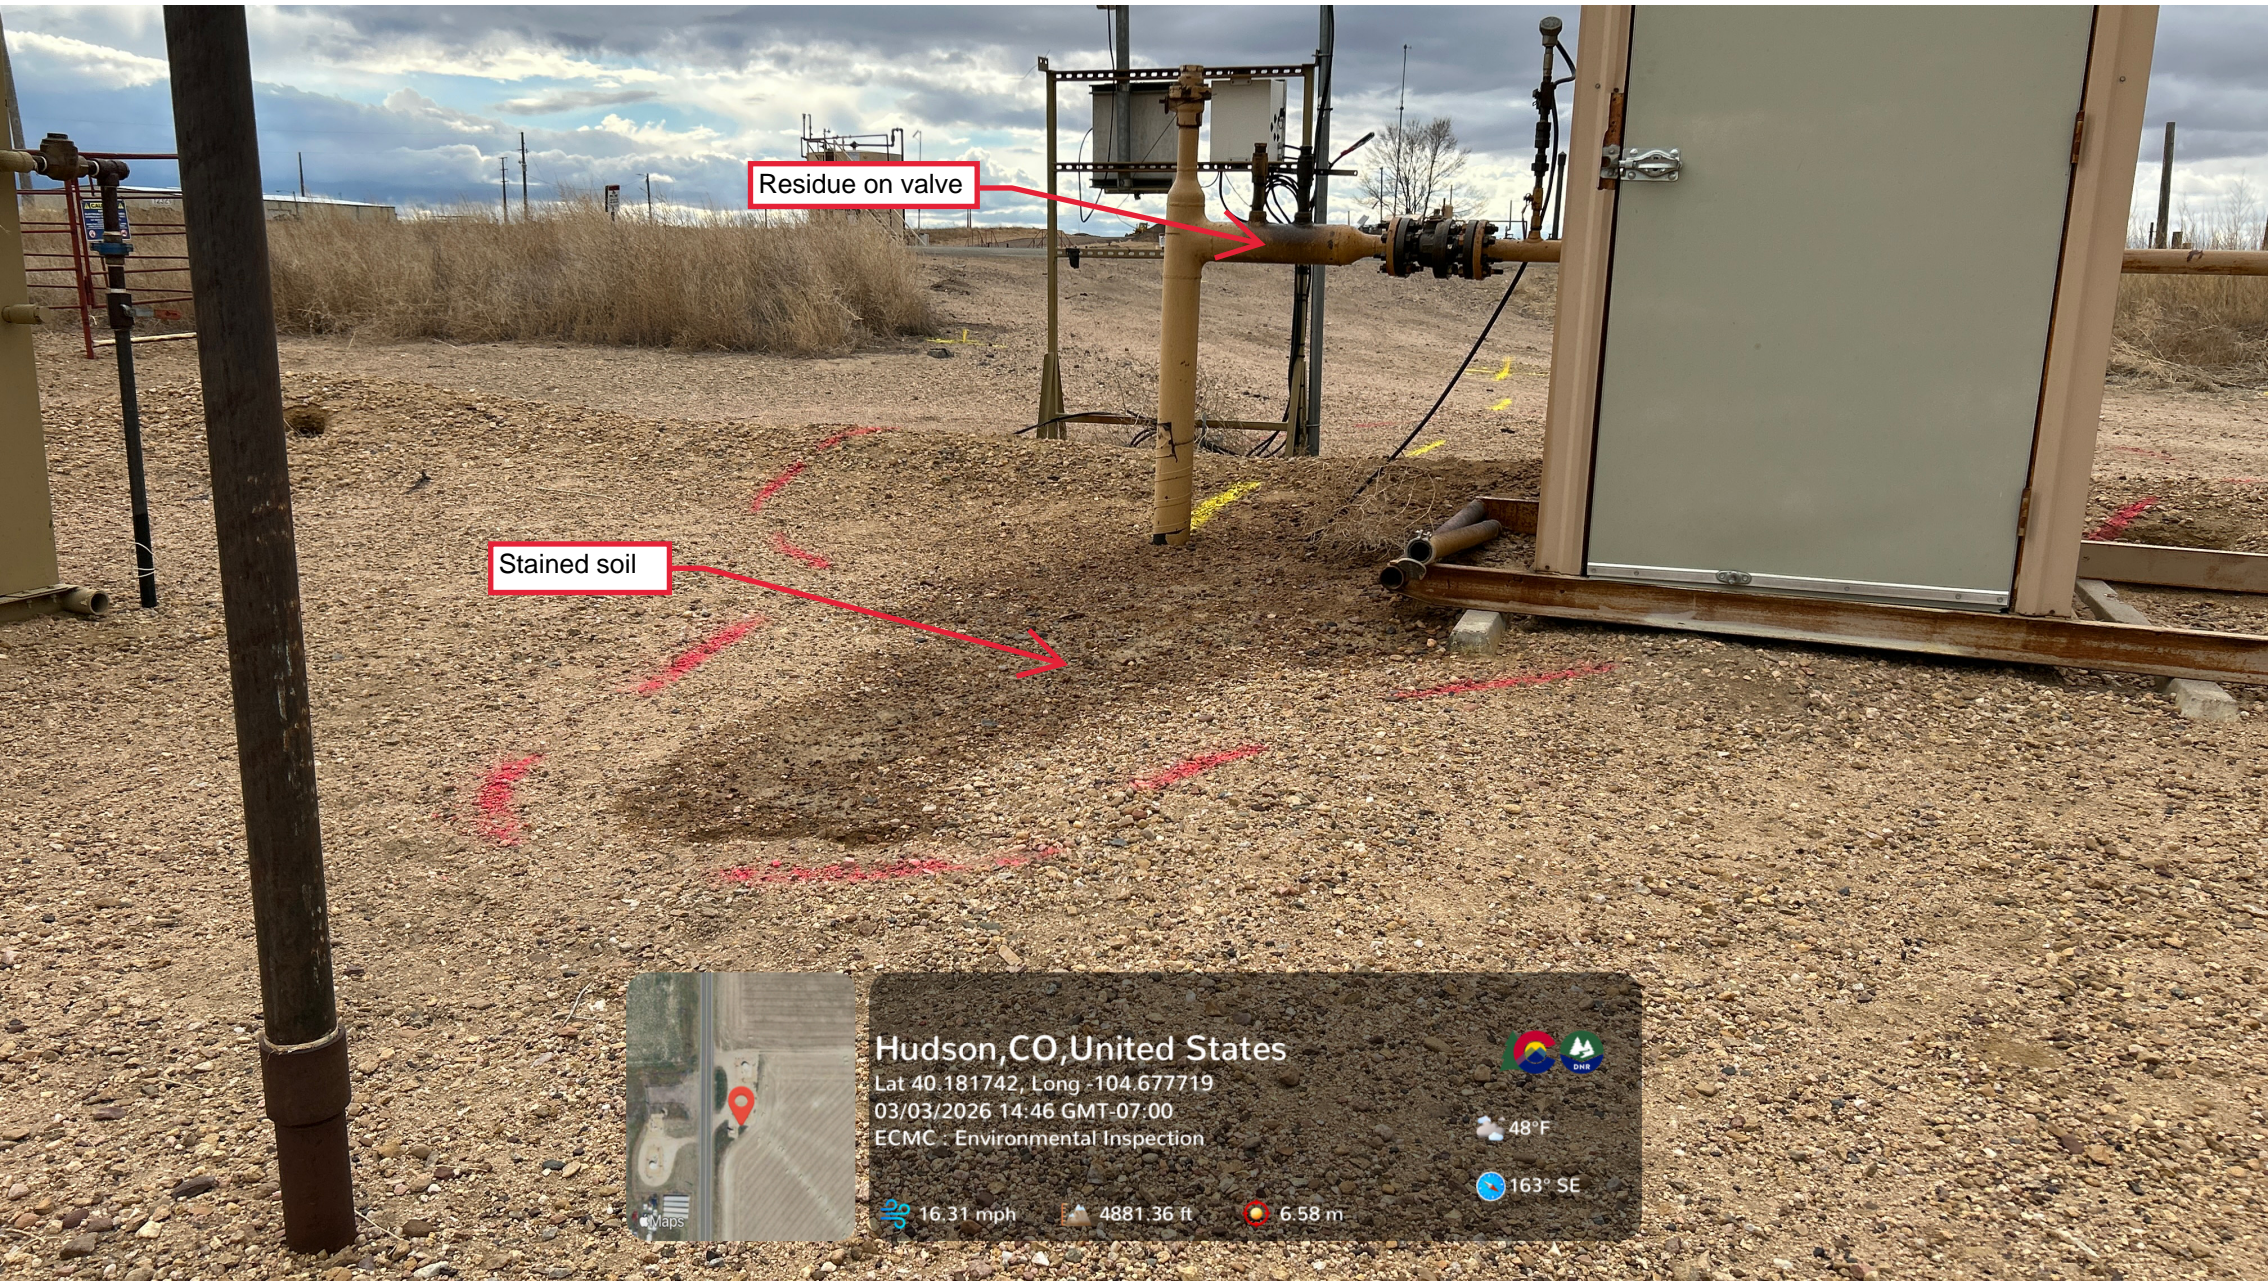
Looking at the stained soil.

Residue on valve

Stained soil
