# INSPECTION PHOTOS

**Well: APACHE CANYON 18-16**

**API #: 05-071-08928**

**INSPECTION DOC #: 716302010**

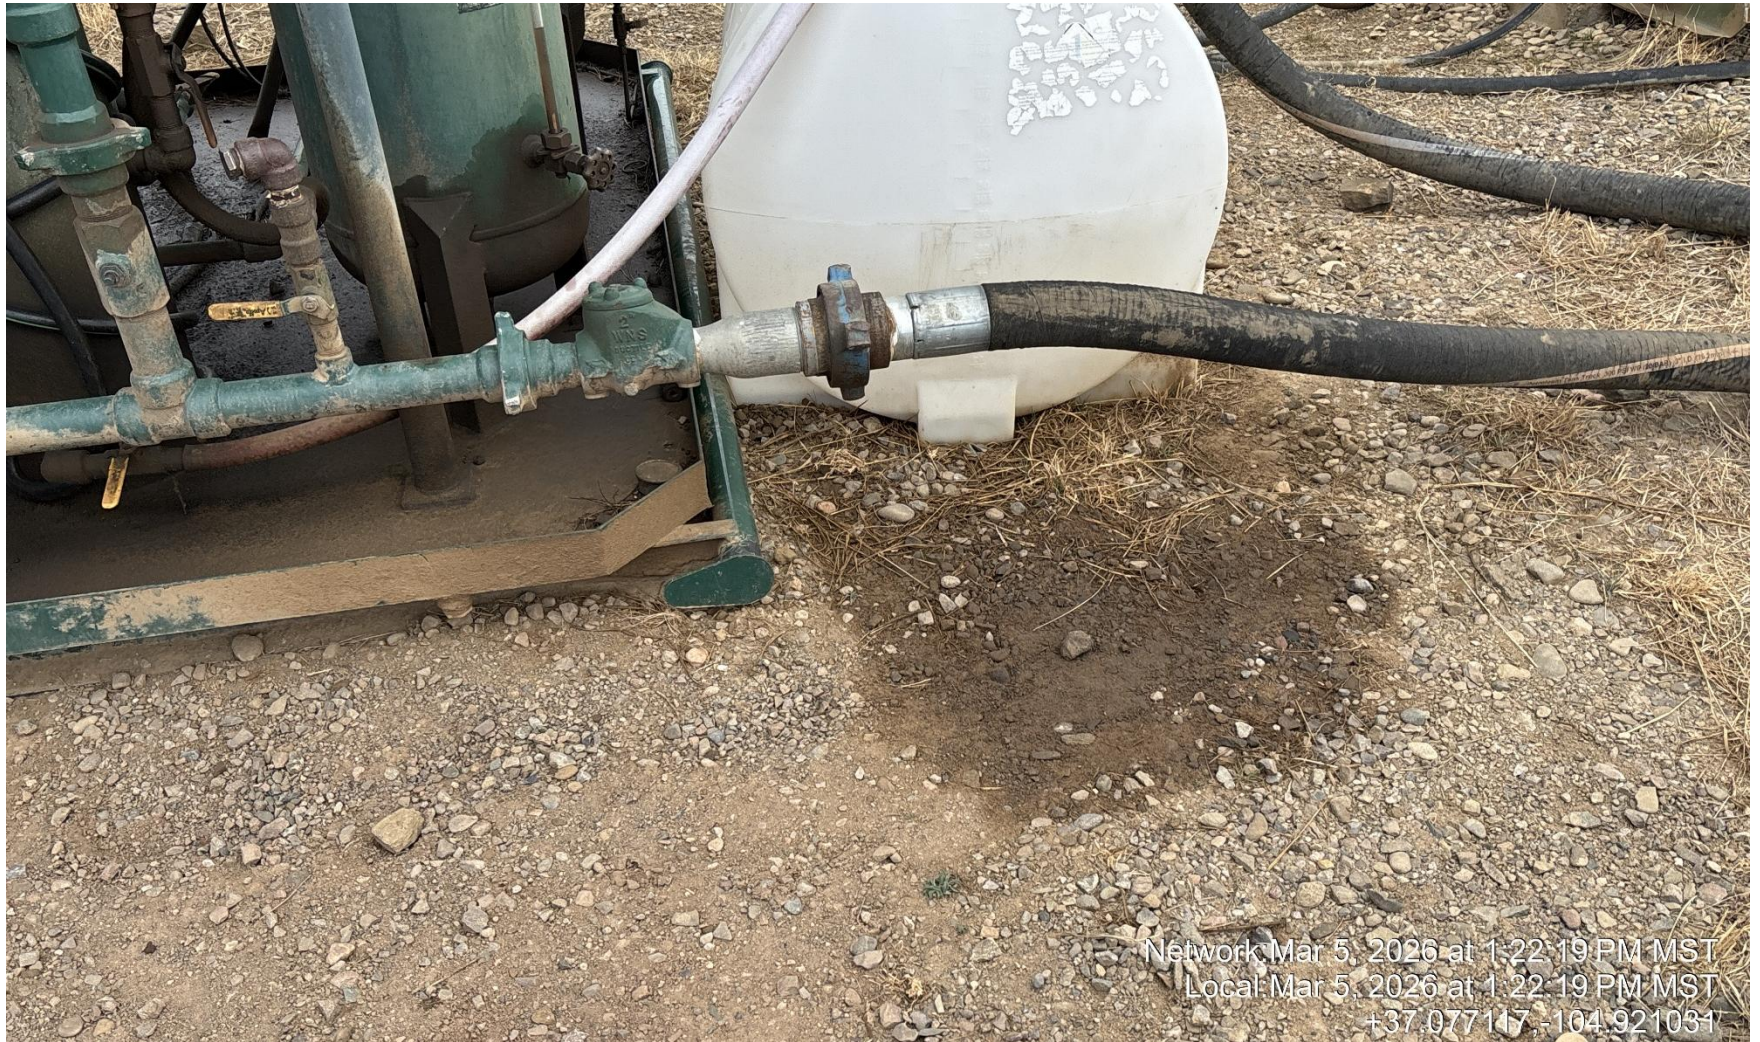
**PHOTO 5: AREA OF IMPACTED SOIL NEAR COMPRESSOR. Conduct maintenance on equipment, cleanup stained material and review self inspection processes. COMPLY WITH RULE 1002,(2).D. CA DATE 3/12/2026.**

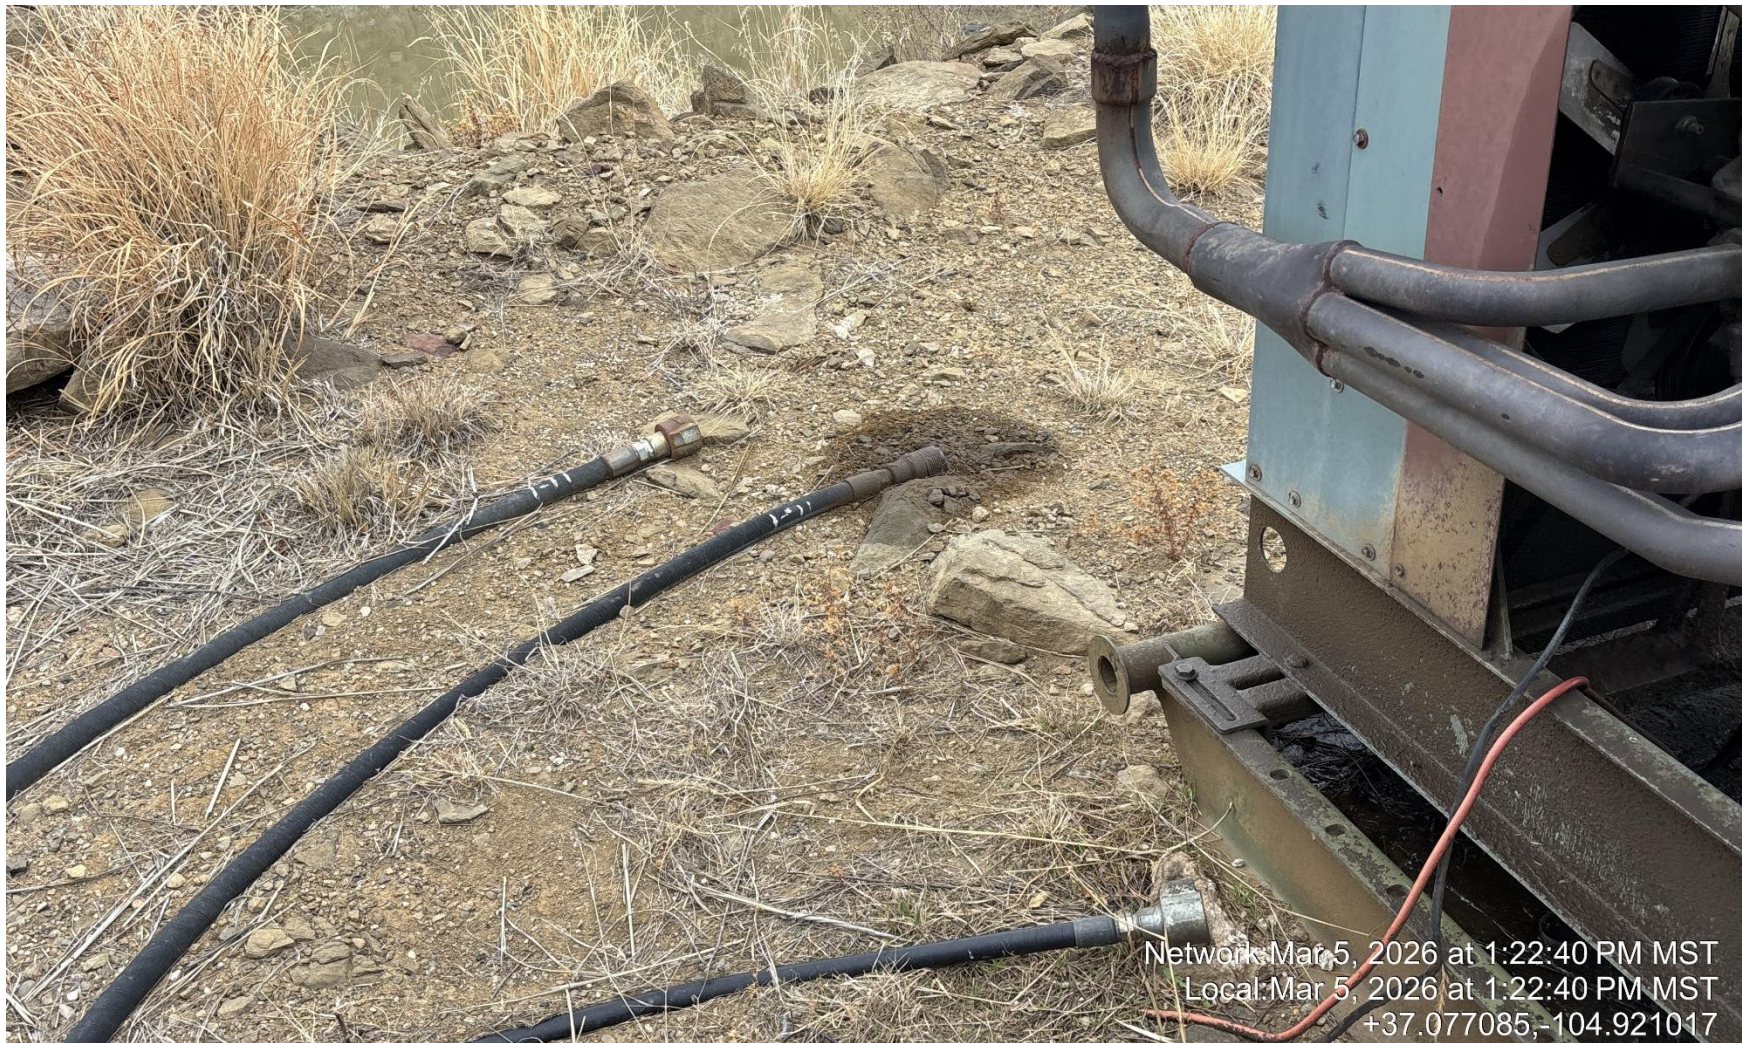
**PHOTO 6: AREA OF IMPACTED SOIL FROM PRIME MOVER HYDRALIC HOSE. Conduct maintenance on equipment, cleanup stained material and review self inspection processes. COMPLY WITH RULE 1002,(2).D. CA DATE 3/12/2026.**

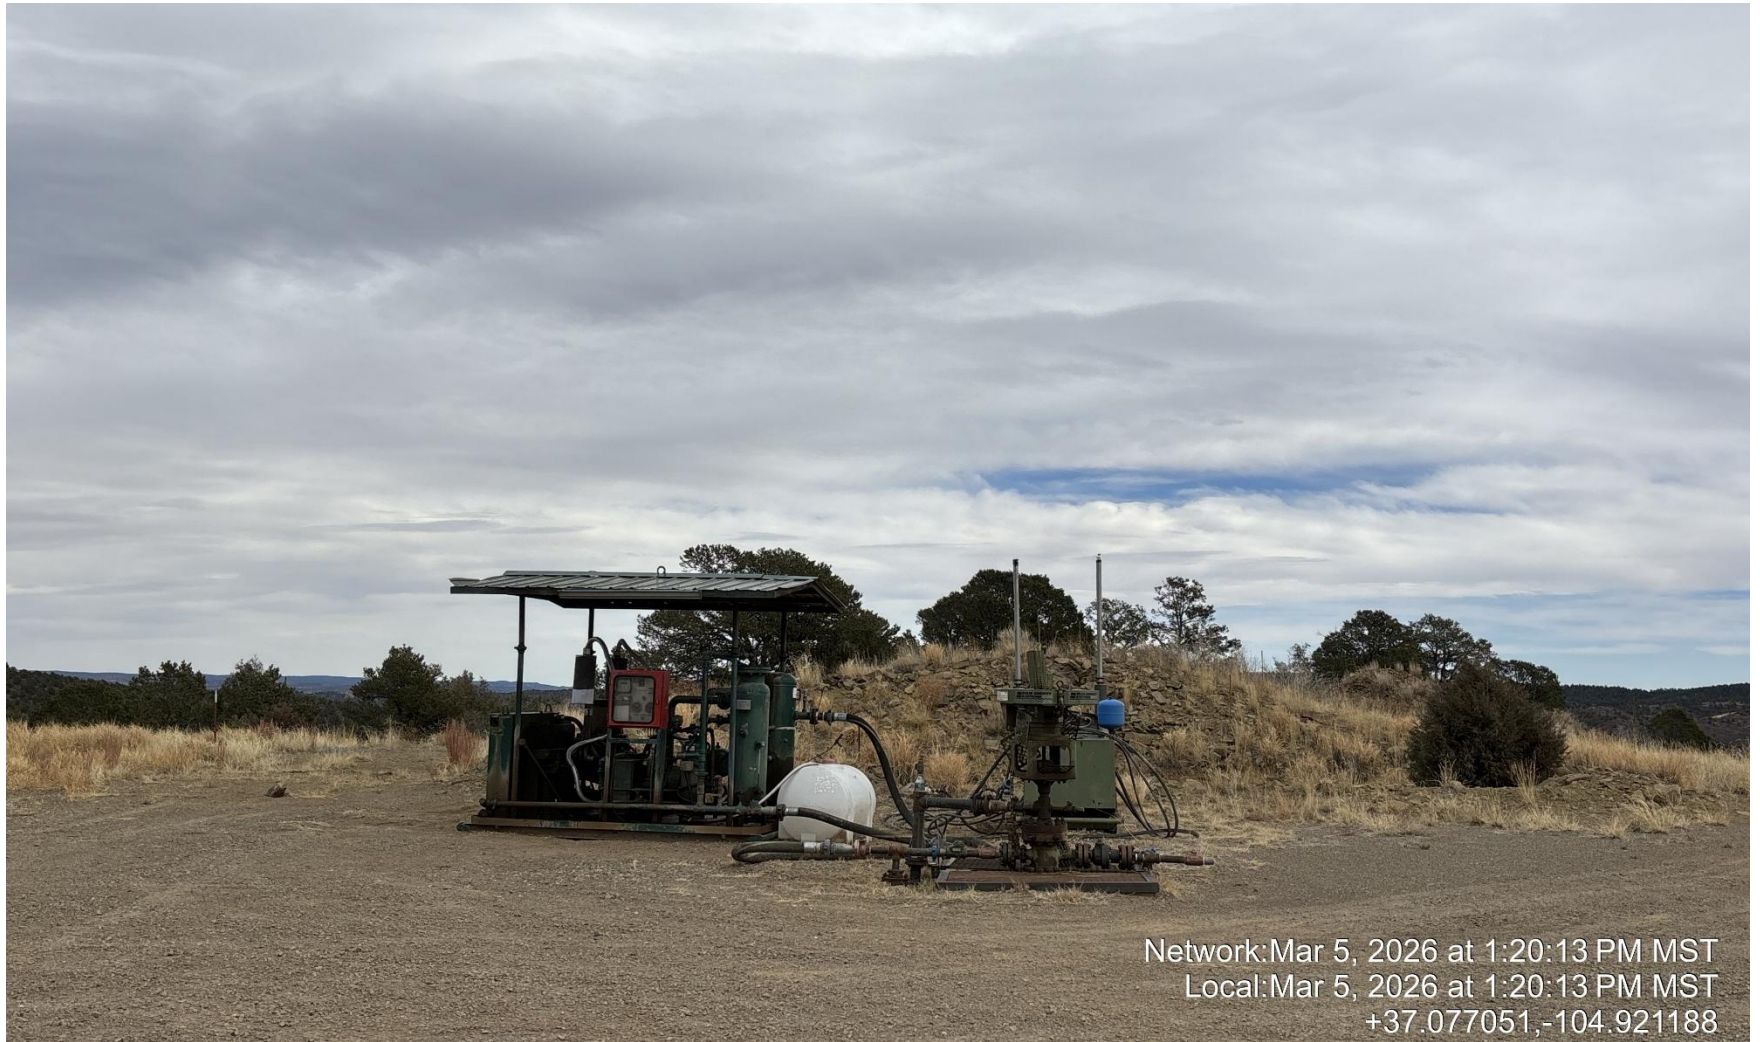
**PHOTO 7: Vacuum pump observed on well without ECMC approval. Provide ECMC with documentation showing approval of use of vacuum pump. CA DATE 3/24/2026.**

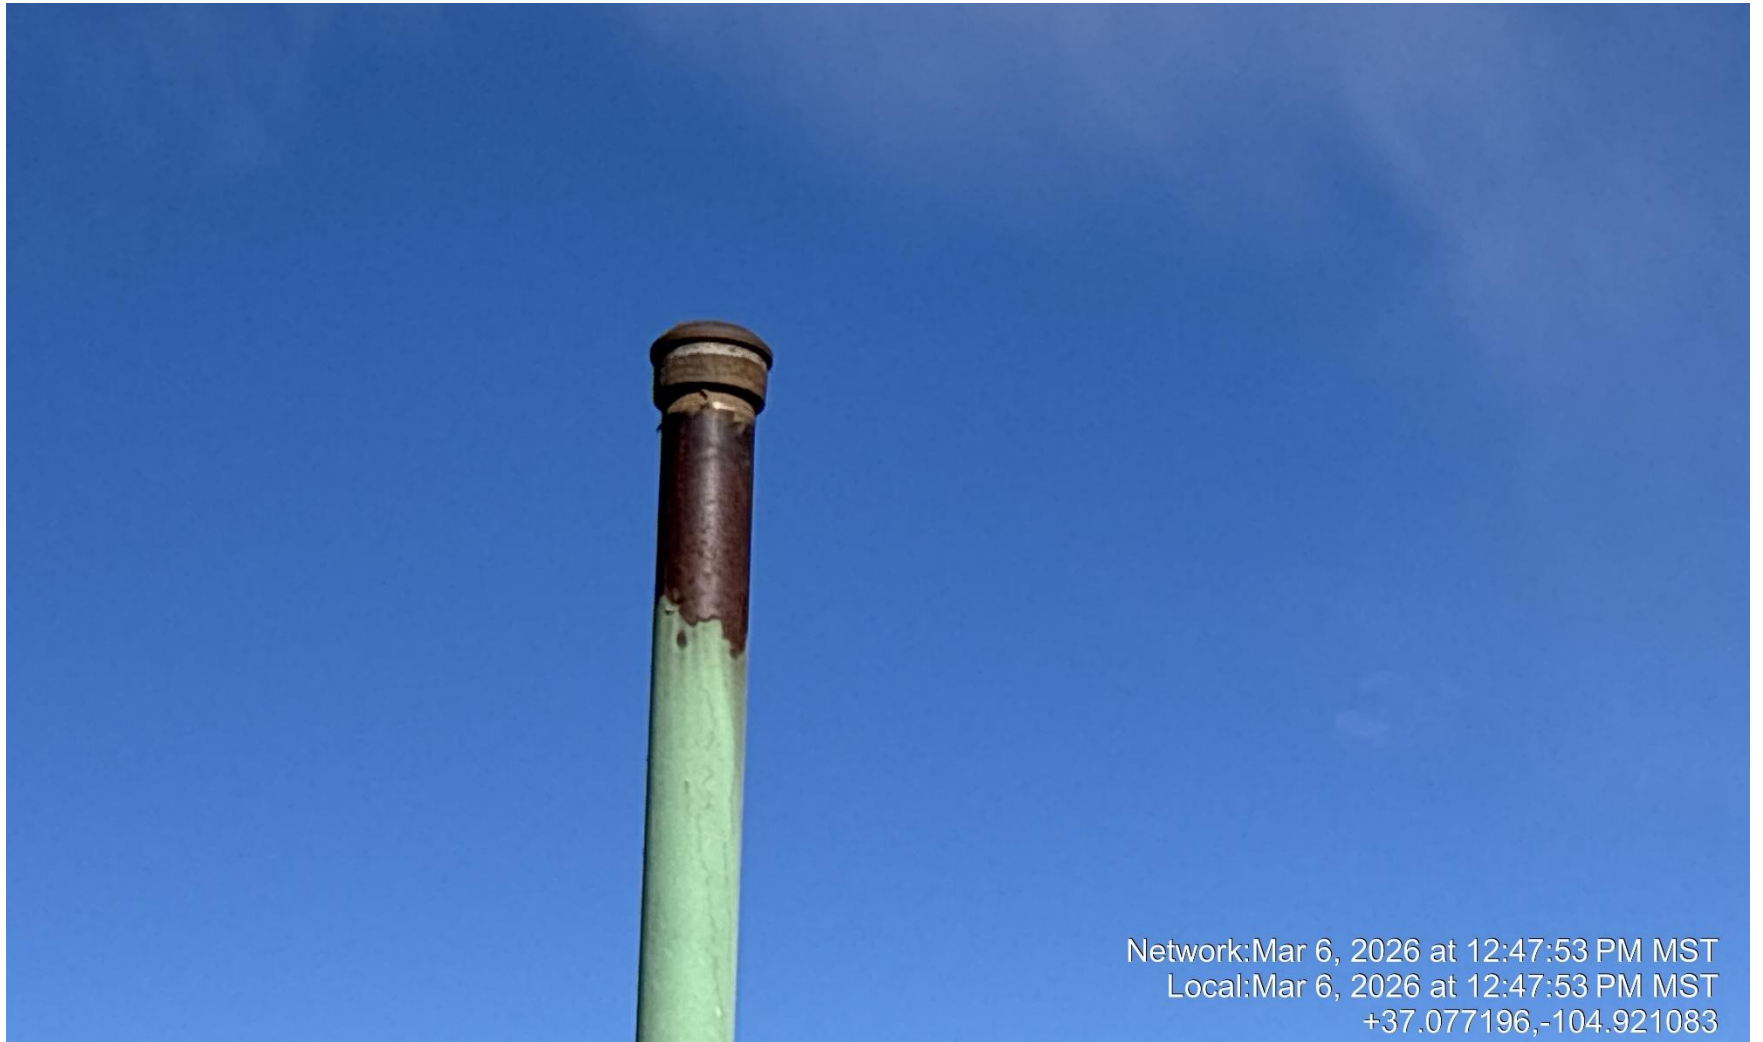
**PHOTO 8: Equipment does not properly prevent wildlife entrance or egress (BIRD PROTECTION). Install or repair wildlife protection equipment PER RULE 608.b.(7). CA DATE 3/12/2026.**

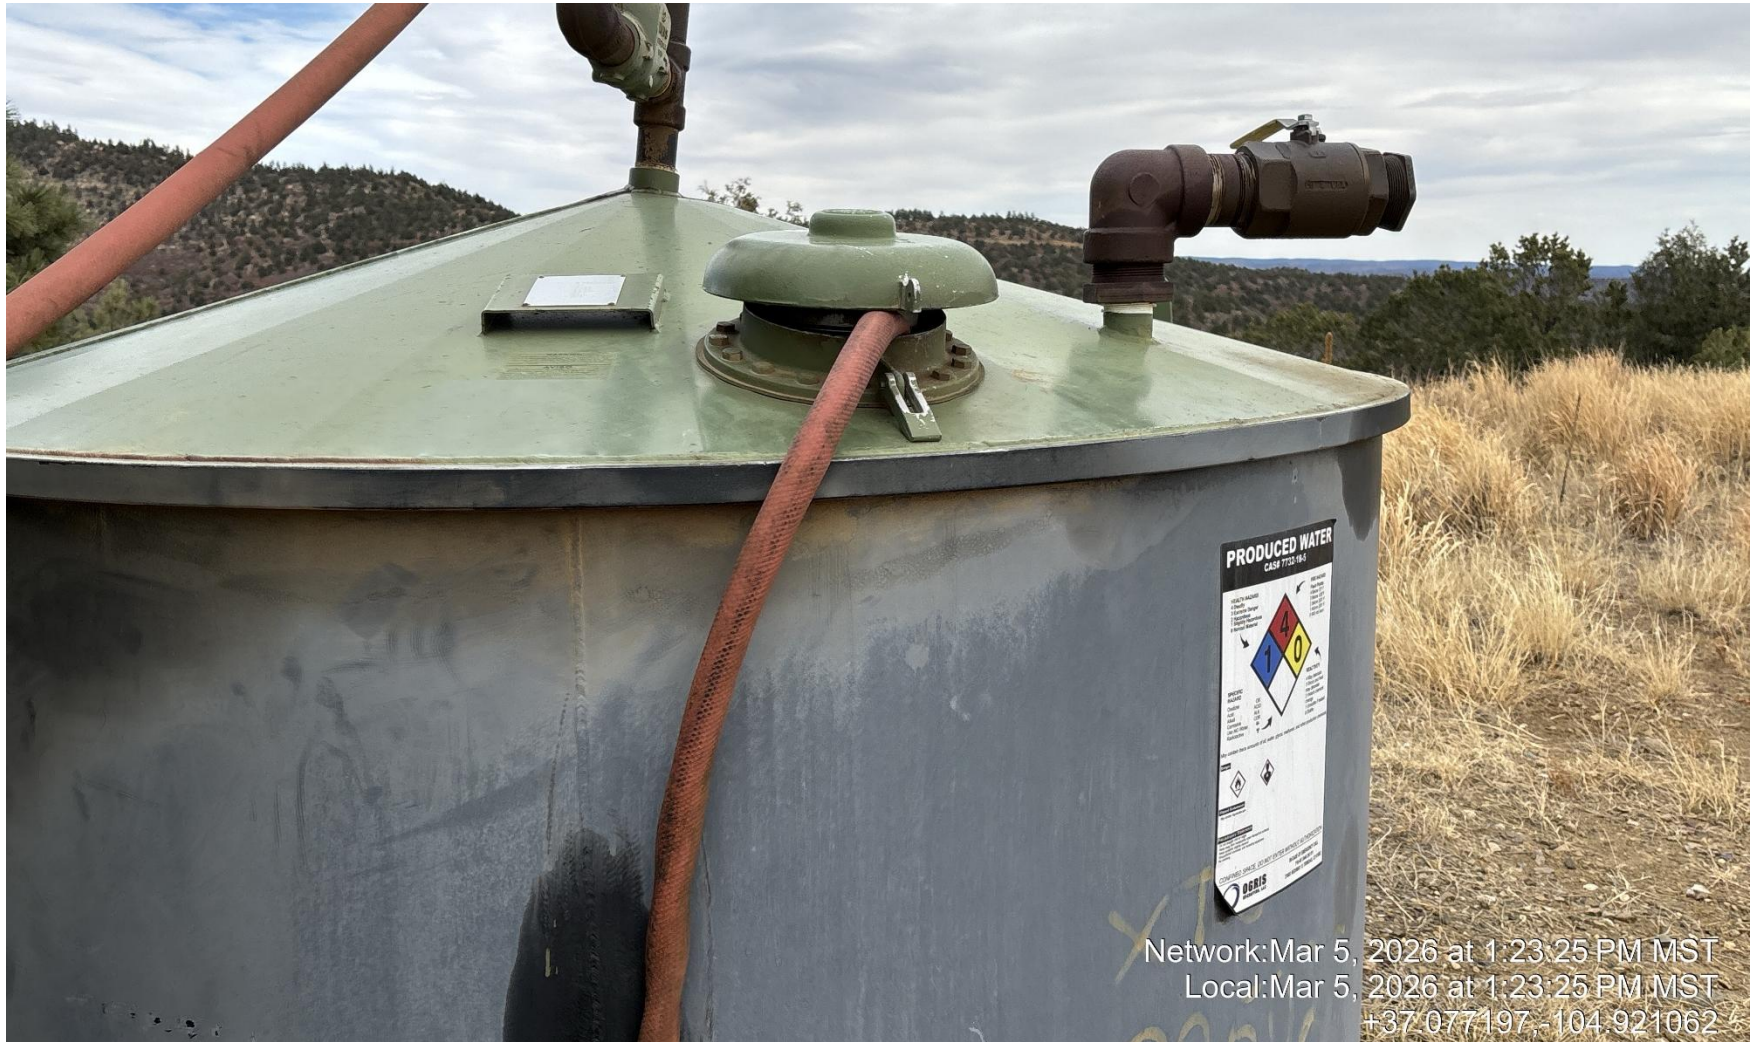
**PHOTO 9: Gauge hatch open when not being accessed for gauging or not sealed. Close and seal gauge hatches when not accessing tank per Rule 608. CA DATE 3/7/2026**

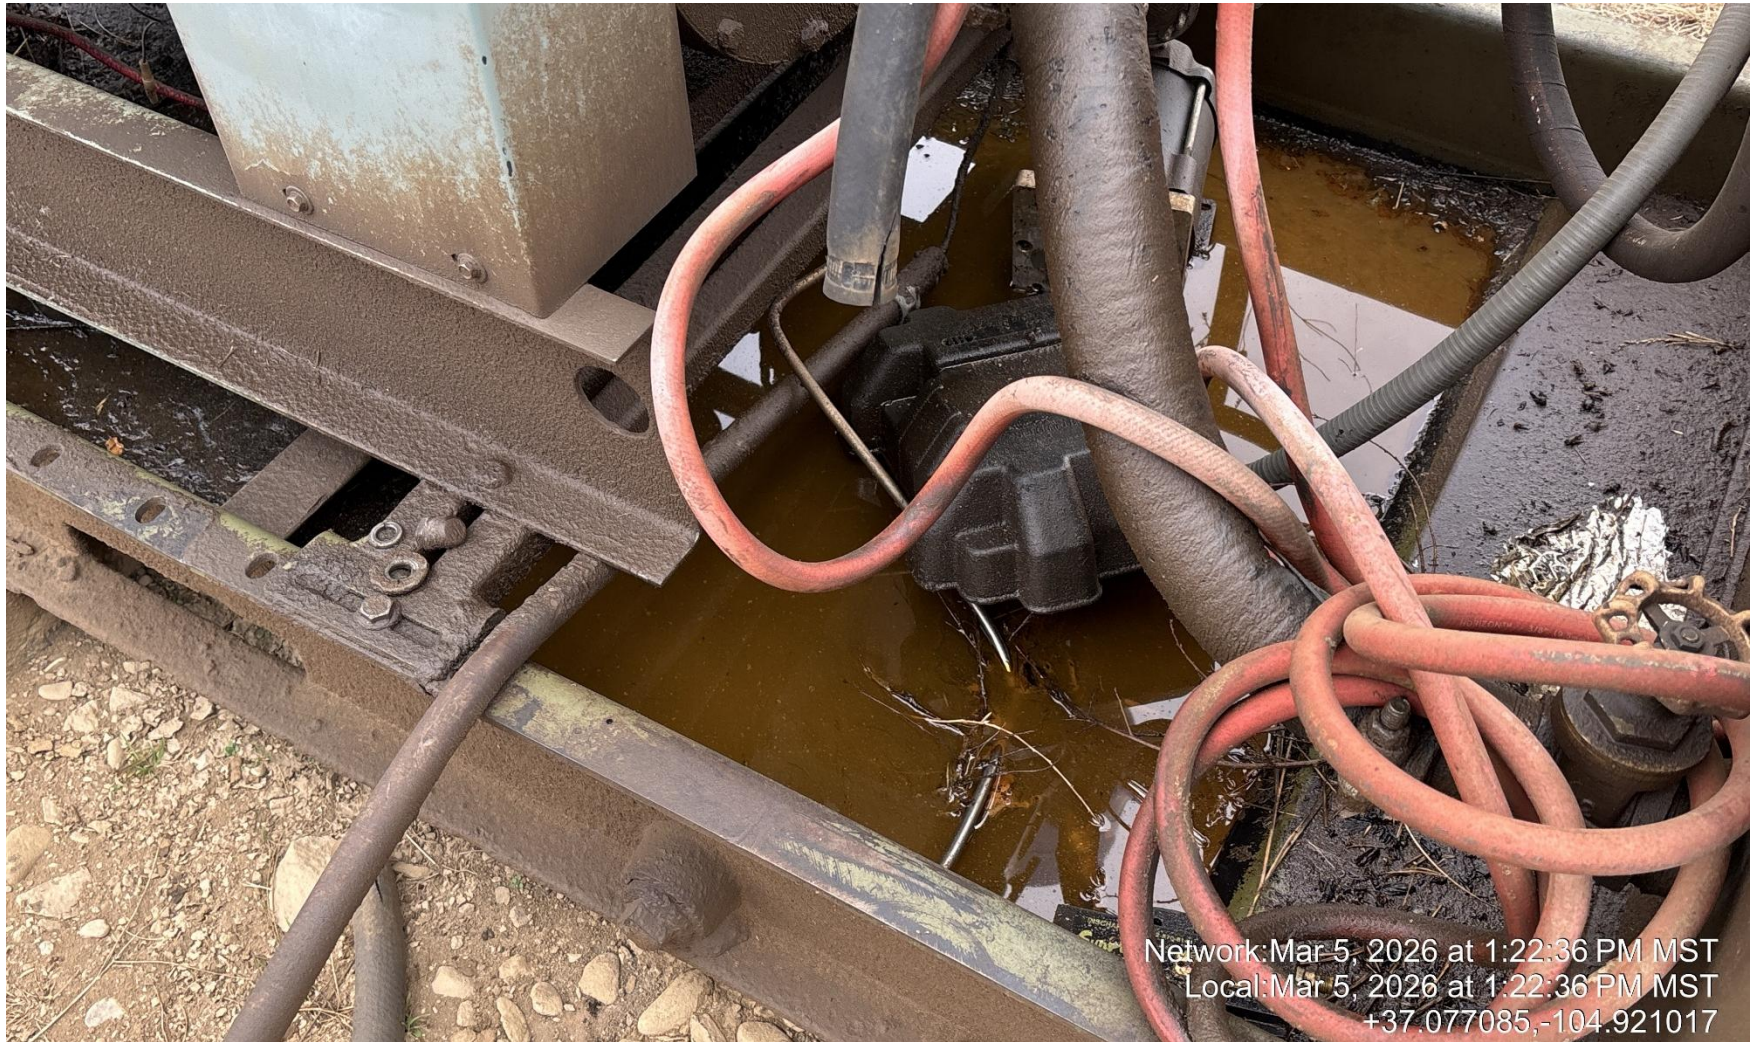
**PHOTO 9: OILY WASTE IN PRIME MOVER ENGIN SKID WITHOUT WILDLIFE PROTECTION SCREENS OR NETTING. DRAIN OILY WASTE REPAIR ALL LEAKS AND REMOVE IMPACTED SOIL PER RULE 1002..(2).D & 1002.f.(2)B, Comply with general provisions of the oil and gas act for wildlife protection AND SB-181. CA DATE 24 HOURS TO DRAIN OILY WASTE OR INSTALL WILDLIFE PROTECTION 3/12/2026 FOR ANY IMPACTED SOILS.**
