Final Reclamation Inspection

Operator: KERR MCGEE OIL & GAS ONSHORE LP

Location ID: 332898

Location Name: HSR-KNOX-65N67W 3SWNW

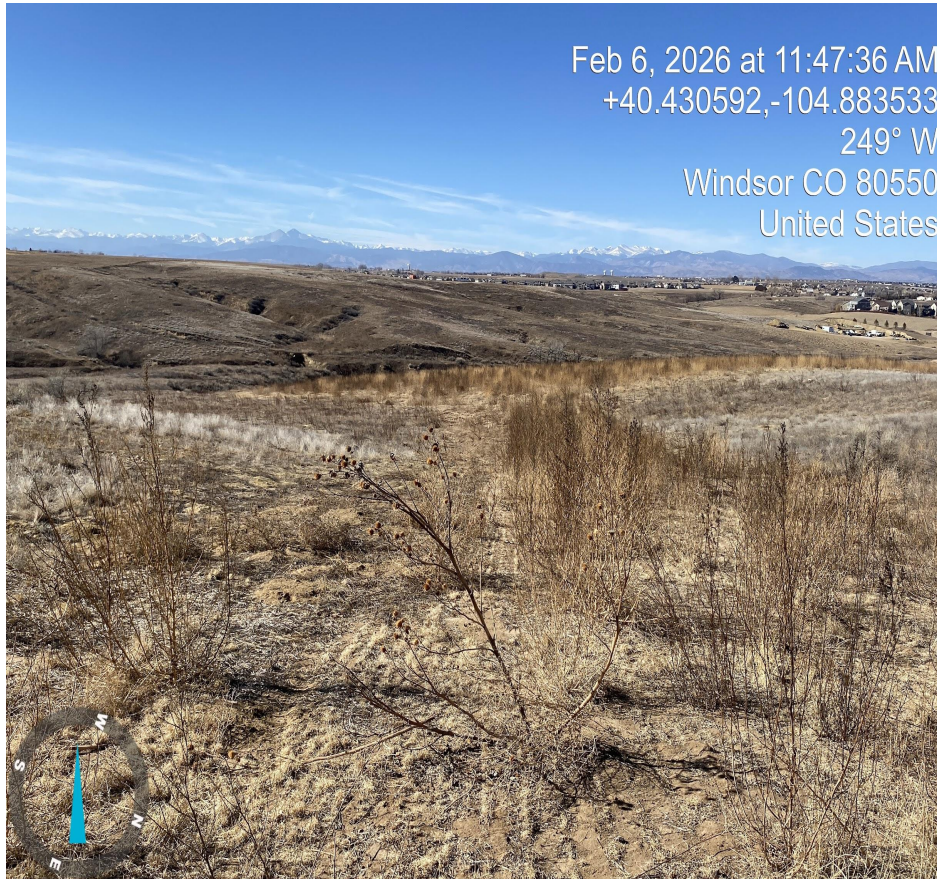
Photo 1. Photo taken from the access road looking down on the location. An attempt to reclaim the access road was made based on evidence of drill seed rows; however, the road has a significant amount of undesirable weeds present, and desirable vegetation is stunted.

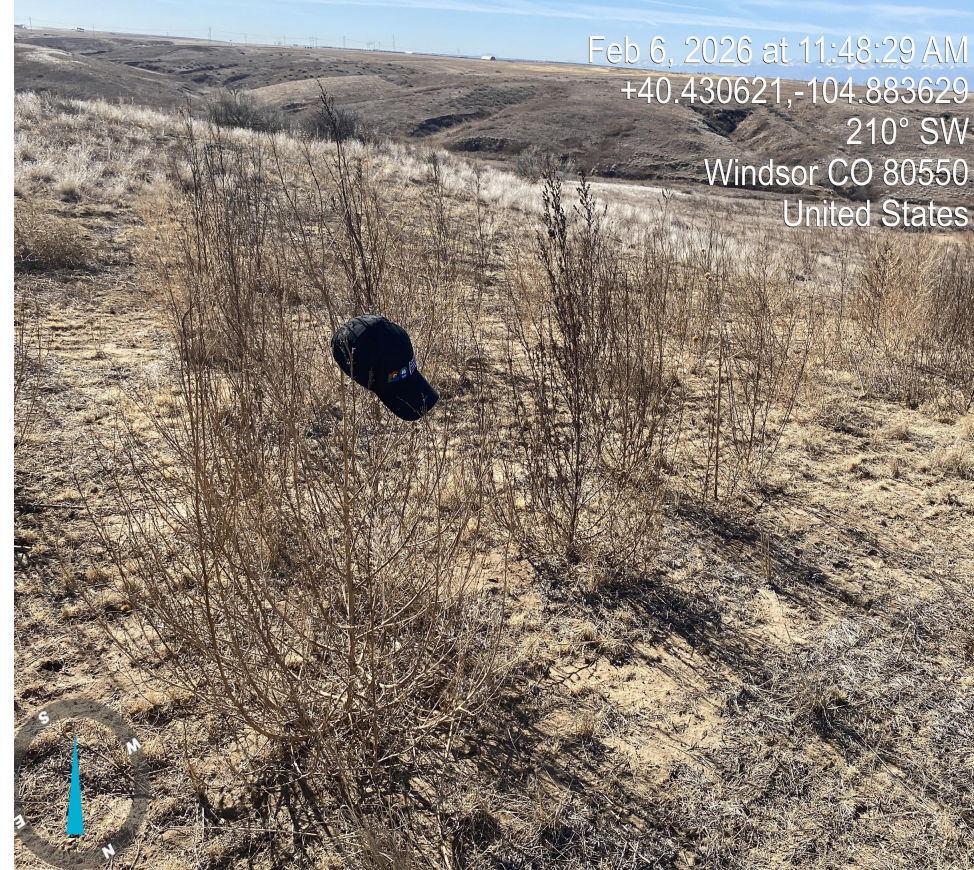
Photo 2. Photo taken on the access road going to the location. Weeds are over 4 feet tall and need to be controlled. Additionally, desirable vegetation is stunted, and bare areas are present between drill rows.

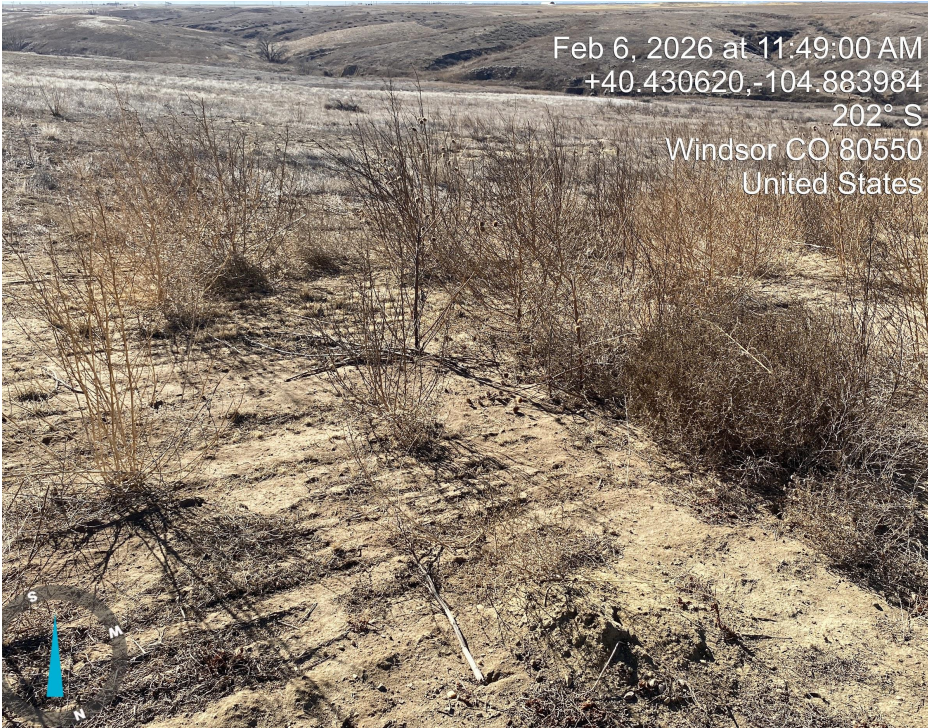
Photo 3. Photo taken from access road showing undesirable weeds and bare areas present.

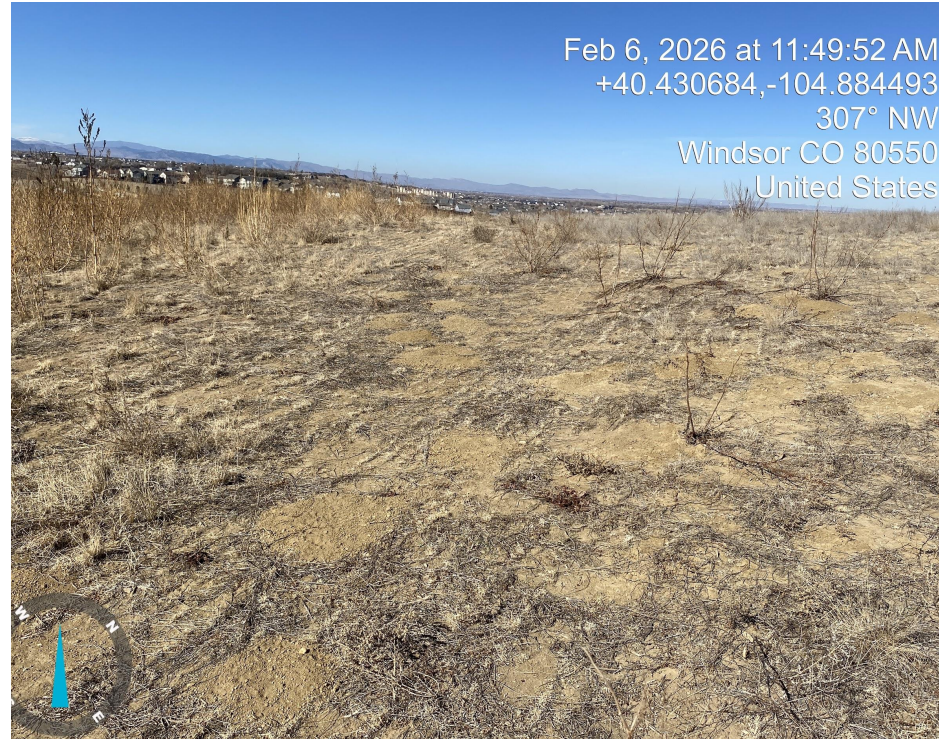
Photo 4. Photo taken from the Easter portion of the location showing undesirable weeds. Evidence of drill-seeded rows with some native grasses present; however, many bare areas remain.

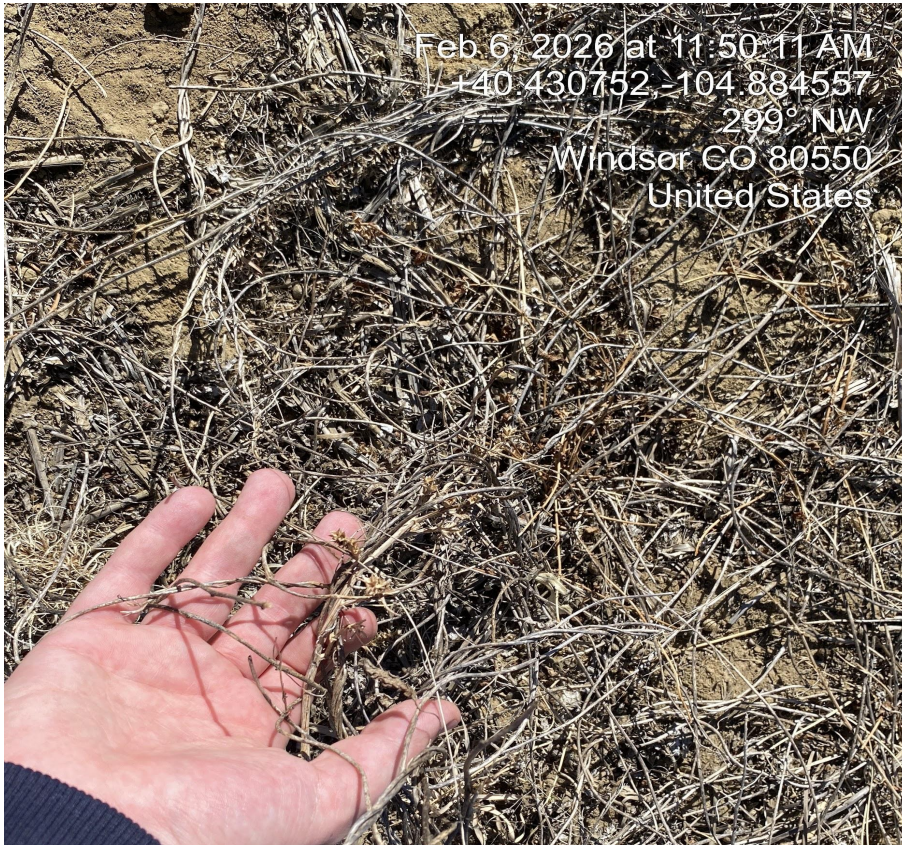
Photo 5. Photo taken on location showing the presence of a List C noxious weed, field bindweed.

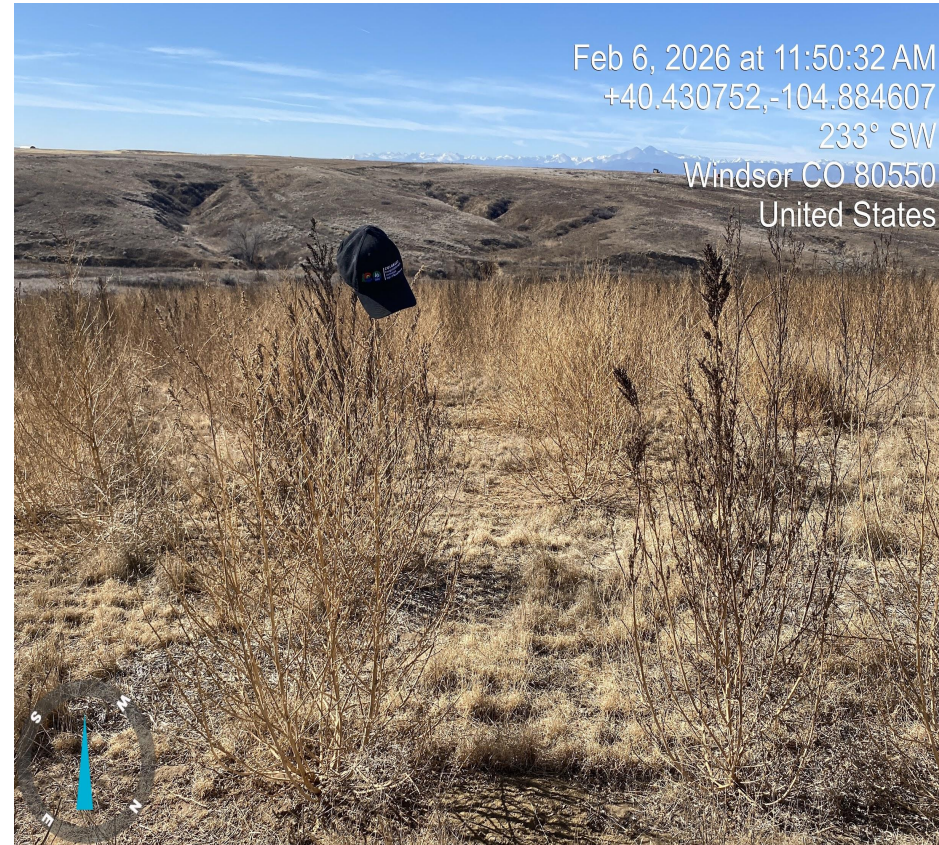
Photo 6. Photo taken from eastern side of location facing south west showing large weeds present.

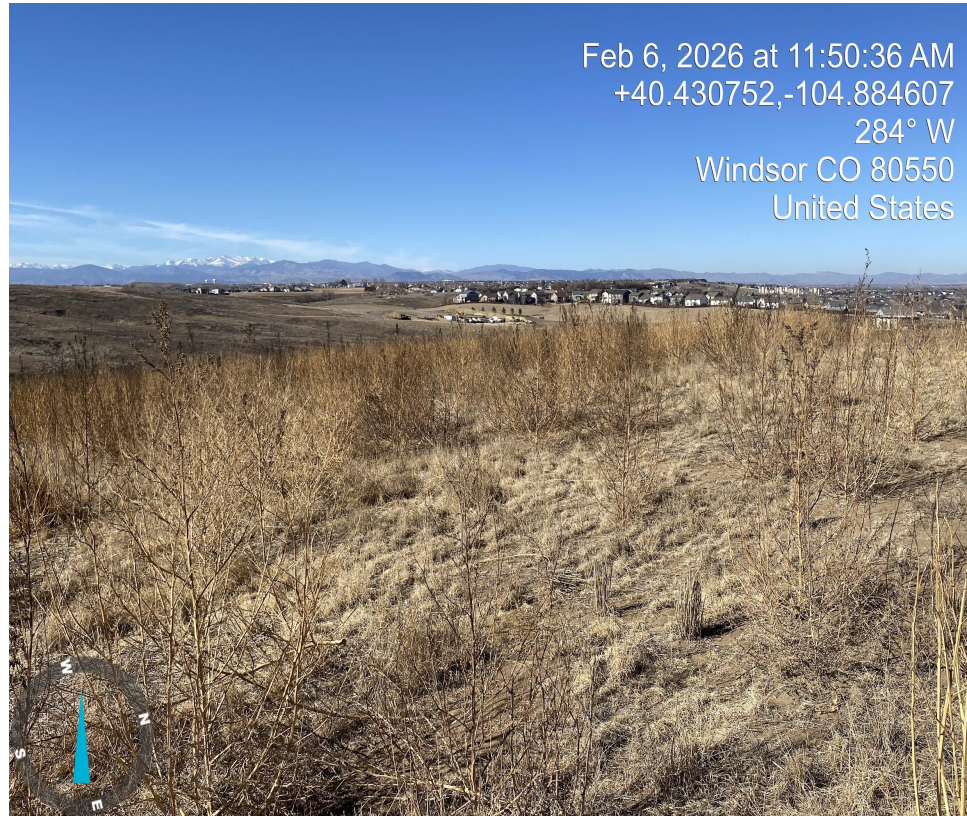
Photo 7. Photo taken from eastern side of location facing west. See comment under photo 6.

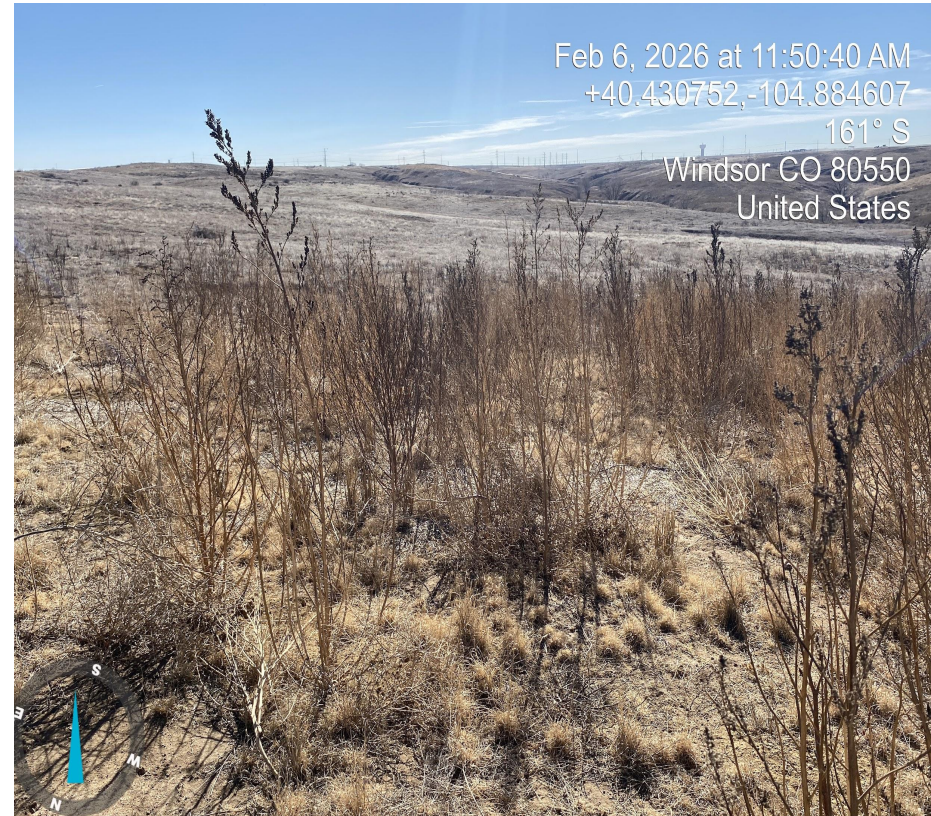
Photo 8. Photo taken from eastern side of location facing South. See comment under photo 6.

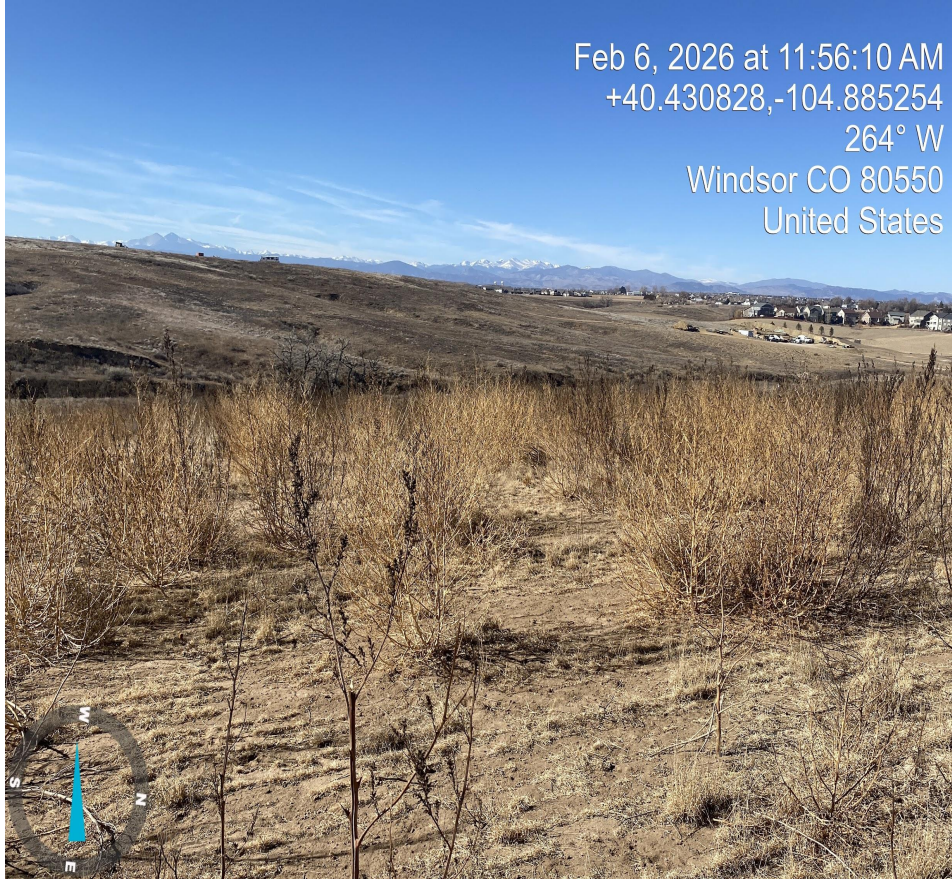
Feb 6, 2026 at 11:56:10 AM
+40.430828,-104.885254
264° W
Windsor CO 80550
United States

Photo 9. Photo shows desirable grass species that were present on the location, giving some evidence of previous reclamation work; however, undesirable plants outnumber natives significantly.

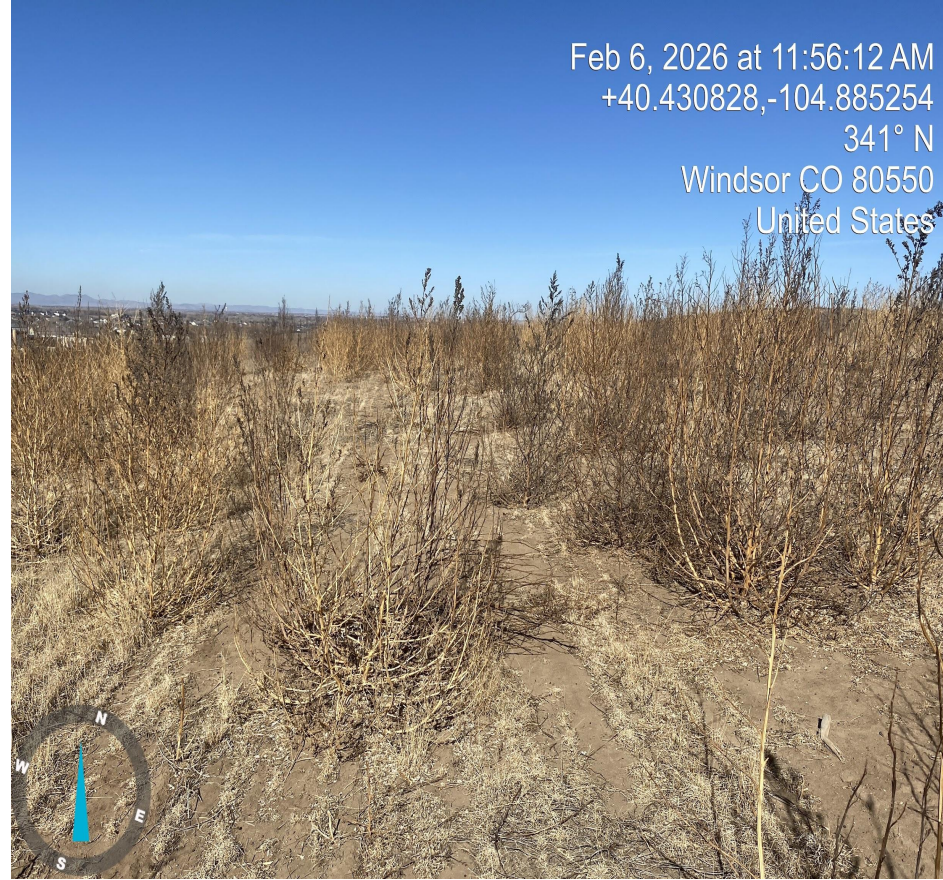
Feb 6, 2026 at 11:56:12 AM
+40.430828,-104.885254
341° N
Windsor CO 80550
United States

Photo 10. Photo shows undesirable plant species present on location.
