# Final Reclamation Inspection

Operator: KERR MCGEE OIL & GAS ONSHORE LP

Location ID: 332954

Location Name: HSR-KNOX-65N67W 3NWSE

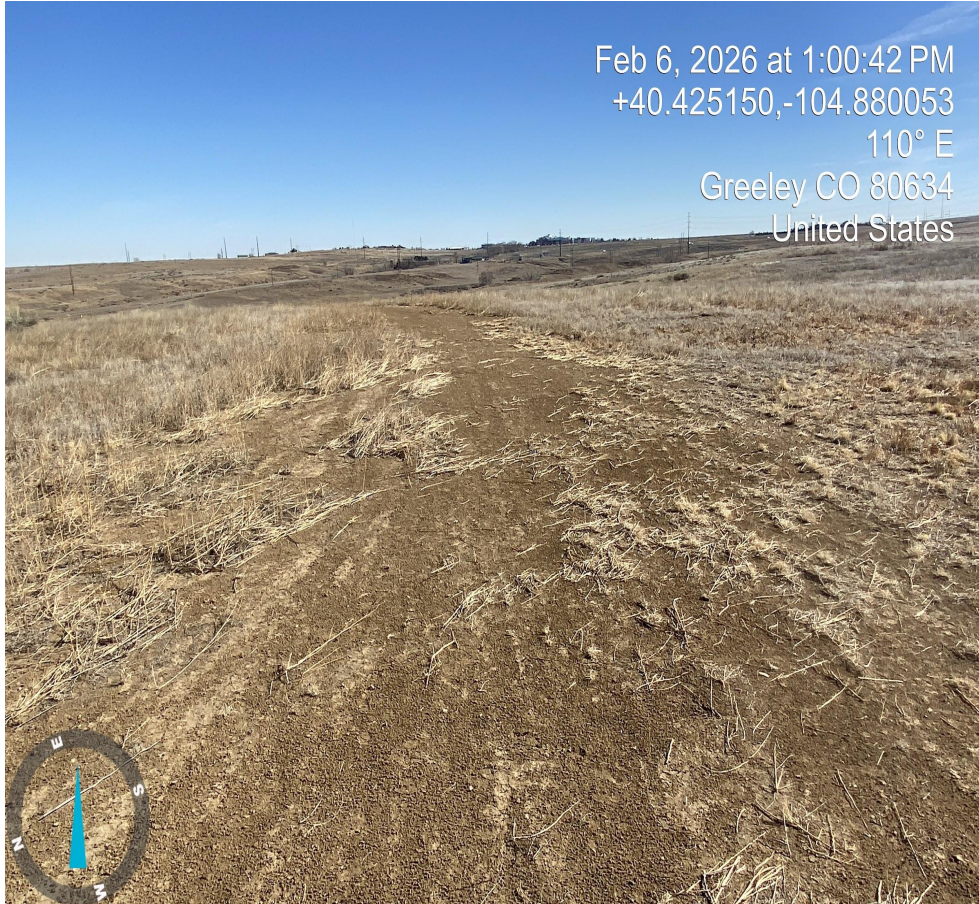
**Photo 1.** . Photo taken from the access road. The access road has not been reclaimed and remains bare. There is evidence of raindrop-impact erosion, and a high risk of stormwater erosion on bare soil along the access road.

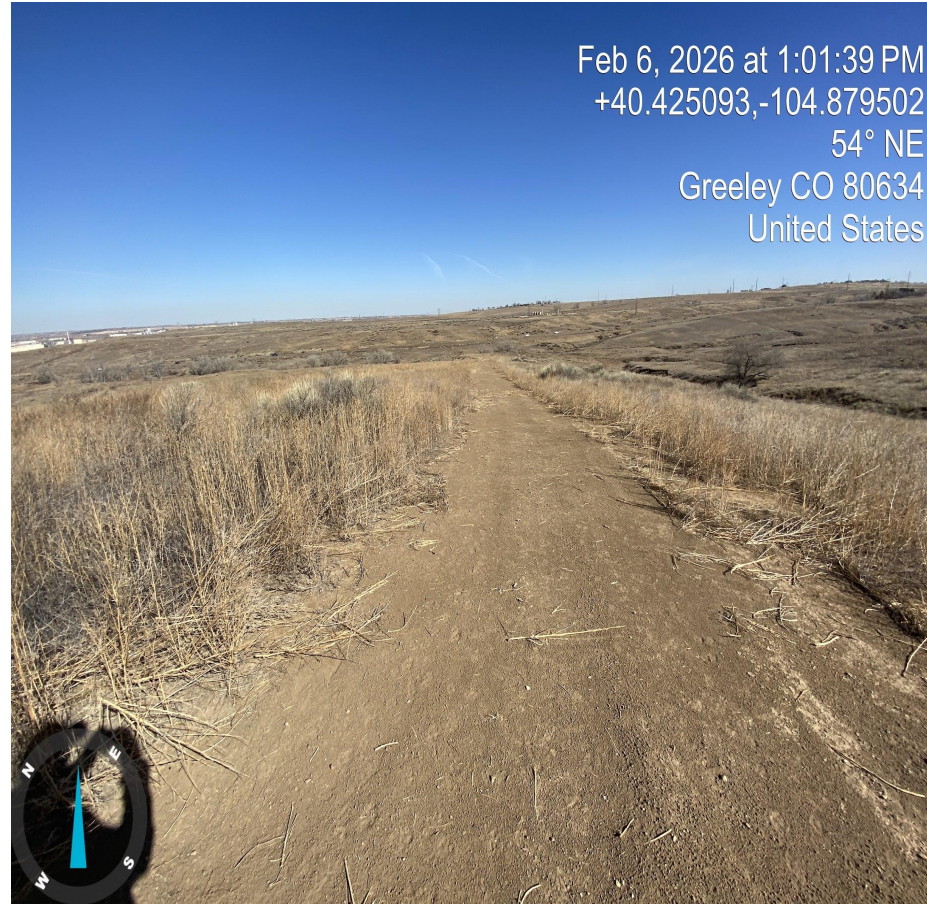
**Photo 2.** Photo taken on the access road going to the location. See the comment under photo 1.

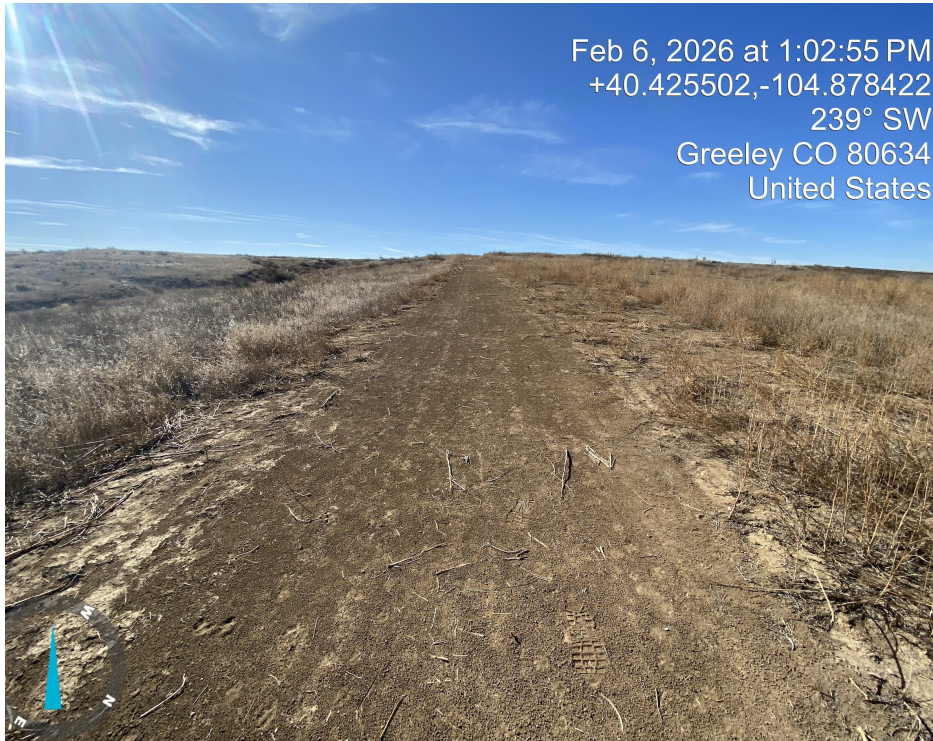
**Photo 3.** Photo taken from the access road. See the comment in photo 1.

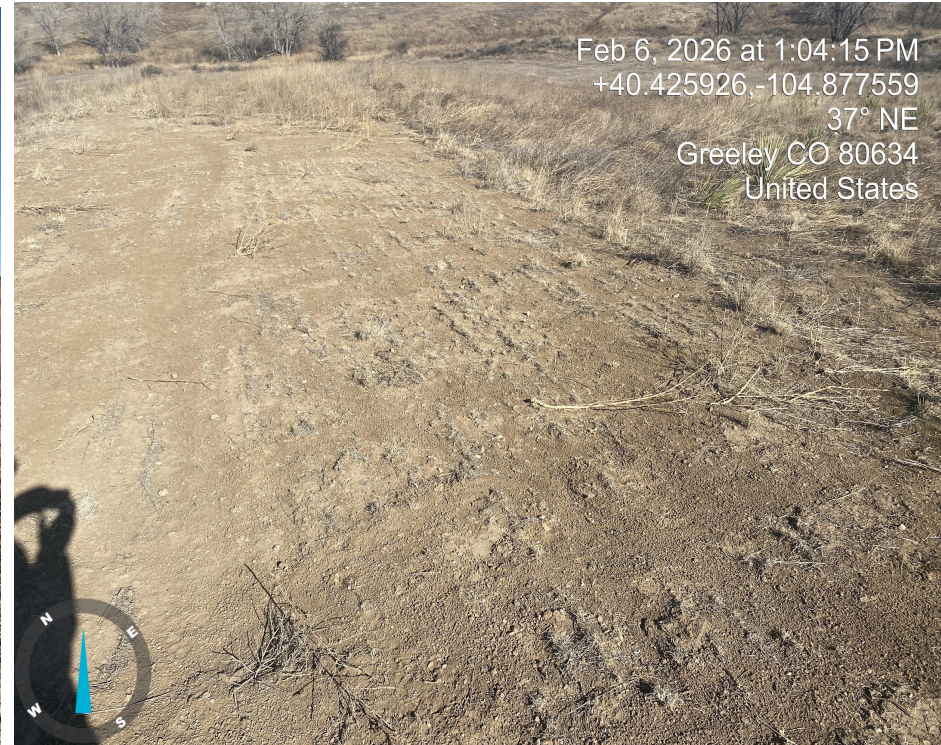
**Photo 4.** Photo taken from the access road showing minimal evidence of drill seeding rows and predominantly bare soil.

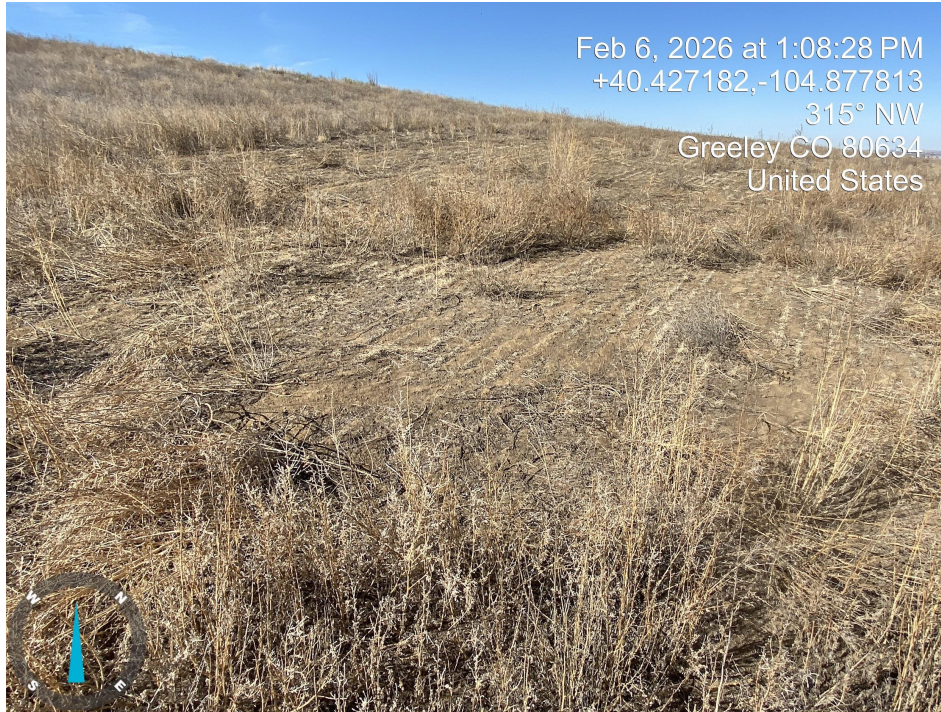
**Photo 5.** Photo taken from the southern end of the location, facing northwest. Weeds are present on the location and in the bar areas. Reclamation was started, as evidenced by the drill seeing rows; however, it does not seem to be progressing.

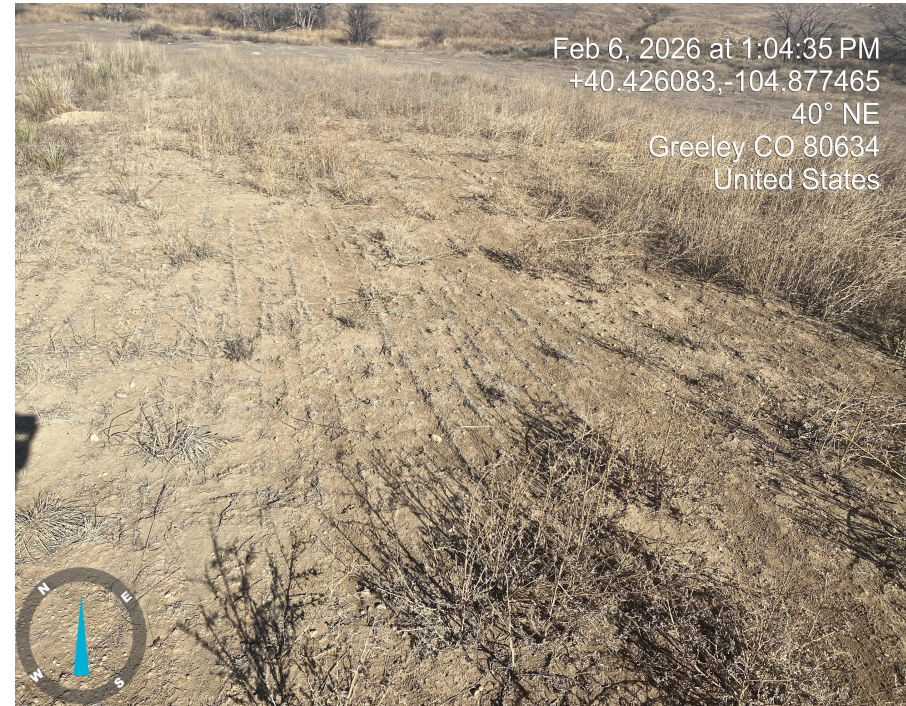
**Photo 6.** Photo taken from location facing north east. See comment in photo 5.

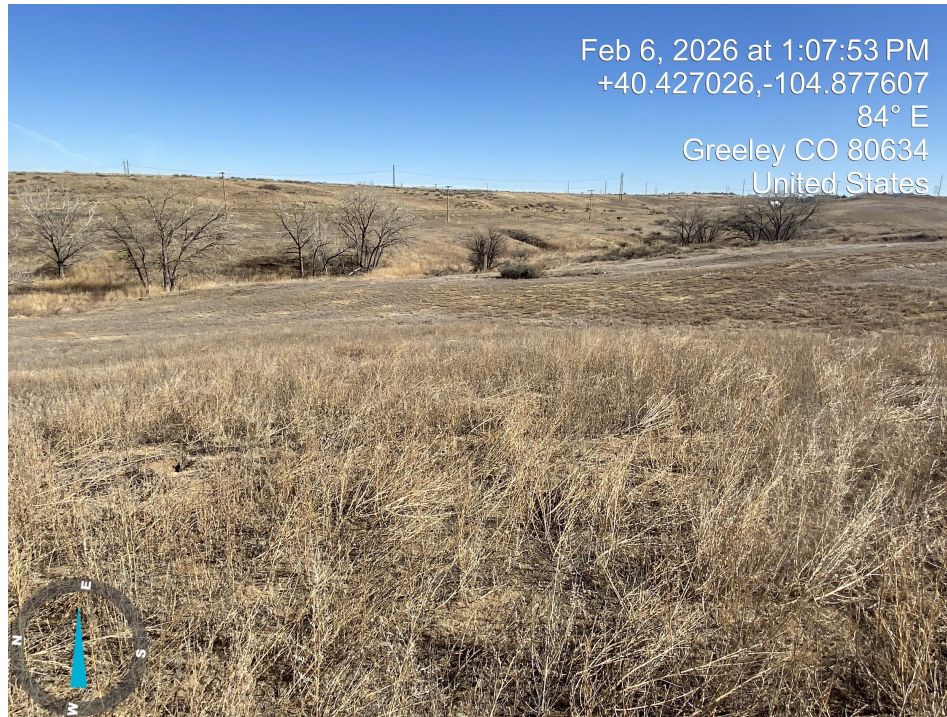
**Photo 7.** Photo taken from southwestern edge of location facing east. Well pad has undesirable annual vegetation present throughout the location.

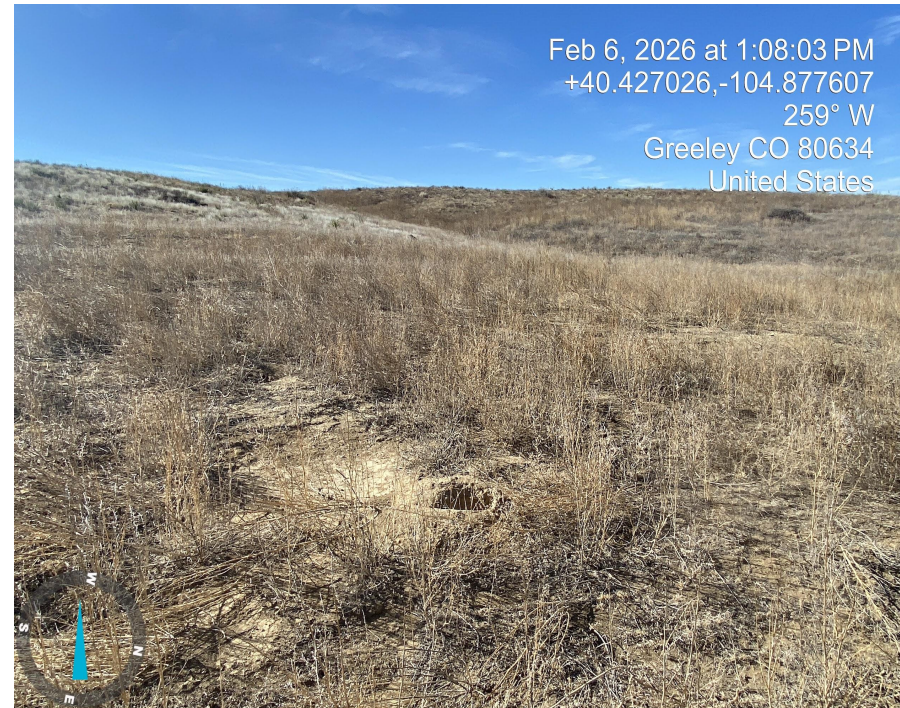
**Photo 8.** Photo taken from the southeast side of the well pad facing west, showing undesirable annual vegetation growing on the location.

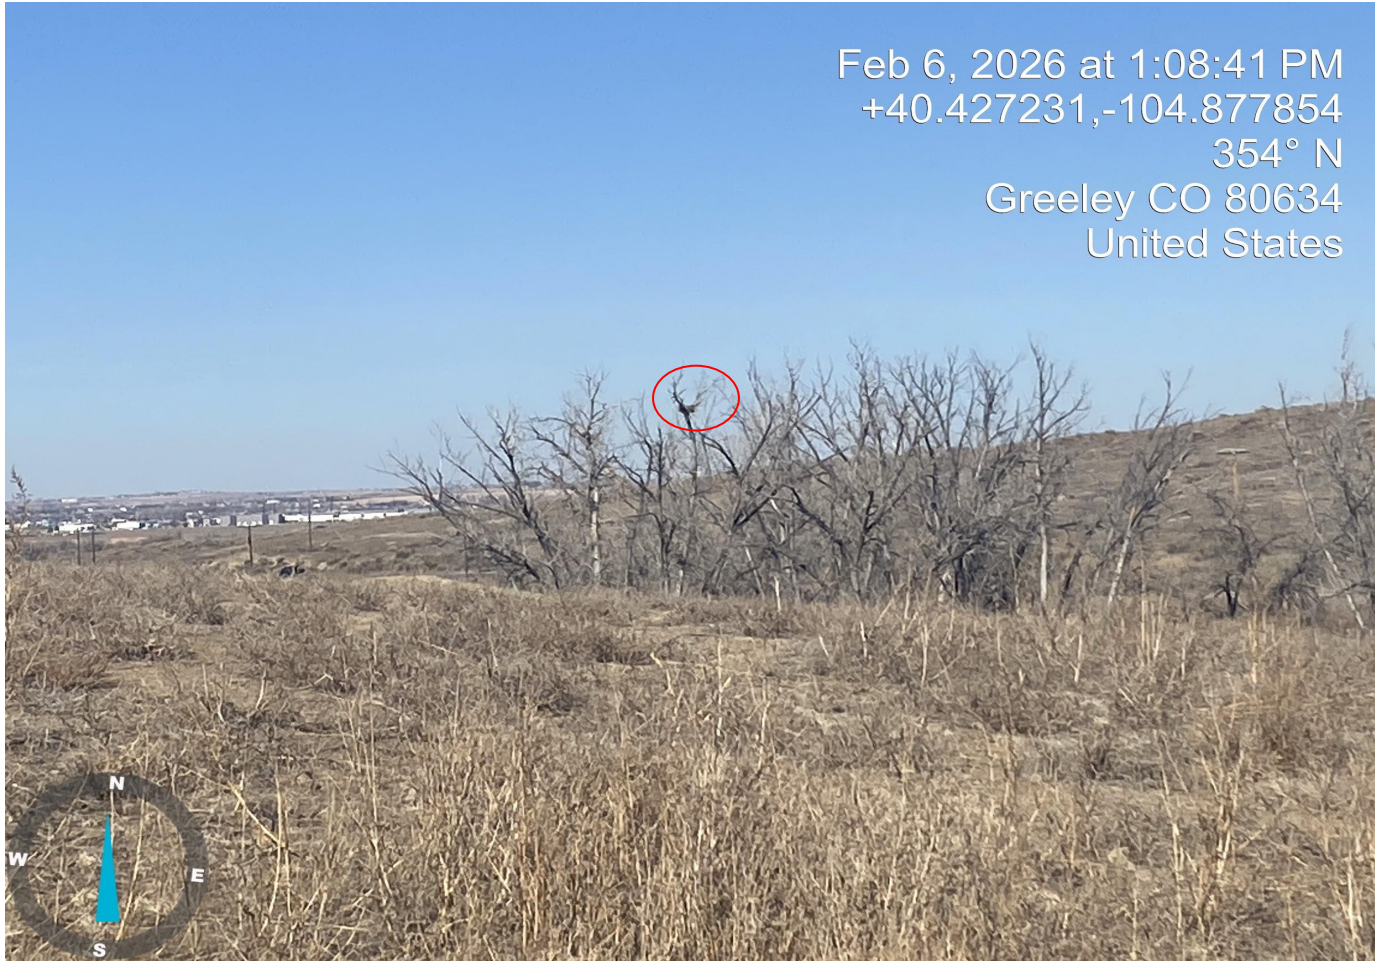
**Photo 9.** Photo taken from north eastern side of well pad. Redtail hawk observed at nest outlined in red circle. Nest is less than 400 feet the northeast of the well pad.
