Inspection Photos

Operator: TEP Rocky Mountain LLC #96850

Location ID: 414294

Inspection Doc: 719200904

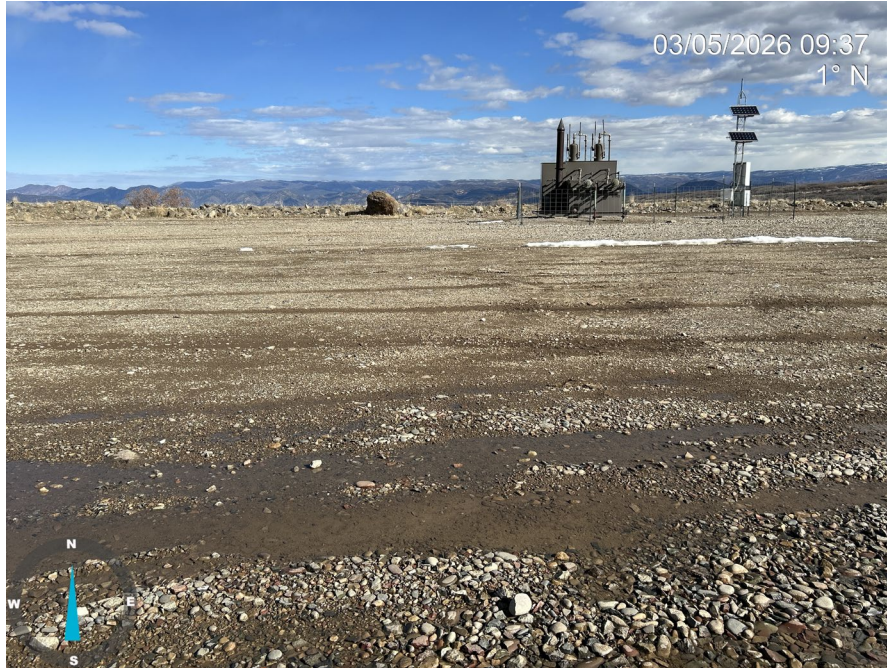
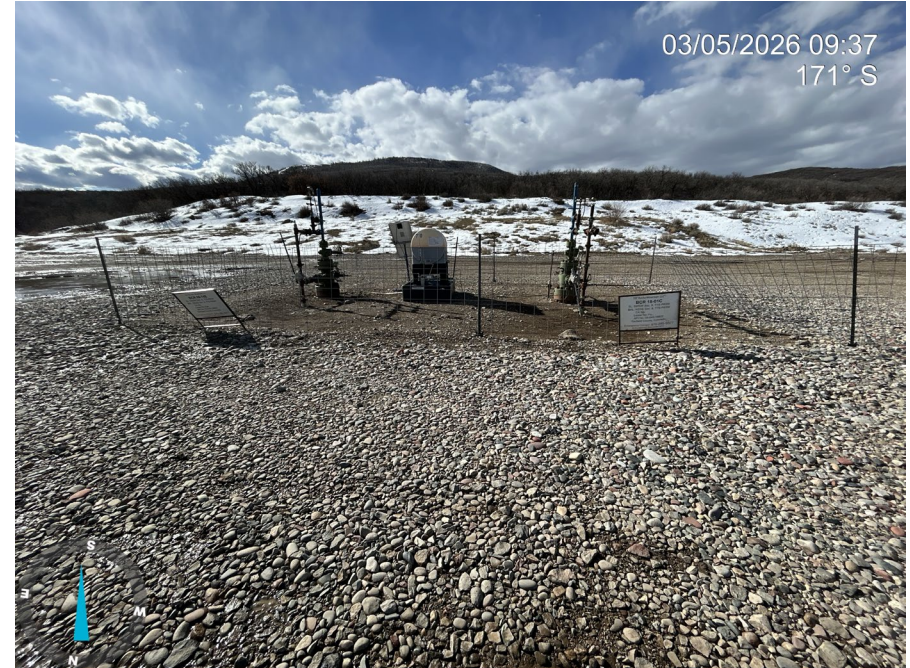
Photo 1: Photos showing an overview of the location looking north and south, respectively.

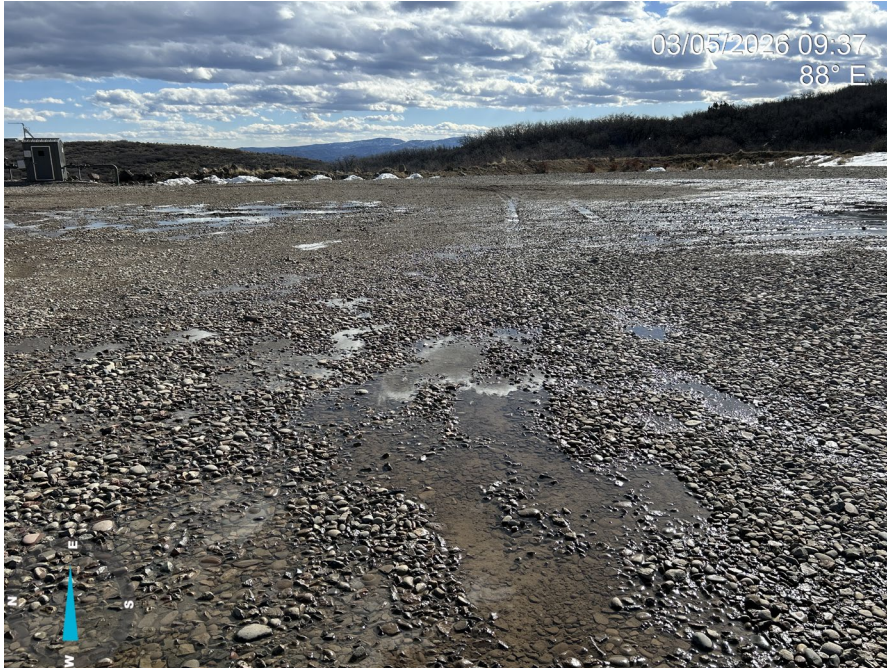
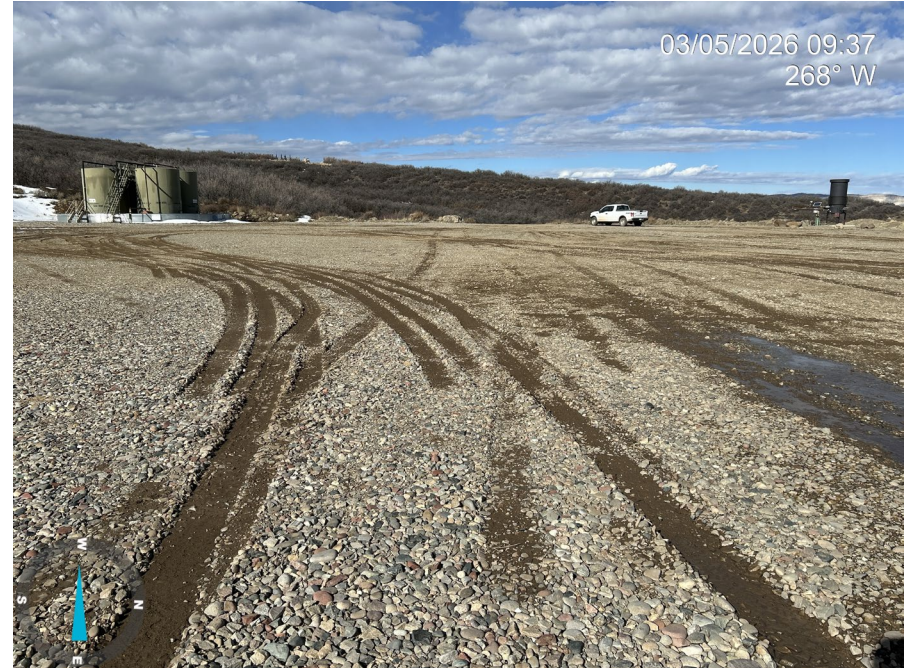
Photo 2: Photos showing an overview of the location looking east and west, respectively.

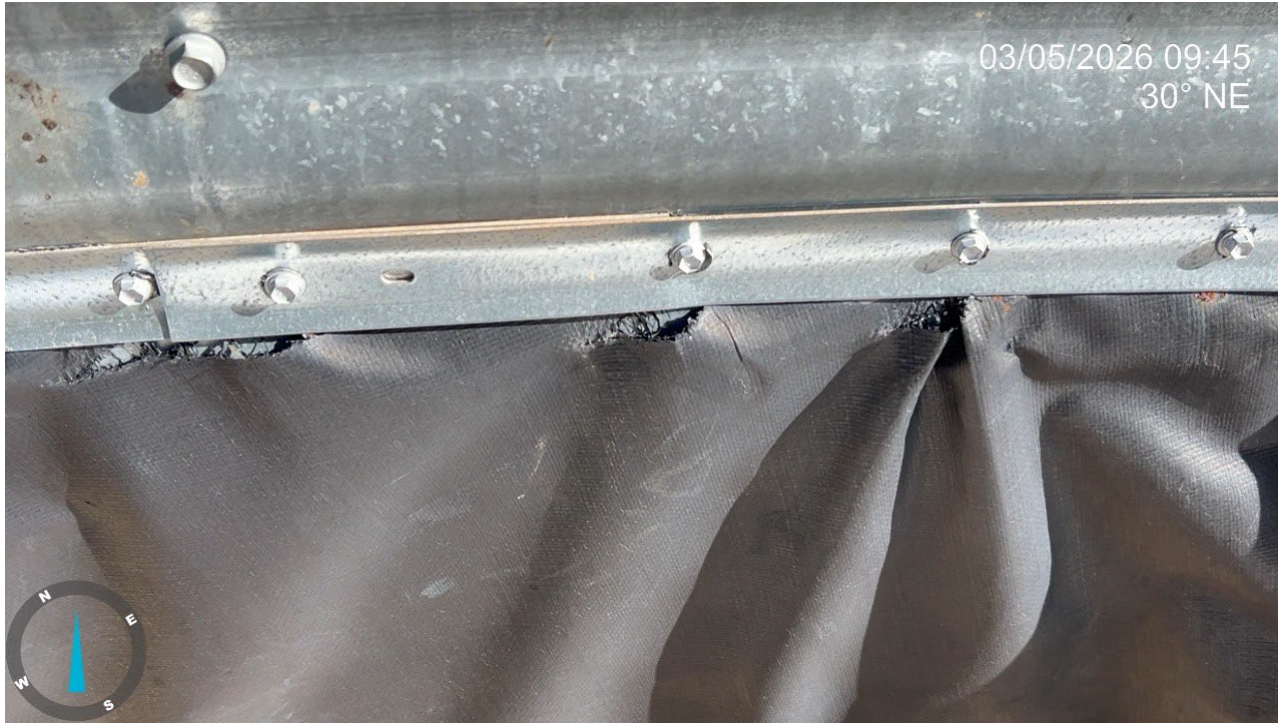
Photo 3: Photo showing an example of rips and tears in tanks' secondary containment black geotextile liner; comply with Rule 603.o.

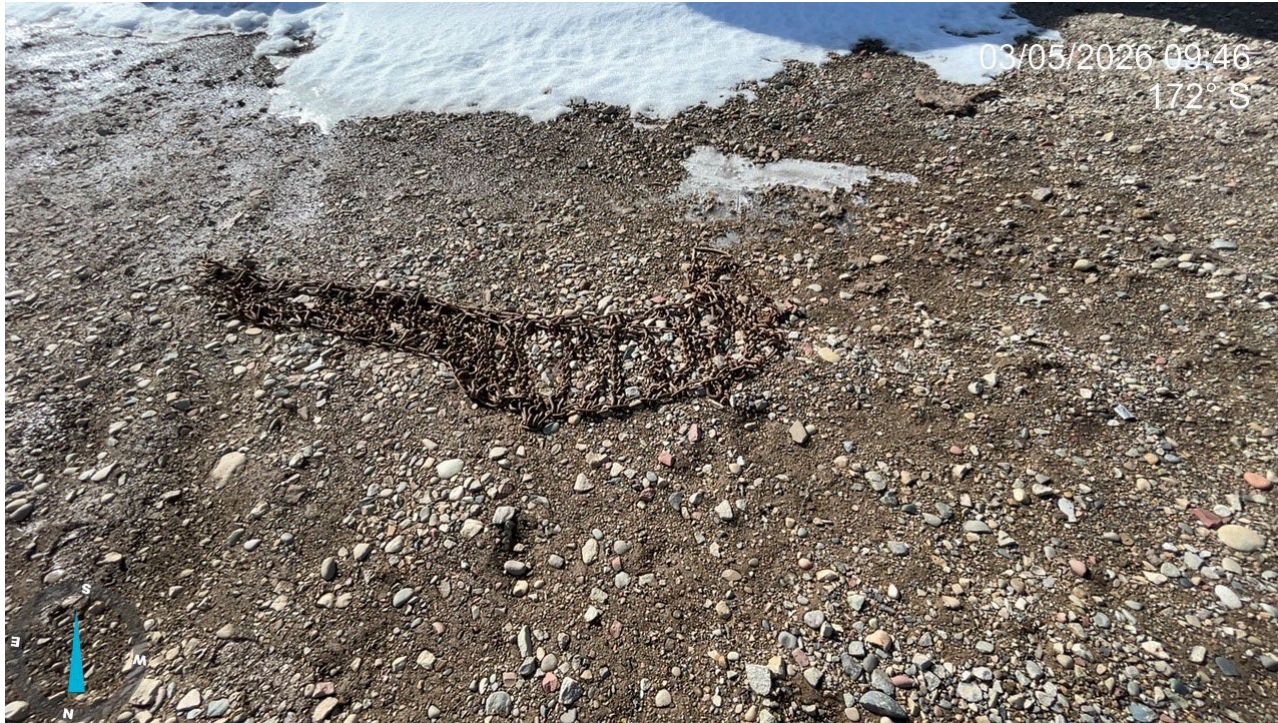
Photo 4: Photo showing tire chains present near the tanks' secondary containment system. Removal is required; comply with Rule 606.a.

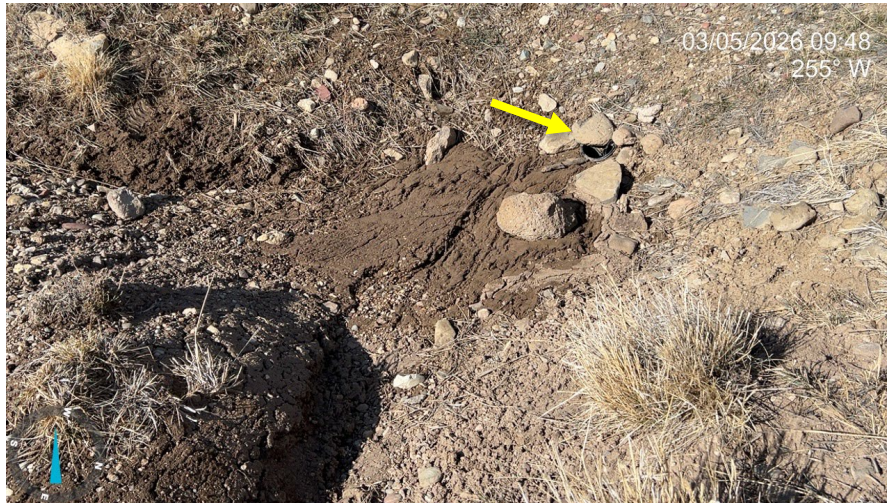
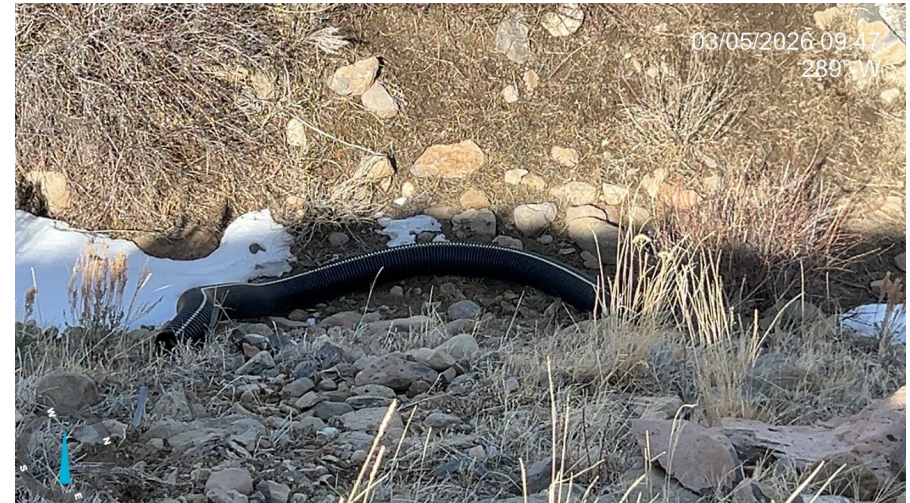
Photo 5: Photos showing a culvert on the northwestern portion of the site is laden with sediment and partially crushed by a rock; the black drainage pipe appears to be disconnected on the outlet side. Maintenance is required; comply with Rule 1002.f.

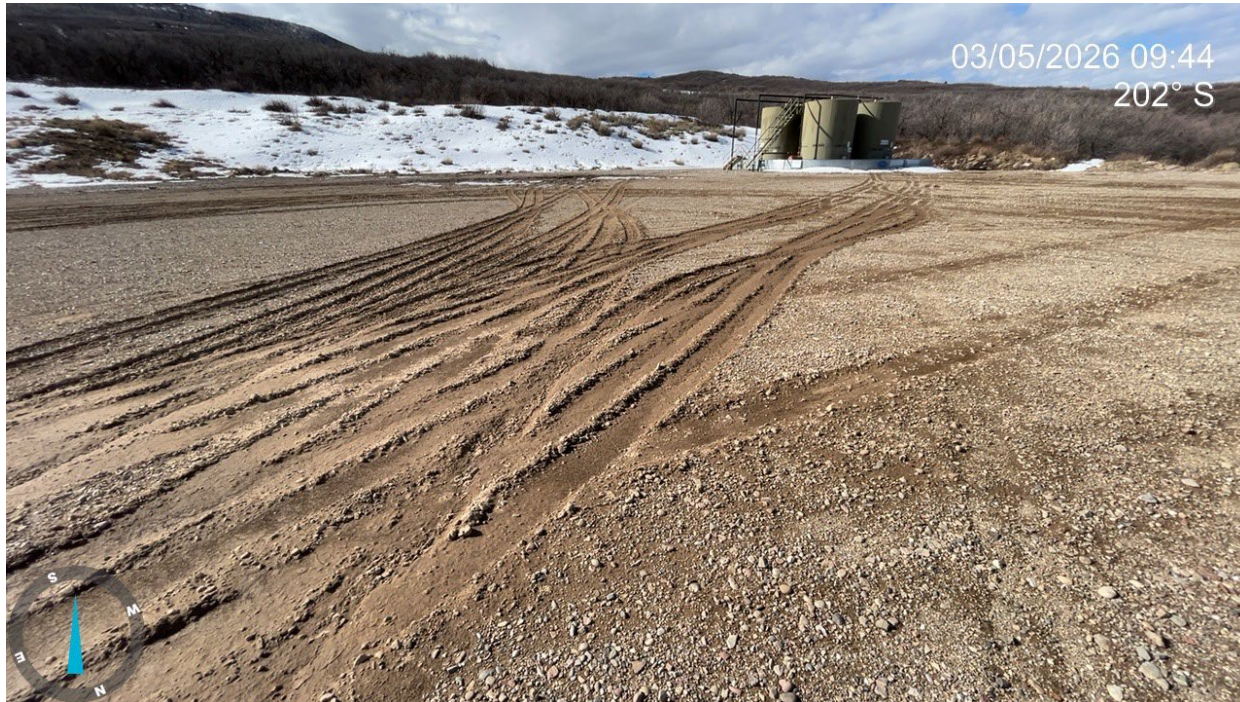
Photo 6: Photos showing an example of vehicle tracking that is occurring on the working pad surface; maintenance is required. Comply with Rule 1002.f.

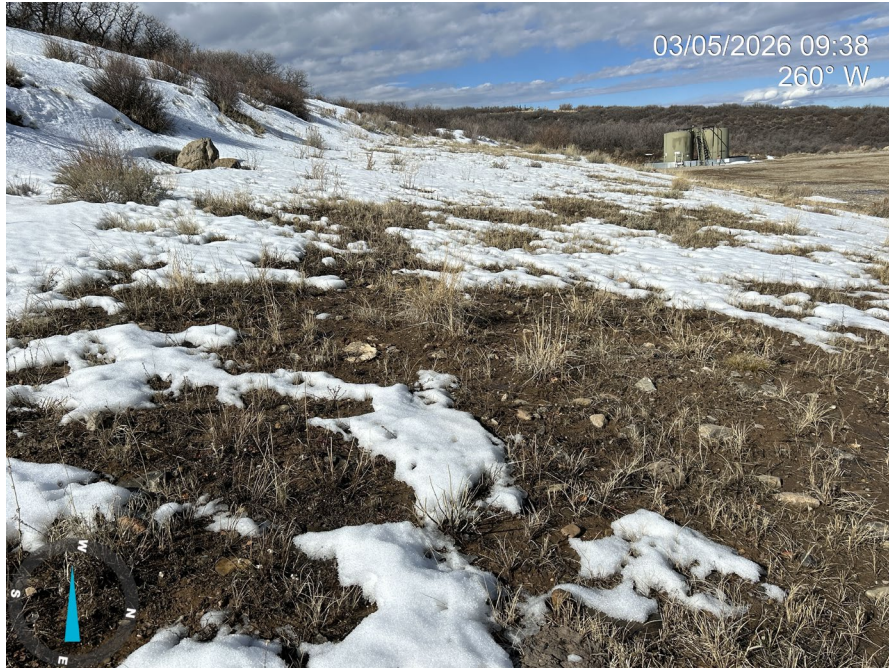
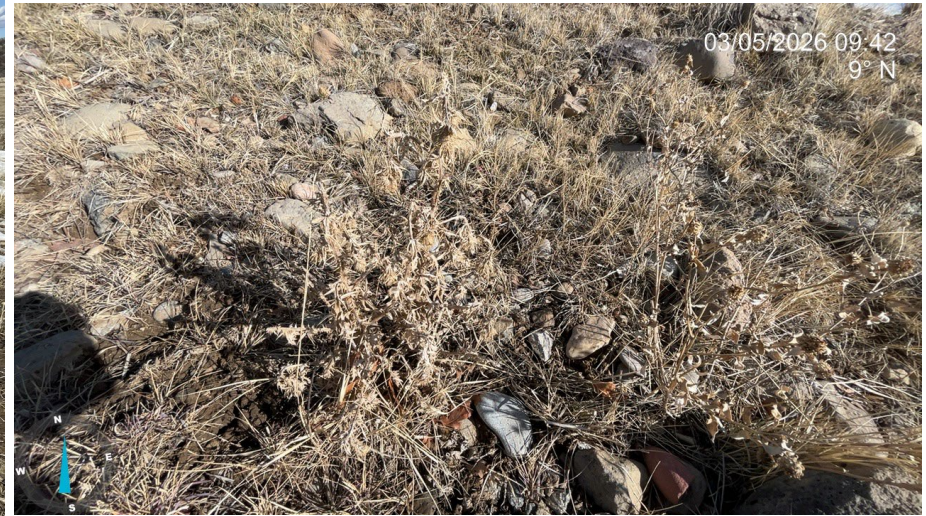
Photo 7: Photos showing an example of the southern interim area and a thistle skeleton; perennial grasses and shrubs are present, interim areas are progressing towards 1003 requirements. Ongoing weed management is necessary.
