# Final Reclamation Inspection

Operator: HIGHPOINT OPERATING CORPORATION – 10071

Location ID: 476919

Inspection Photos  
Location Name: NHF-Laura/4-63-3 SWNW  
Location ID: 476919

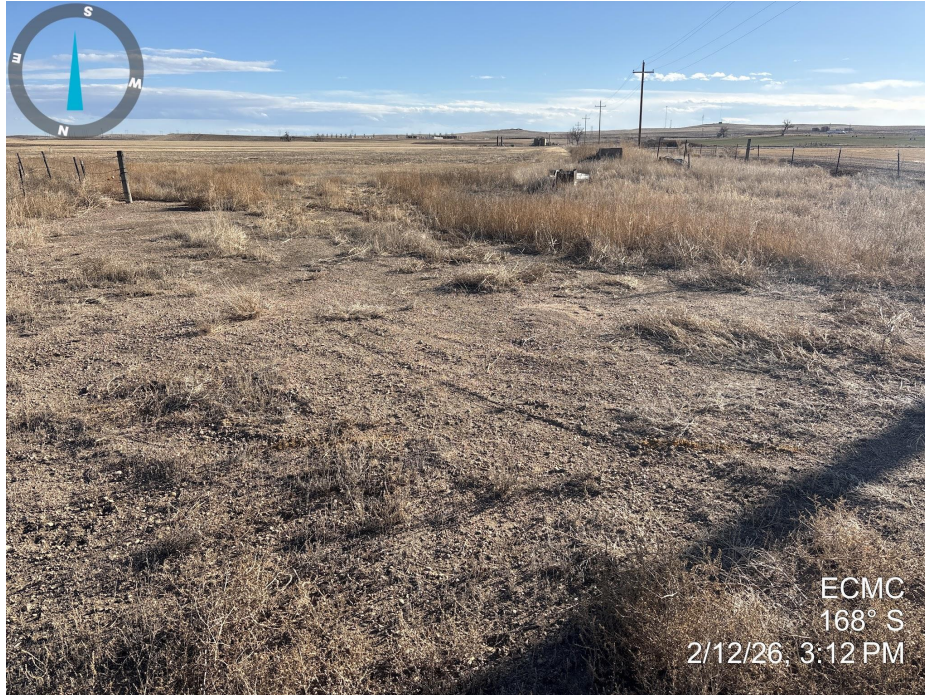
**Photo 1.** Photo taken of the tank battery location, facing north. Photo illustrates that final reclamation does not meet Rule 1004 standards at the location as gravel, bare ground, and weedy annual vegetation were observed across the northern portion of the location.

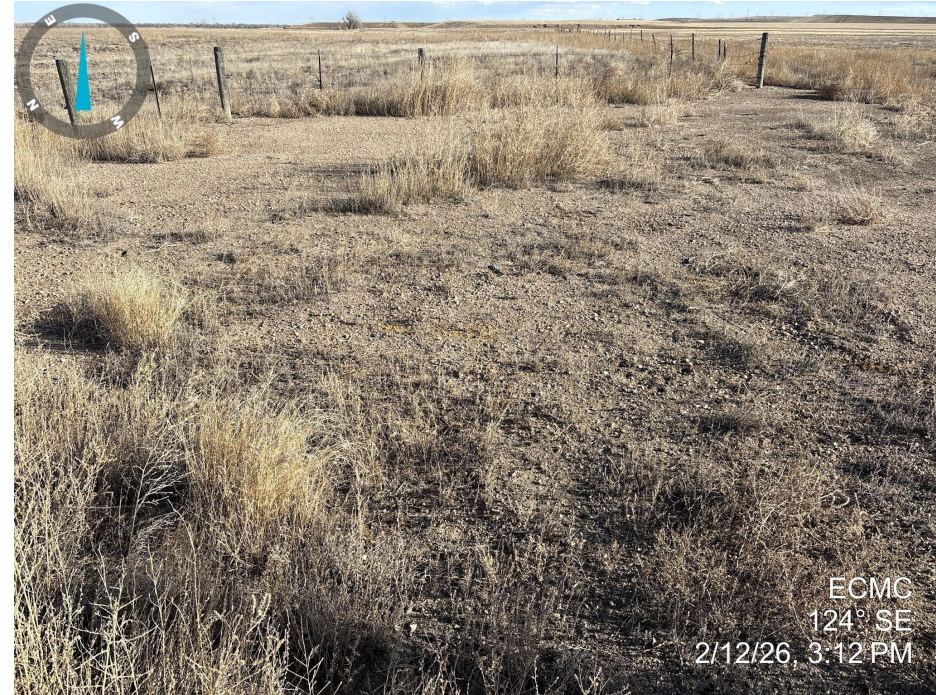
**Photo 2.** Photo taken of the tank battery location, facing southeast. See comments under Photo 1.

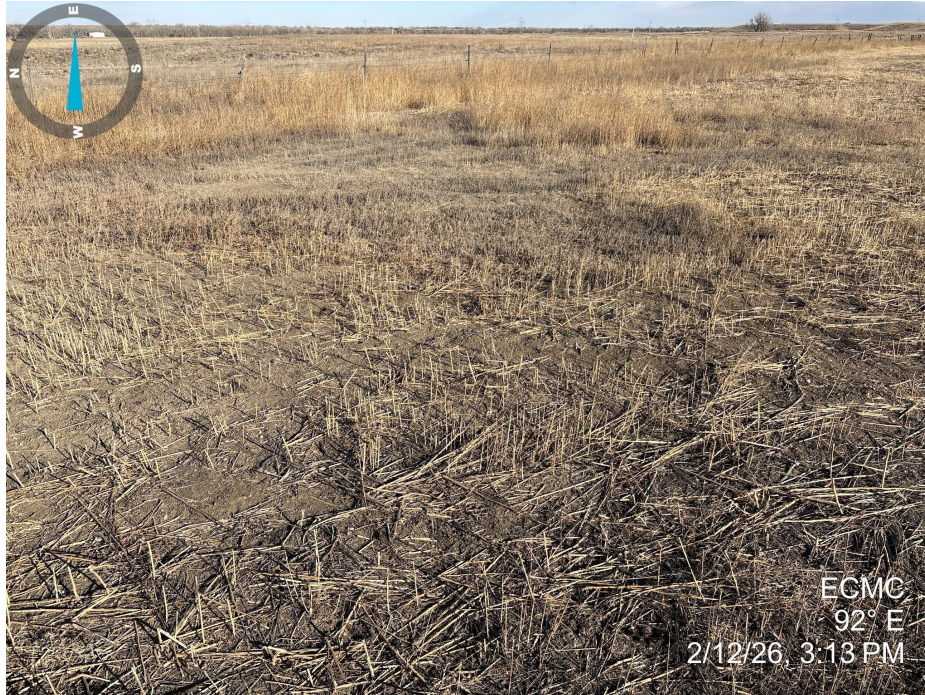
**Photo 3.** Photo taken of the tank battery location, facing east. See comments under Photo 1.

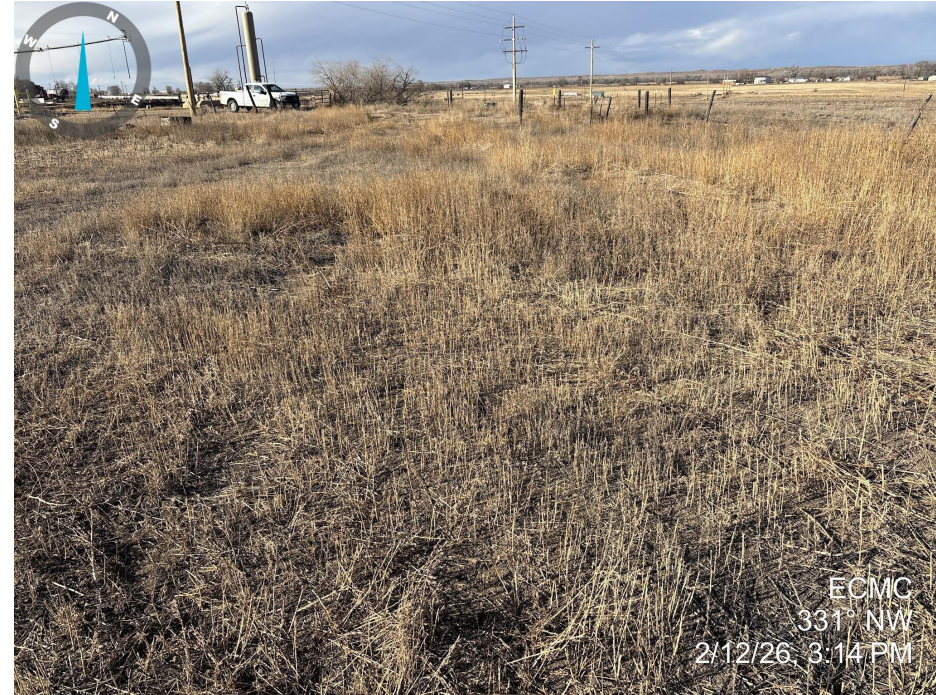
**Photo 4.** Photo taken of the tank battery location, facing northwest. See comments under Photo 1.

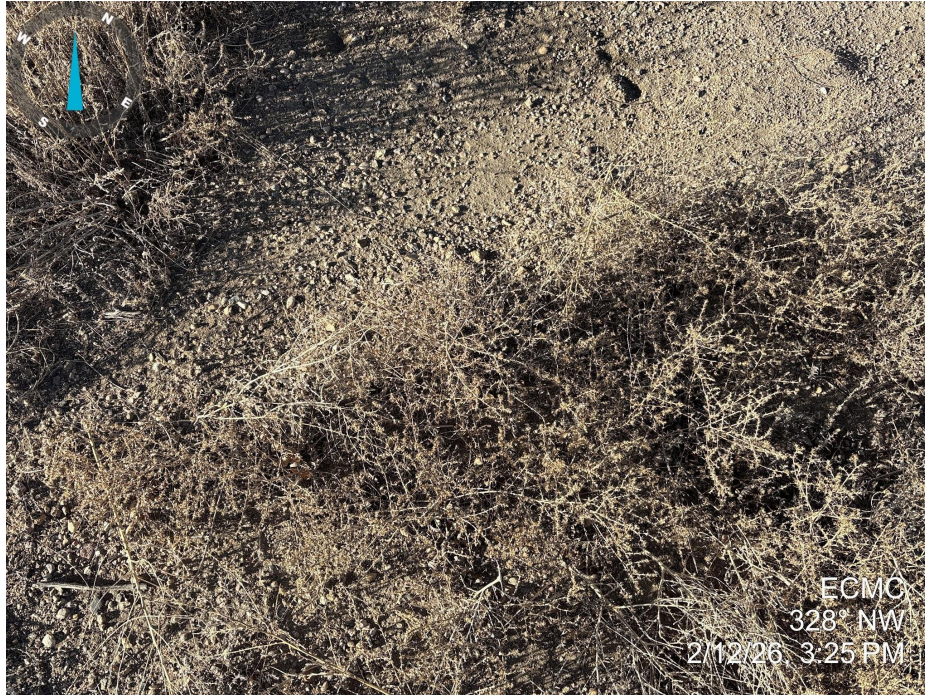
**Photo 5.** Photo taken of ground cover at the tank battery location. Photo illustrates gravel and weedy annual vegetation including kochia (*Bassia scoparia*).

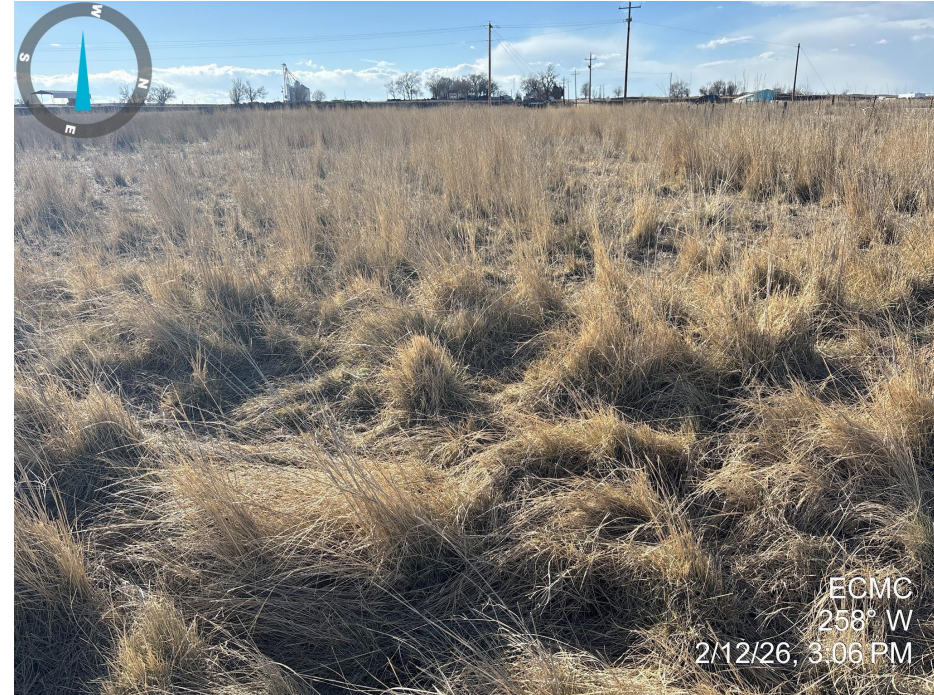
**Photo 6.** Photo taken of the reference area to the location, west of the location, facing west. Photo illustrates perennial grass vegetation.
