# Final Reclamation Inspection

Operator: HIGHPOINT OPERATING CORPORATION – 10071

Location ID: 306087

Inspection Document #: 718801373

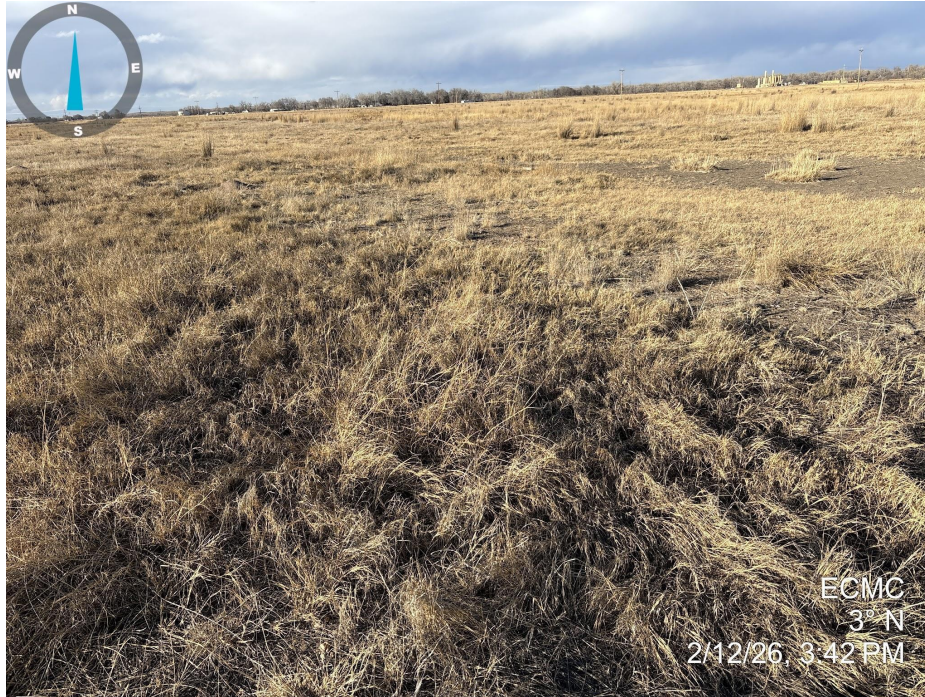
**Photo 1.** Photo taken of the well location, facing north. Photo illustrates that final reclamation activities appear to have taken place at the location, and vegetation establishment at the well location meets Rule 1004 standards.

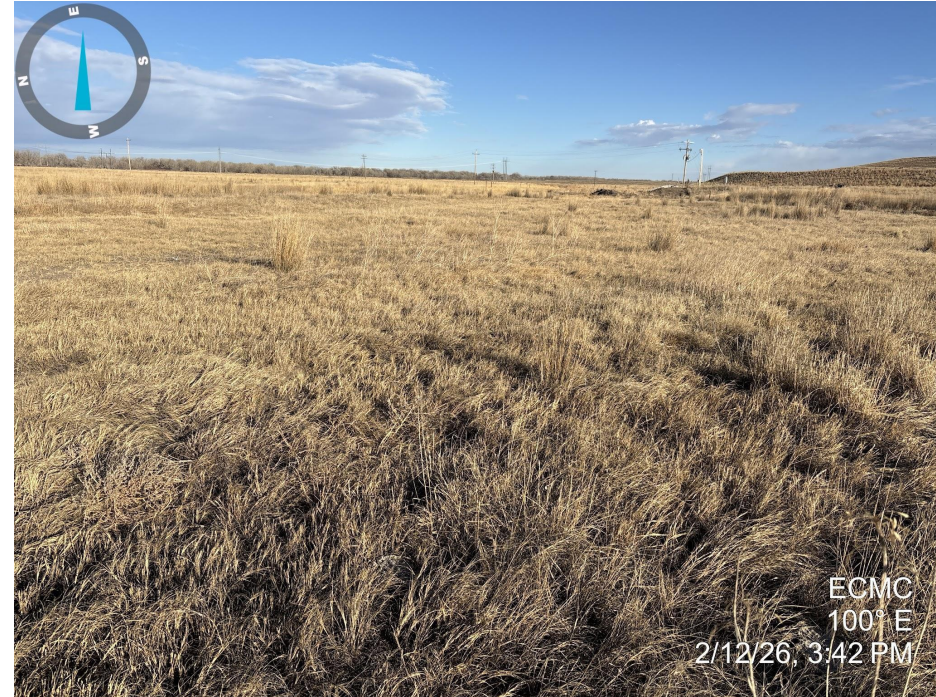
**Photo 2.** Photo taken of the well location, facing east. See comments under Photo 1.

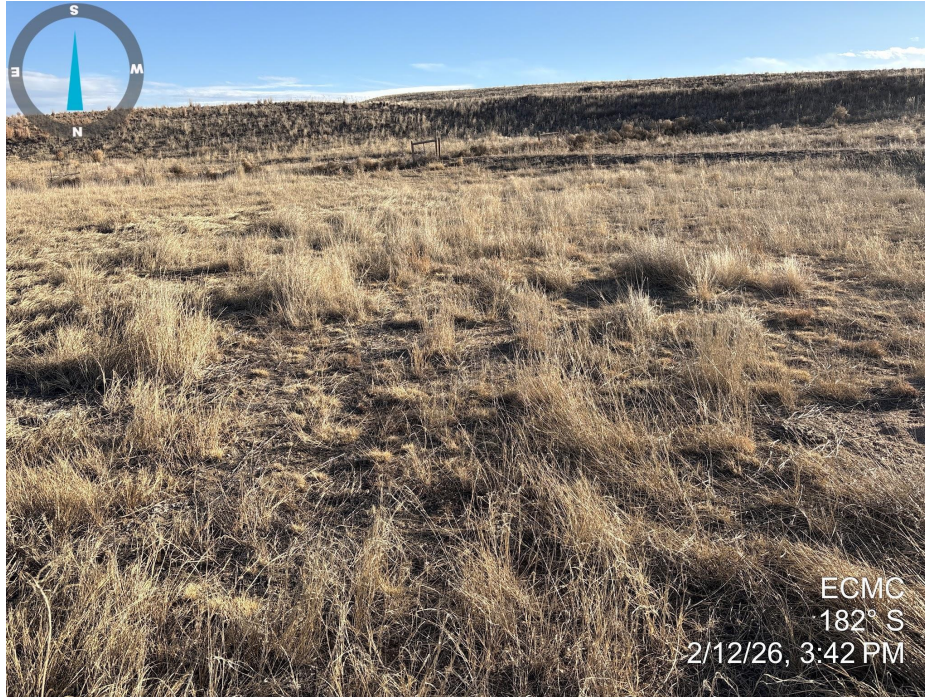
**Photo 3.** Photo taken of the well location, facing south. See comments under Photo 1.

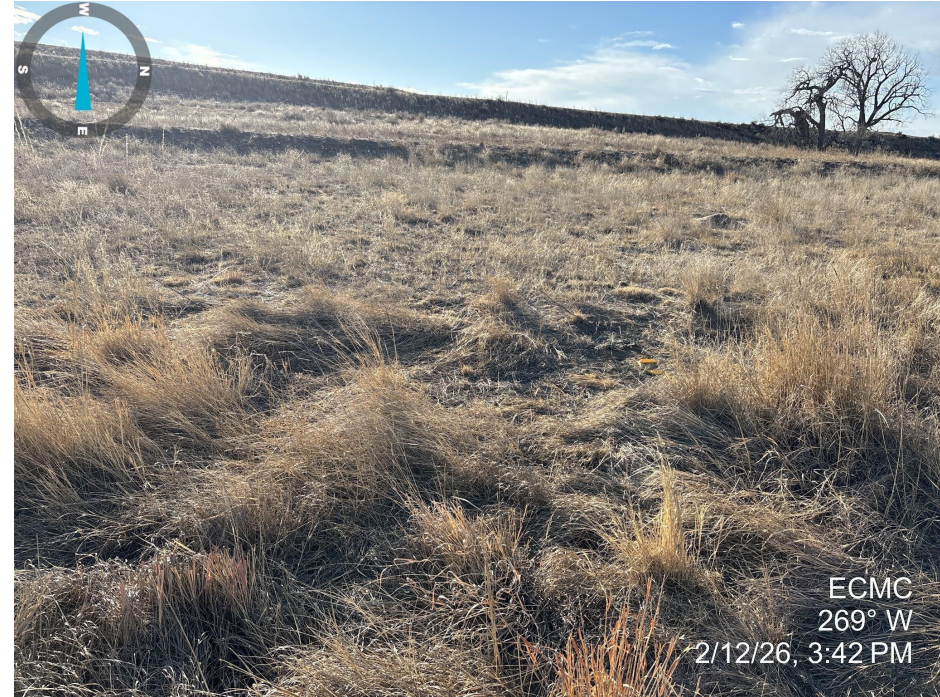
**Photo 4.** Photo taken of the well location, facing west. See comments under Photo 1.

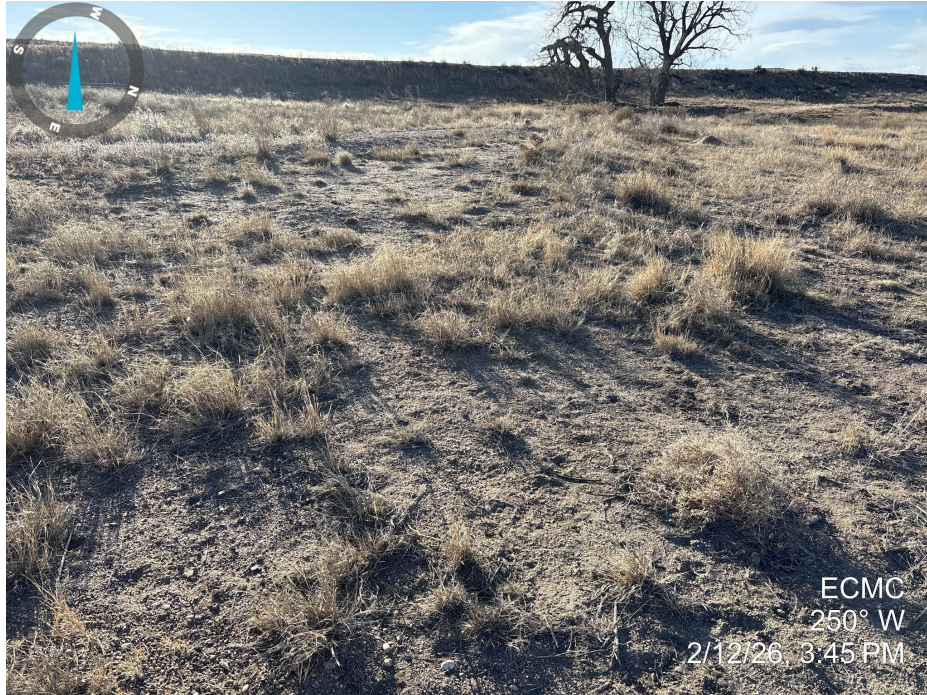
**Photo 5.** Photo taken of the access road to the location, facing west. Photo illustrates that final reclamation does not meet Rule 1004 standards along the access road as gravel and bare ground were observed across this portion of the location.

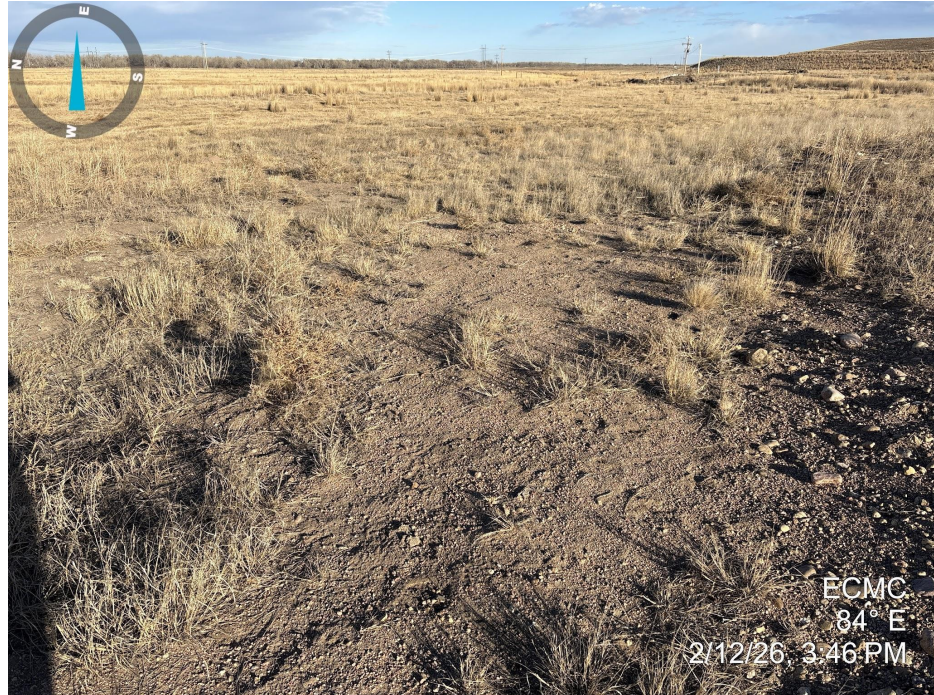
**Photo 6.** Photo taken of the access road to the location, facing east. See comments under Photo 5.

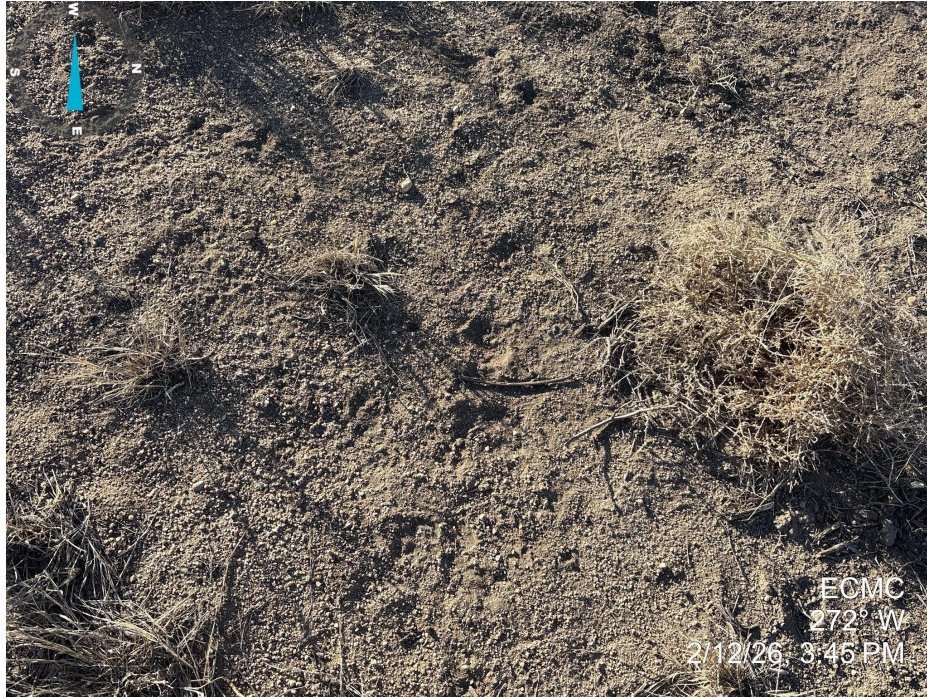
**Photo 7.** Photo taken of ground cover at the access road to the location. Photo illustrates gravel, weedy annual vegetation including kochia (*Bassia scoparia*), perennial grass, and bare ground.

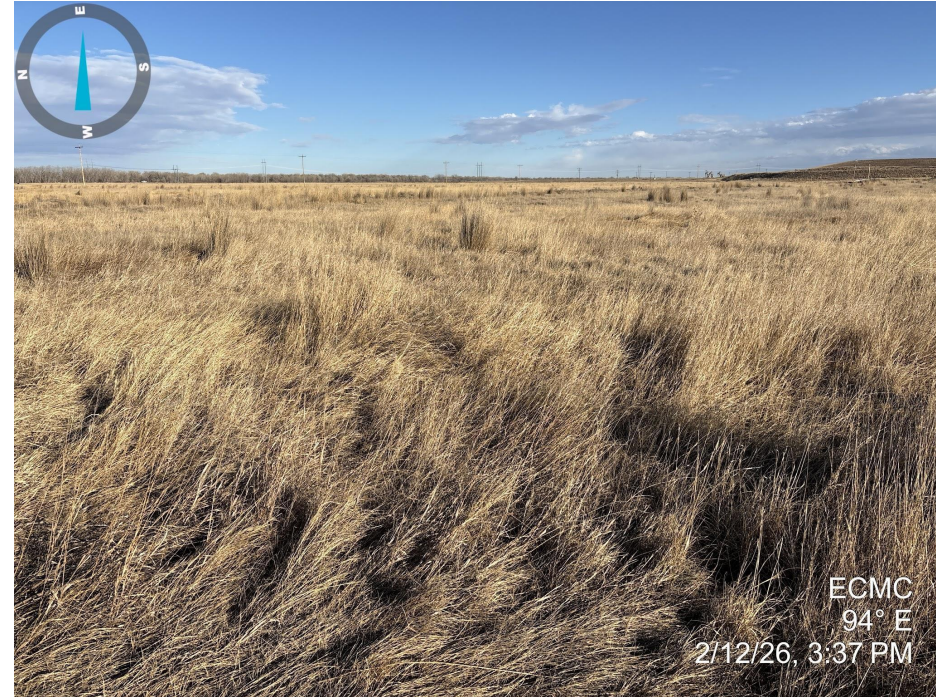
**Photo 8.** Photo taken of the reference area to the location, north of the location, facing east. Photo illustrates perennial grass vegetation.
