Final Reclamation Inspection

Operator: BONANZA CREEK ENERGY OPERATING COMPANY
LLC - 8960

Location ID: 421634

Inspection Photos
Location Name: Park #S-4
Location ID: 421634

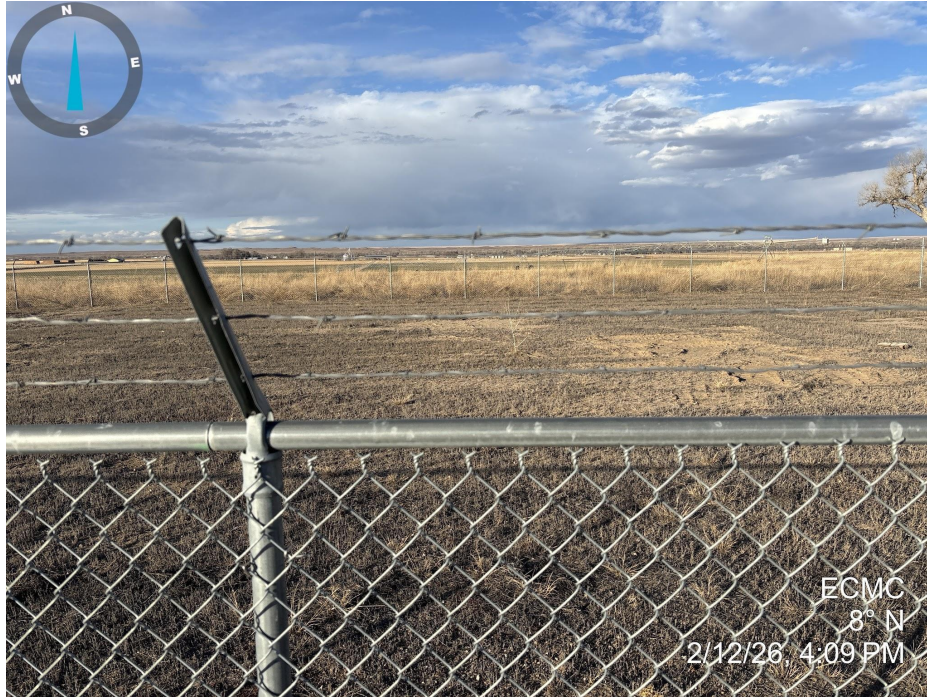
Photo 1. Photo taken of the multi-well location, facing north. Photo illustrates that final reclamation activities do not appear to have taken place and vegetation establishment does not meet Rule 1004 standards as bare ground and weedy annual vegetation were observed across the location. There is a fence in place around the multi-well location.

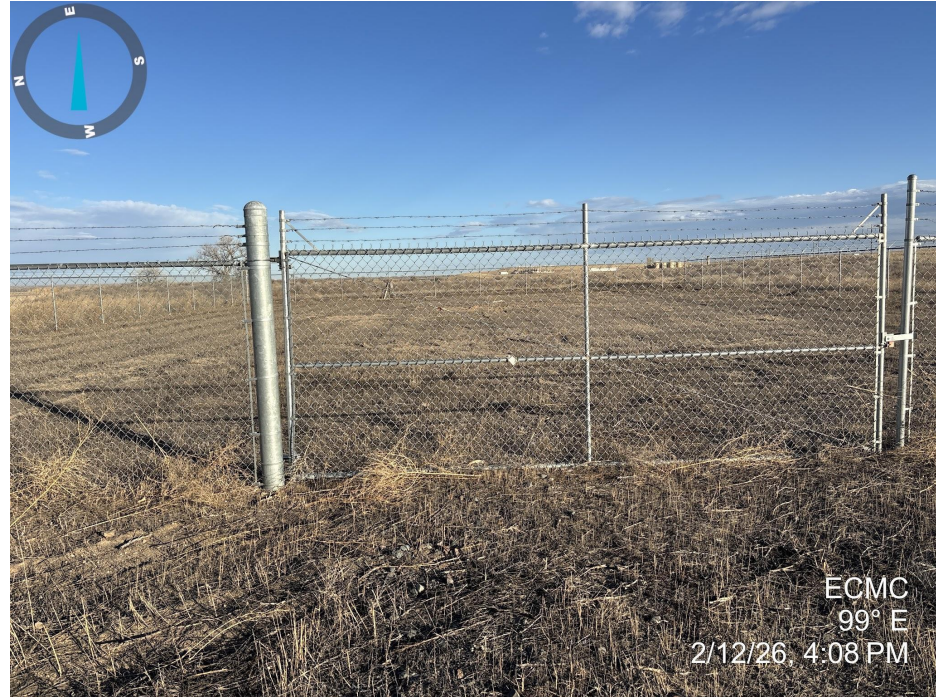
Photo 2. Photo taken of the multi-well location, facing east. See comments under Photo 1.

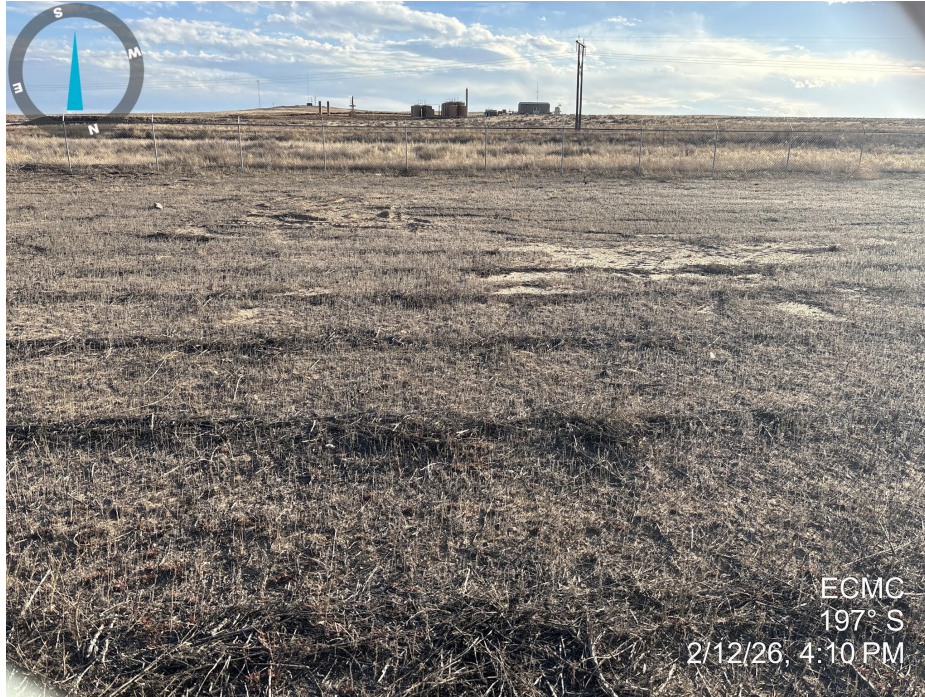
Photo 3. Photo taken of the multi-well location, facing south.
See comments under Photo 1.

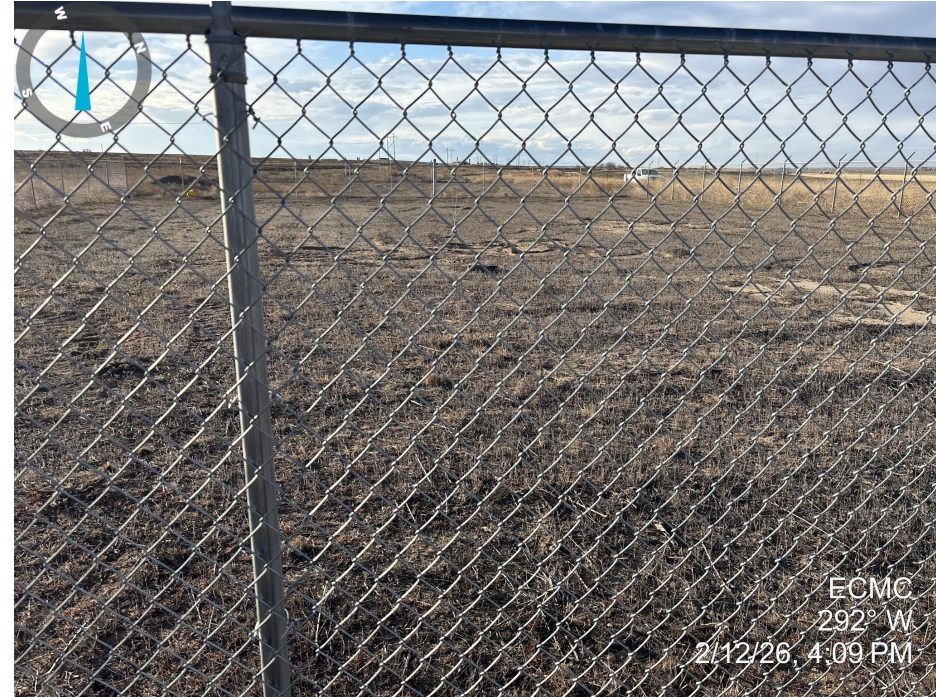
Photo 4. Photo taken of the multi-well location, facing west.
See comments under Photo 1.

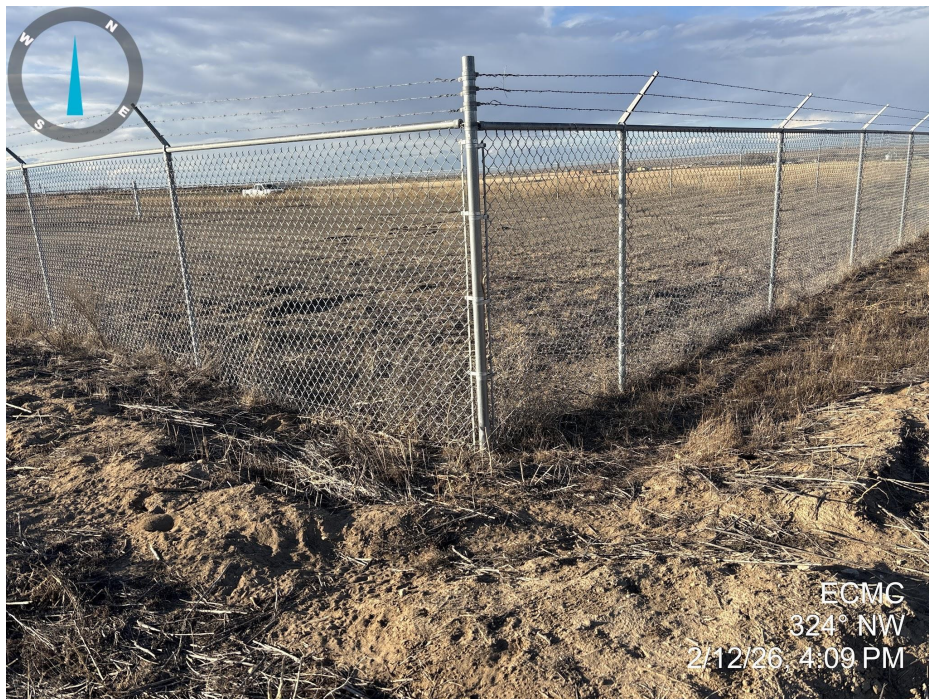
Photo 5. Photo taken of the well location, facing northwest. Photo illustrates that fencing is in place around the location.

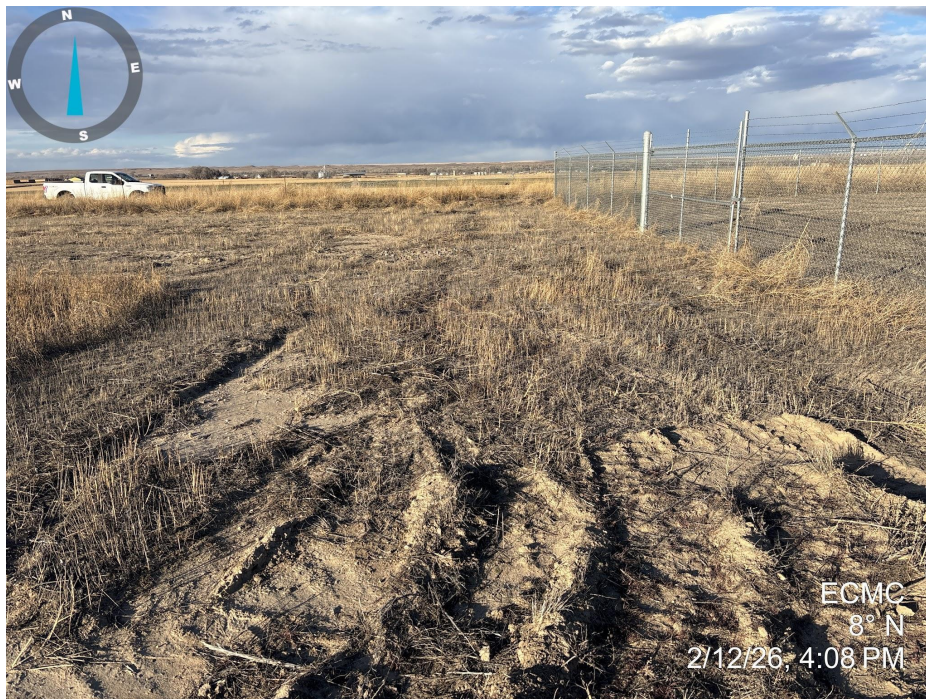
Photo 6. Photo taken of the tank battery location, facing north. Photo illustrates that final reclamation activities do not appear to have taken place at the location as gravel, bare ground, and weedy annual vegetation were observed across the location.

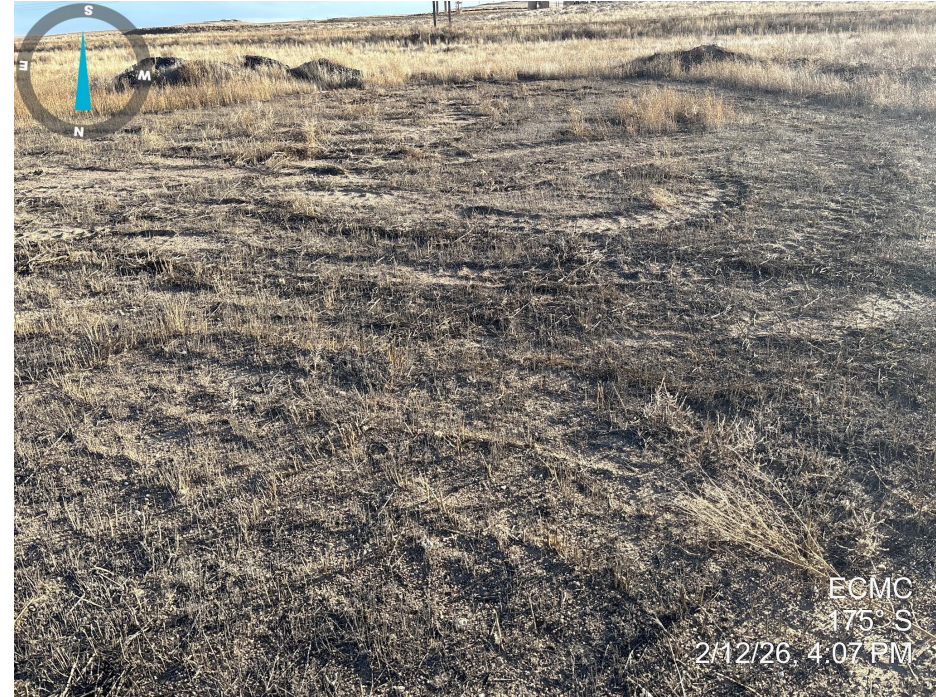
Photo 8. Photo taken of the tank battery location, facing south. See comments under Photo 5.

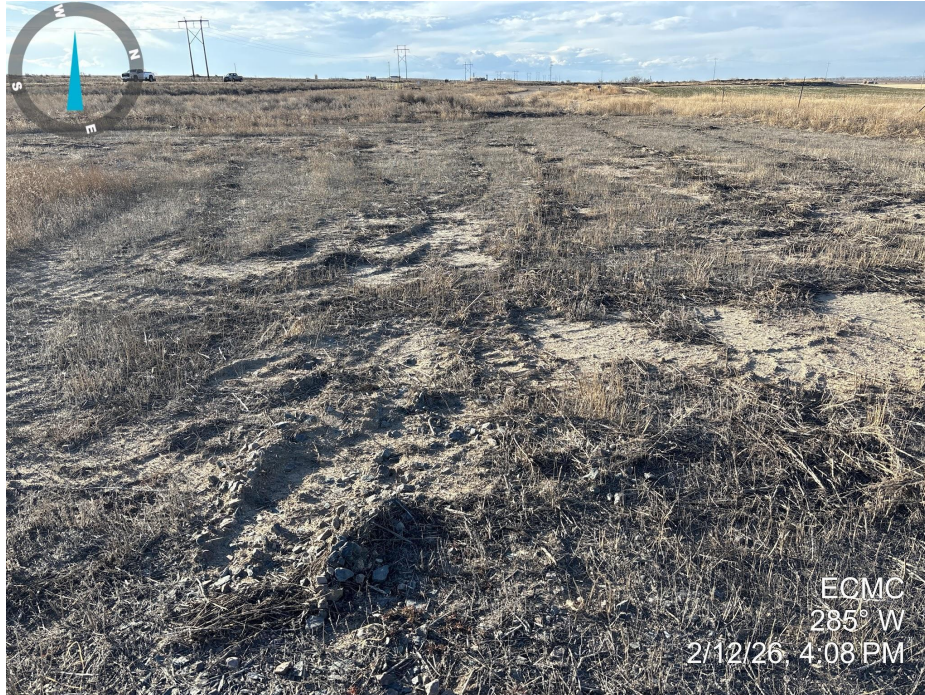
Photo 9. Photo taken of the tank battery location, facing west. See comments under Photo 5.

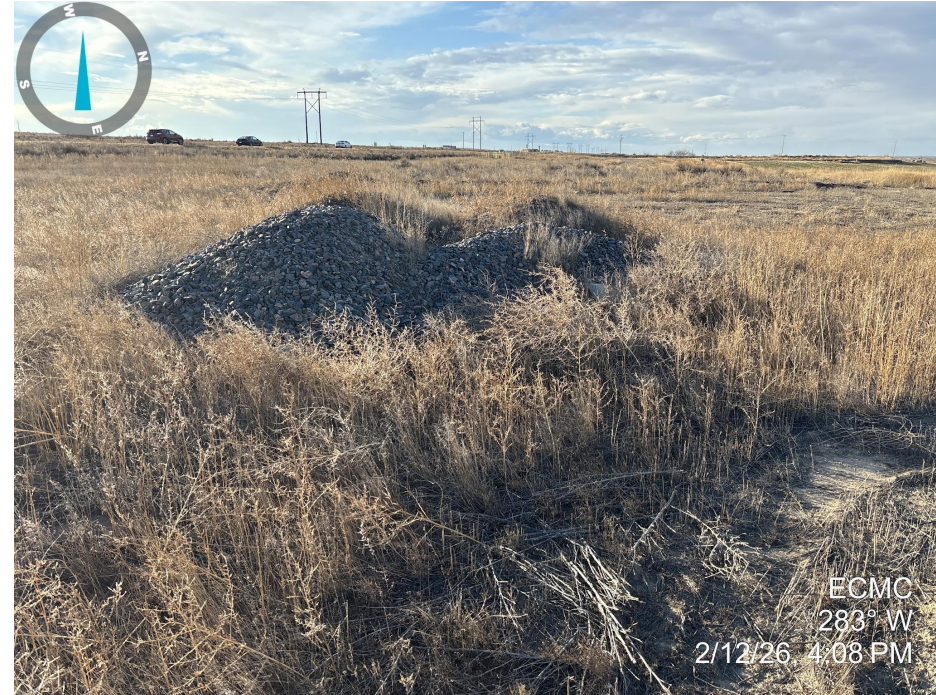
Photo 10. Photo taken of the tank battery location, facing west. Photo illustrates a pile of gravel remains on the location. Weedy annual vegetation including kochia (*Bassia scoparia*) and russian thistle (*Salsola tragus*) were observed across the location.

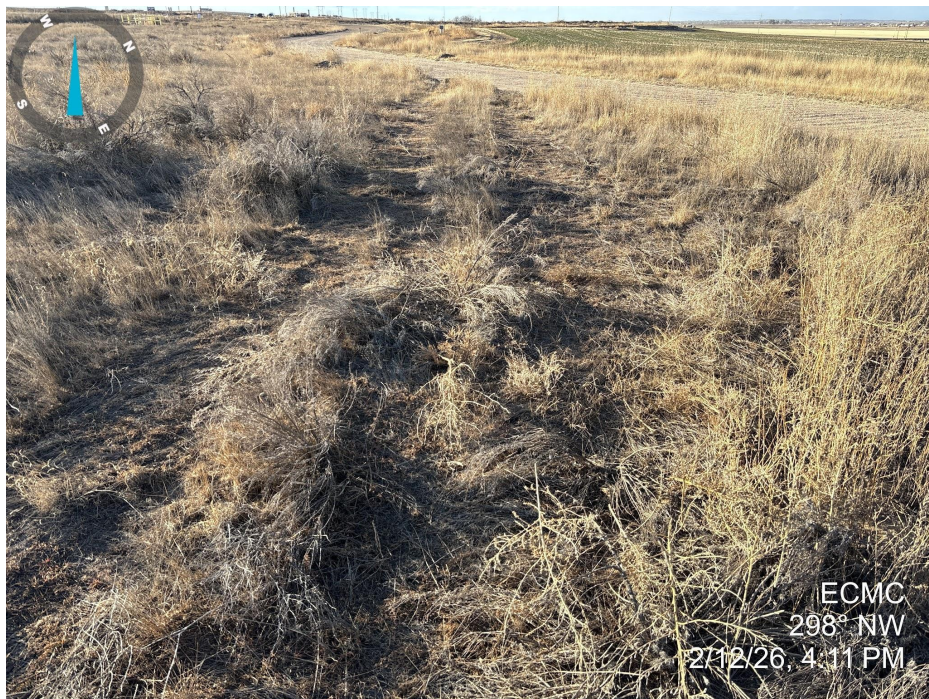
Photo 11. Photo taken of the access road to the location, facing northwest. Photo illustrates that vegetation establishment does not meet Rule 1004 standards along the access road. Weedy annual vegetation was observed along the road including kochia (*Bassia scoparia*) and russian thistle (*Salsola tragus*).

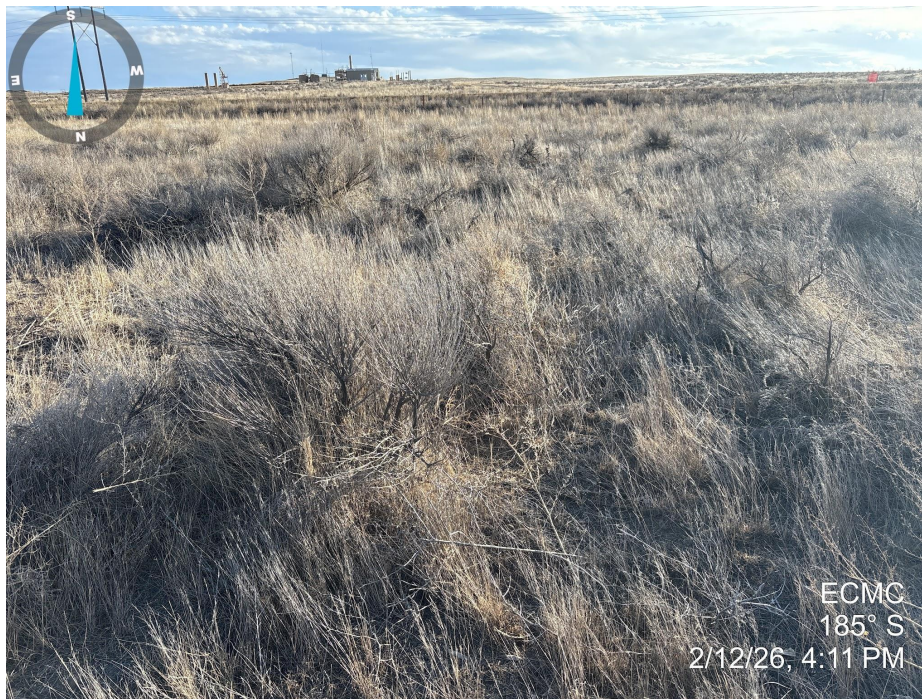
Photo 12. Photo taken of the reference area to the location, west of the location, facing south. Photo illustrates perennial grass vegetation.
