Final Reclamation Inspection

Operator: BONANZA CREEK ENERGY OPERATING COMPANY
LLC - 8960

Location ID: 305241

Inspection Photos
Location Name: PARK #44-4
Location ID: 305241

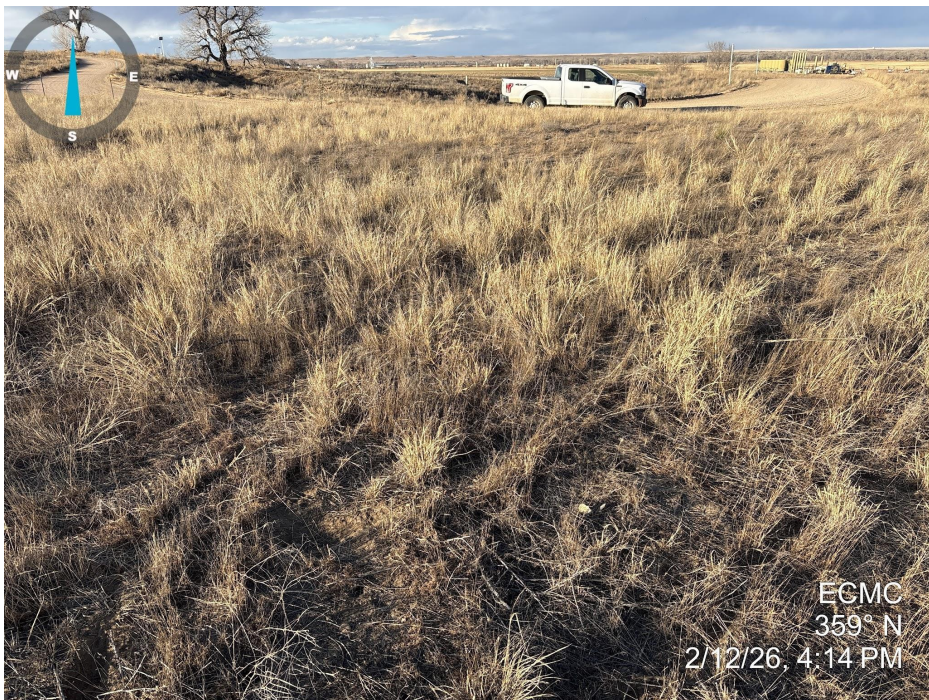
Photo 1. Photo taken of the well location, facing north. Photo illustrates that final reclamation activities appear to have taken place, but vegetation establishment does not meet Rule 1004 standards as weedy annual vegetation including cheatgrass (*Bromus tectorum*), a List C Noxious Weed species, was observed at the location.

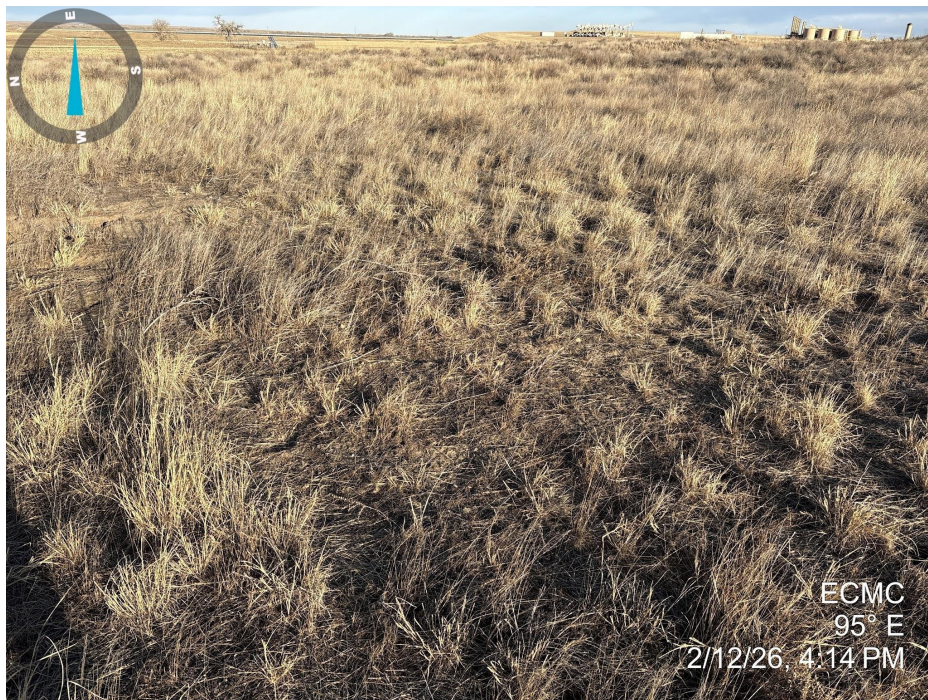
Photo 2. Photo taken of the well location, facing east. See comments under Photo 1.

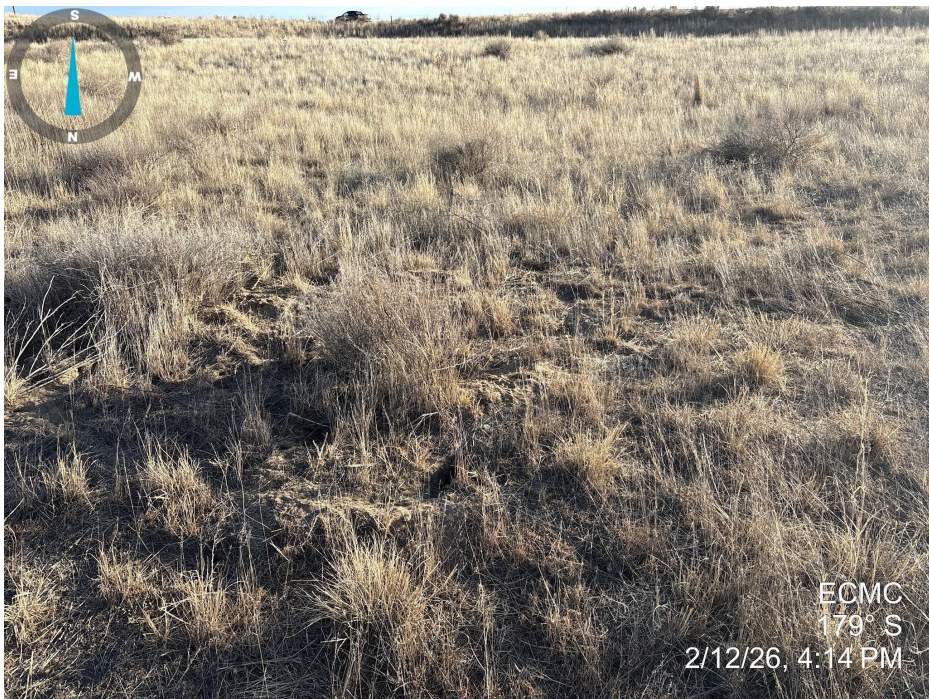
Photo 3. Photo taken of the well location, facing south. See comments under Photo 1.

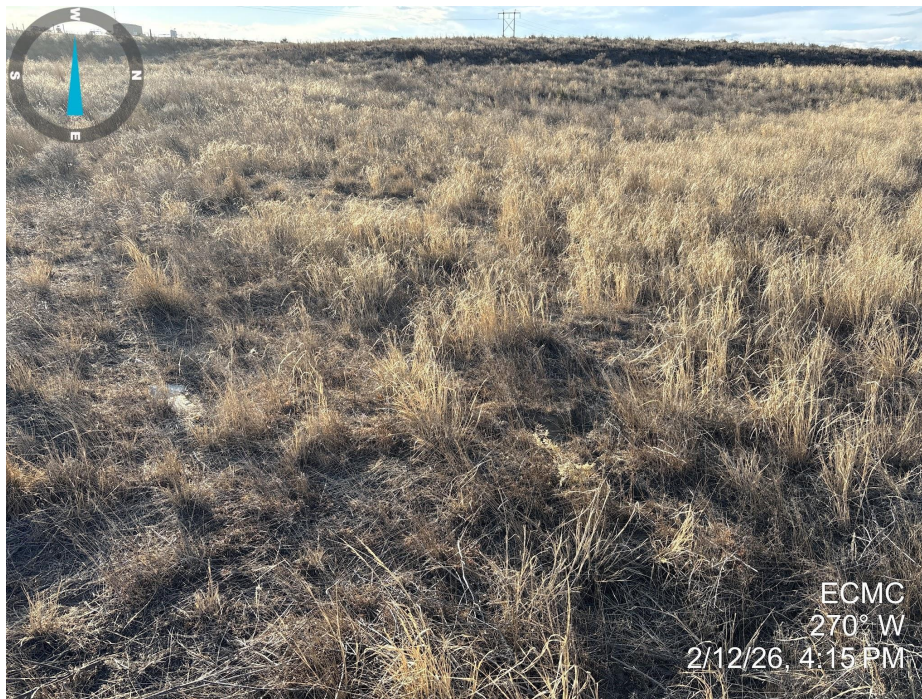
Photo 4. Photo taken of the well location, facing west. See comments under Photo 1.

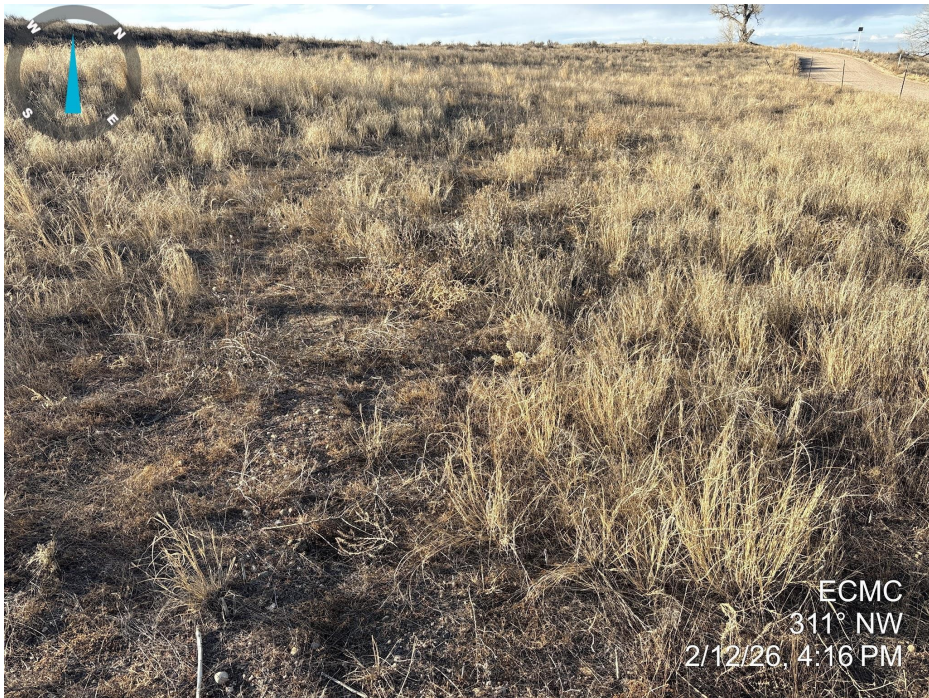
Photo 5. Photo taken of the access road between the well and tank battery location, facing northwest. Photo illustrates that final reclamation activities appear to have taken place, but vegetation establishment does not meet Rule 1004 standards and gravel remains. Weedy annual vegetation including cheatgrass (*Bromus tectorum*) was observed at the location.

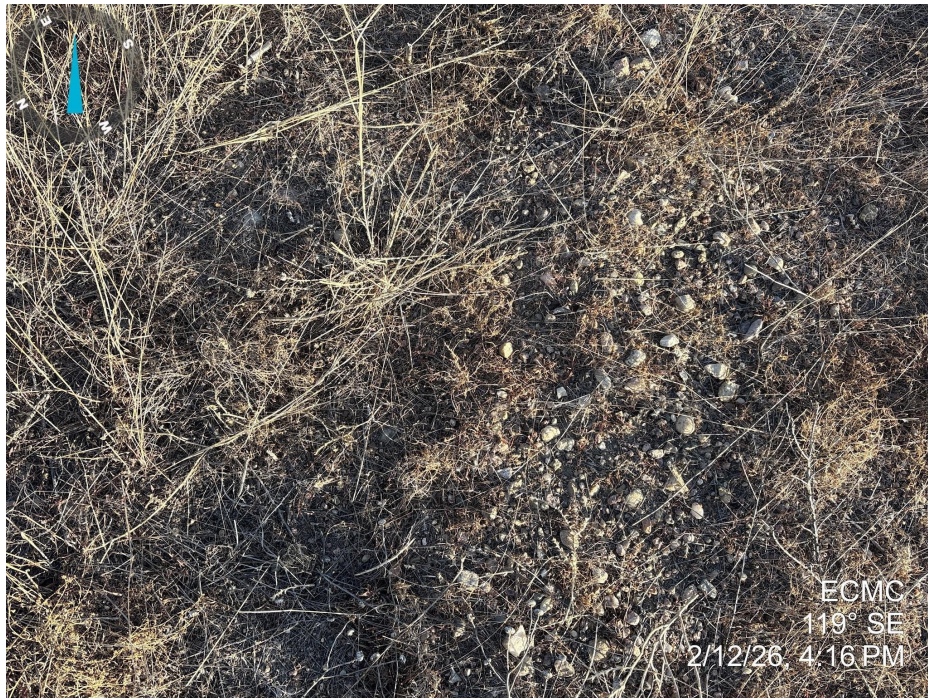
Photo 6. Photo taken of ground cover along the access road. Photo illustrates gravel, perennial grass, and weedy annual vegetation including cheatgrass (*Bromus tectorum*).

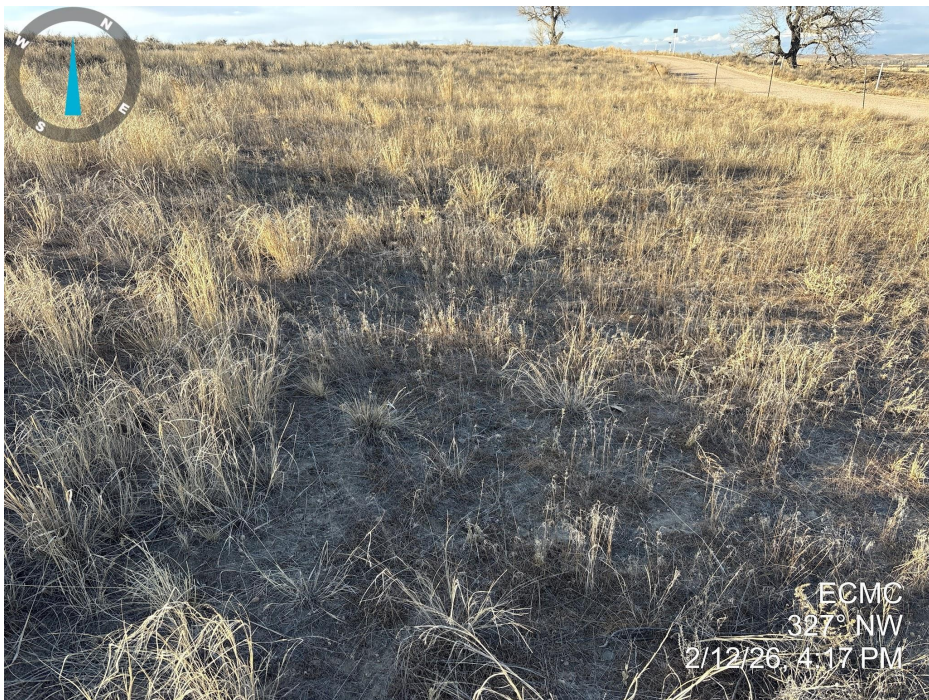
Photo 7. Photo taken of the tank battery location, facing northwest. Photo illustrates that final reclamation activities appear to have taken place, but vegetation has not established to Rule 1004 standards as weedy annual vegetation including cheatgrass (*Bromus tectorum*), a List C Noxious Weed species, was observed at the location.

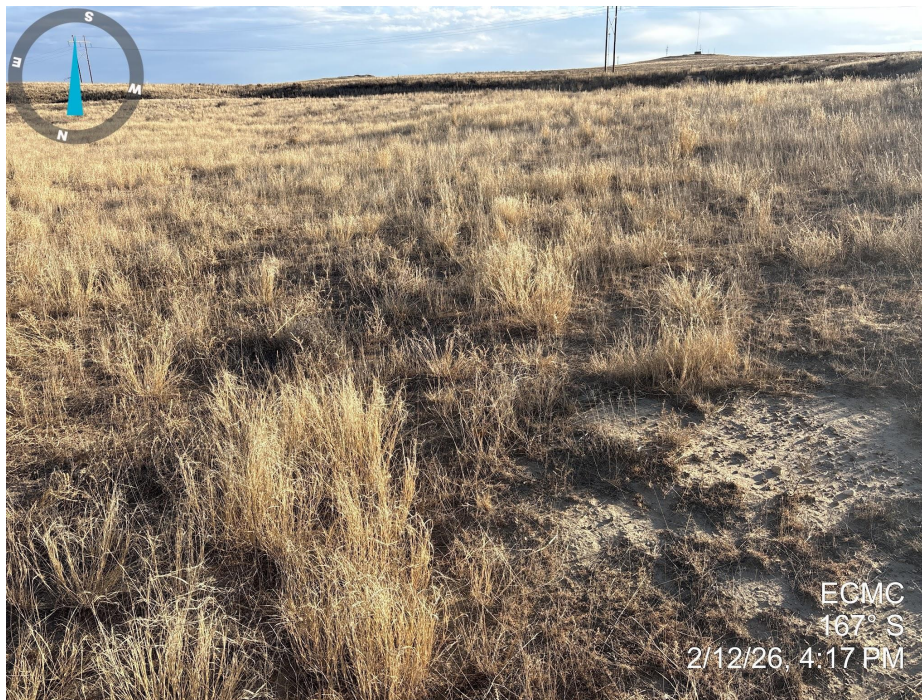
Photo 8. Photo taken of the tank battery location, facing south. See comments under Photo 7.

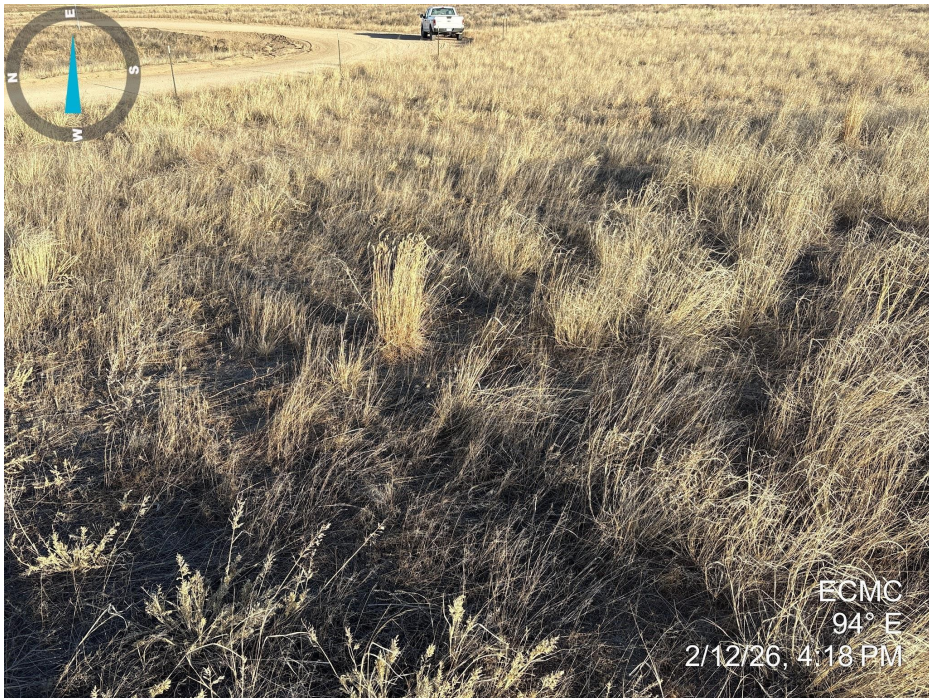
Photo 9. Photo taken of the tank battery location, facing east. See comments under Photo 7.

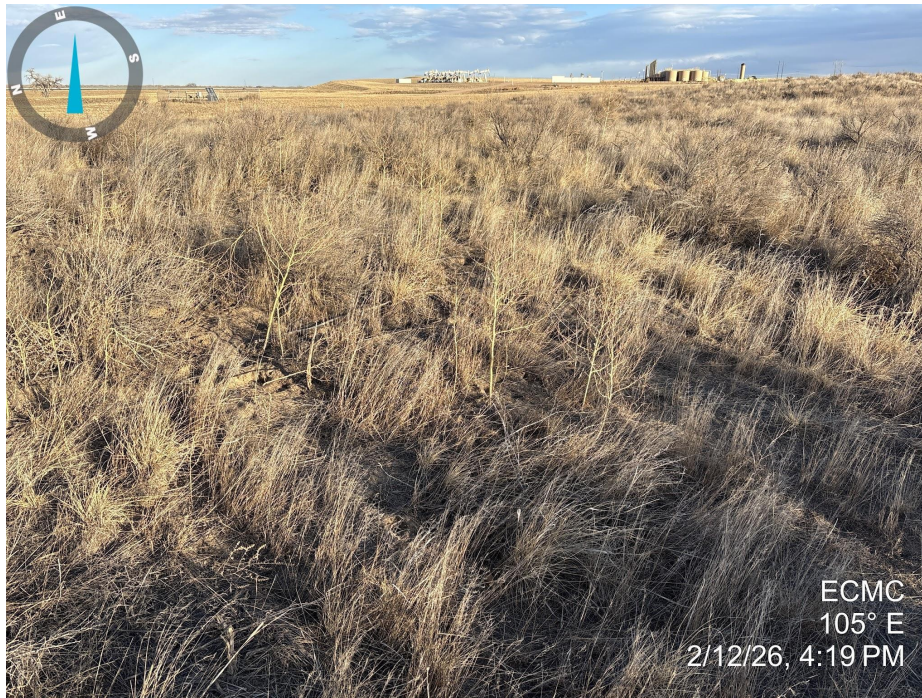
Photo 10. Photo taken of the reference area to the location, northeast of the location, facing east. Photo illustrates perennial grass and weedy annual vegetation.
