Final Reclamation Inspection

Operator: BONANZA CREEK ENERGY OPERATING COMPANY
LLC - 8960

Location ID: 331364

Inspection Photos
Location Name: PARK #34-4
Location ID: 331364

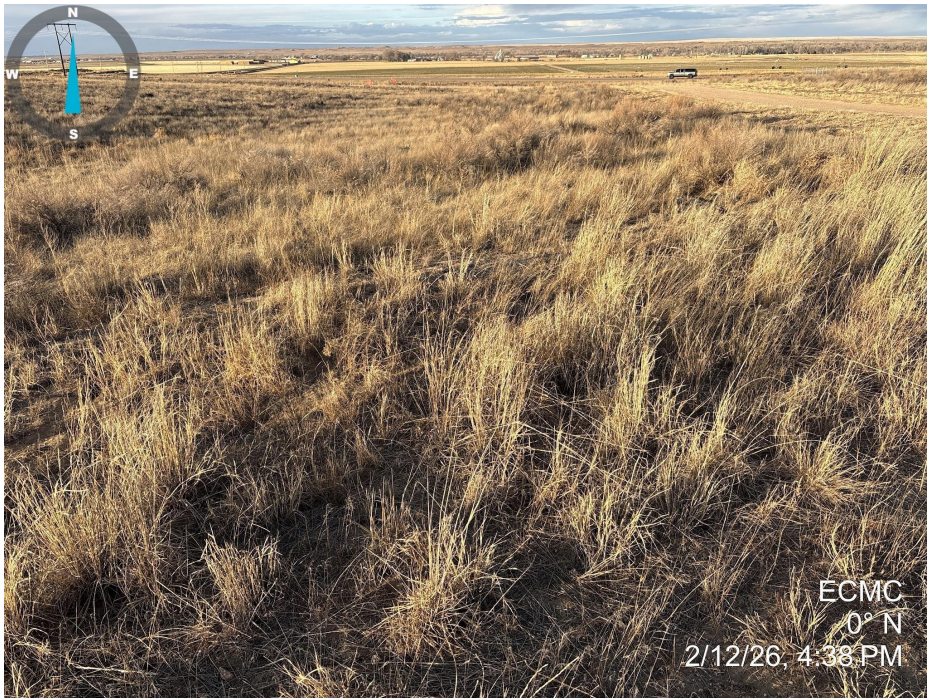
Photo 1. Photo taken of the well location, facing north. Photo illustrates that final reclamation activities appear to have taken place at the well location, but vegetation establishment does not meet Rule 1004 standards. Weedy annual vegetation including cheatgrass (*Bromus tectorum*), a List C Noxious Weed species, was observed across the location.

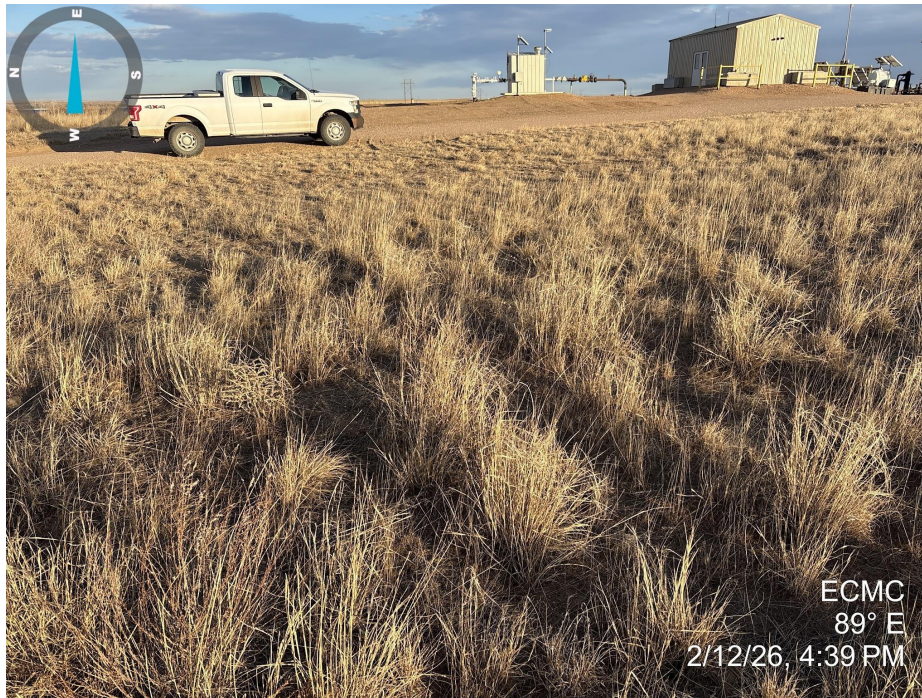
Photo 2. Photo taken of the well location, facing east. See comments under Photo 1.

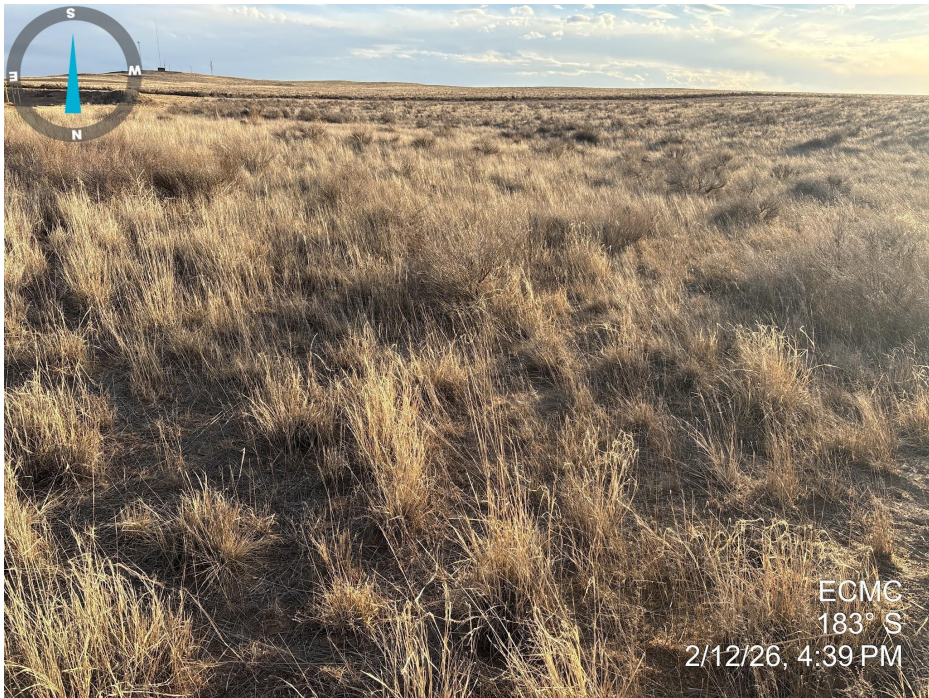
Photo 3. Photo taken of the well location, facing south. See comments under Photo 1.

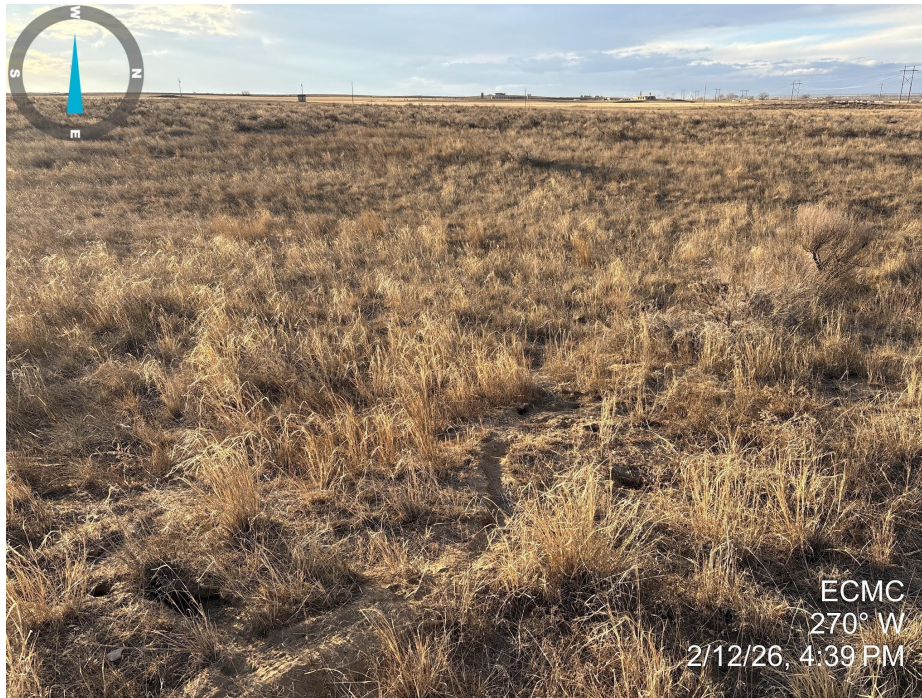
Photo 4. Photo taken of the well location, facing west. See comments under Photo 1.

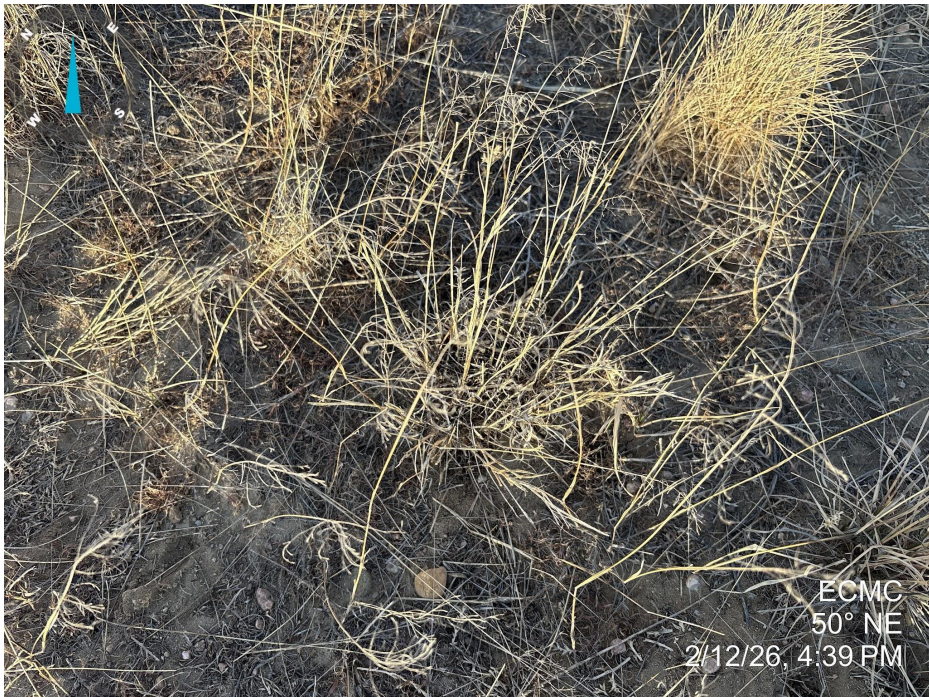
Photo 5. Photo taken of ground cover at the well location. Photo illustrates perennial grass and cheatgrass (*Bromus tectorum*), a List C Noxious Weed species.

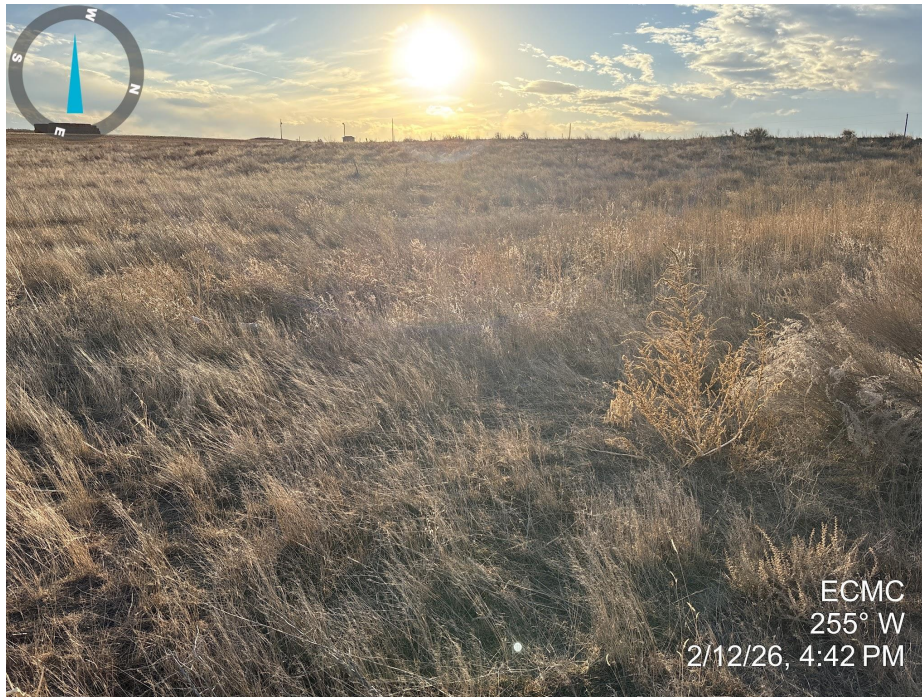
Photo 6. Photo taken of the reference area to the location, northwest of the location, facing west. Photo illustrates perennial grass vegetation.
