Final Reclamation Inspection

Operator: KERR MCGEE OIL & GAS ONSHORE LP - 47120

Location ID: 317550

Location Name: UPRR 21 PAN AM B #1

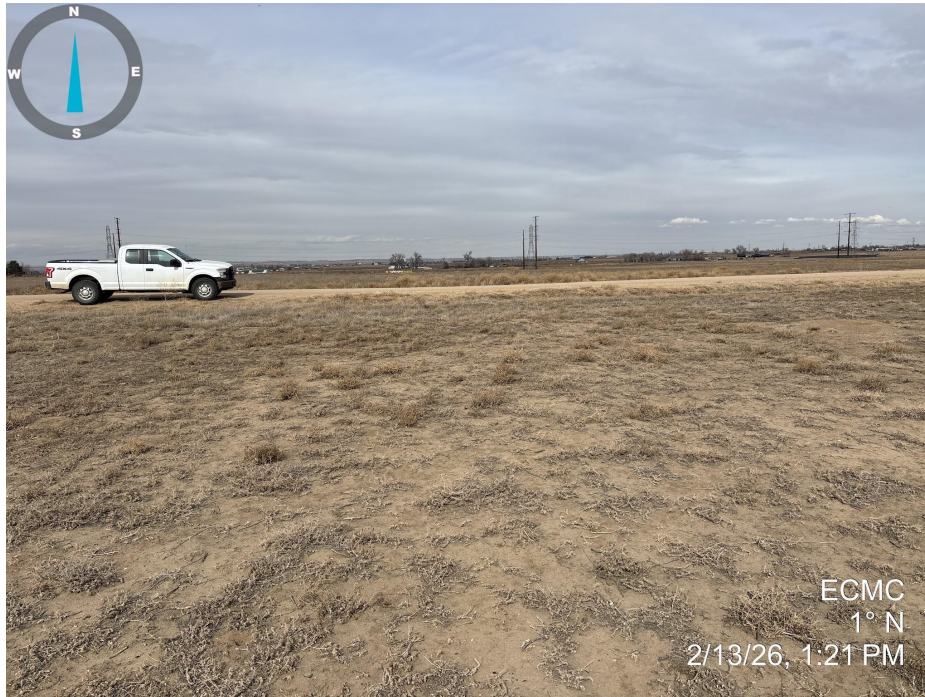
Photo 1. Photo taken of the well location, facing north. Photo illustrates that final reclamation activities appear to have taken place at the well location, but vegetation establishment does not meet Rule 1004 standards.

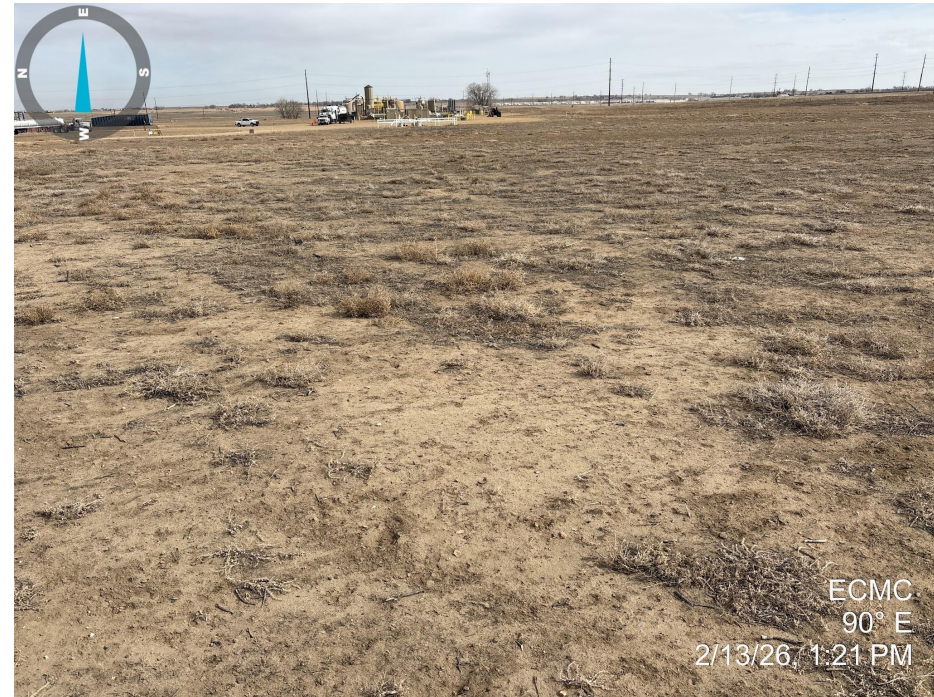
Photo 2. Photo taken of the well location, facing east. See comments under Photo 1.

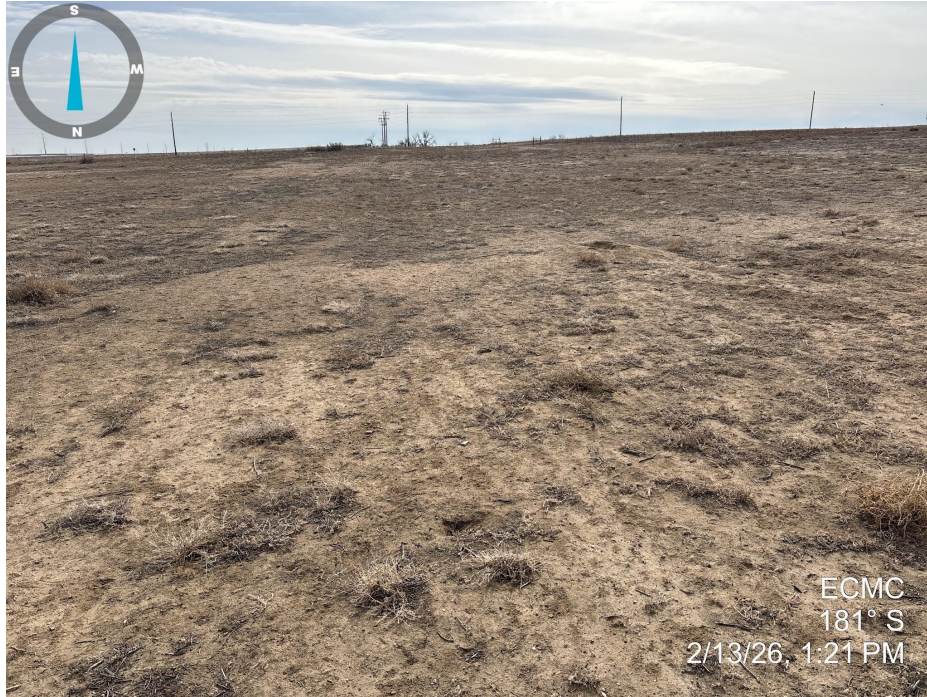
Photo 3. Photo taken of the well location, facing south. See comments under Photo 1.

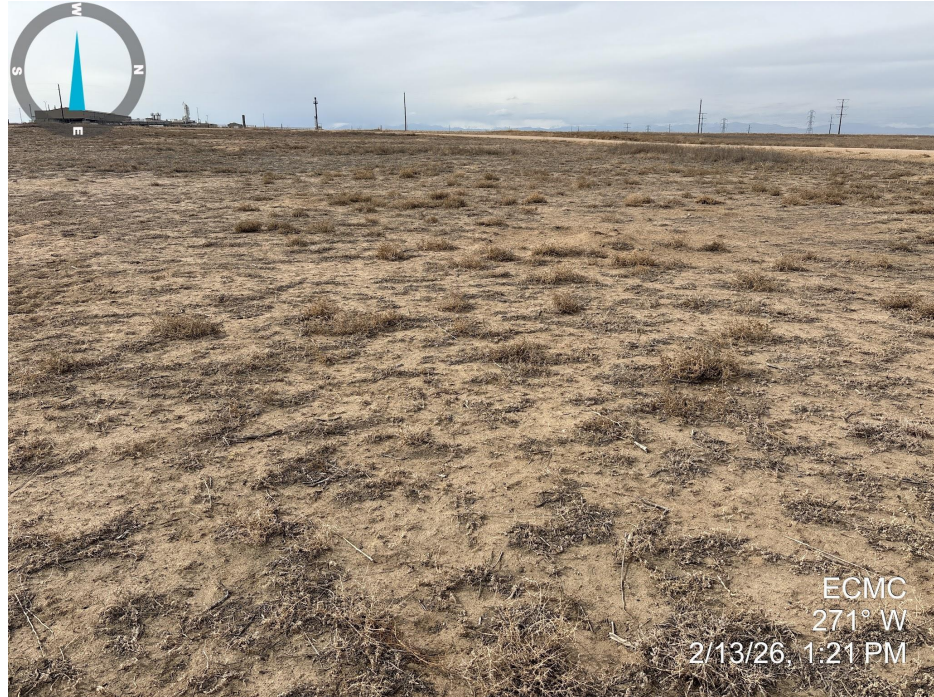
Photo 4. Photo taken of the well location, facing west. See comments under Photo 1.

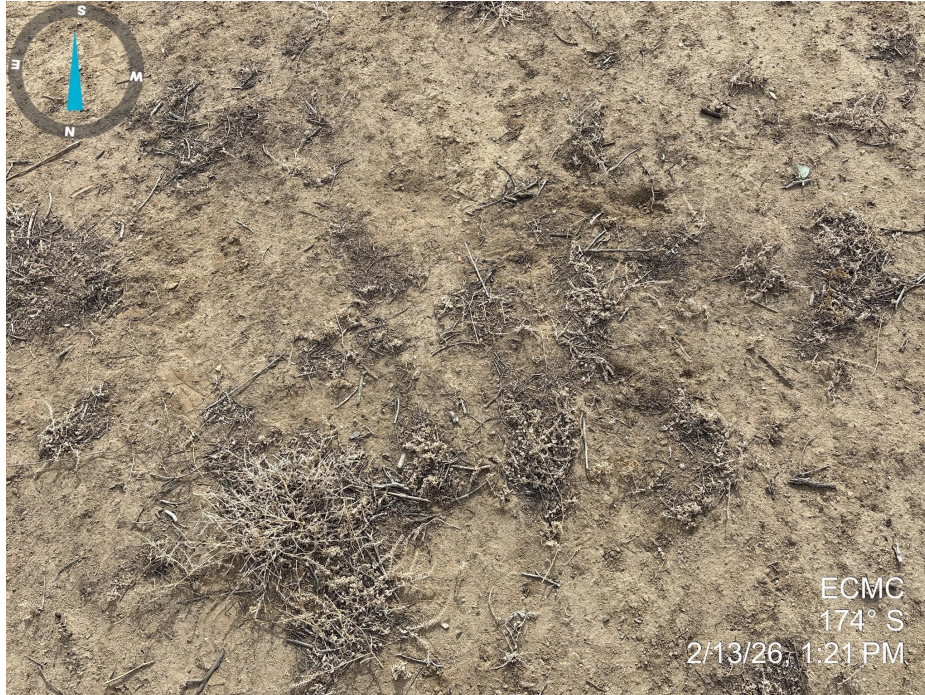
Photo 5. Photo taken of ground cover at the well location. Photo illustrates bare ground and weedy annual vegetation including kochia (*Bassia scoparia*).

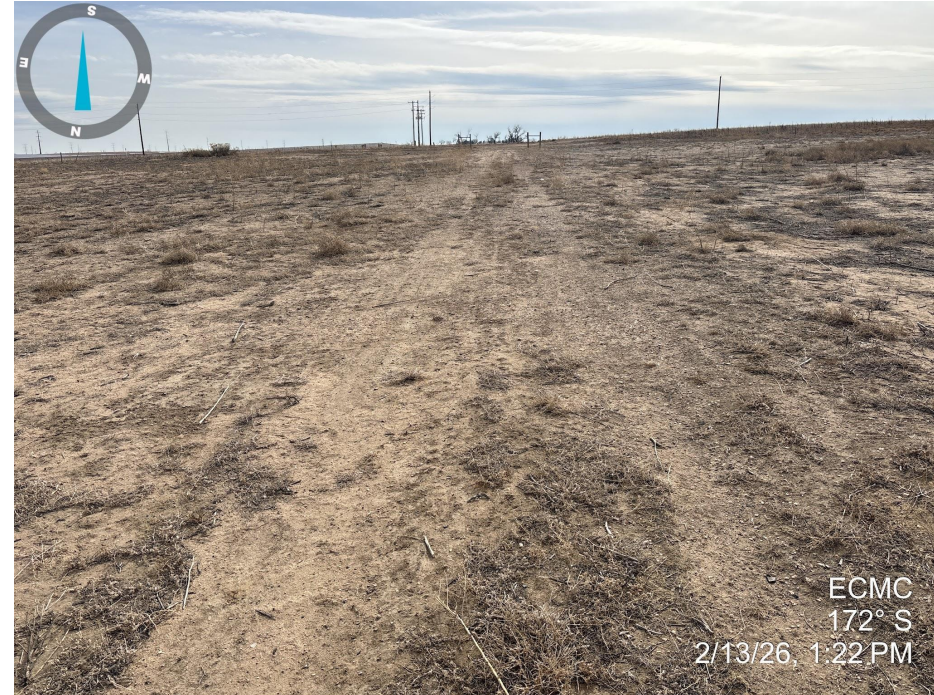
Photo 6. Photo taken of the access road to the location, facing south. Photo illustrates that vegetation has not established to Rule 1004 standards.

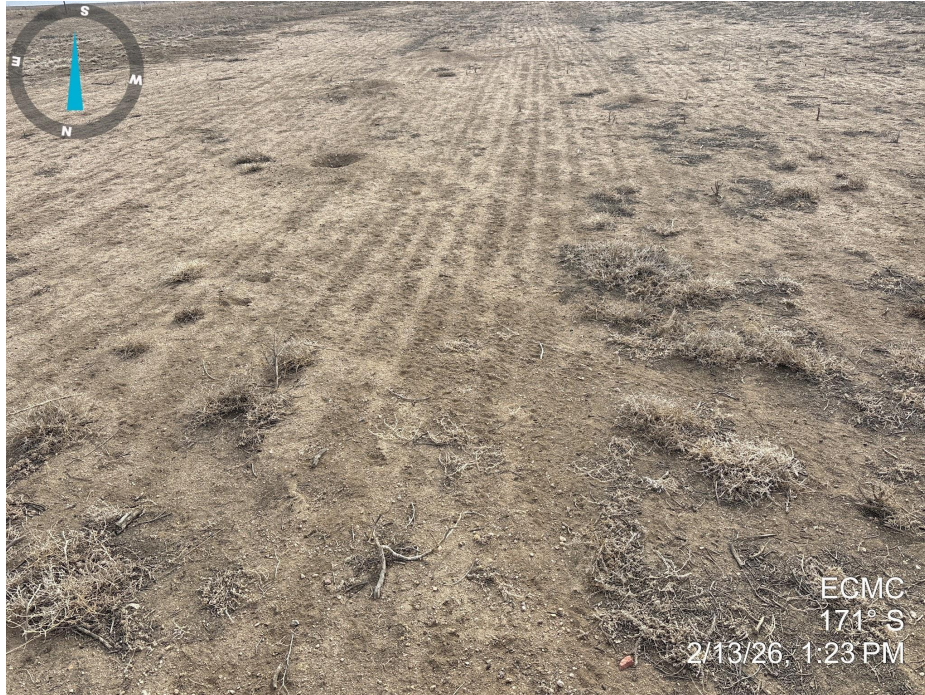
Photo 7. Photo taken of the tank battery location, facing south. Photo illustrates that final reclamation activities appear to have taken place, with evidence of drill row seeding, but vegetation has not established to Rule 1004 standards.

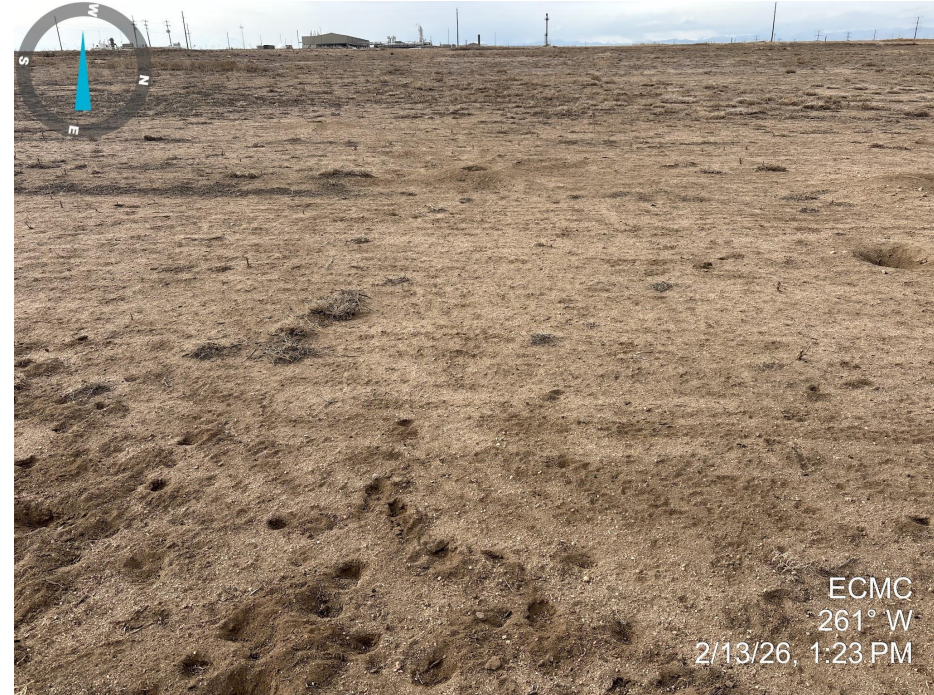
Photo 8. Photo taken of the tank battery location, facing west. See comments under Photo 7.

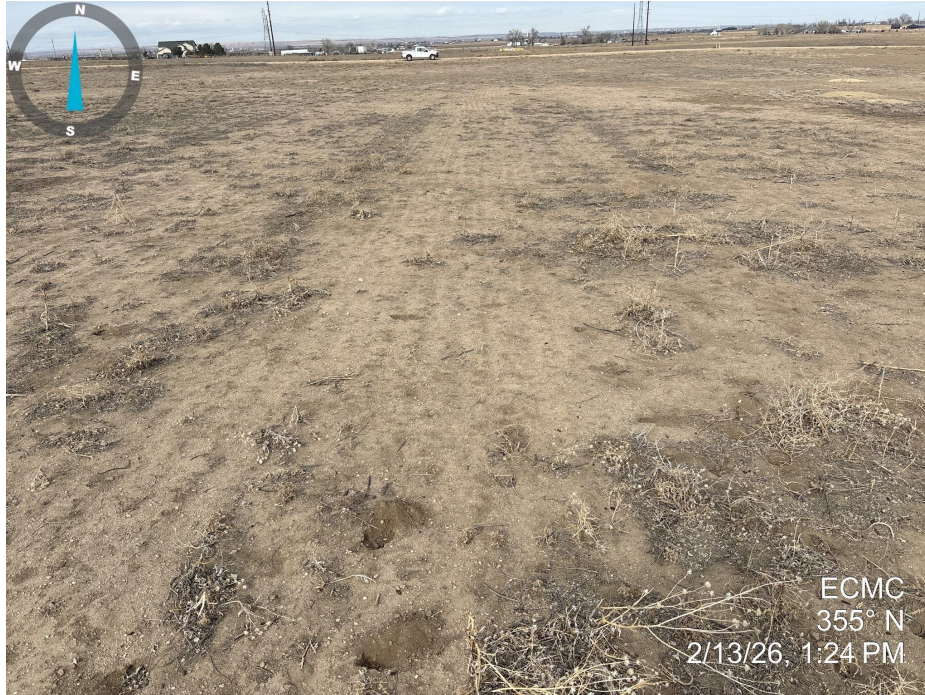
Photo 9. Photo taken of the tank battery location, facing north. See comments under Photo 7.

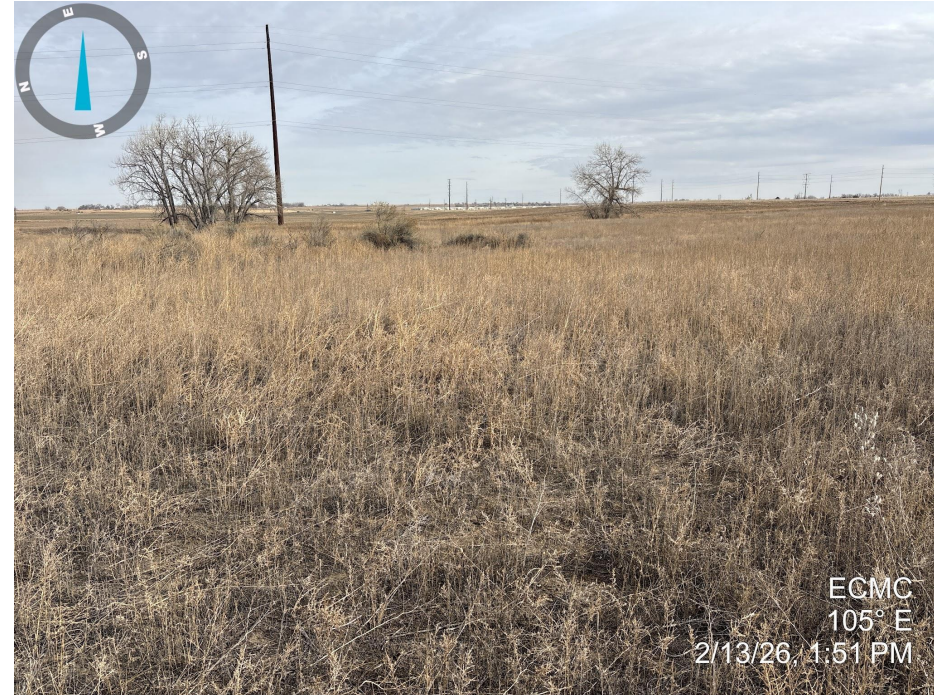
Photo 10. Photo taken of the reference area to the location, east of the location, facing east. Photo illustrates perennial grass and weedy annual vegetation. The area directly surrounding the well location is degraded prairie dog habitat. This reference area is located directly east in the adjacent field to that which contains the well and tank battery location.
