Final Reclamation Inspection

Operator: KERR MCGEE OIL & GAS ONSHORE LP - 47120

Location ID: 327749

Inspection Photos
Location Name: UPRC #9-14K
Location ID: 327749

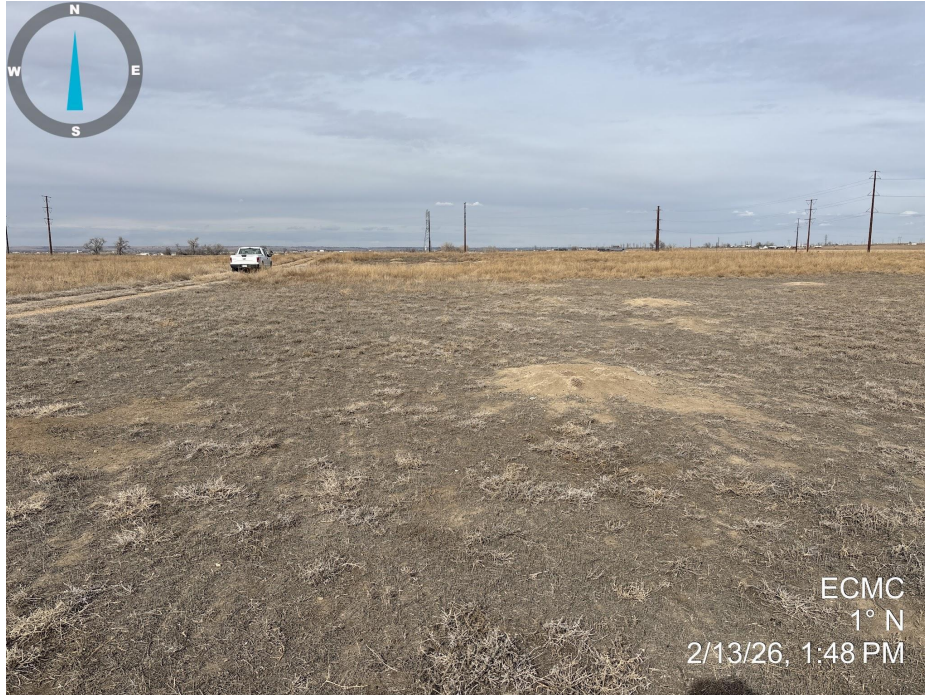
Photo 1. Photo taken of the well location, facing north. Photo illustrates that final reclamation activities appear to have taken place, with evidence of drill row seeding, but vegetation establishment does not meet Rule 1004 standards. Weedy annual vegetation including kochia (*Bassia scoparia*) was observed across the location.

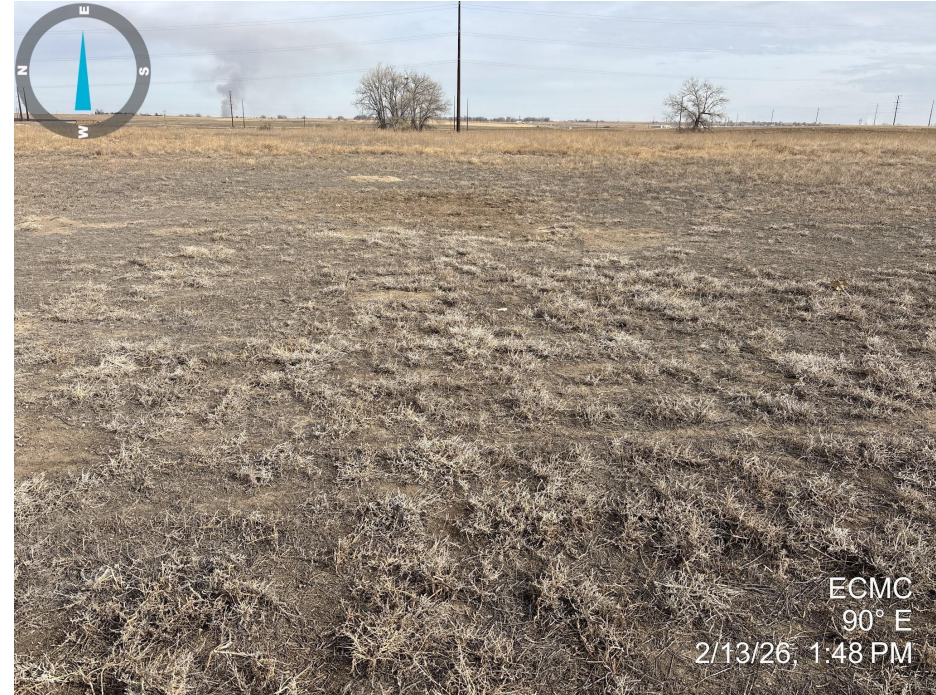
Photo 2. Photo taken of the well location, facing east. See comments under Photo 1.

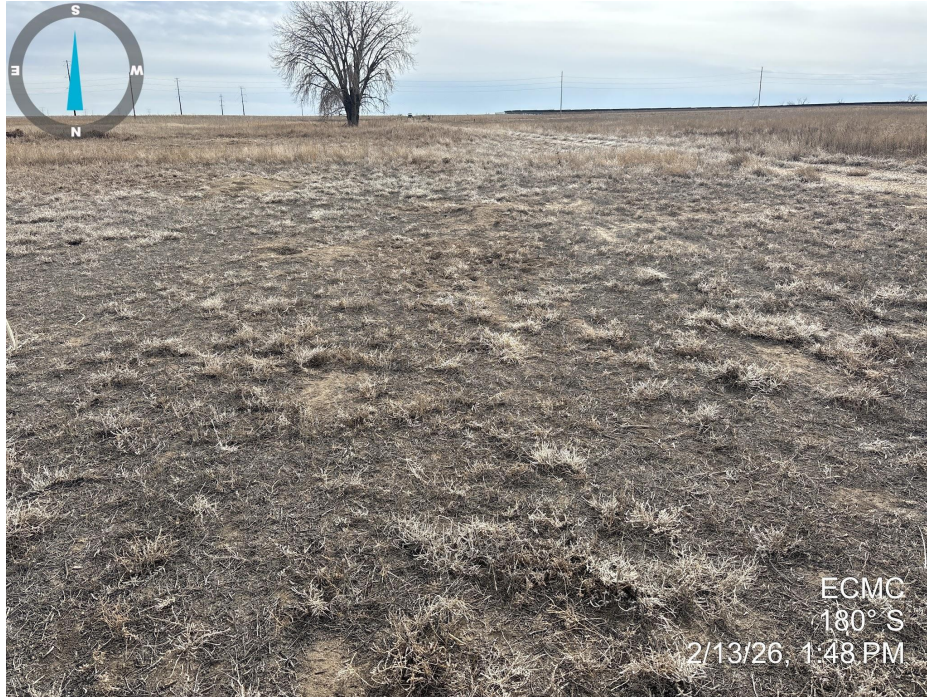
Photo 3. Photo taken of the well location, facing south. See comments under Photo 1.

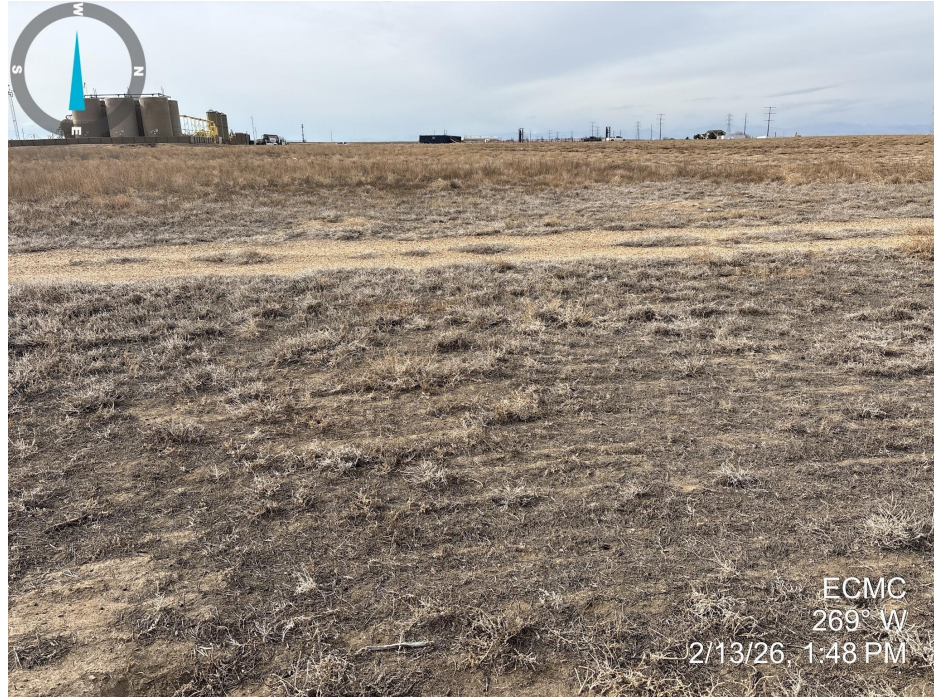
Photo 4. Photo taken of the well location, facing west. See comments under Photo 1.

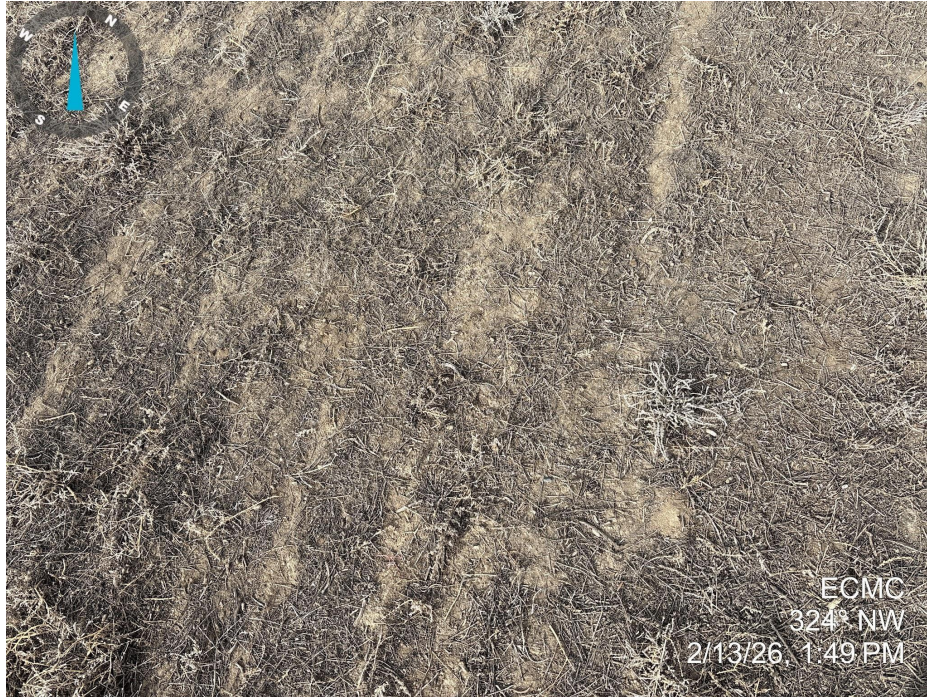
Photo 5. Photo taken of ground cover at the well location. Photo illustrates evidence of drill row seeding with weedy annual vegetation including kochia (*Bassia scoparia*).

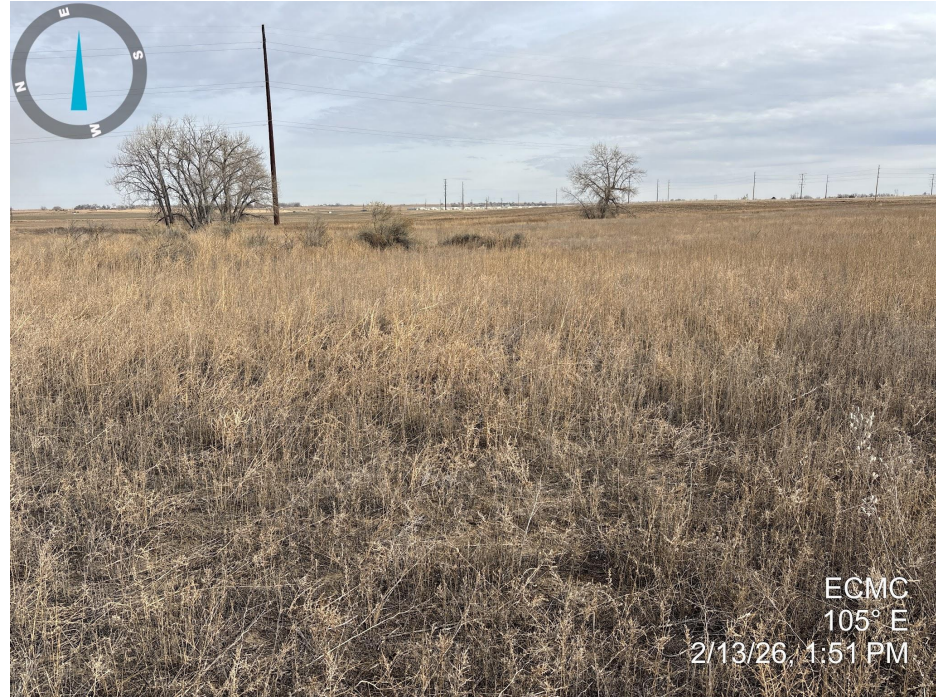
Photo 6. Photo taken of the reference area to the location, east of the location, facing east. Photo illustrates perennial grass and weedy annual vegetation.
