Final Reclamation Inspection

Operator: KERR MCGEE OIL & GAS ONSHORE LP - 47120

Location ID: 327647

Inspection Photos
Location Name: HSR-ROZEMA #4-26A
Location ID: 327647

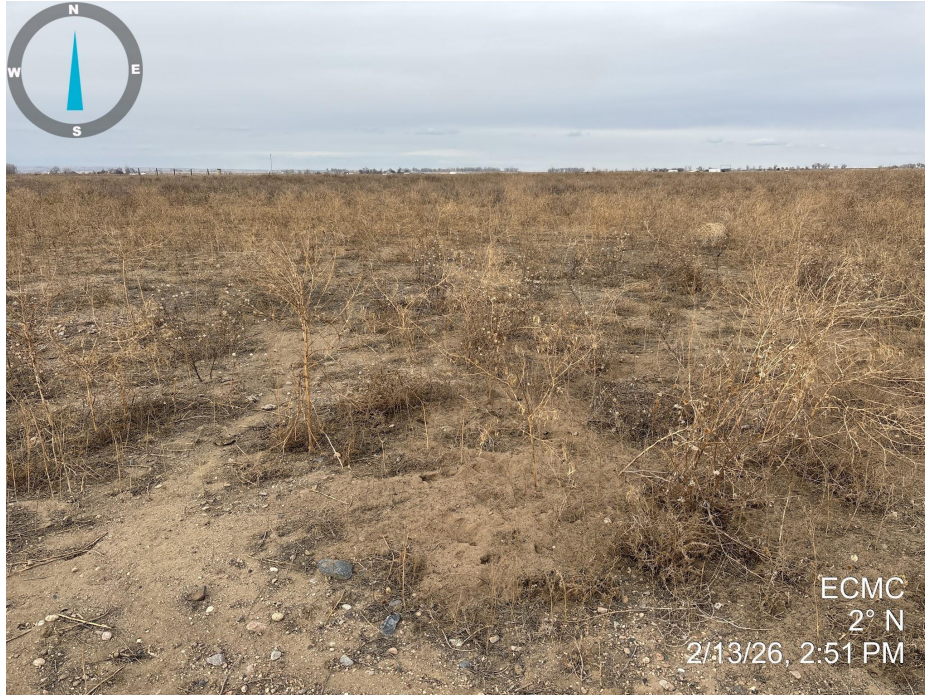
Photo 1. Photo taken of the well location, facing north. Photo illustrates that final reclamation activities appear to have taken place, but vegetation establishment does not meet Rule 1004 standards. Gravel and weedy annual vegetation including russian thistle (*Salsola tragus*) were observed at the location.

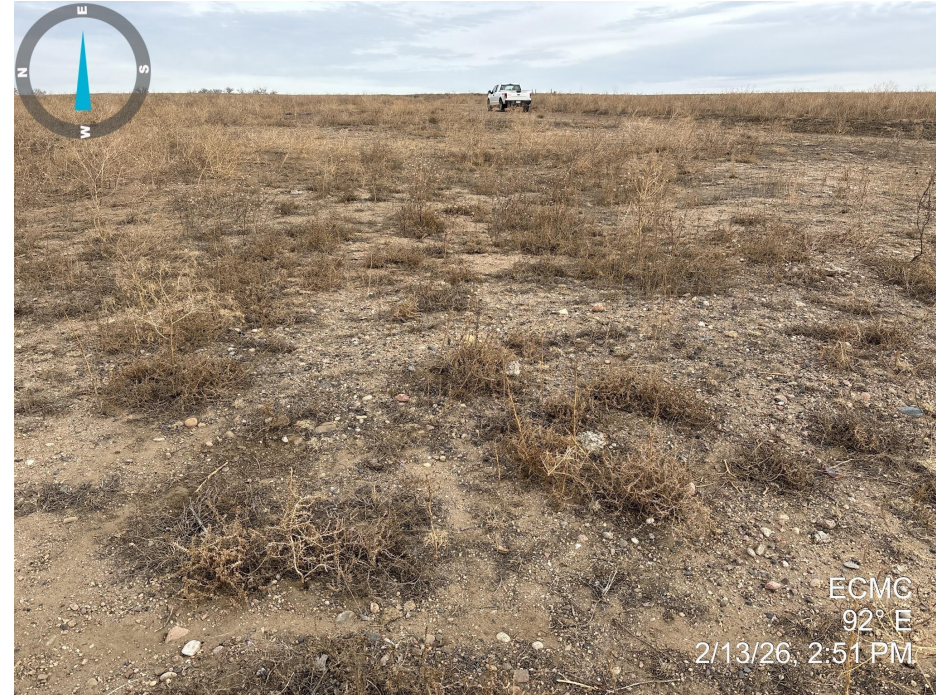
Photo 2. Photo taken of the well location, facing east. See comments under Photo 1.

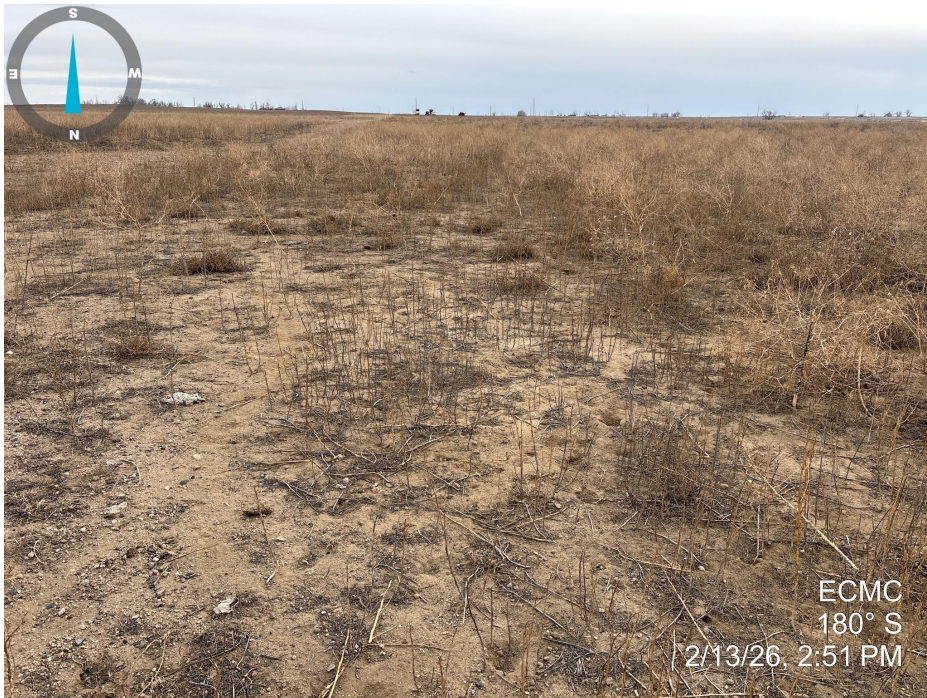
Photo 3. Photo taken of the well location, facing south. See comments under Photo 1.

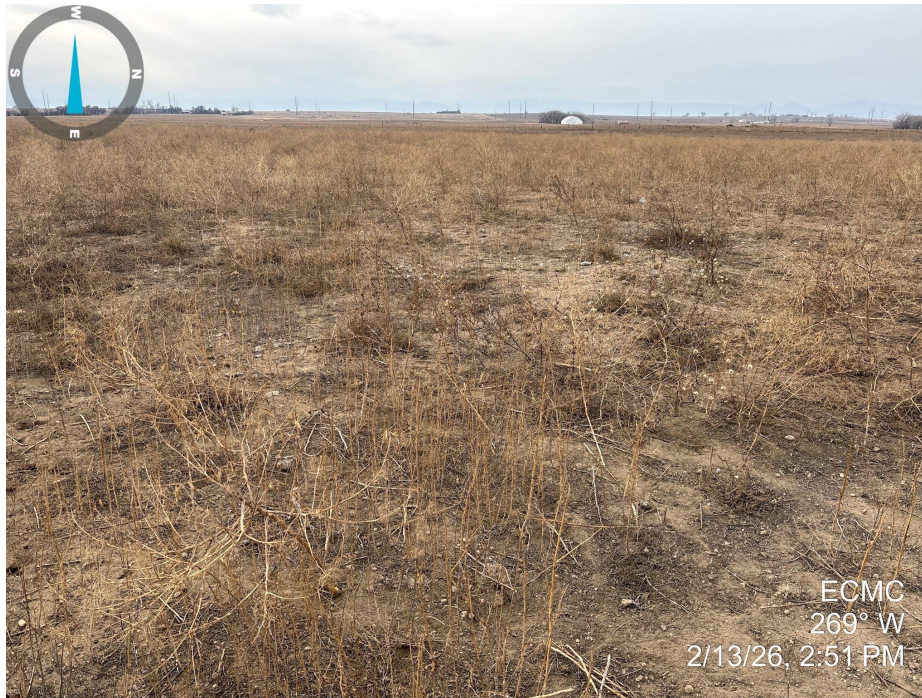
Photo 4. Photo taken of the well location, facing west. See comments under Photo 1.

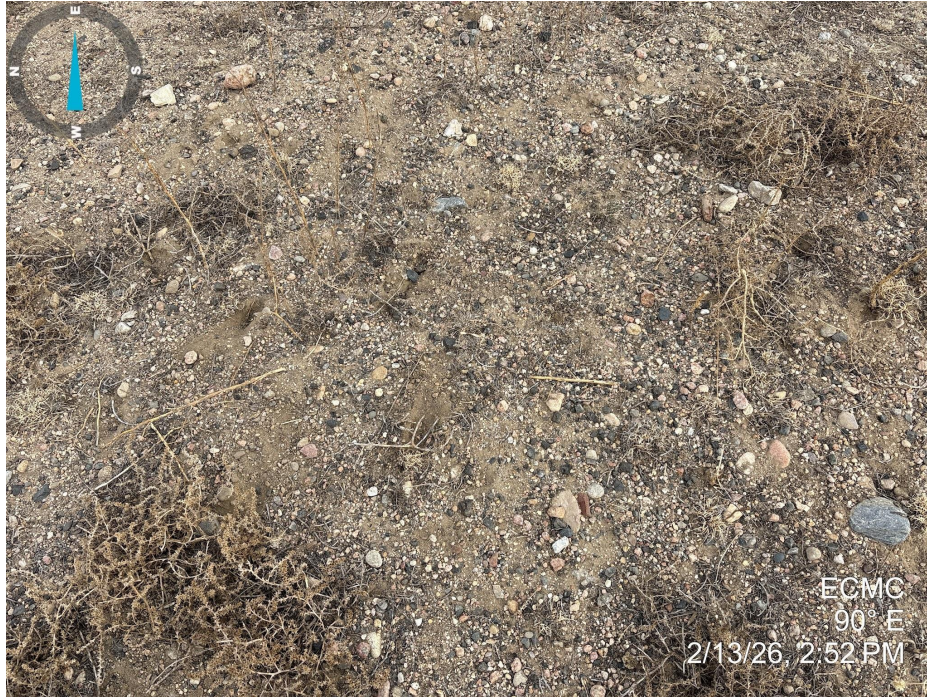
Photo 5. Photo taken of ground cover at the well location. Photo illustrates bare ground, gravel, and weedy annual vegetation including russian thistle (*Salsola tragus*).

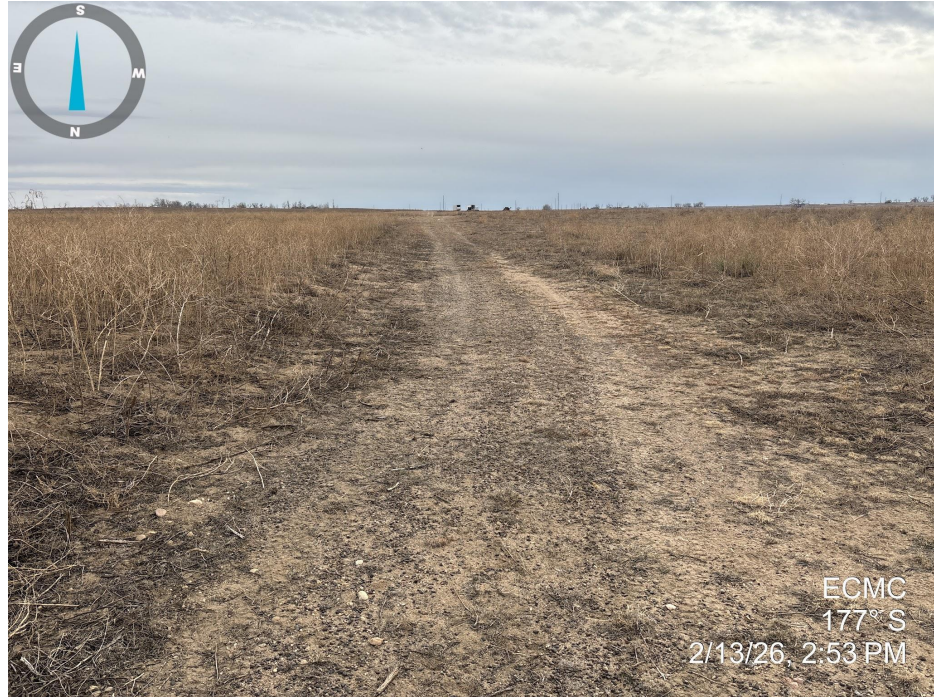
Photo 6. Photo taken of the access road to the location, facing south, away from the location. Photo illustrates that final reclamation activities appear to have taken place, but vegetation has not established to Rule 1004 standards.

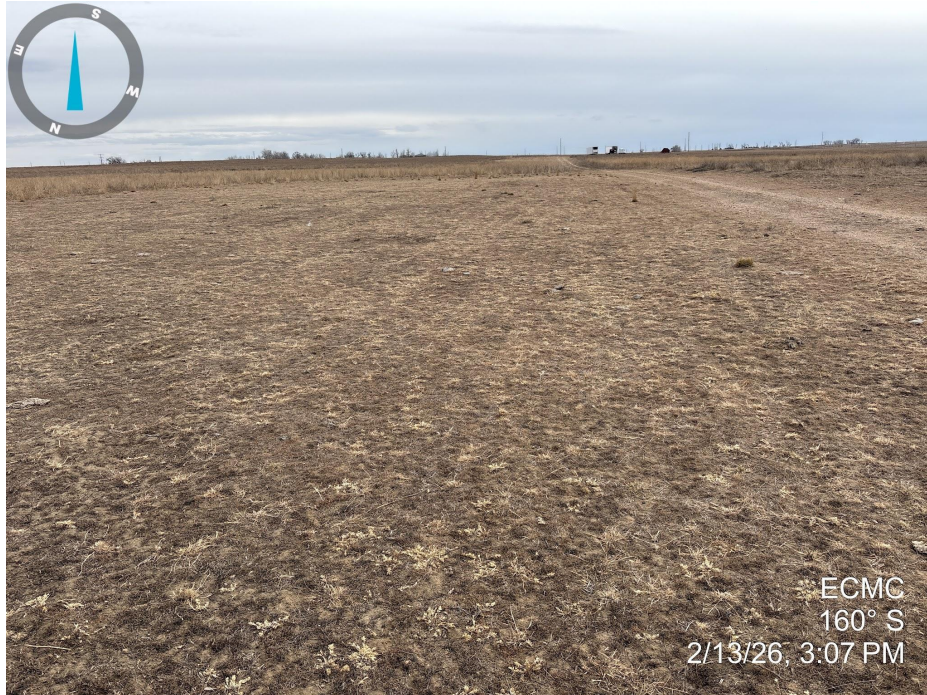
Photo 7. Photo taken of the tank battery location, facing south. Photo illustrates that final reclamation activities have taken place, with evidence of drill row seeding, but vegetation has not established to Rule 1004 standards.

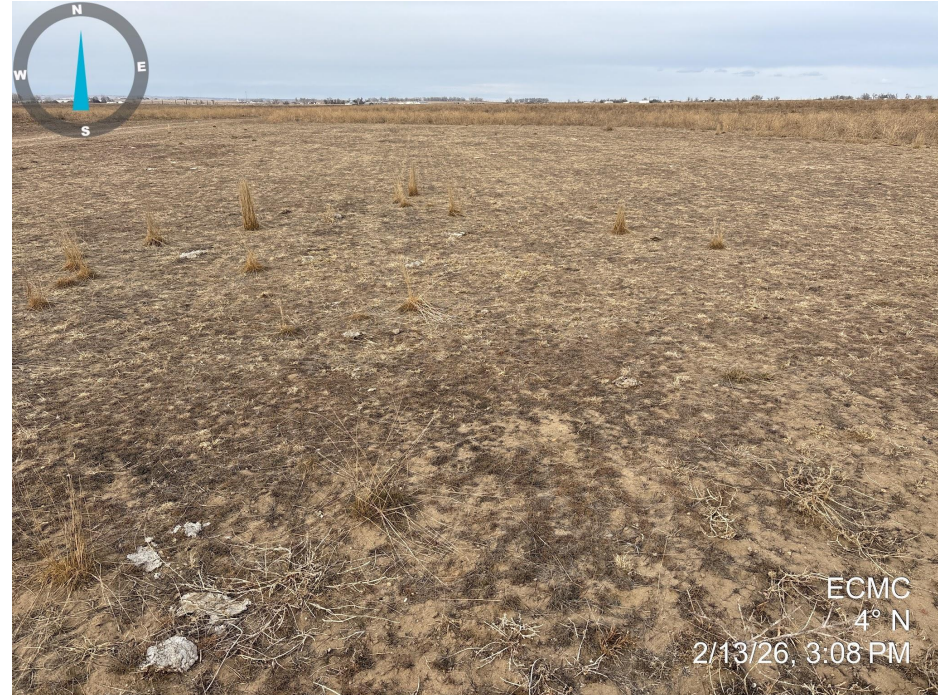
Photo 8. Photo taken of the tank battery location, facing north. See comments under Photo 7.

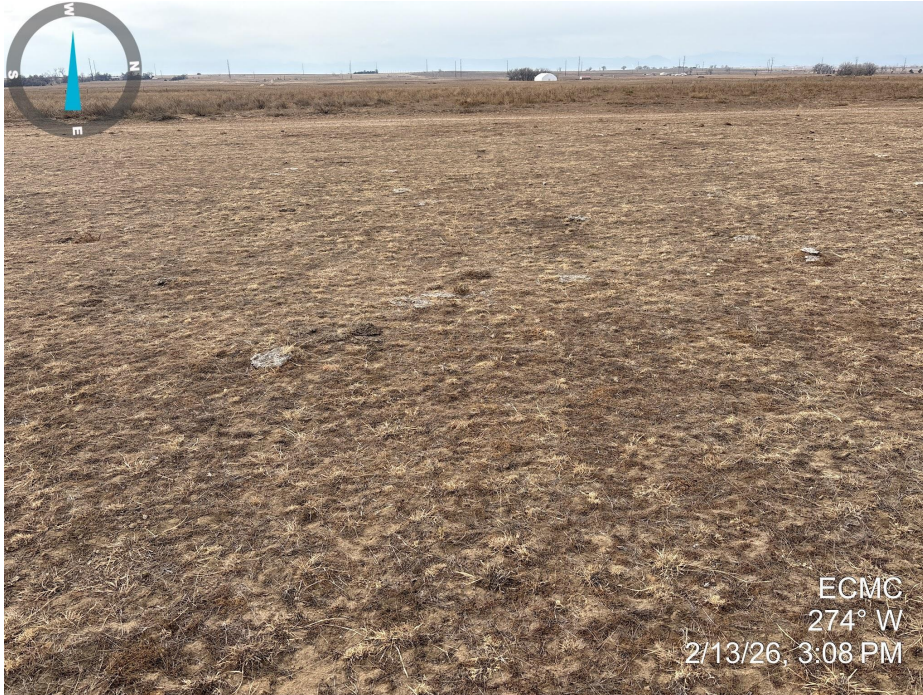
Photo 9. Photo taken of the tank battery location, facing west. See comments under Photo 7.

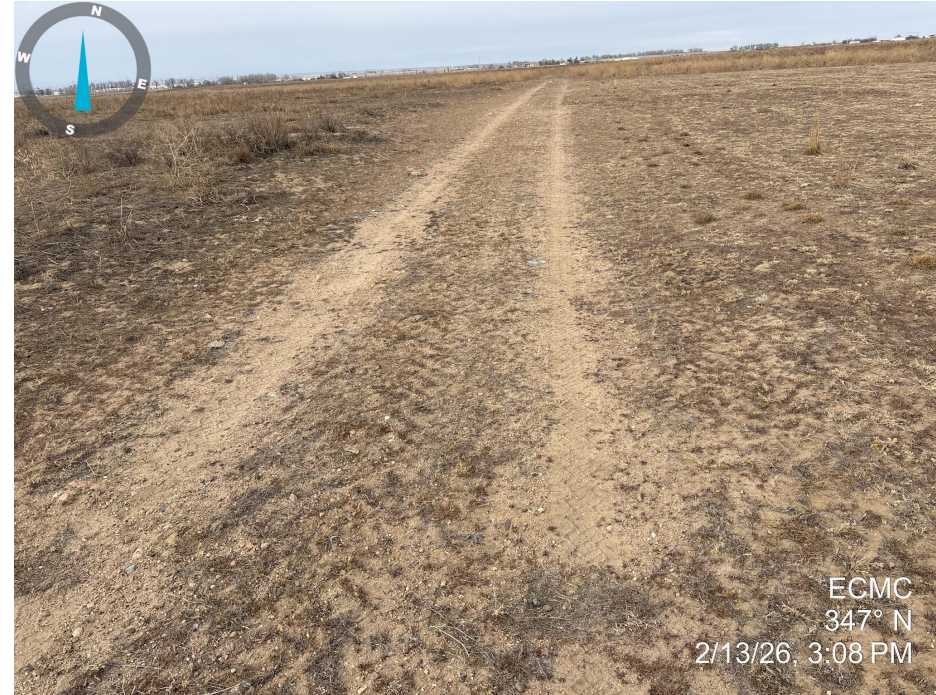
Photo 10. Photo taken of the access road to the tank battery location, facing north. Photo illustrates that final reclamation activities appear to have taken place, but vegetation has not established to Rule 1004 standards and bare ground remains across the access road.

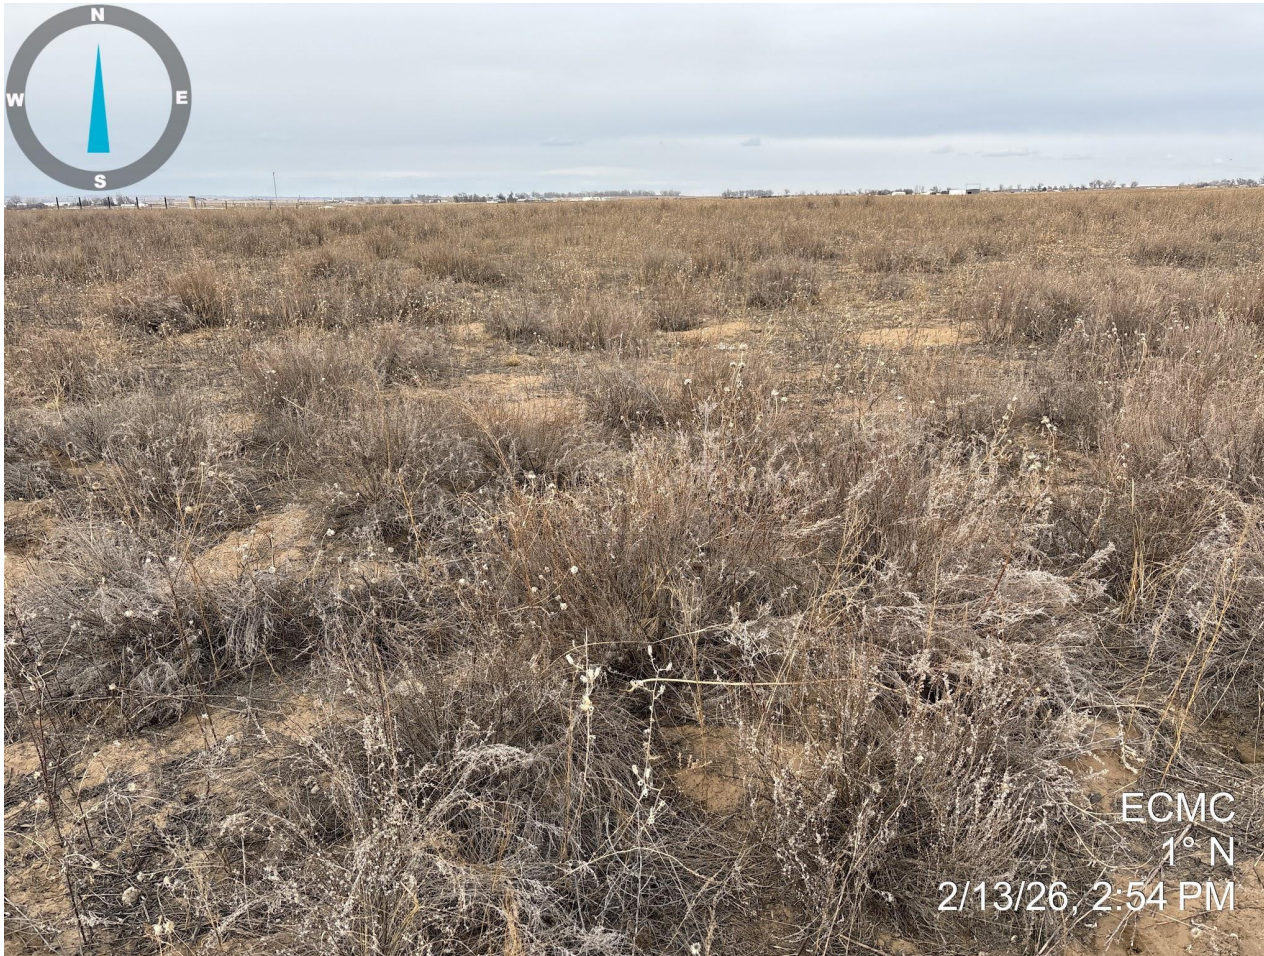
Photo 11. Photo taken of the reference area to the location, north of the well location, facing north. Photo illustrates sand sagebrush and weedy annual vegetation.
