Final Reclamation Inspection

Operator: KERR MCGEE OIL & GAS ONSHORE LP - 47120

Location ID: 327414

Inspection Photos
Location Name: HSR-RUSSELL #3-26
Location ID: 327414

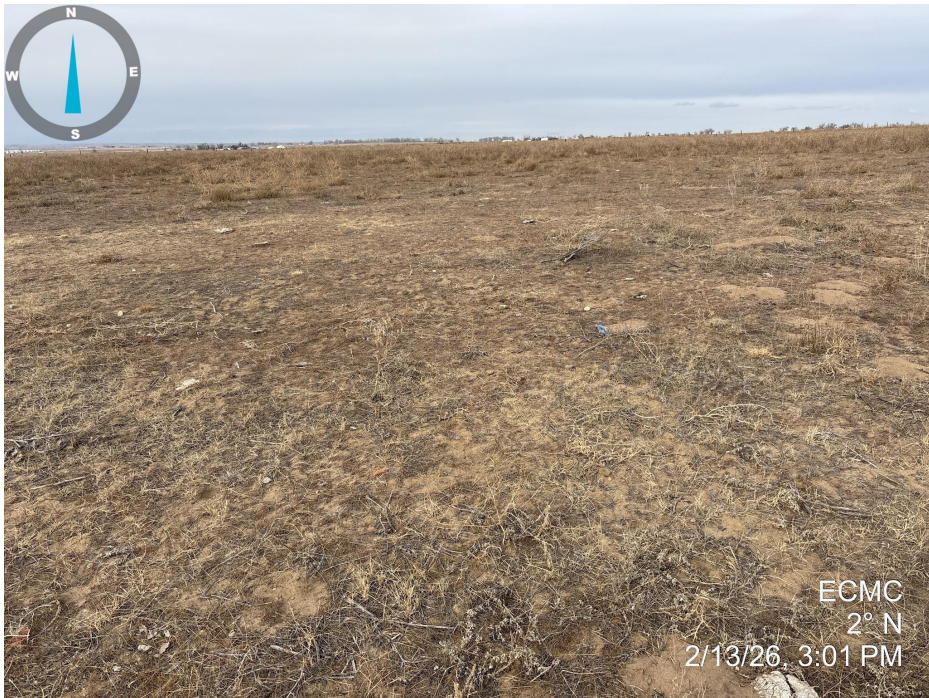
Photo 1. Photo taken of the well location, facing north. Photo illustrates that final reclamation activities appear to have taken place, but vegetation establishment does not meet Rule 1004 standards. Weedy annual vegetation including cheatgrass (*Bromus tectorum*), a List C Noxious Weed species, was observed at the location.

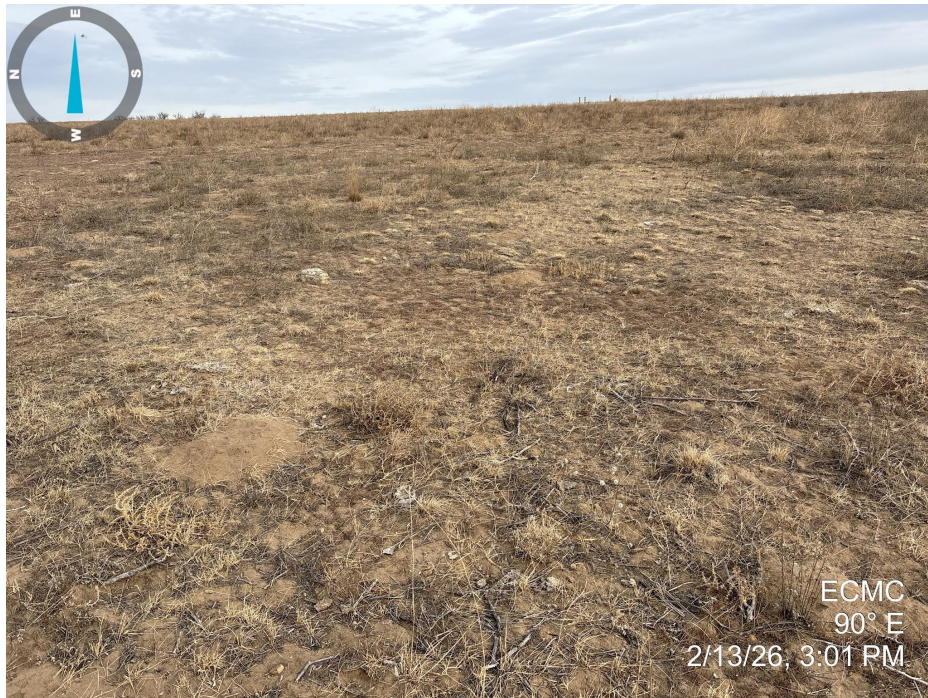
Photo 2. Photo taken of the well location, facing east. See comments under Photo 1.

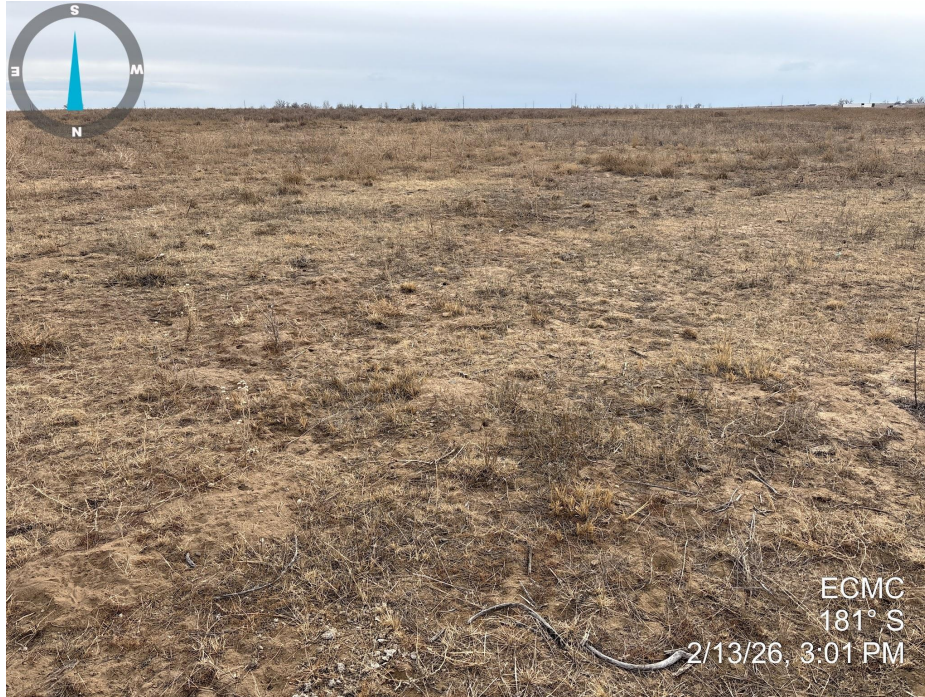
Photo 3. Photo taken of the well location, facing south. See comments under Photo 1.

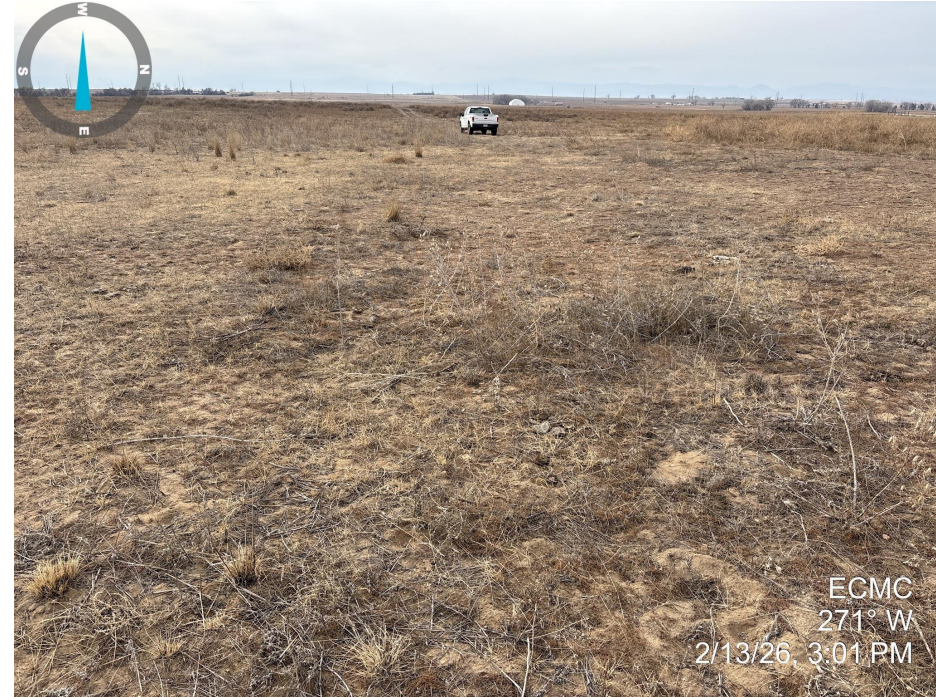
Photo 4. Photo taken of the well location, facing west. See comments under Photo 1.

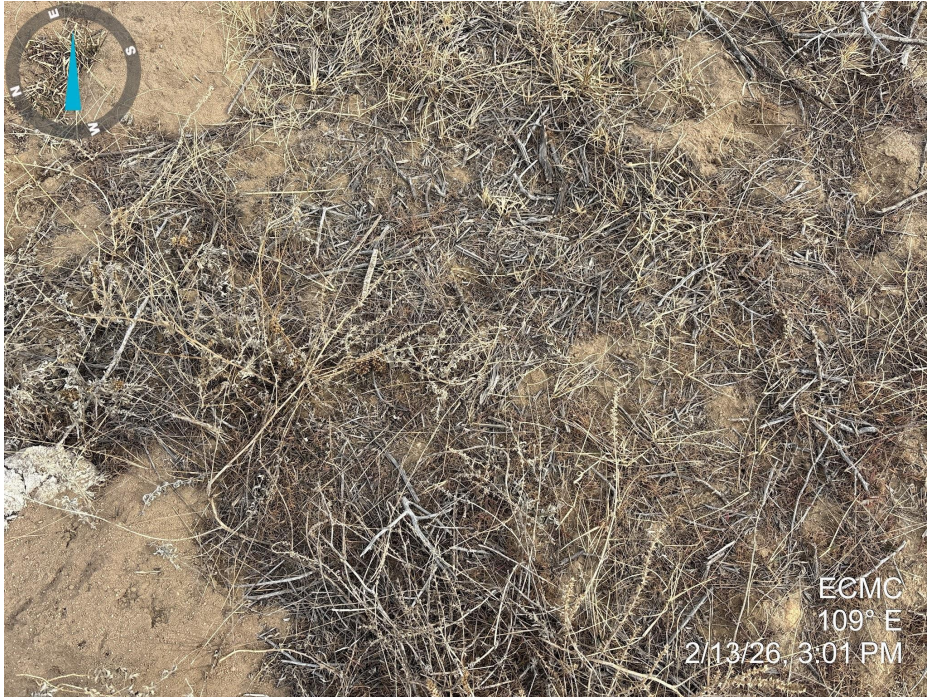
Photo 5. Photo taken of ground cover at the well location. Photo illustrates bare ground, perennial grass, and weedy annual vegetation including russian thistle (*Salsola tragus*) and kochia (*Bassia scoparia*).

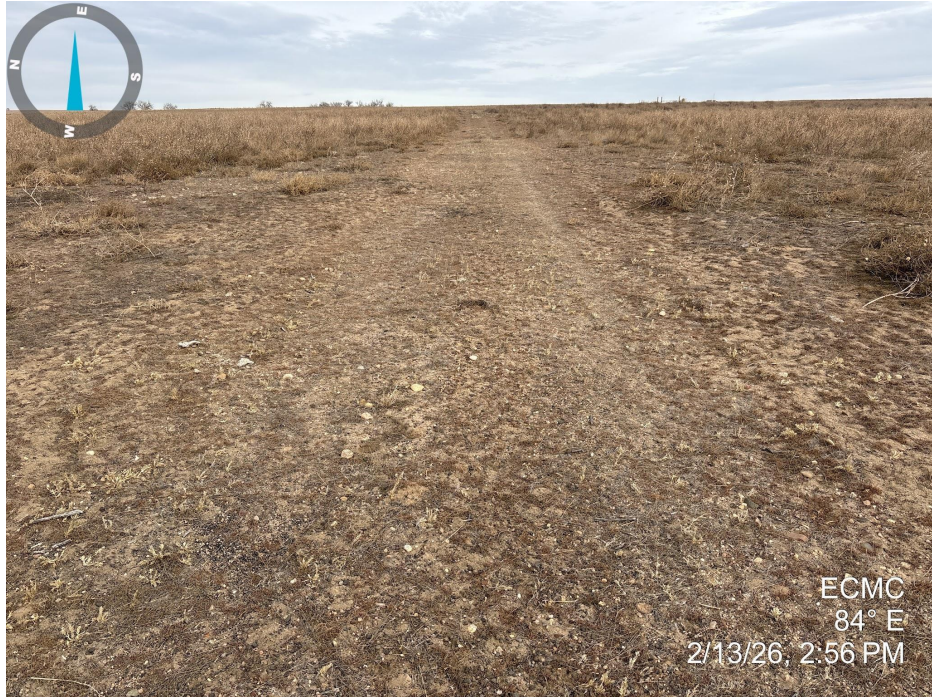
Photo 6. Photo taken of the access road to the location, facing east, towards the location. Photo illustrates that final reclamation activities appear to have taken place, but vegetation has not established to Rule 1004 standards.

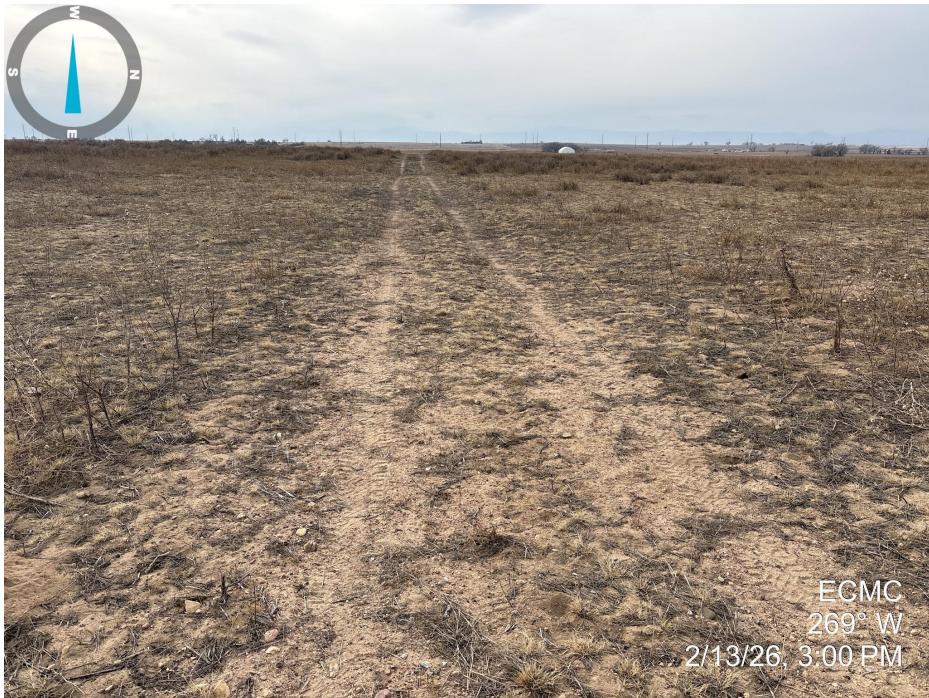
Photo 7. Photo taken of the access road to the location, facing west, away from the location. See comments under Photo 6.

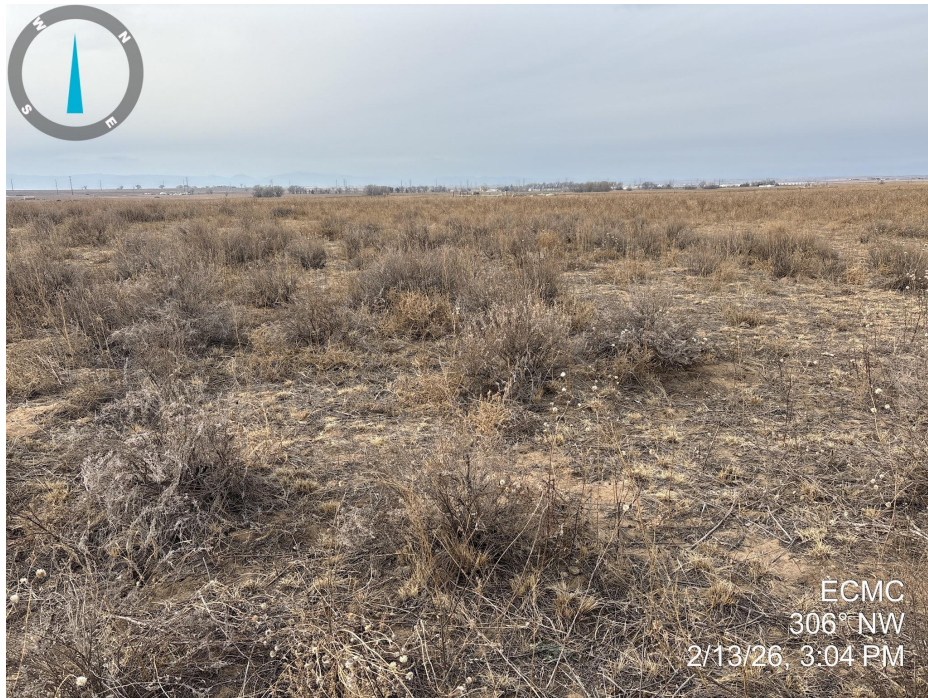
Photo 8. Photo taken of the reference area to the location, west of the well location, facing northwest. Photo illustrates sand sagebrush, perennial grass, and weedy annual vegetation.
