Final Reclamation Inspection

Operator: KERR MCGEE OIL & GAS ONSHORE LP - 47120

Location ID: 327415

Inspection Photos
Location Name: HSR-FOGELMAN #6-26A
Location ID: 327415

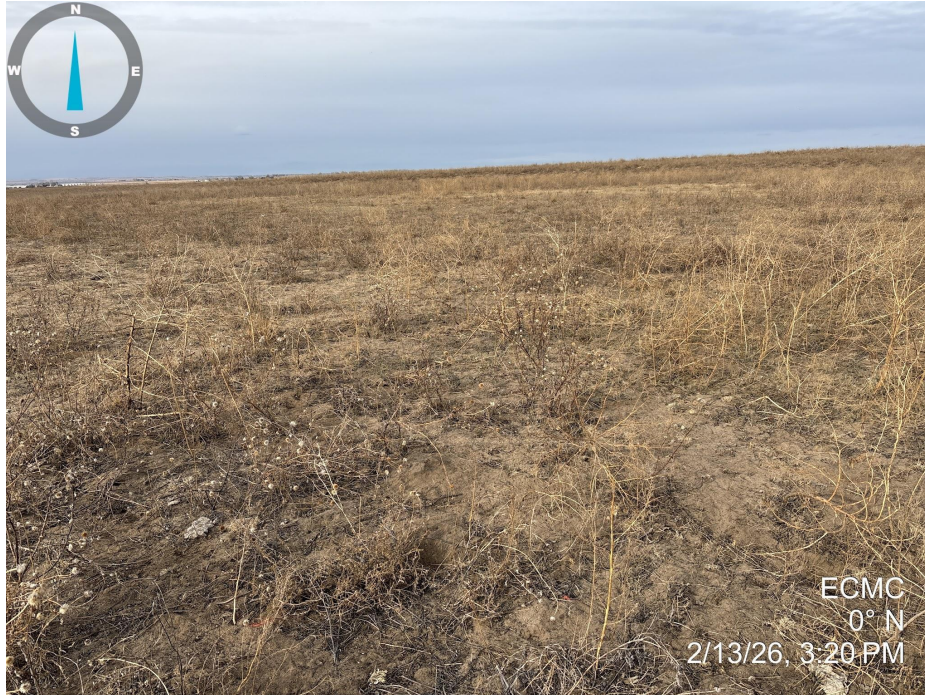
Photo 1. Photo taken of the well location, facing north. Photo illustrates that final reclamation activities appear to have taken place and vegetation is establishing at the location.

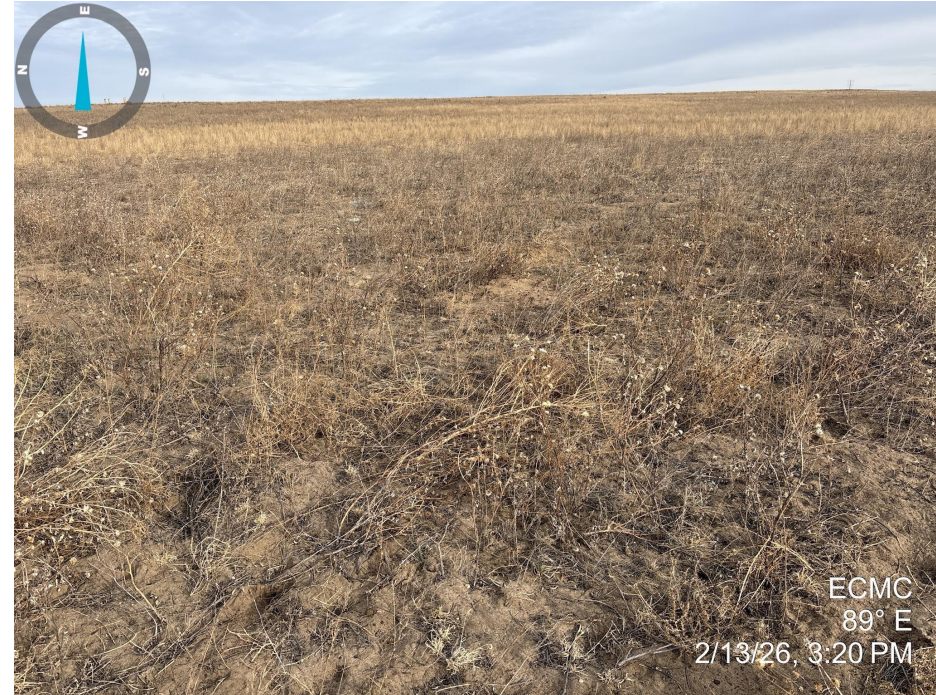
Photo 2. Photo taken of the well location, facing east. See comments under Photo 1.

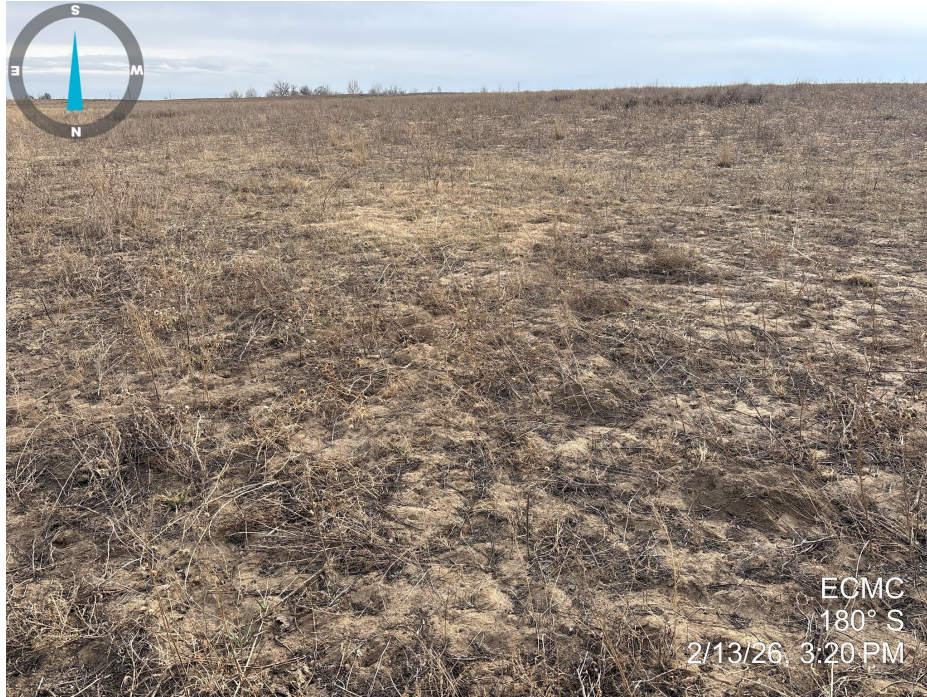
Photo 3. Photo taken of the well location, facing south. See comments under Photo 1.

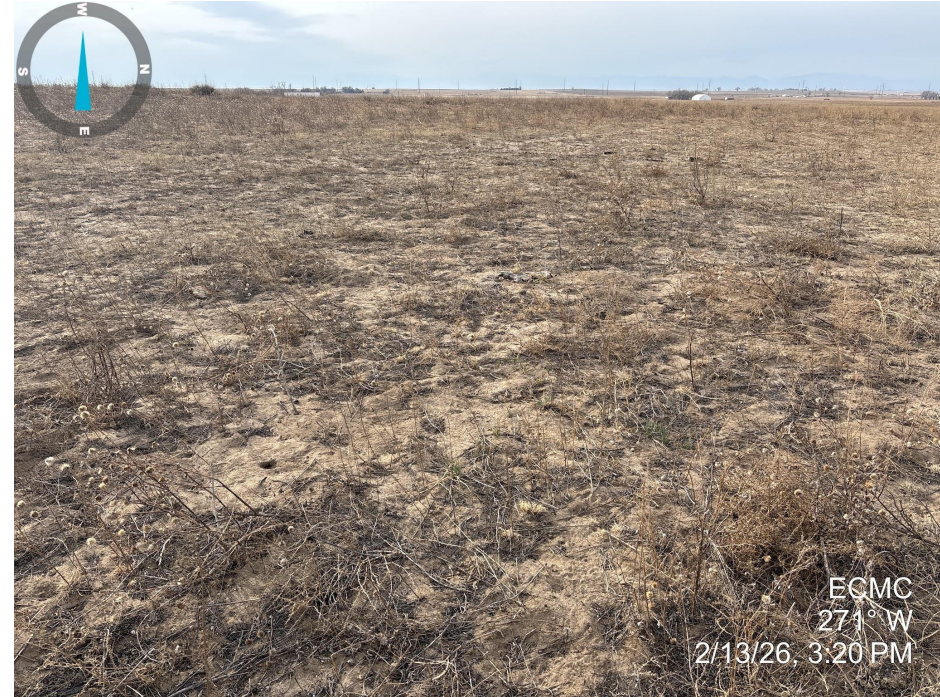
Photo 4. Photo taken of the well location, facing west. See comments under Photo 1.

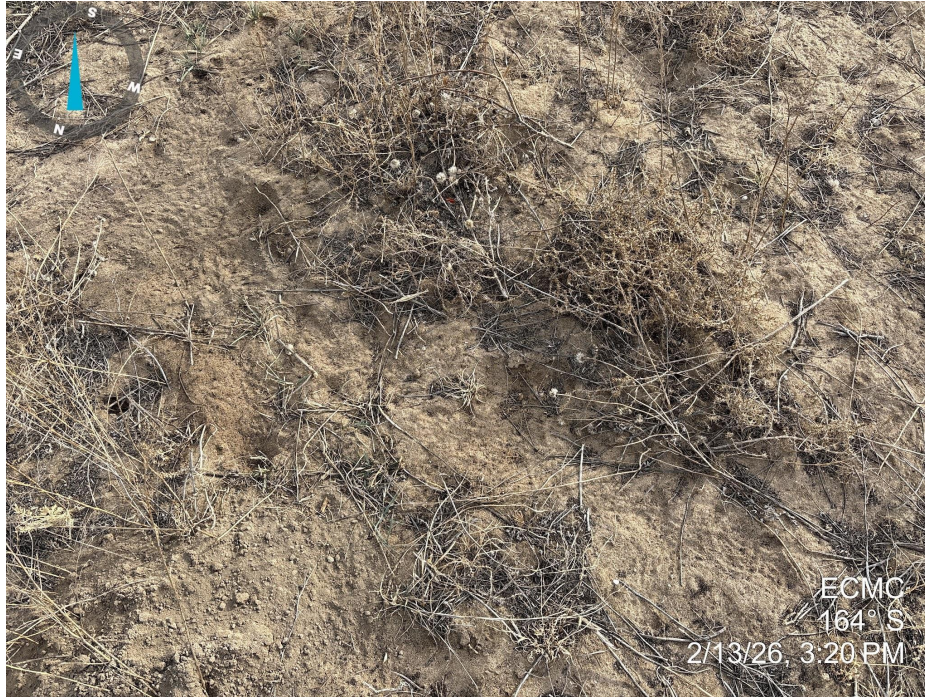
Photo 5. Photo taken of ground cover at the well location. Photo illustrates bare ground, perennial grass, and weedy annual vegetation including russian thistle (*Salsola tragus*) and kochia (*Bassia scoparia*).

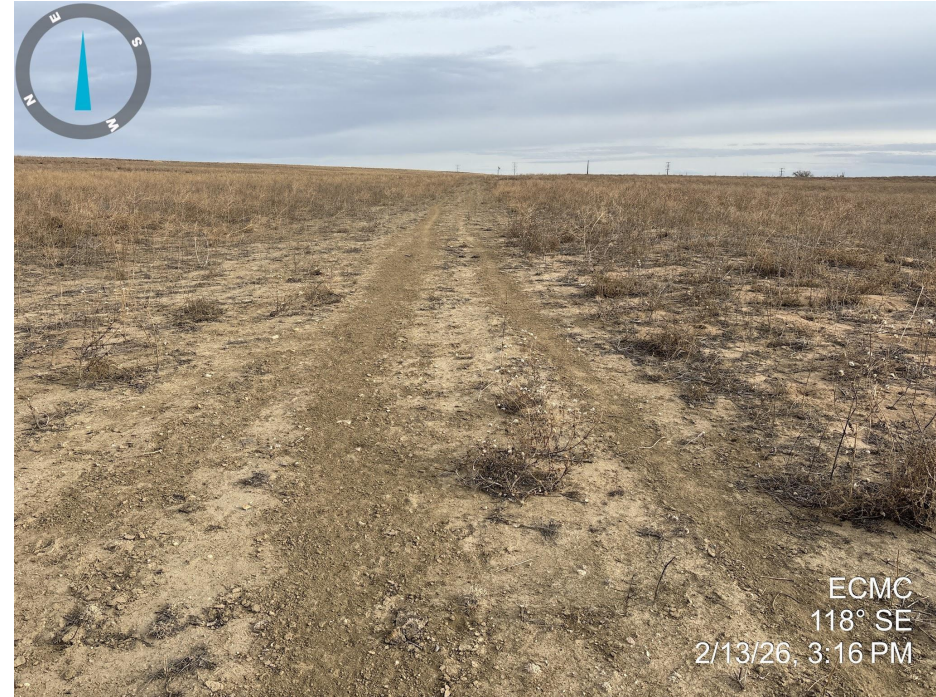
Photo 6. Photo taken of the access road to the location, facing southeast, towards the location. Photo illustrates that final reclamation activities appear to have taken place, but vegetation has not established to Rule 1004 standards.

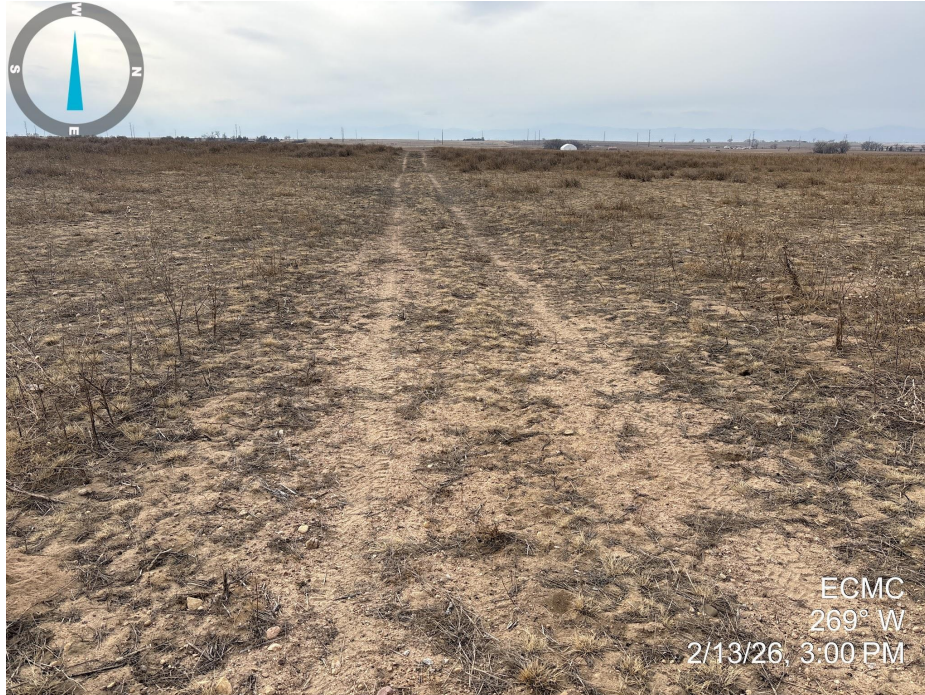
Photo 7. Photo taken of the access road to the location, facing west, away from the location. See comments under Photo 6.

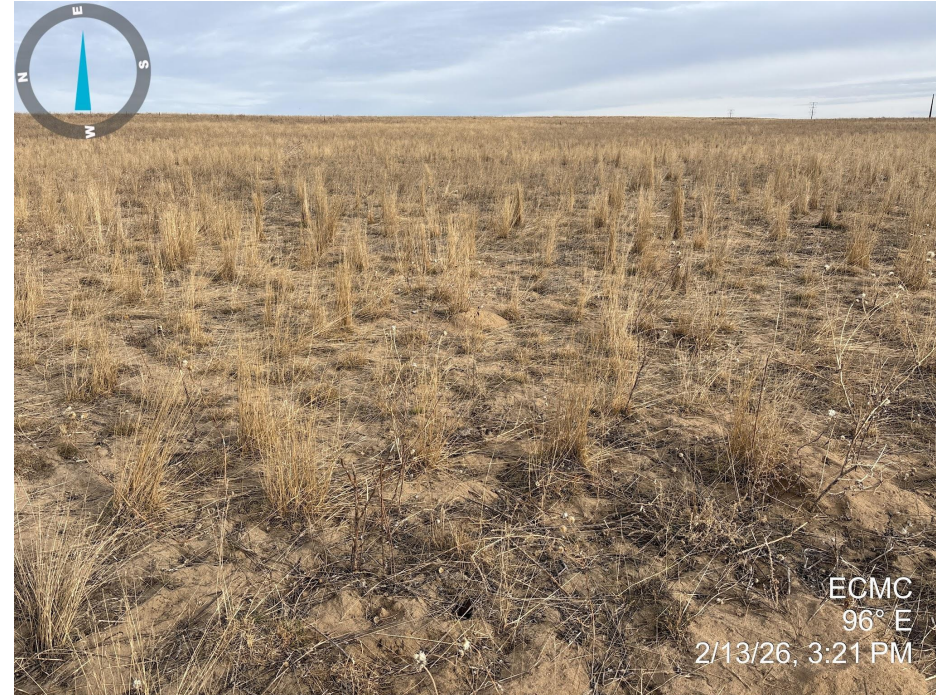
Photo 8. Photo taken of the reference area to the location, east of the location, facing east. Photo illustrates perennial grass and weedy annual vegetation.
