# Final Reclamation Inspection

February 13, 2026

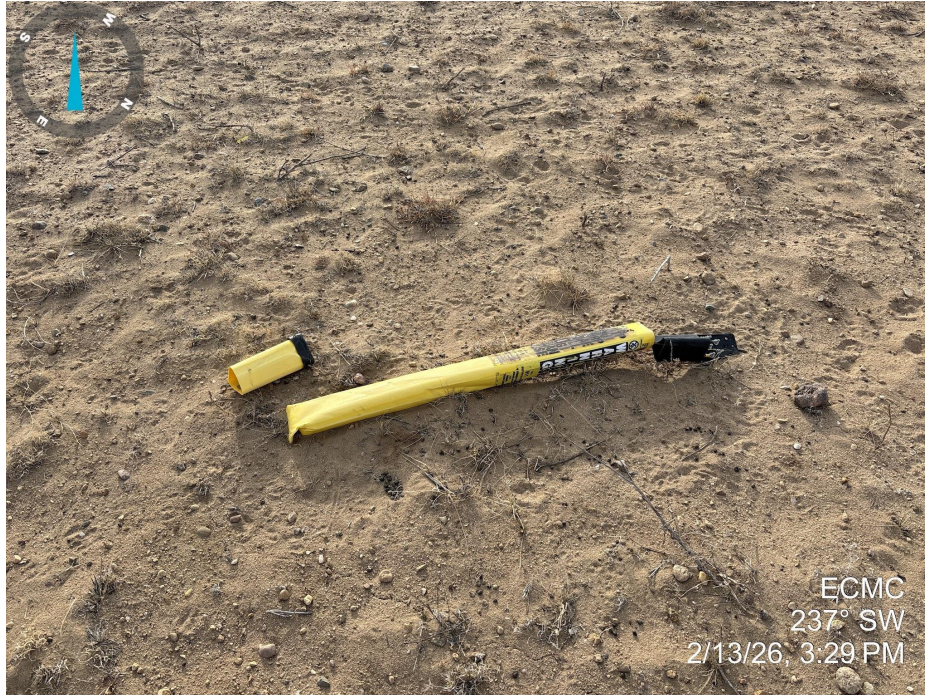
**Photo 9.** Photo taken of the tank battery location, facing southwest. Photo illustrates a pipeline marker that has been broken.

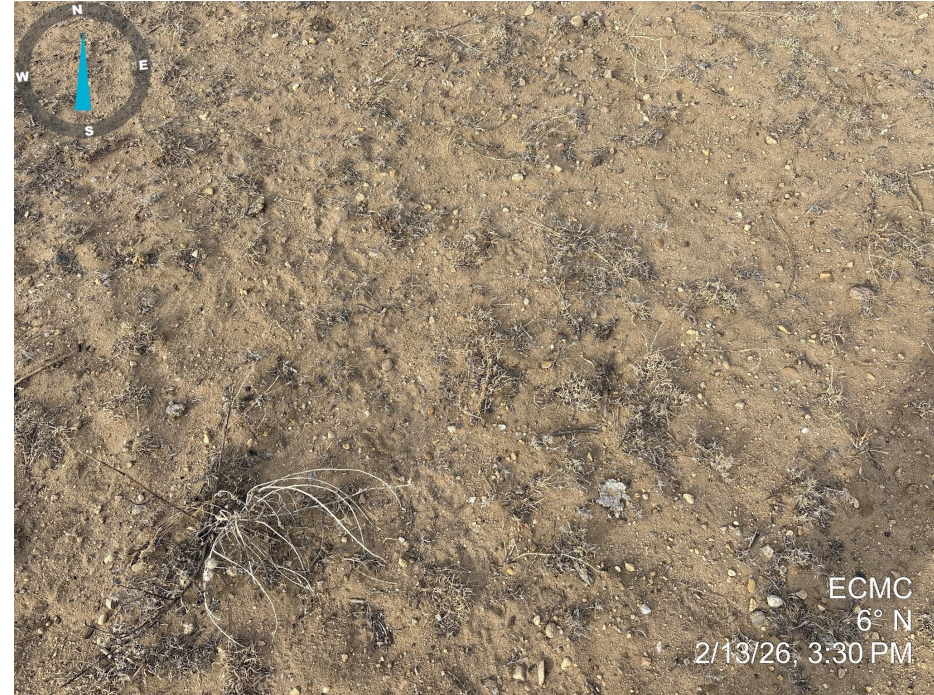
**Photo 10.** Photo taken of ground cover at the tank battery location. Photo illustrates bare ground, gravel, and perennial grass.
