Final Reclamation Inspection

Operator: KERR MCGEE OIL & GAS ONSHORE LP - 47120

Location ID: 317547

Inspection Photos
Location Name: UPRR 22 PAN AM A #1
Location ID: 317547

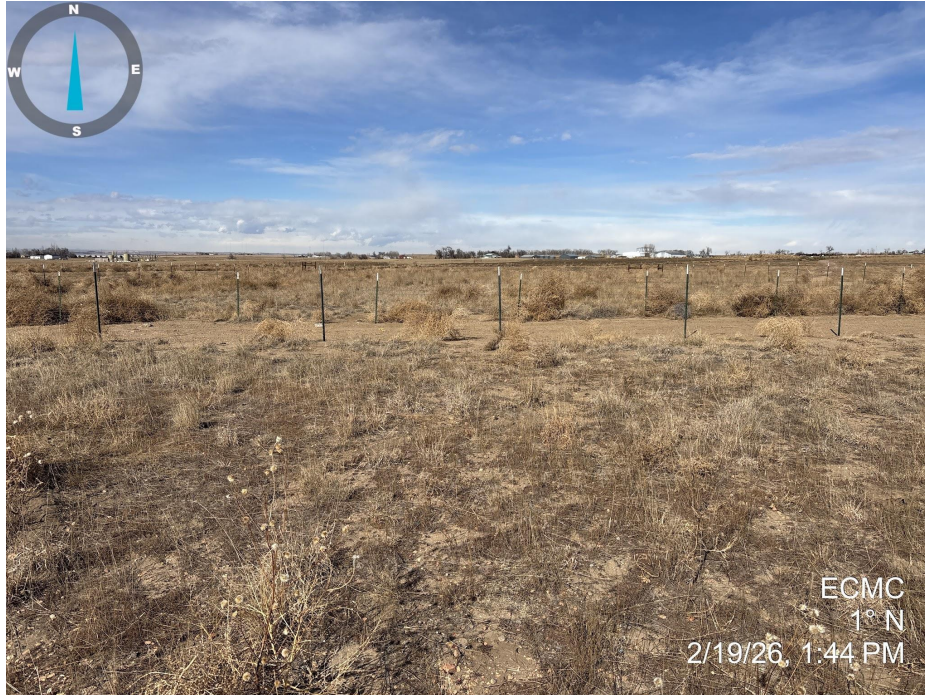
Photo 1. Photo taken of the well location, facing north. Photo illustrates that final reclamation activities appear to have taken place at the well location, but vegetation establishment does not meet Rule 1004 standards as weedy annual vegetation including cheatgrass (*Bromus tectorum*), a List C Noxious Weed species was observed at the location. Fencing is in place surrounding the location.

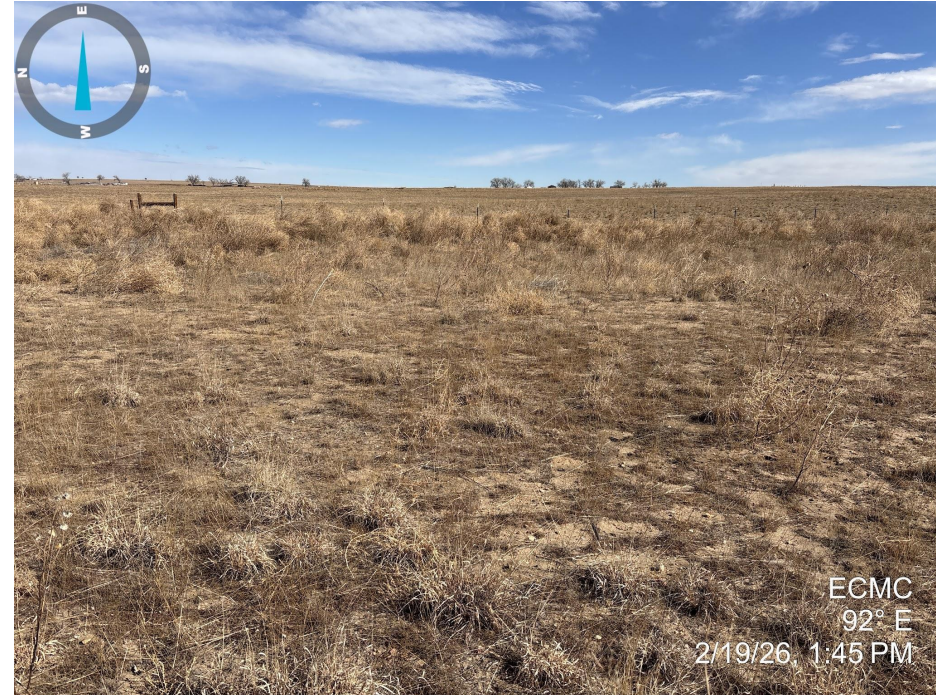
Photo 2. Photo taken of the well location, facing east. See comments under Photo 1.

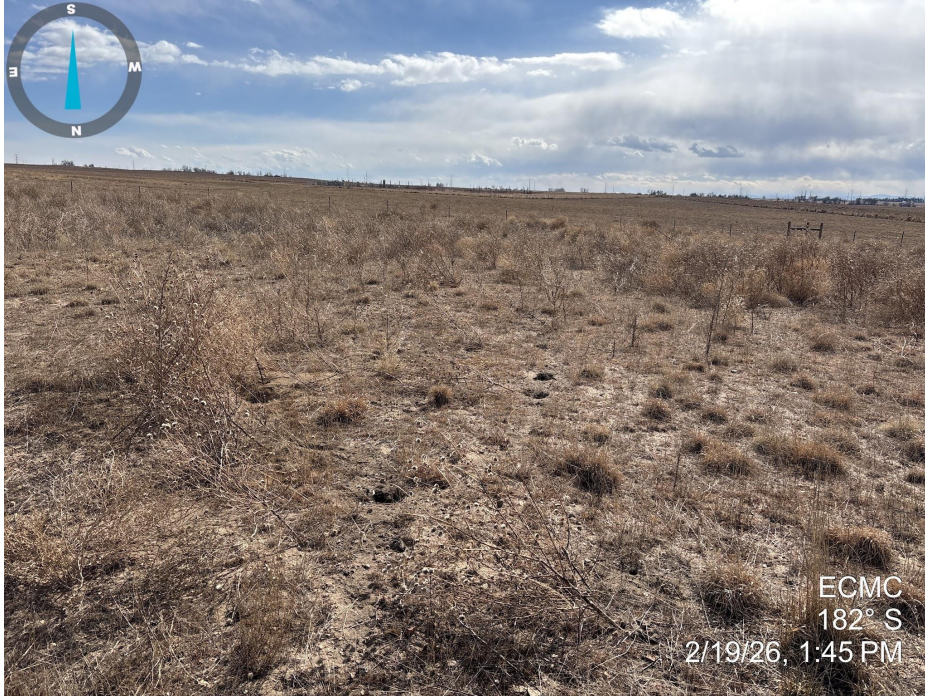
Photo 3. Photo taken of the well location, facing south. See comments under Photo 1.

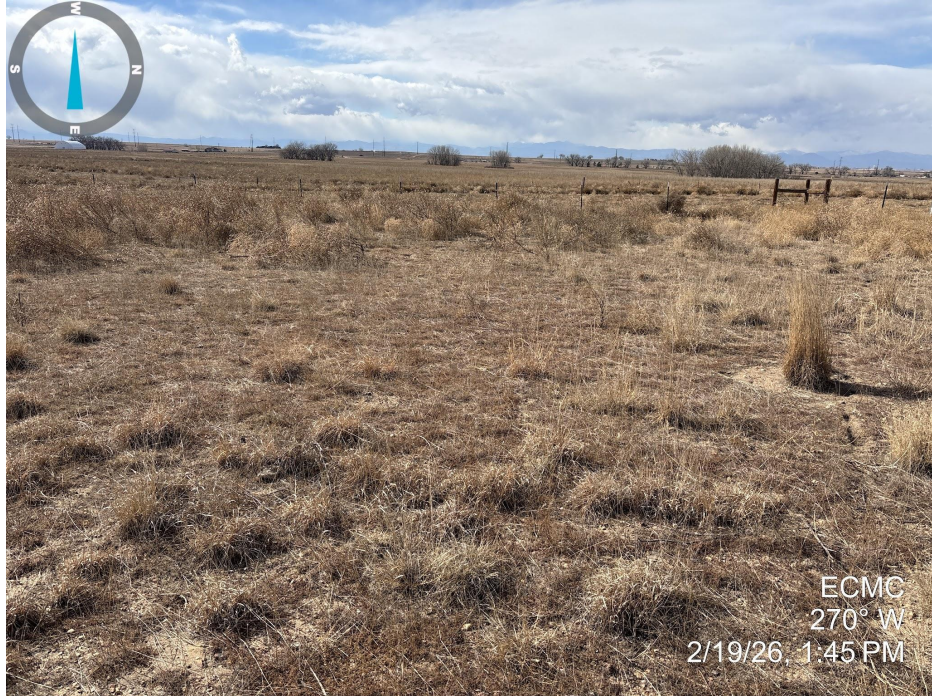
Photo 4. Photo taken of the well location, facing west. See comments under Photo 1.

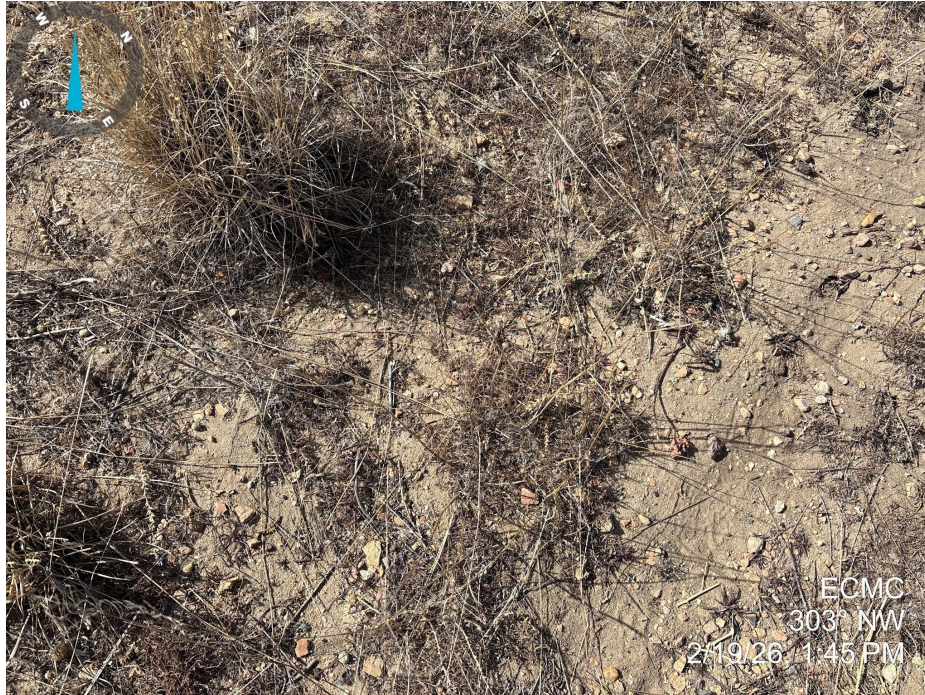
Photo 5. Photo taken of ground cover at the well location. Photo illustrates bare ground, perennial grass, and weedy annual vegetation including cheatgrass (*Bromus tectorum*), a List C Noxious Weed species.

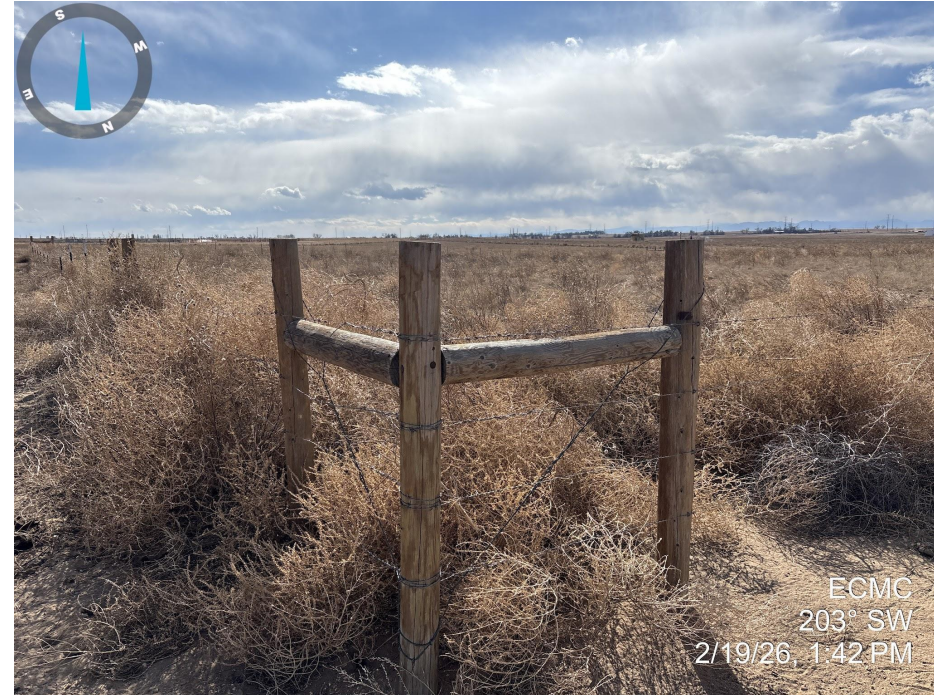
Photo 6. Photo taken of the well location, facing southwest. Photo illustrates that a fence remains surrounding the location.

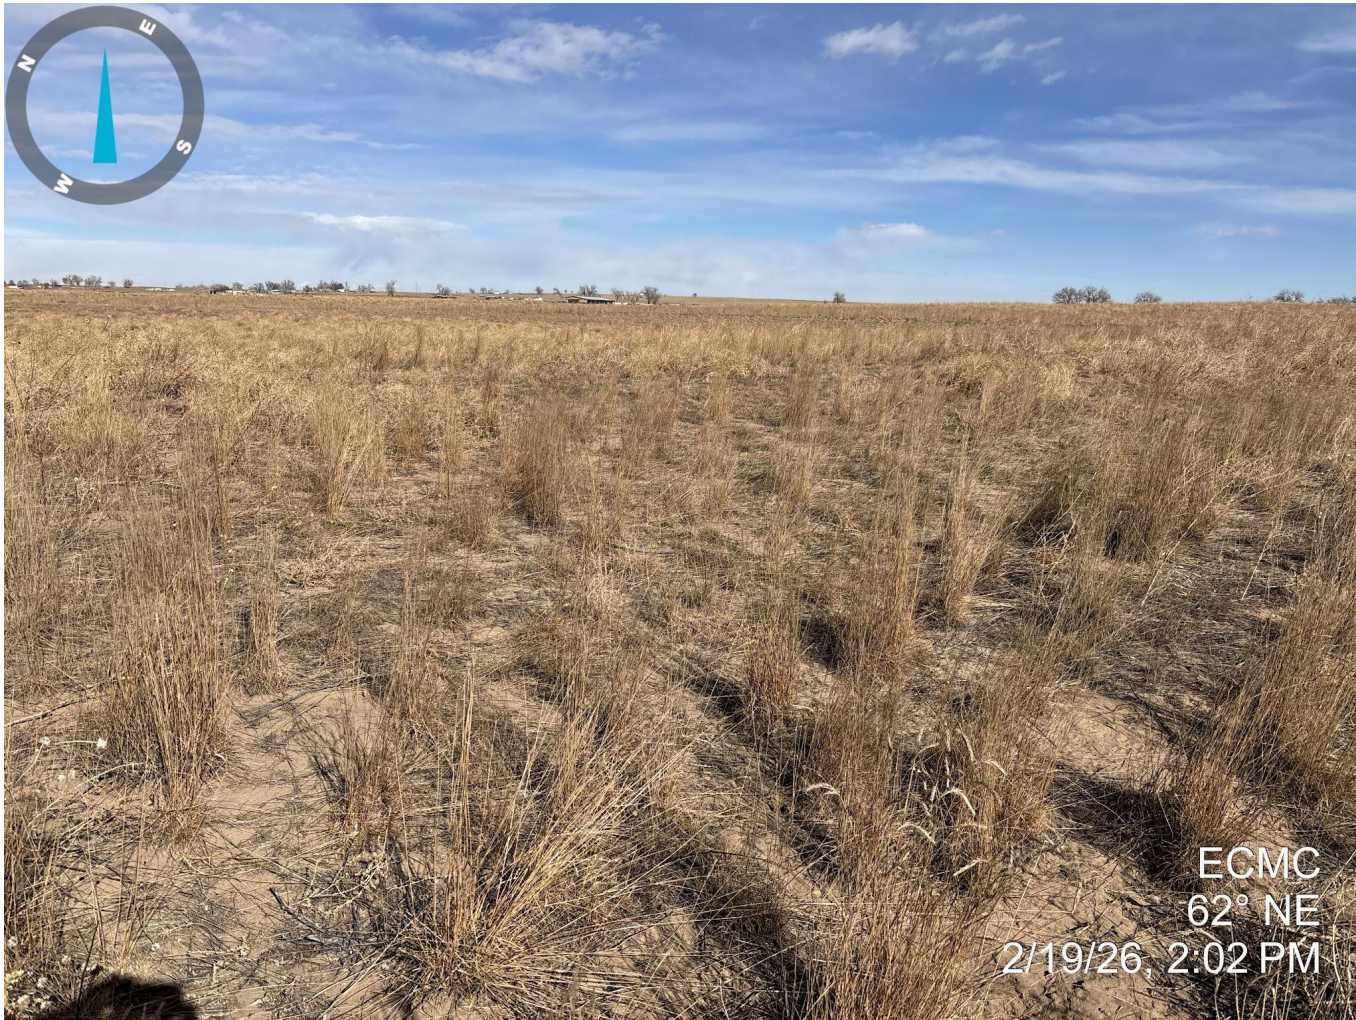
Photo 7. Photo taken of the reference area to the location, south of the location, facing northeast. Photo illustrates perennial grass and weedy annual vegetation.
