Final Reclamation Inspection

Operator: KERR MCGEE OIL & GAS ONSHORE LP - 47120

Location ID: 305125

Inspection Photos
Location Name: FARLEY #19-23
Location ID: 305125

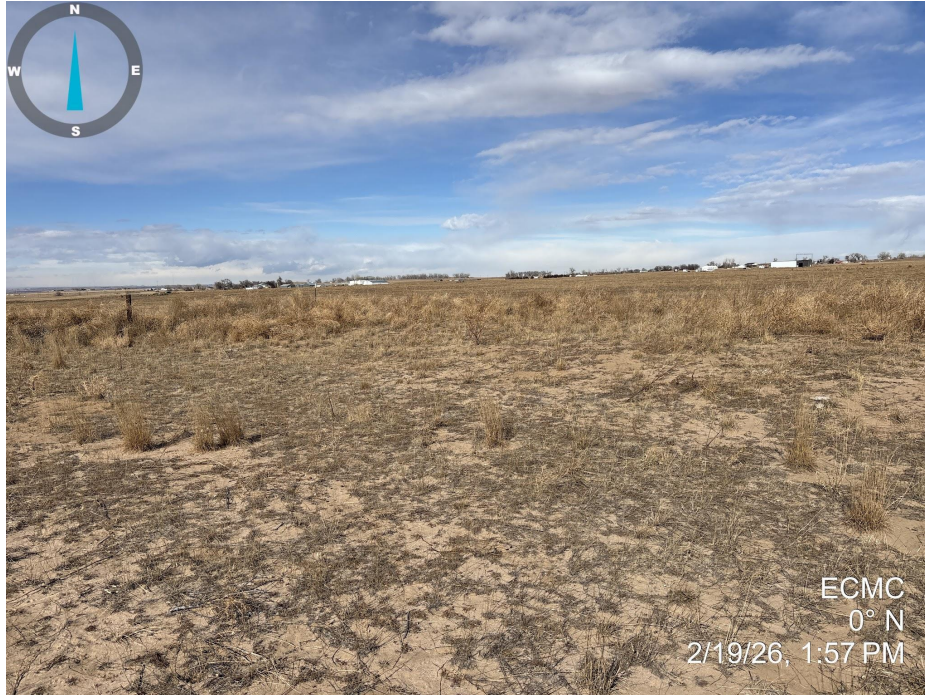
Photo 1. Photo taken of the well location, facing north. Photo illustrates that final reclamation activities appear to have taken place at the well location, but vegetation establishment does not meet Rule 1004 standards and weedy annual vegetation including cheatgrass (*Bromus tectorum*), a List C Noxious Weed species was observed at the location. Fencing is in place surrounding the location.

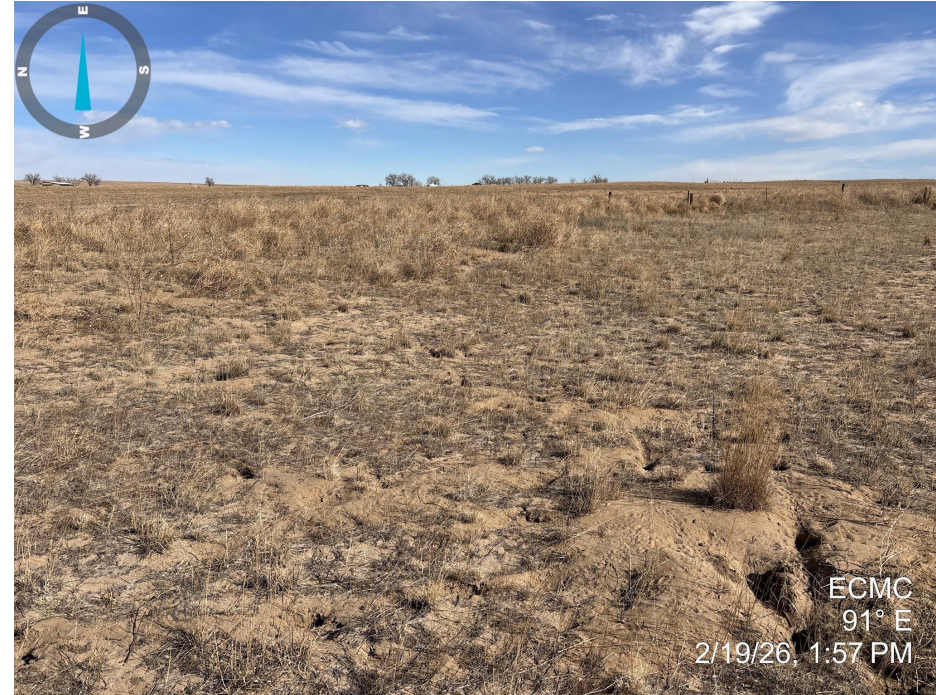
Photo 2. Photo taken of the well location, facing east. See comments under Photo 1.

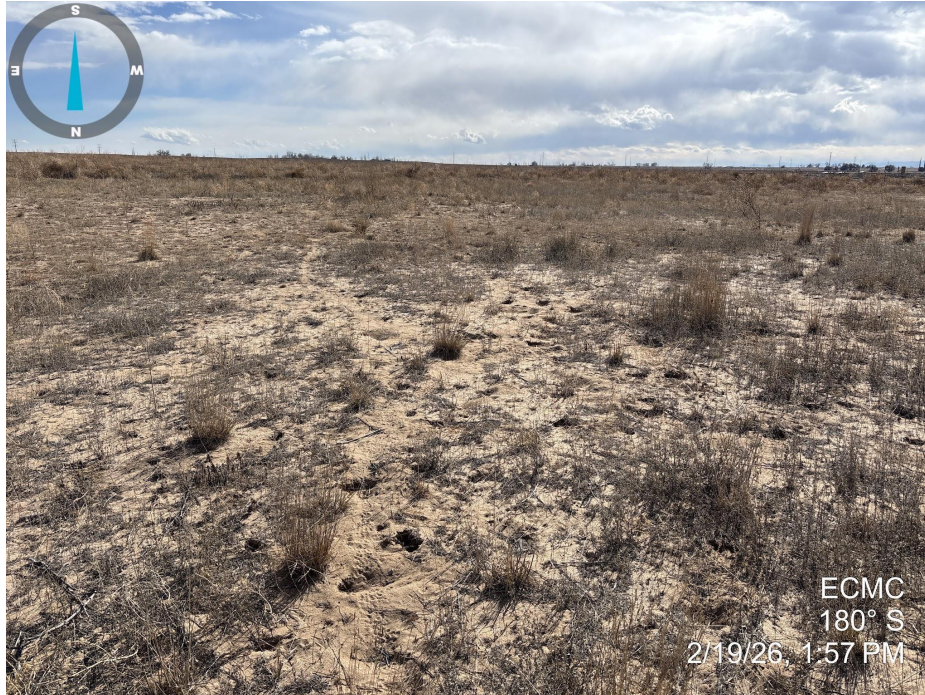
Photo 3. Photo taken of the well location, facing south. See comments under Photo 1.

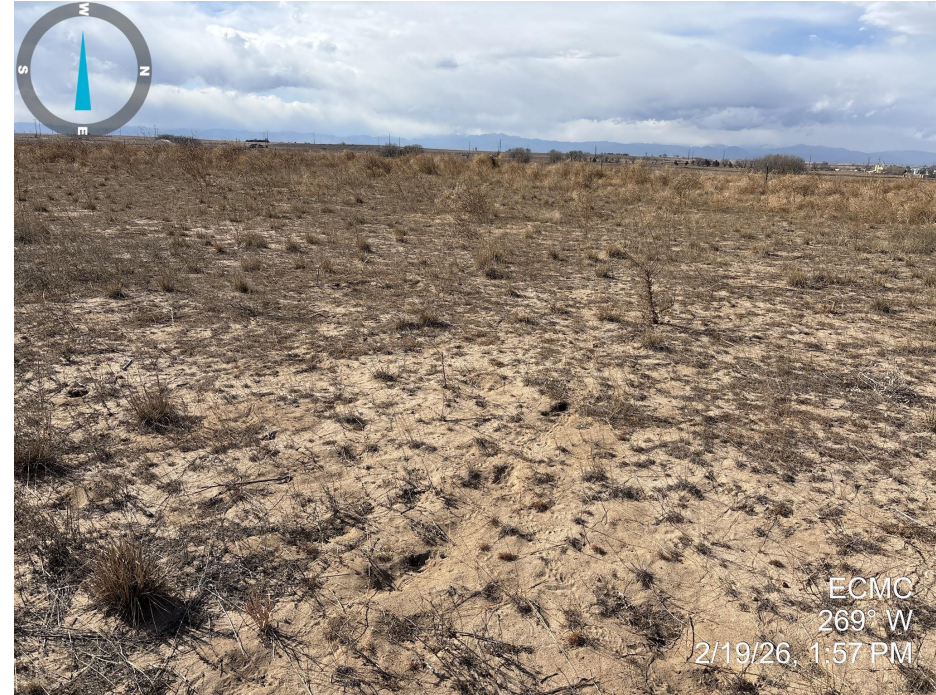
Photo 4. Photo taken of the well location, facing west. See comments under Photo 1.

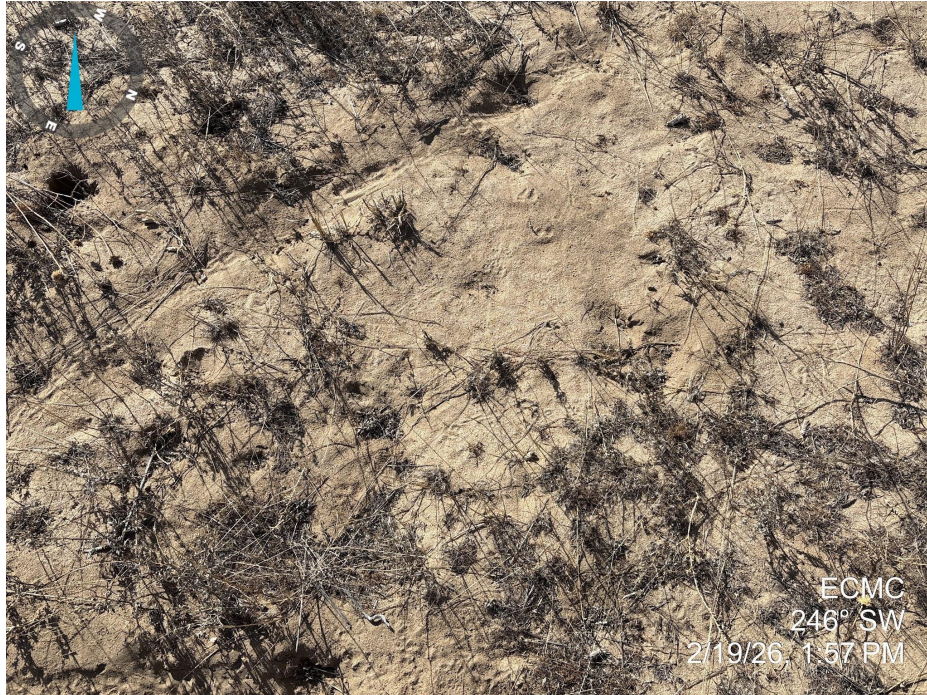
Photo 5. Photo taken of ground cover at the well location. Photo illustrates bare ground, perennial grass, and weedy annual vegetation including cheatgrass (*Bromus tectorum*), a List C Noxious Weed species.

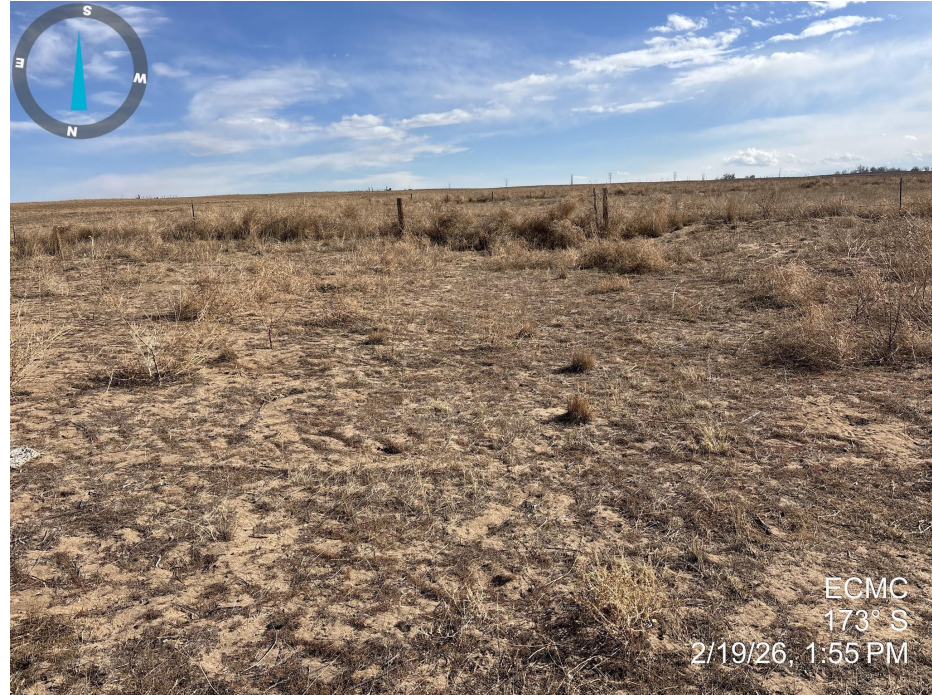
Photo 6. Photo taken of the access road to the well location, facing south, towards the location. Photo illustrates that final reclamation activities have taken place along the access road, but vegetation has not established to Rule 1004 standards.

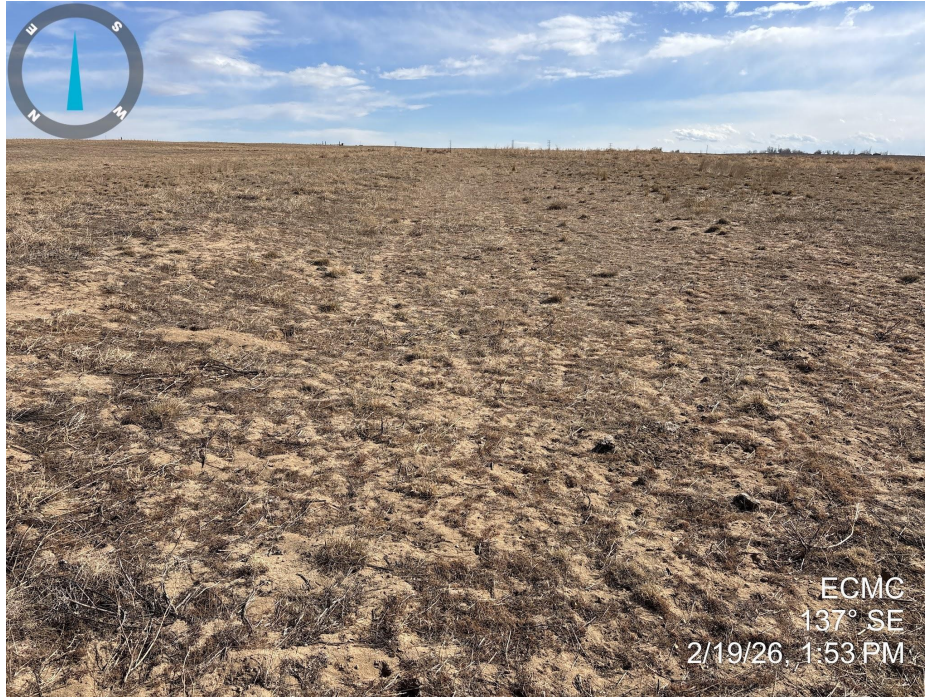
Photo 7. Photo taken of the access road to the well location, facing southeast, towards the location. See comments under Photo 6.

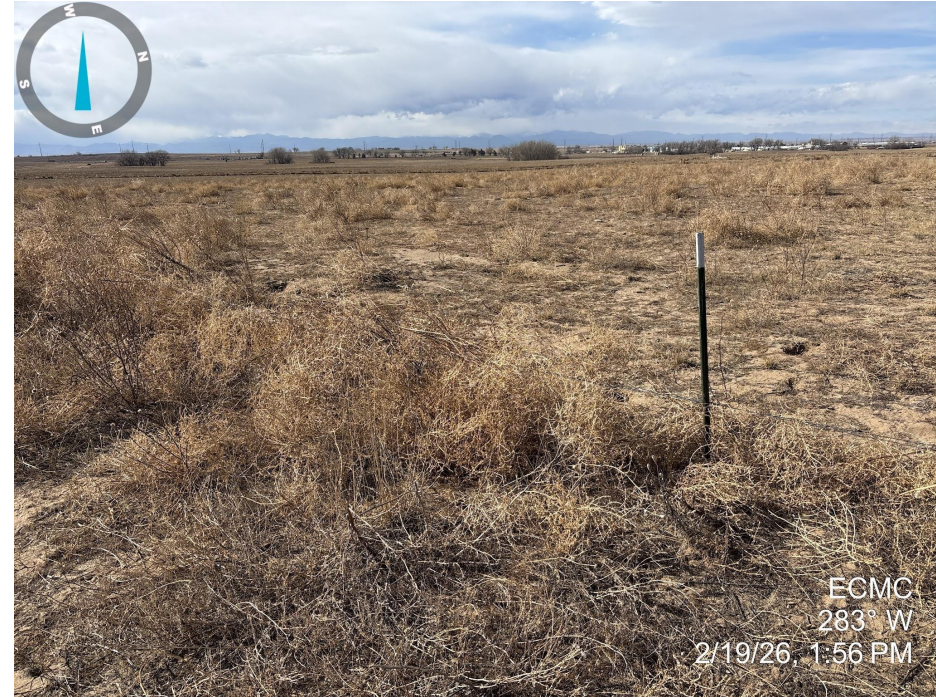
Photo 8. Photo taken of the well location, facing west. Photo illustrates that the fence is in disrepair along this portion of the location.
