Final Reclamation Inspection

Operator: KERR MCGEE OIL & GAS ONSHORE LP - 47120

Location ID: 332435

Inspection Photos
Location Name: FARLEY #23-23
Location ID: 332435

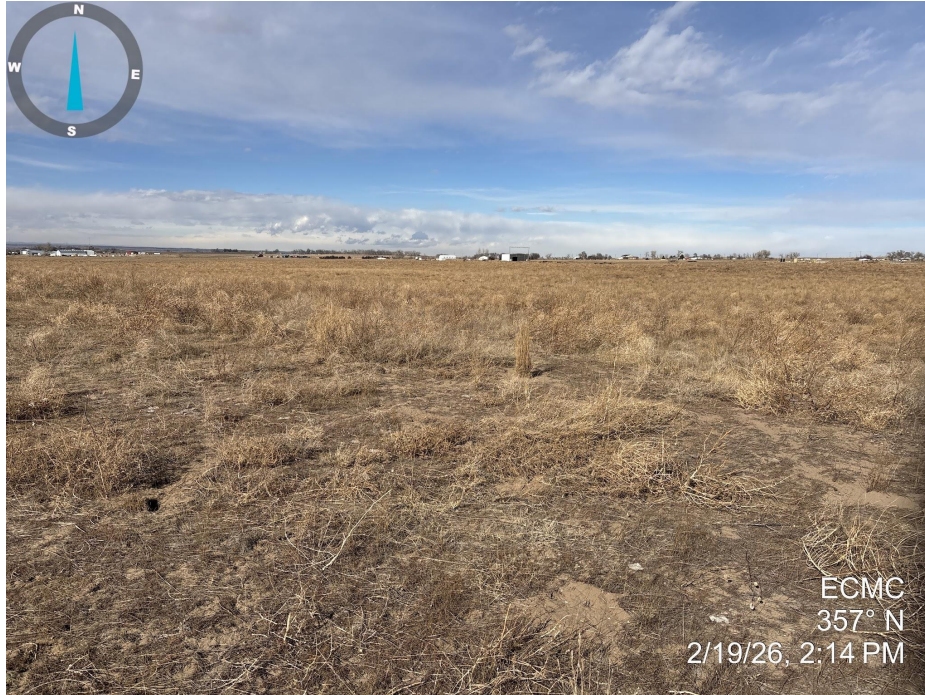
Photo 1. Photo taken of the well location, facing north. Photo illustrates that final reclamation activities appear to have taken place at the well location, but vegetation establishment does not meet Rule 1004 standards and weedy annual vegetation including cheatgrass (*Bromus tectorum*), a List C Noxious Weed species was observed at the location.

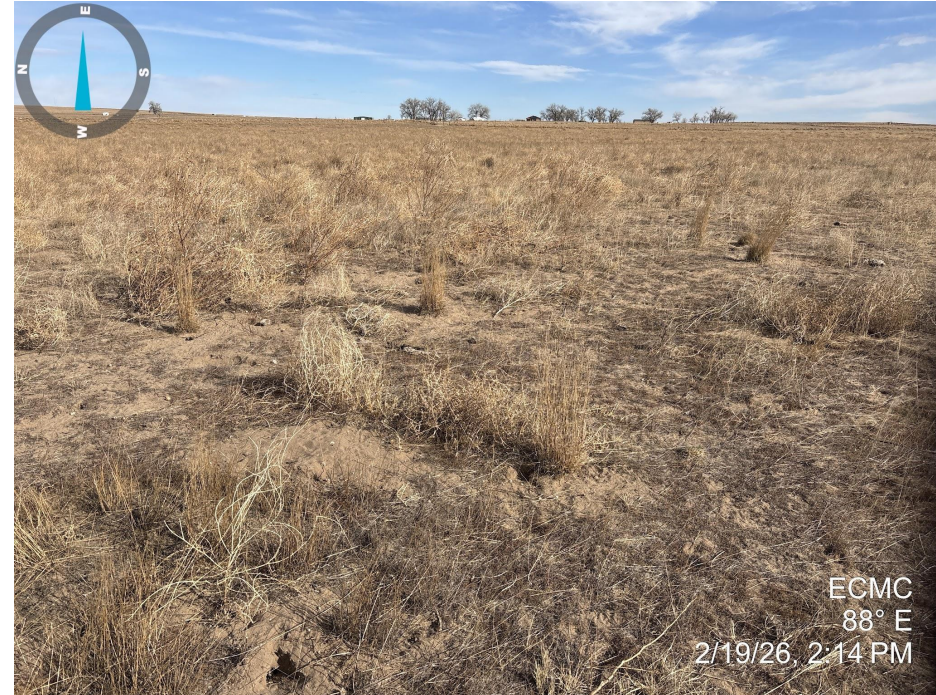
Photo 2. Photo taken of the well location, facing east. See comments under Photo 1.

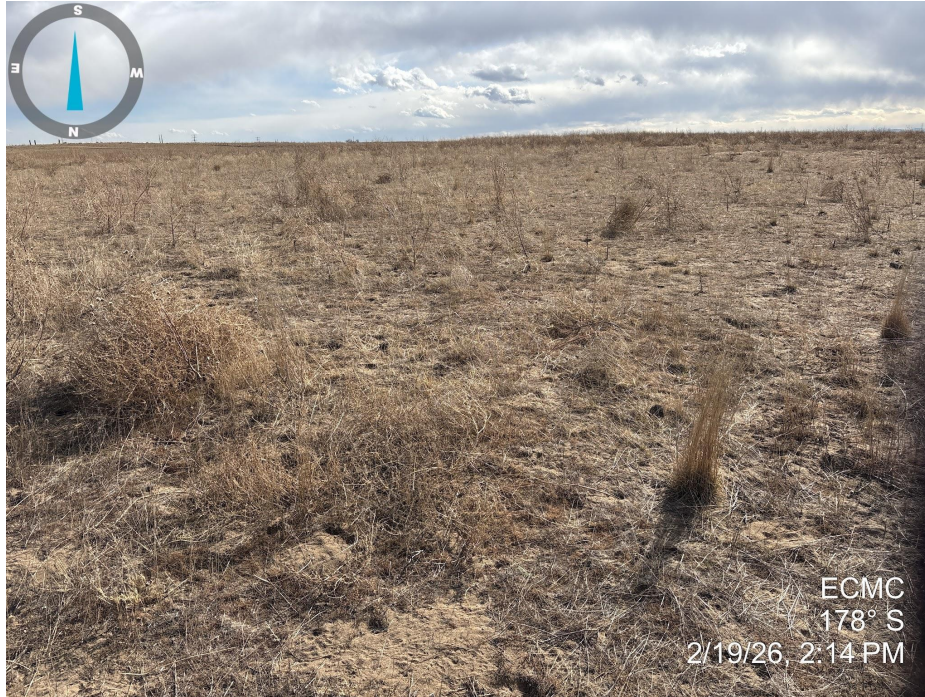
Photo 3. Photo taken of the well location, facing south. See comments under Photo 1.

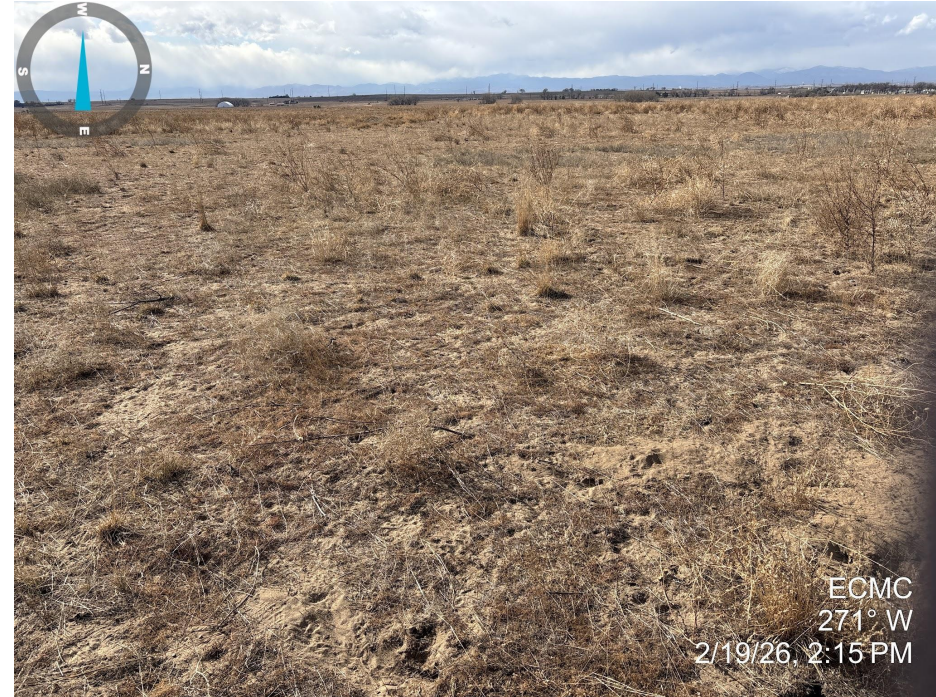
Photo 4. Photo taken of the well location, facing west. See comments under Photo 1.

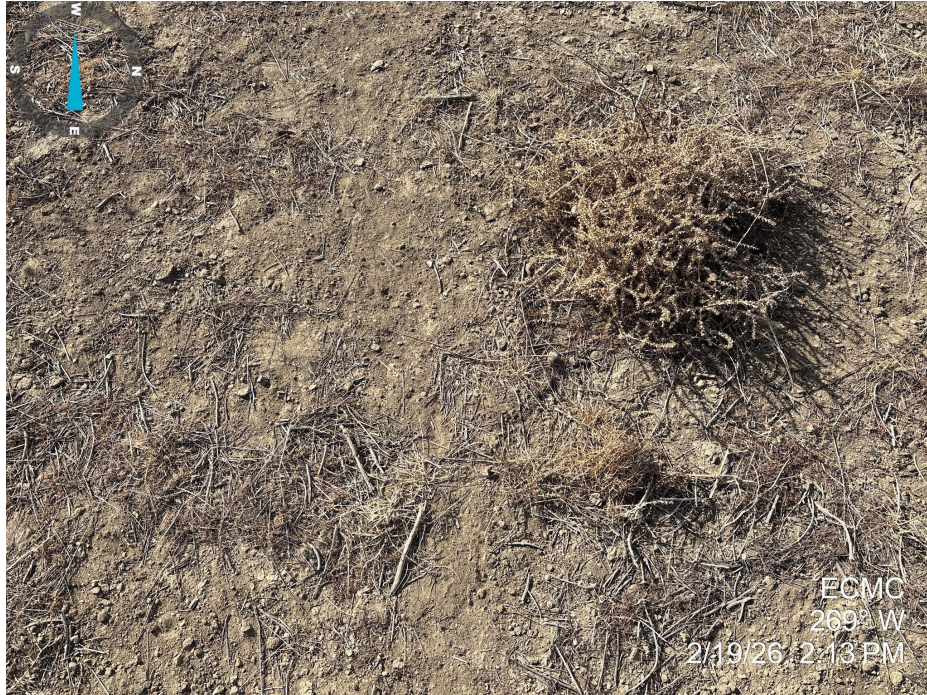
Photo 5. Photo taken of ground cover at the well location. Photo illustrates bare ground, perennial grass, and weedy annual vegetation including russian thistle (*Salsola tragus*).

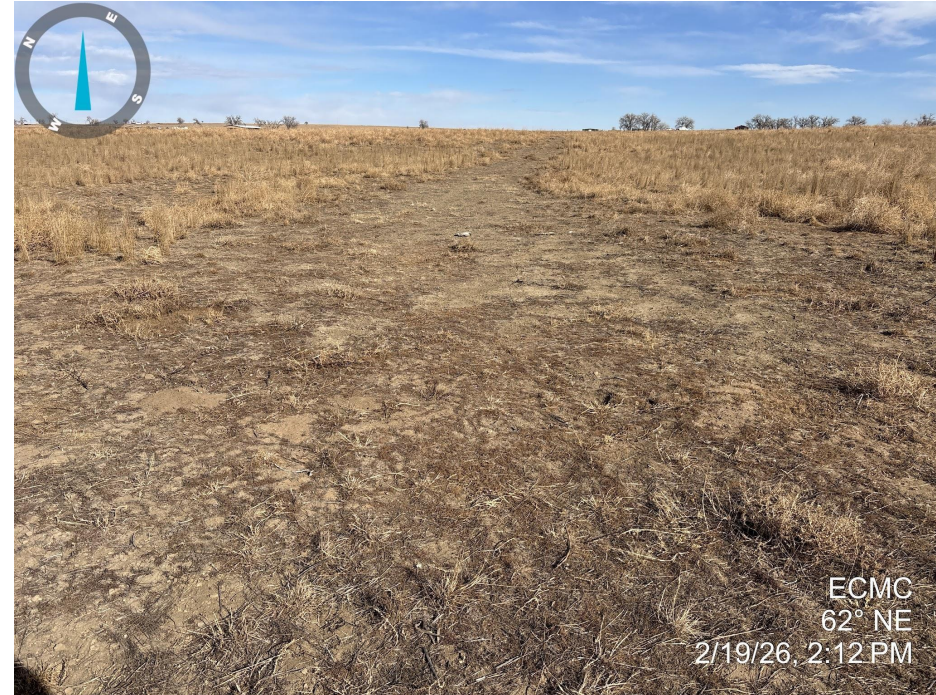
Photo 6. Photo taken of the access road to the well location, facing northeast, towards the location. Photo illustrates that final reclamation activities have taken place along the access road, but vegetation has not established to Rule 1004 standards.

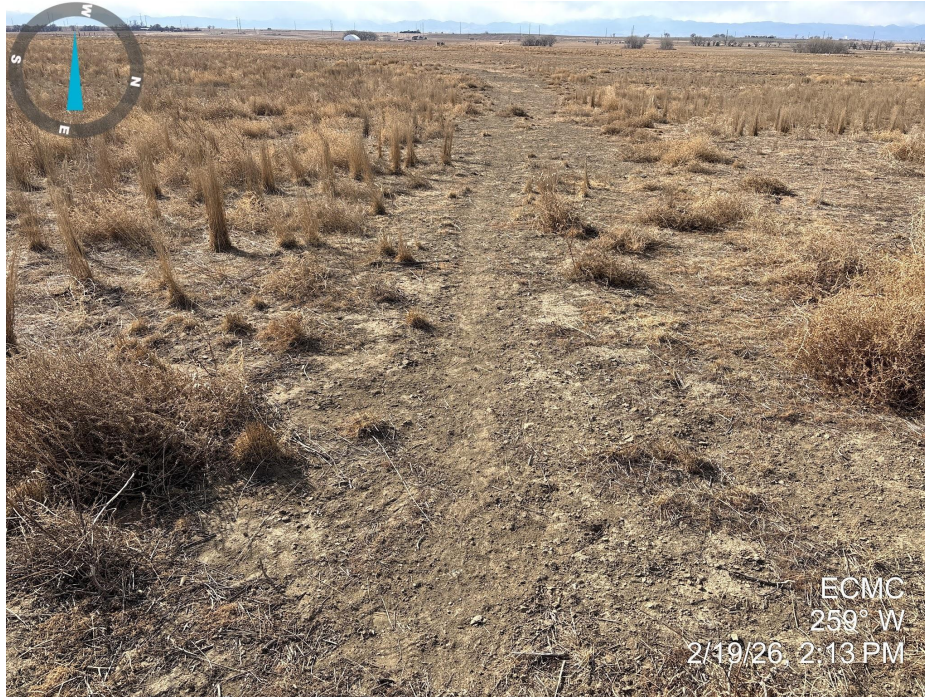
Photo 7. Photo taken of the access road to the well location, facing west, away from the location. See comments under Photo 6.

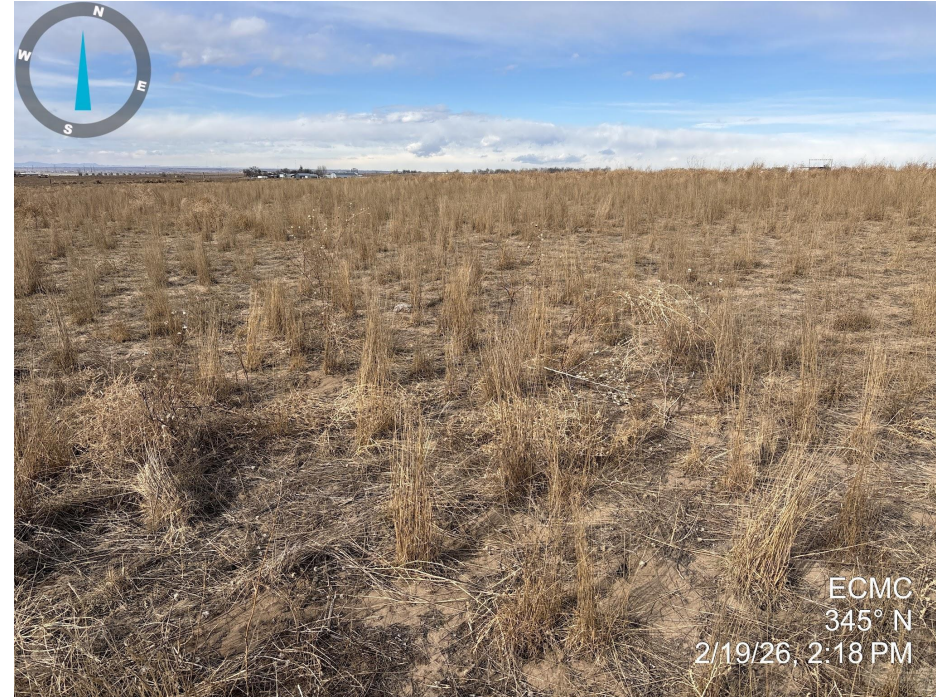
Photo 8. Photo taken of the reference area to the location, west of the location, facing north. Photo illustrates perennial grass and weedy annual vegetation.
