Final Reclamation Inspection

Operator: KERR MCGEE OIL & GAS ONSHORE LP - 47120

Location ID: 327115

Inspection Photos
Location Name: HSR-MORGAN #11-23
Location ID: 327115

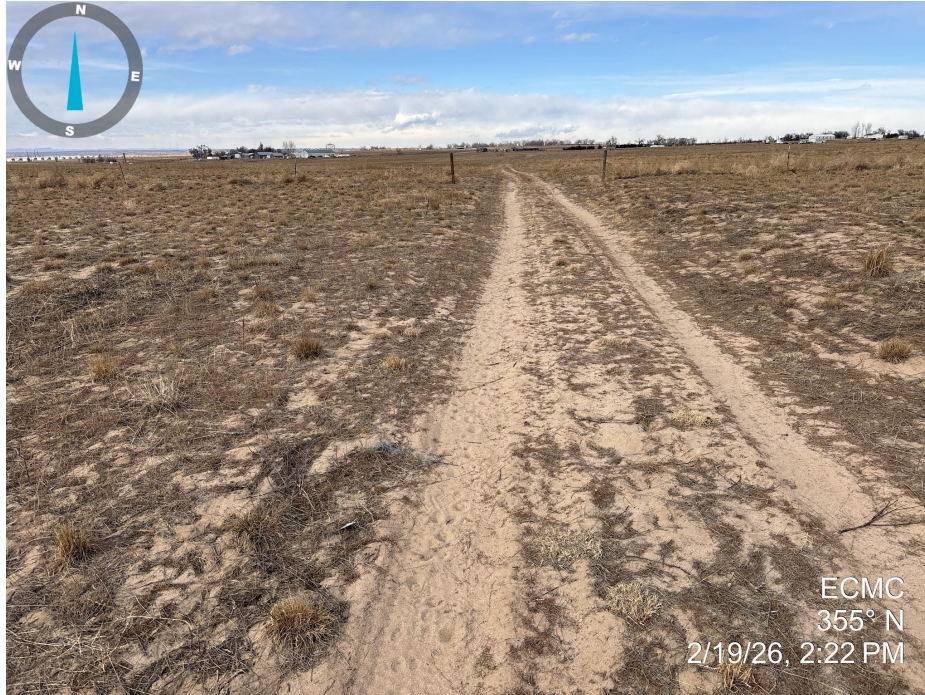
Photo 1. Photo taken of the well location, facing north. Photo illustrates that final reclamation activities appear to have taken place, but vegetation establishment does not meet Rule 1004 standards and weedy annual vegetation including cheatgrass (*Bromus tectorum*), a List C Noxious Weed species, was observed at the location. An access road to a shut-in well runs through the location.

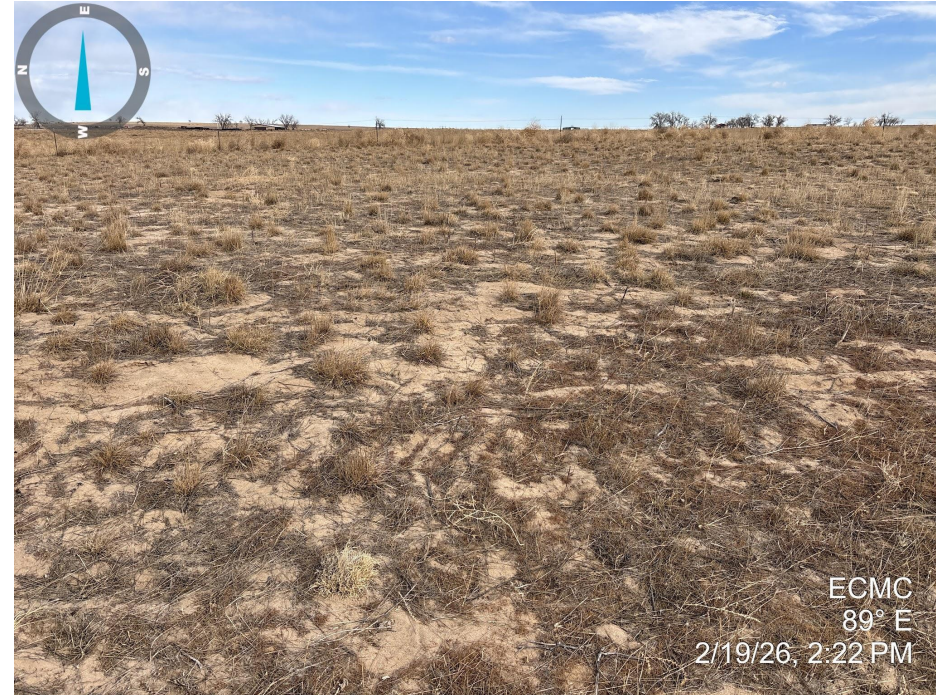
Photo 2. Photo taken of the well location, facing east. See comments under Photo 1.

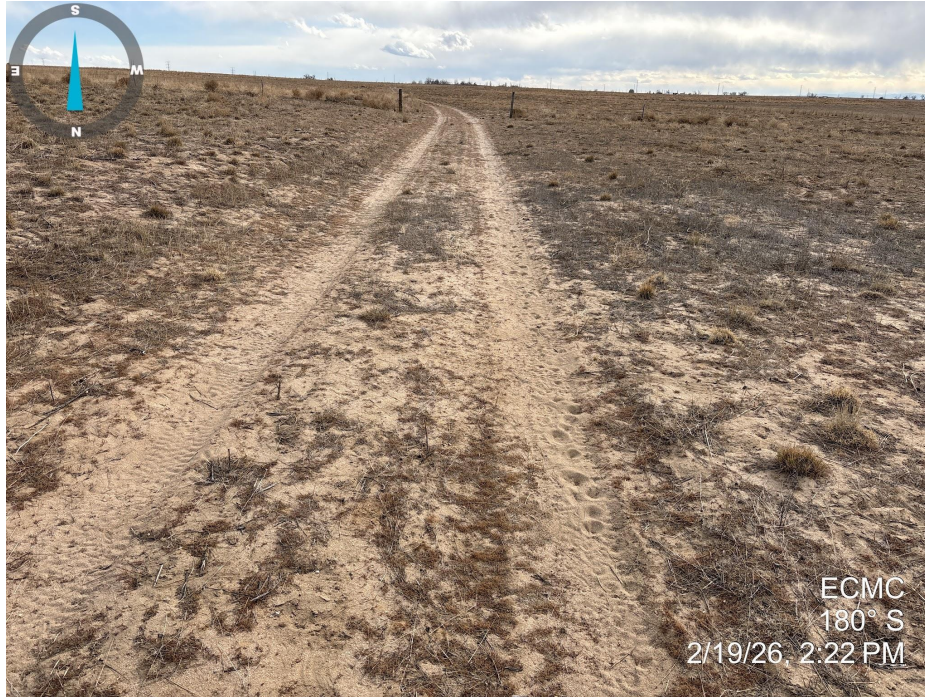
Photo 3. Photo taken of the well location, facing south. See comments under Photo 1.

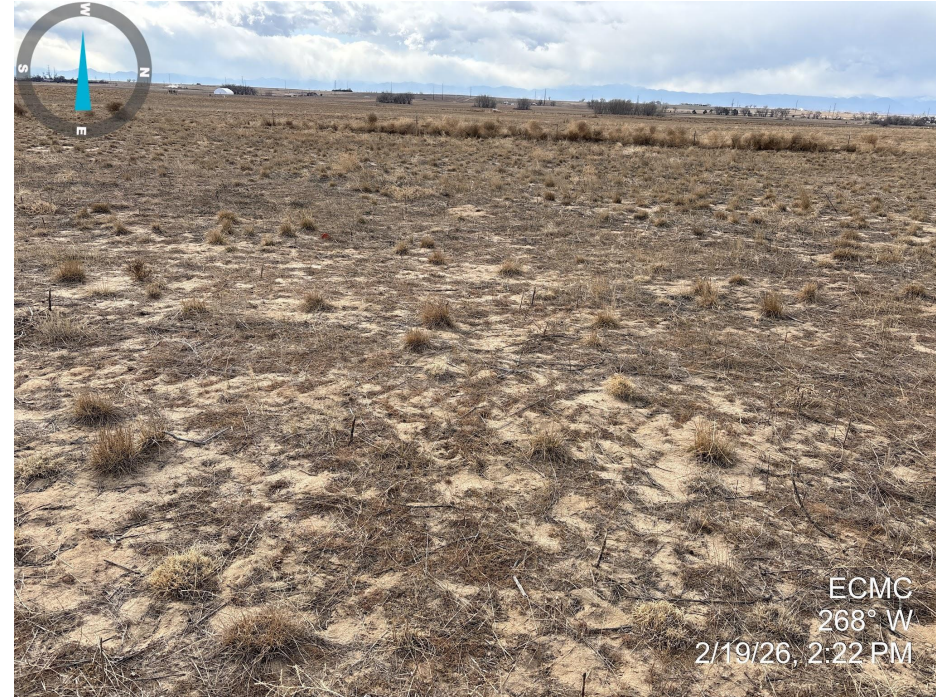
Photo 4. Photo taken of the well location, facing west. See comments under Photo 1.

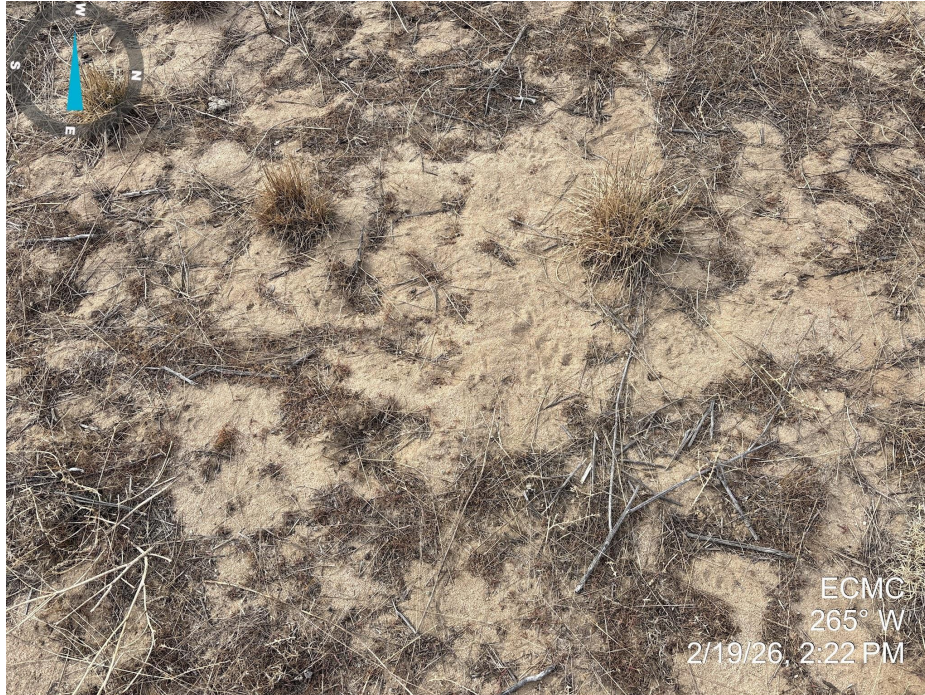
Photo 5. Photo taken of ground cover at the well location. Photo illustrates bare ground, perennial grass, and weedy annual vegetation including cheatgrass (*Bromus tectorum*), a List C Noxious Weed species.

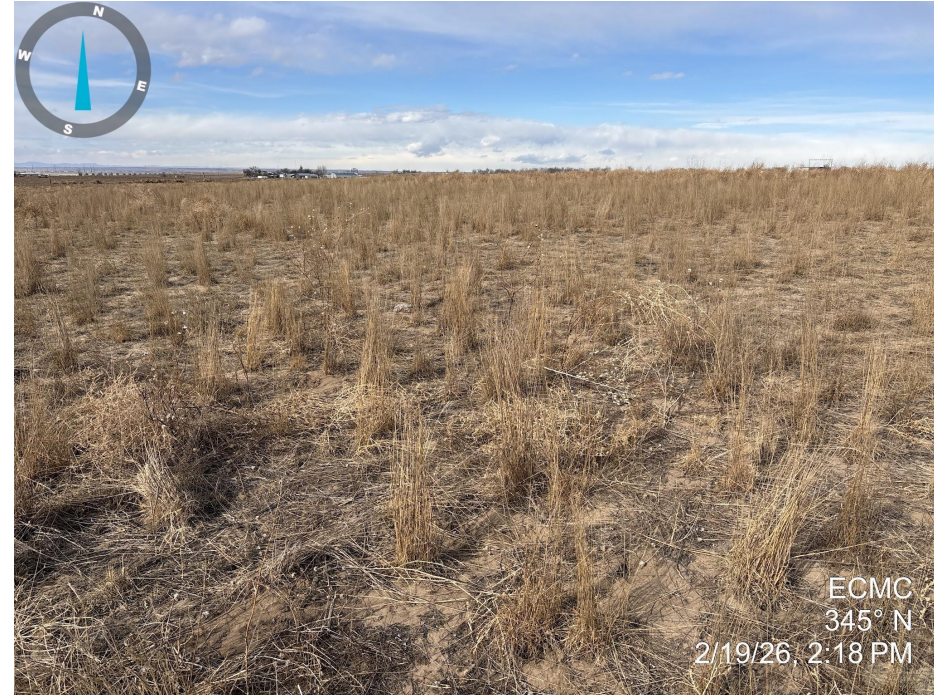
Photo 6. Photo taken of the reference area to the location, southeast of the location, facing north. Photo illustrates perennial grass and weedy annual vegetation.
