Inspection Photos

Operator: Koch Exploration Company #49100

Location ID: 316191

Inspection Doc: 719200942

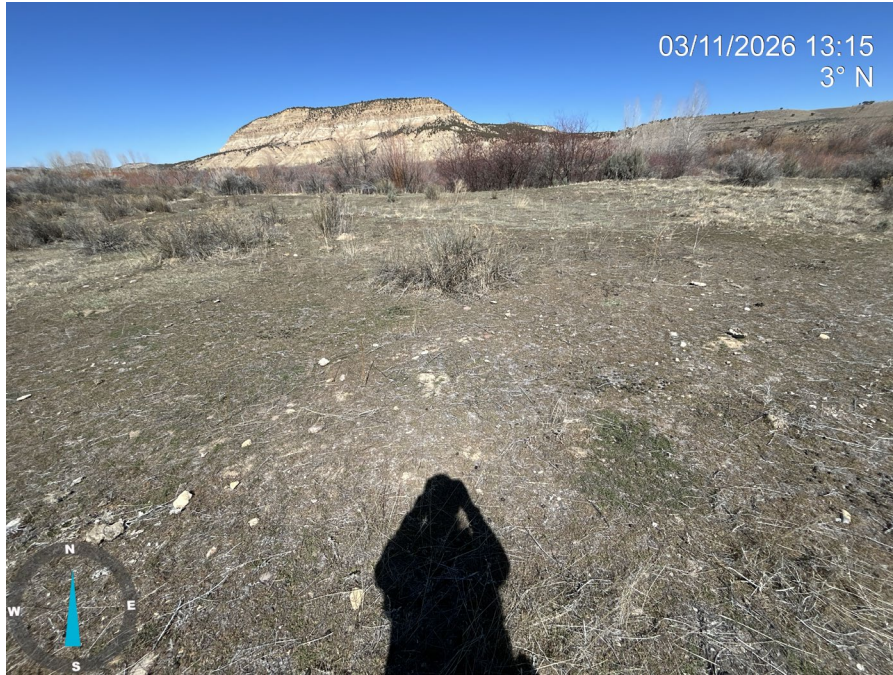
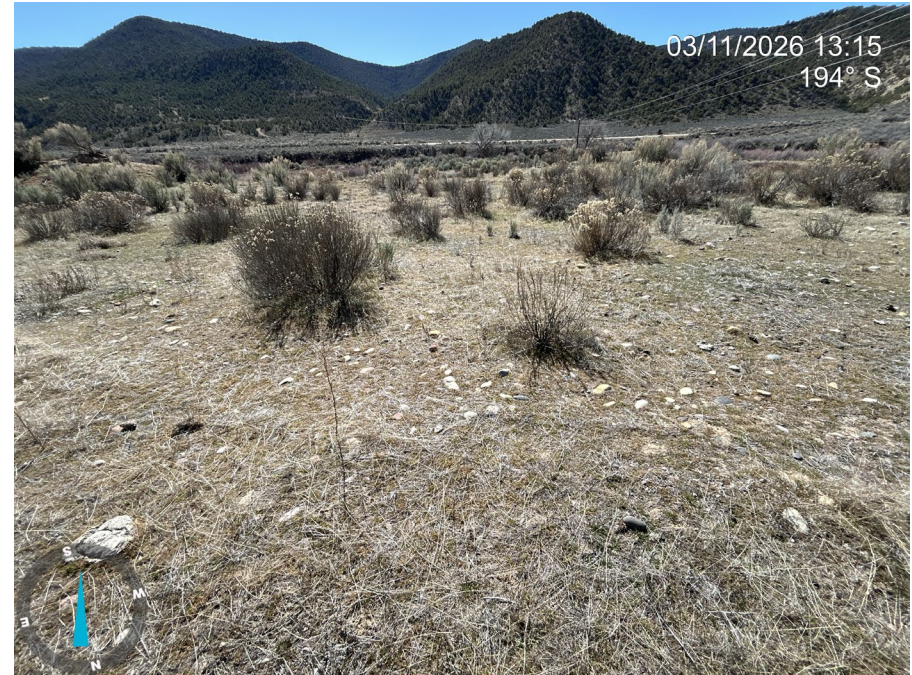
Photo 1: Photos showing an overview of the location looking north and south, respectively.

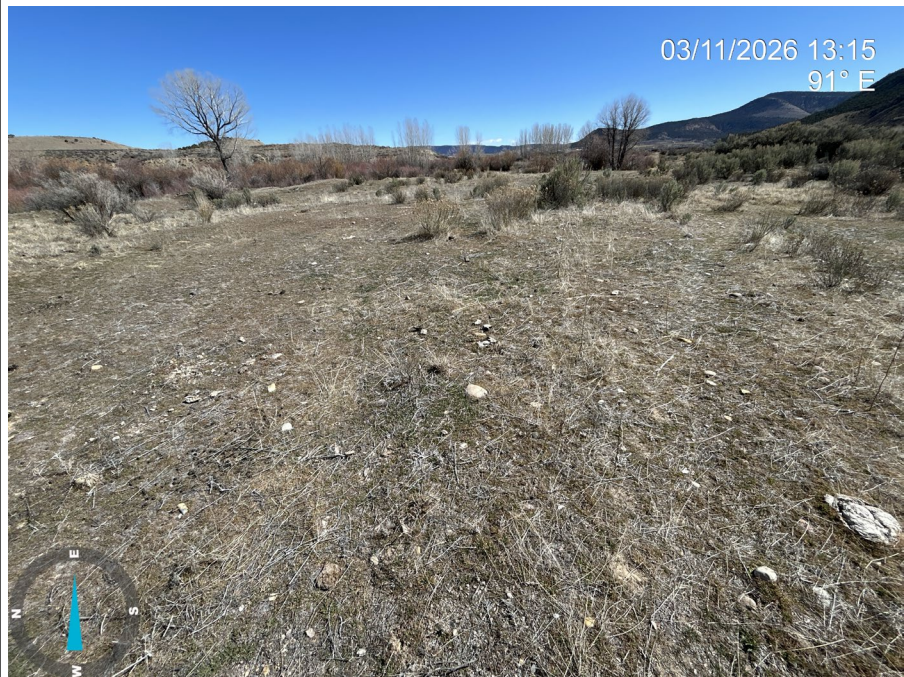
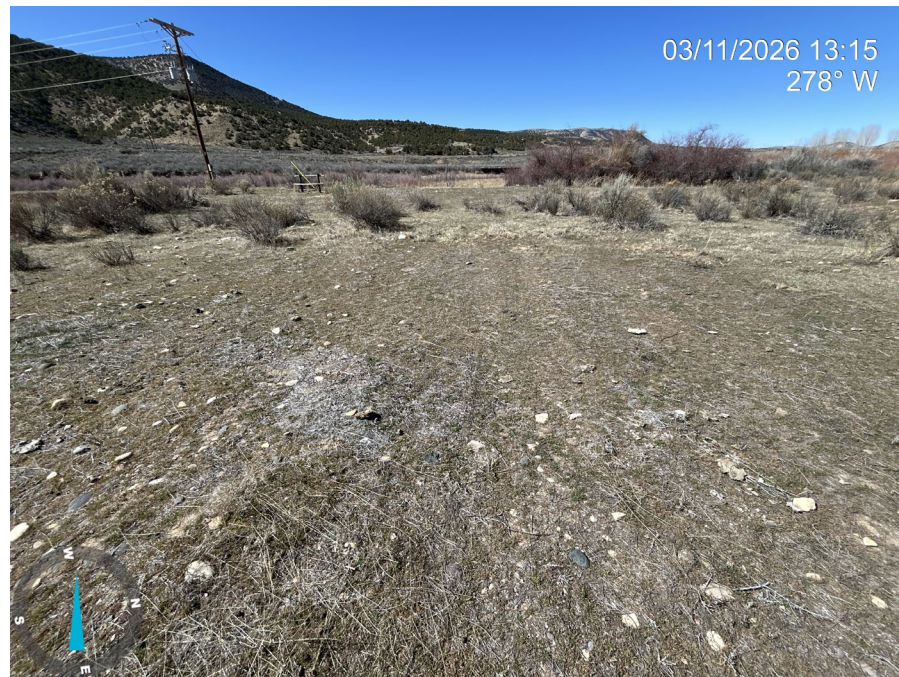
Photo 2: Photos showing an overview of the location looking east and west, respectively.

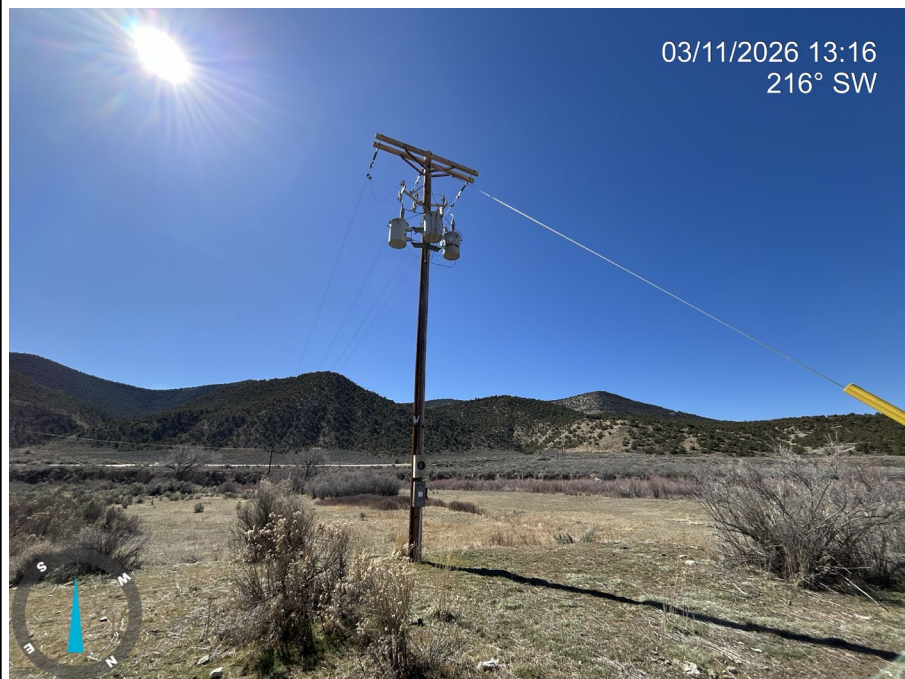
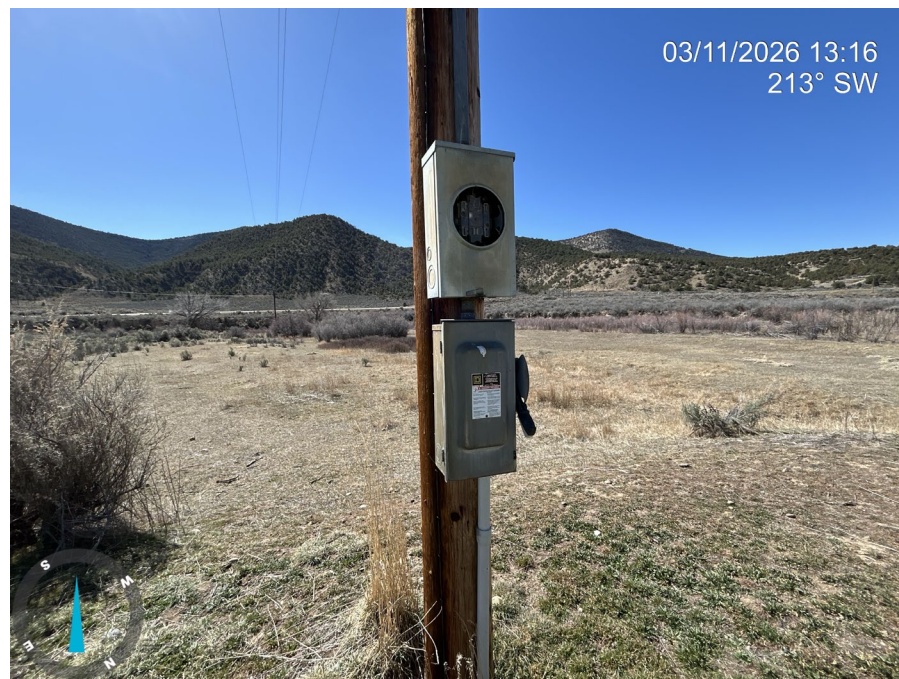
Photo 3: Electrical equipment that does not appear to be in use is present on the southwestern corner of the location. Removal is required; comply with Rule 1004.a.

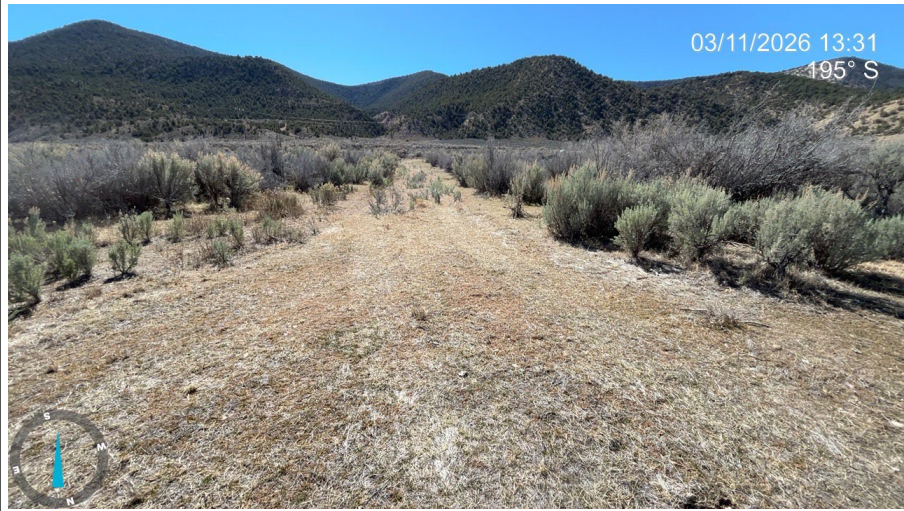
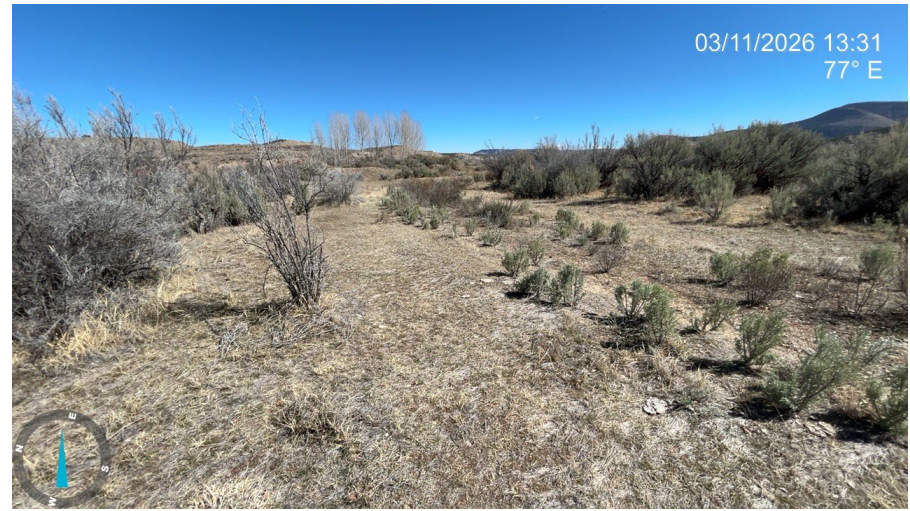
Photo 4: Photos showing access roads leading to the location have established native vegetation. Dispersed gravel is present in some places.

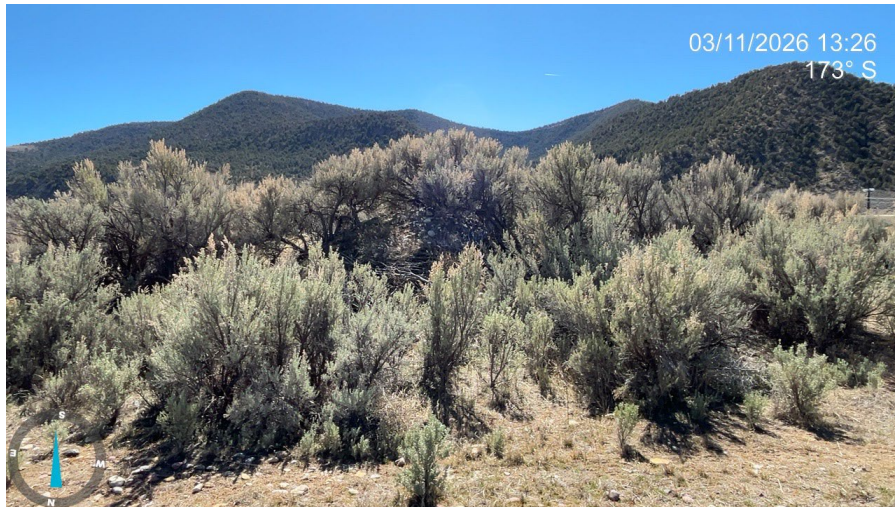
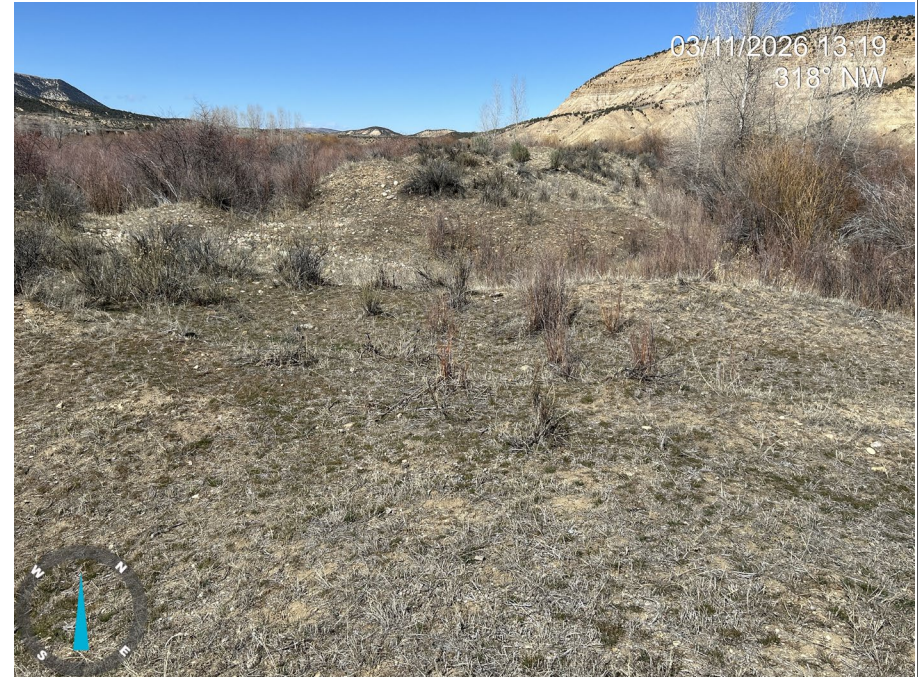
Photo 5: Photos showing that portions of the location appear to be poorly recontoured; however, mature vegetation has established and additional recontouring efforts are not required at this time.

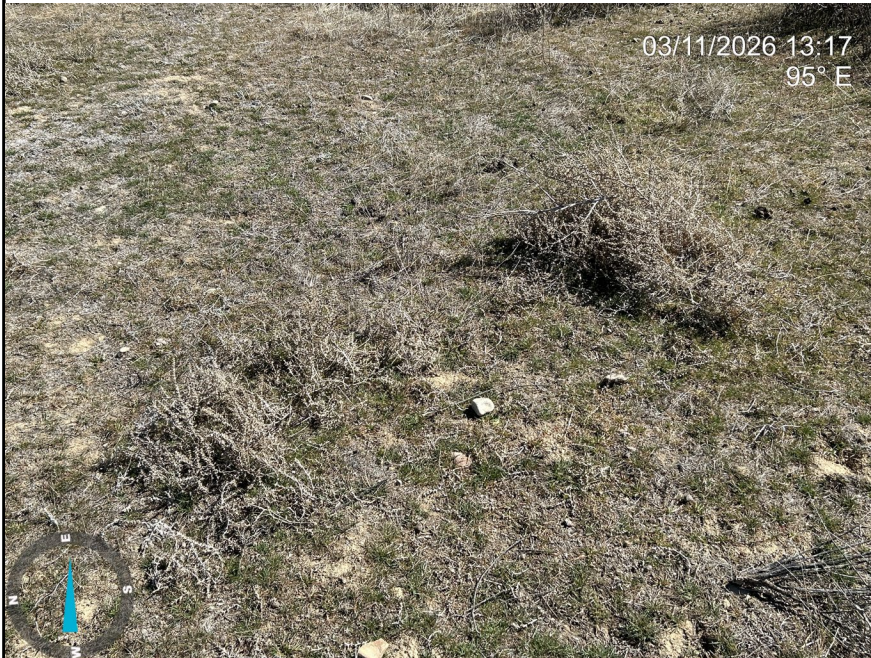
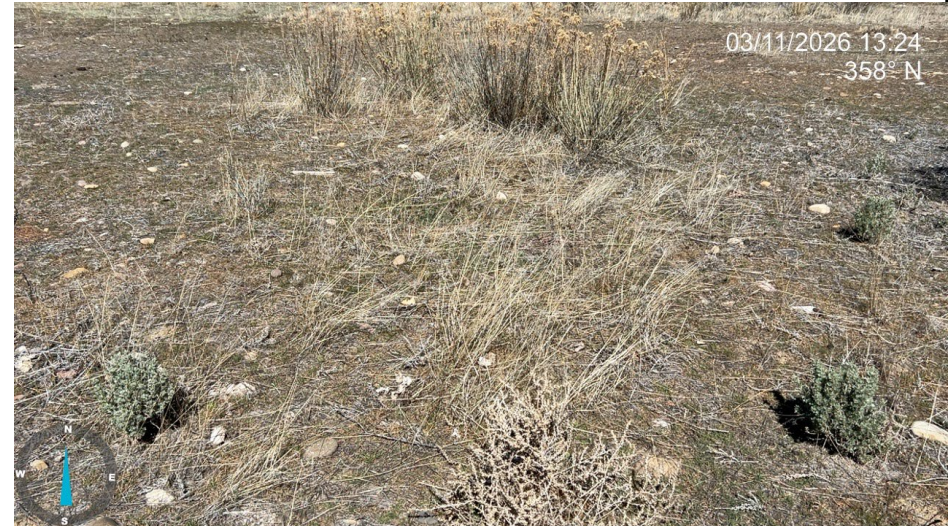
Photo 6: Photos showing examples of prickly Russian thistle and cheatgrass, an undesirable weedy annual and a noxious weed species, scattered throughout the location in secondary to tertiary amounts. Weed control is advised; a follow-up inspection will be conducted during future growing seasons to fully assess vegetation composition and cover.

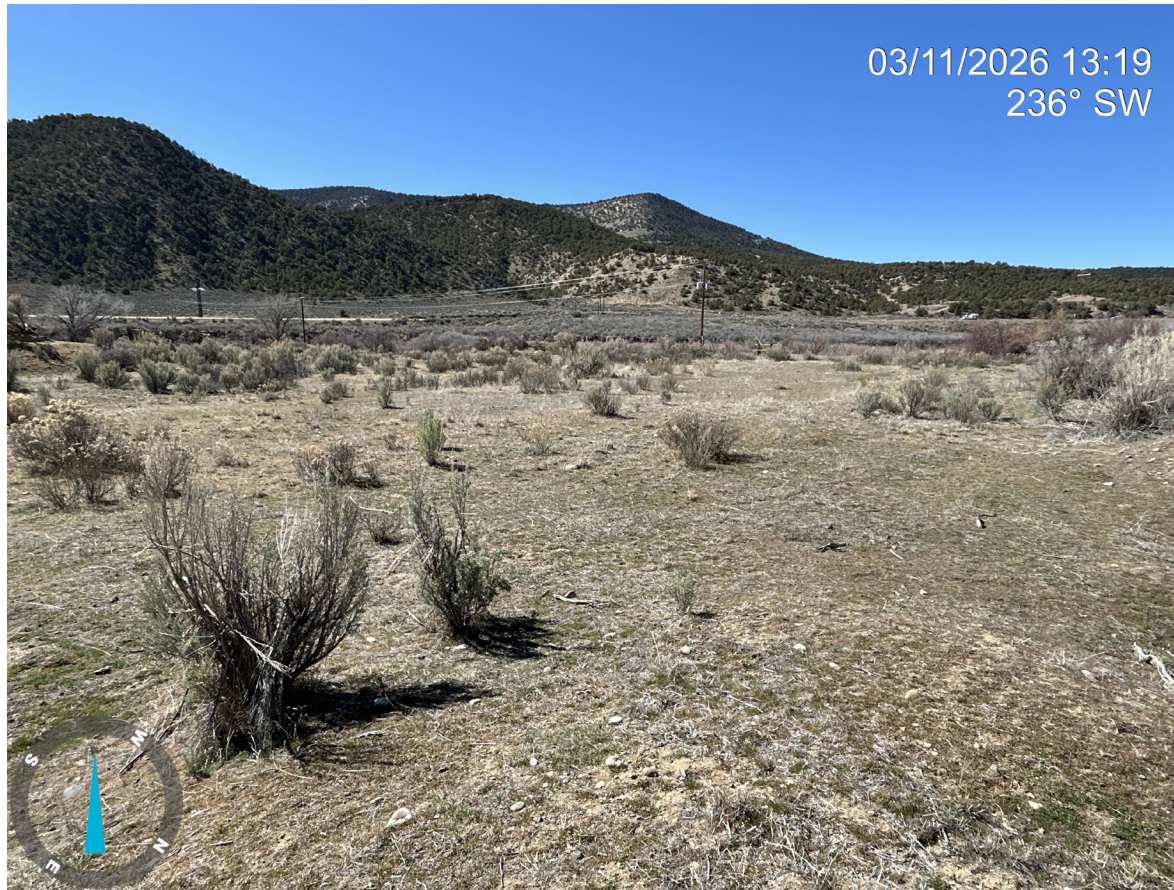
Photo 7: Photo showing a general overview of the location looking southwest.
