INSPECTION PHOTOS

Well: HILL RANCH 22-12V

API #: 05-071-07211

INSPECTION DOC #: 716302052

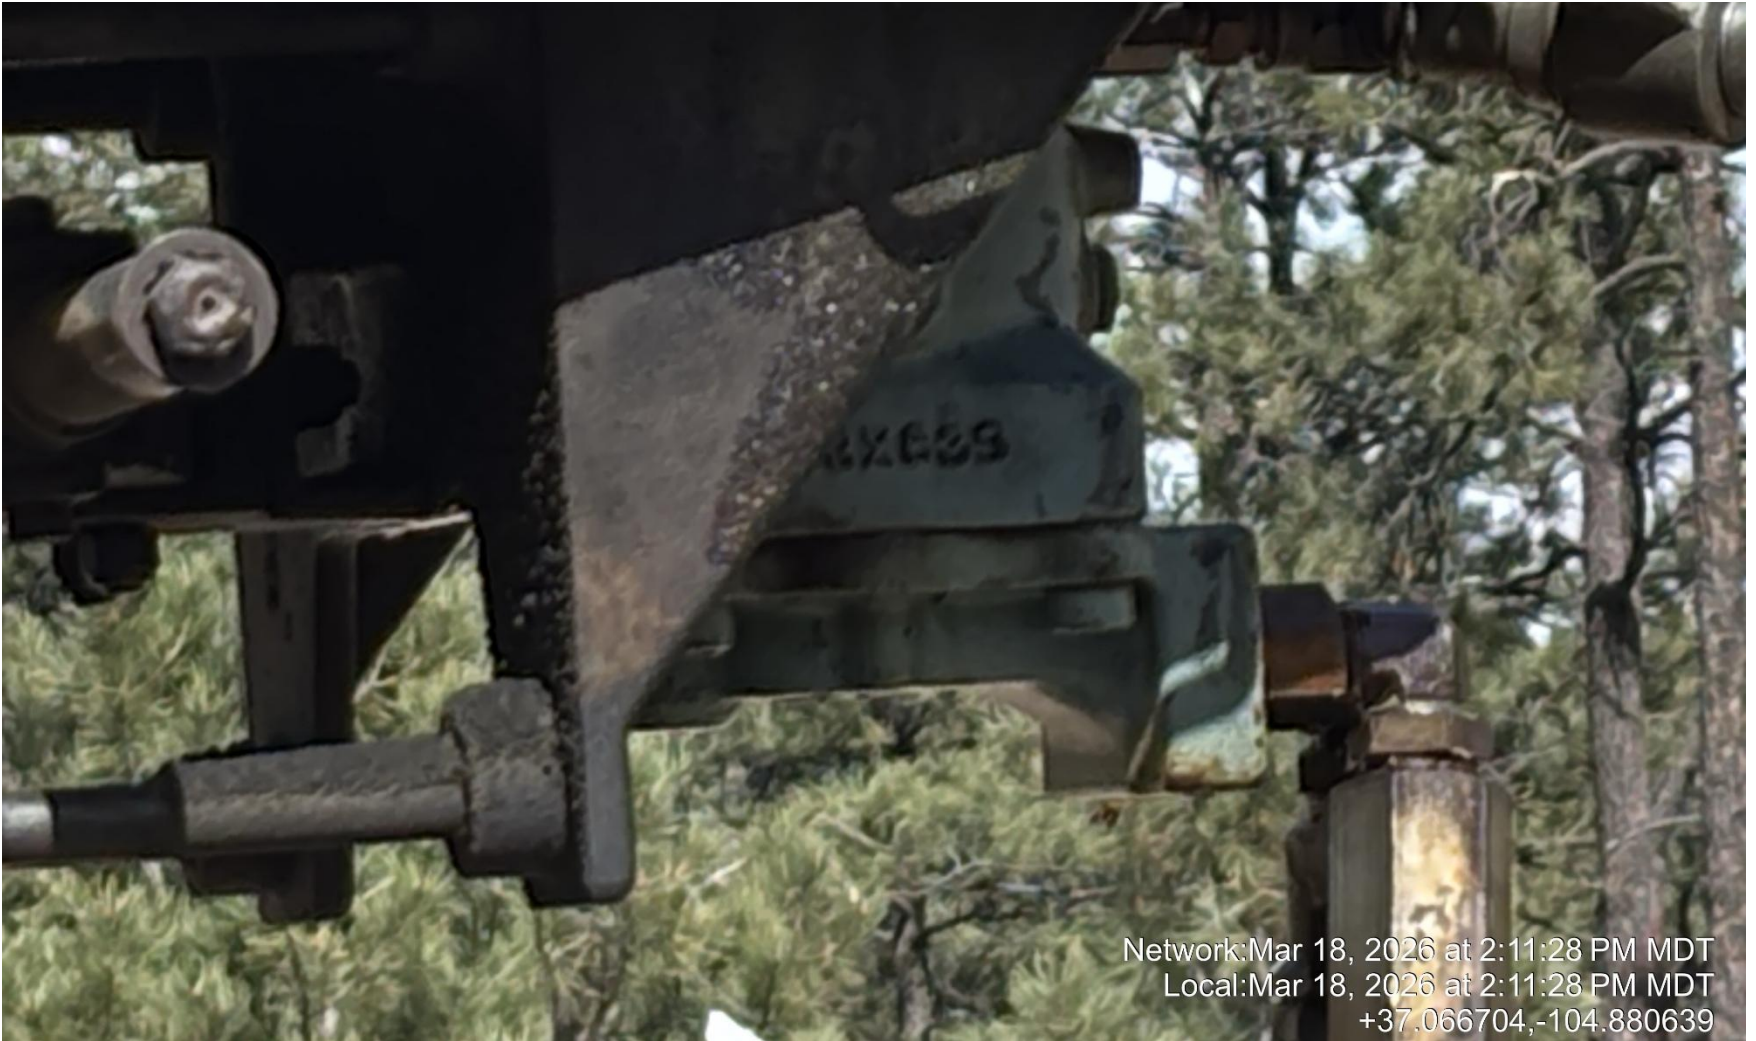
PHOTO 5: AREA OF IMPACTED SOIL NEAR WELLHEAD APPEARS TO BE FROM LEAKING DRIVEHEAD. Conduct maintenance on equipment, cleanup stained material and review self inspection processes. COMPLY WITH RULE 1002,(2).D. THIS IS THE SECOND NOTICE FOR THIS CA, IMMEDIATE ACTION IS REQUIRED.

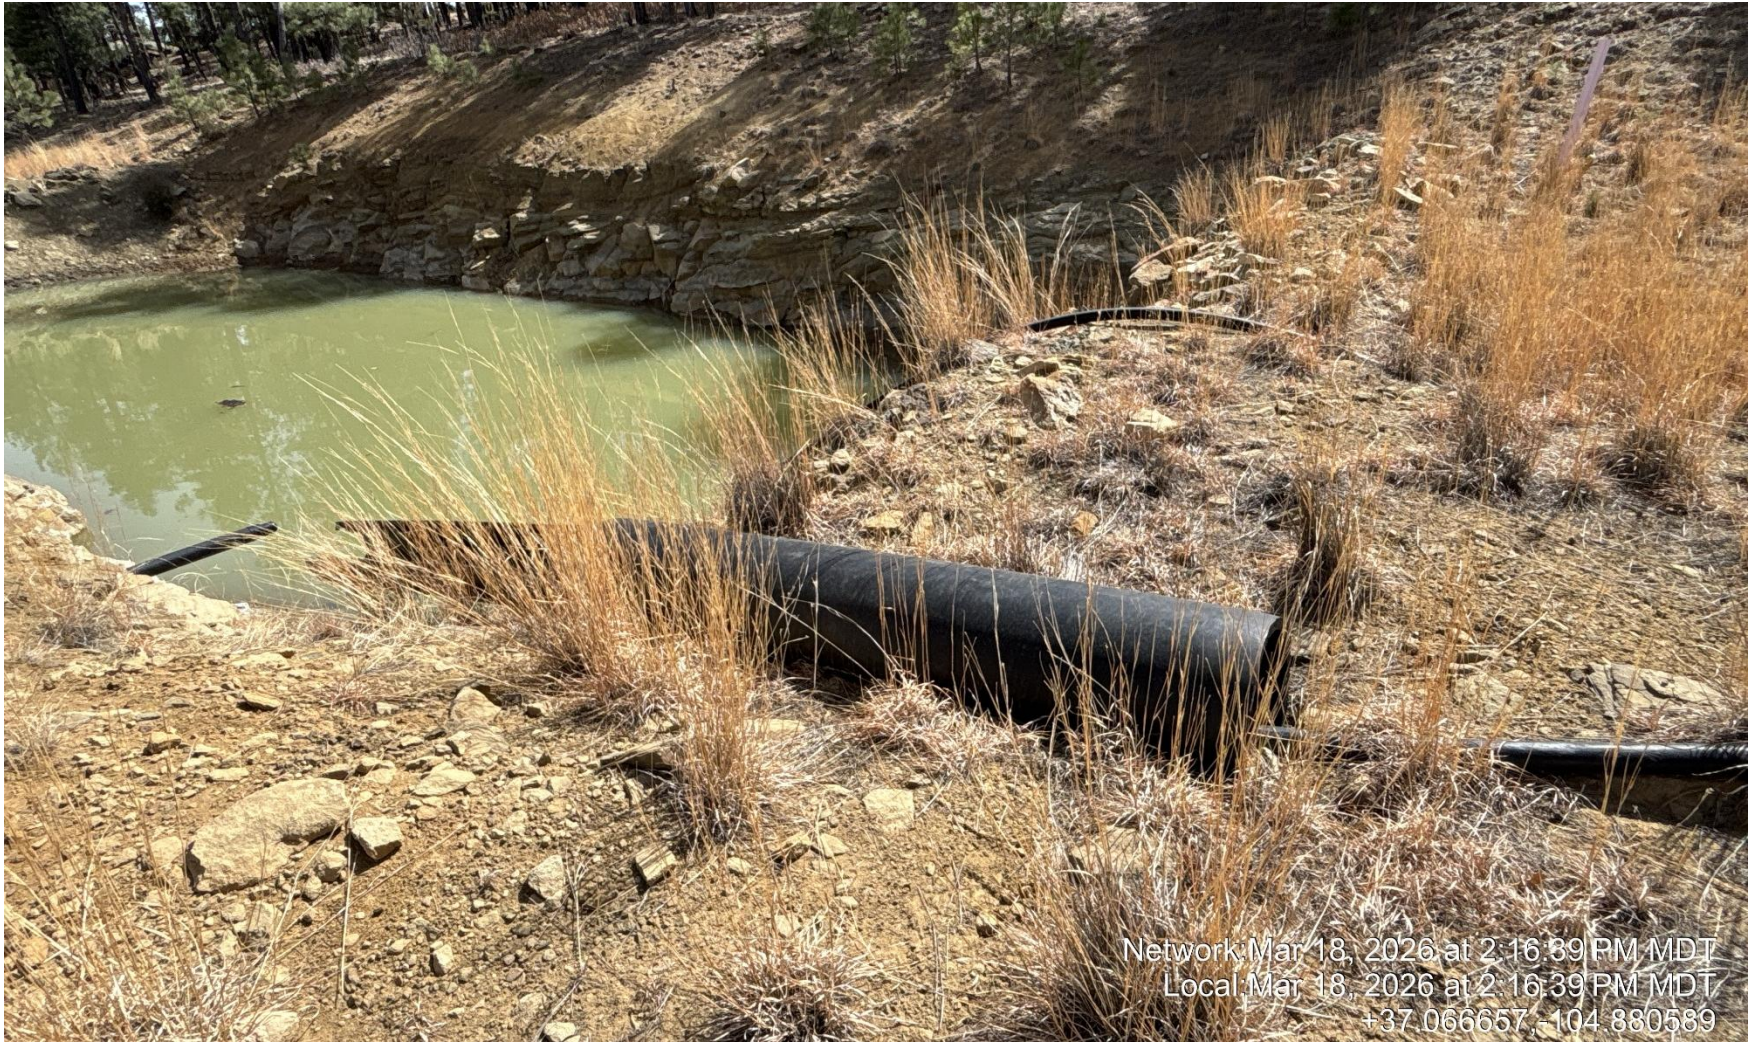
PHOTO 6: LEAKING DRIVEHEAD. COMPLY WITH RULE 1002,.(2).D. THIS IS THE SECOND NOTICE FOR THIS CA, IMMEDIATE ACTION IS REQUIRED.

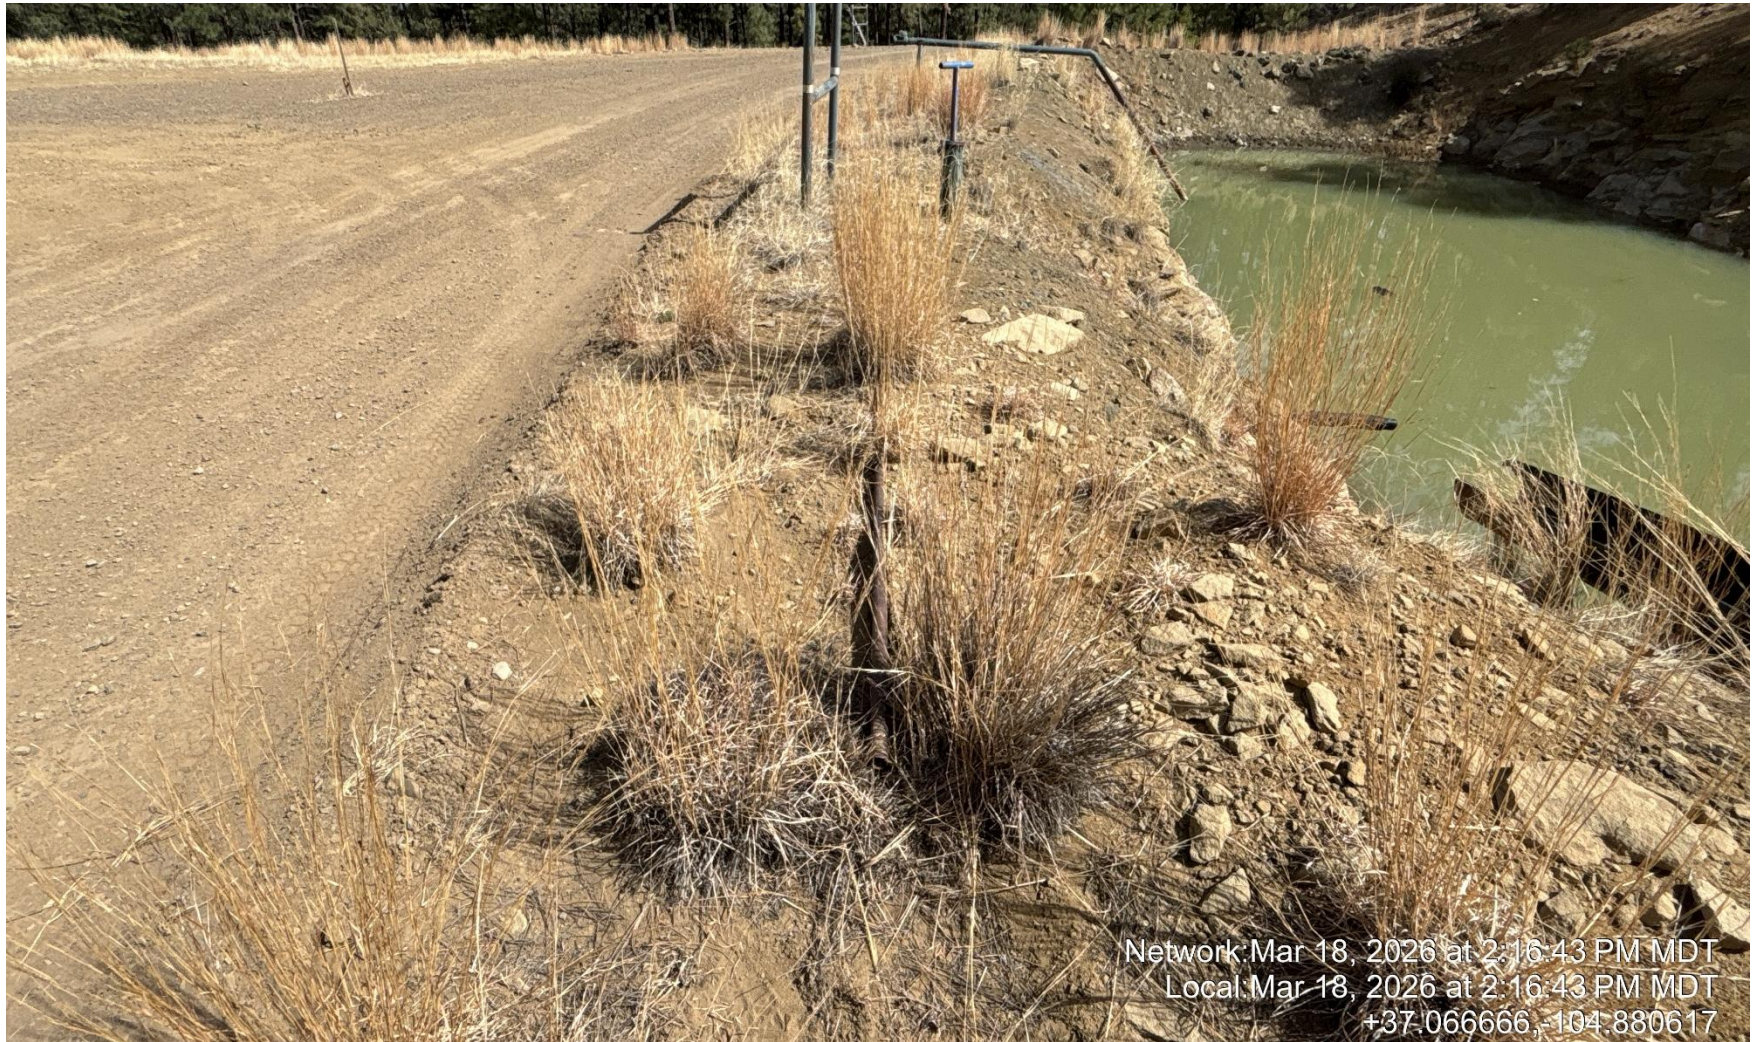
PHOTO 7: UNUSED EQUIPMENT (LARGE POLLY PIPE AND 2" POLLY PIPE AND EDGE OF PIT). REMOVE UNUSED EQUIPMENT PER RULE 606. CA DATE 3/24/2026.

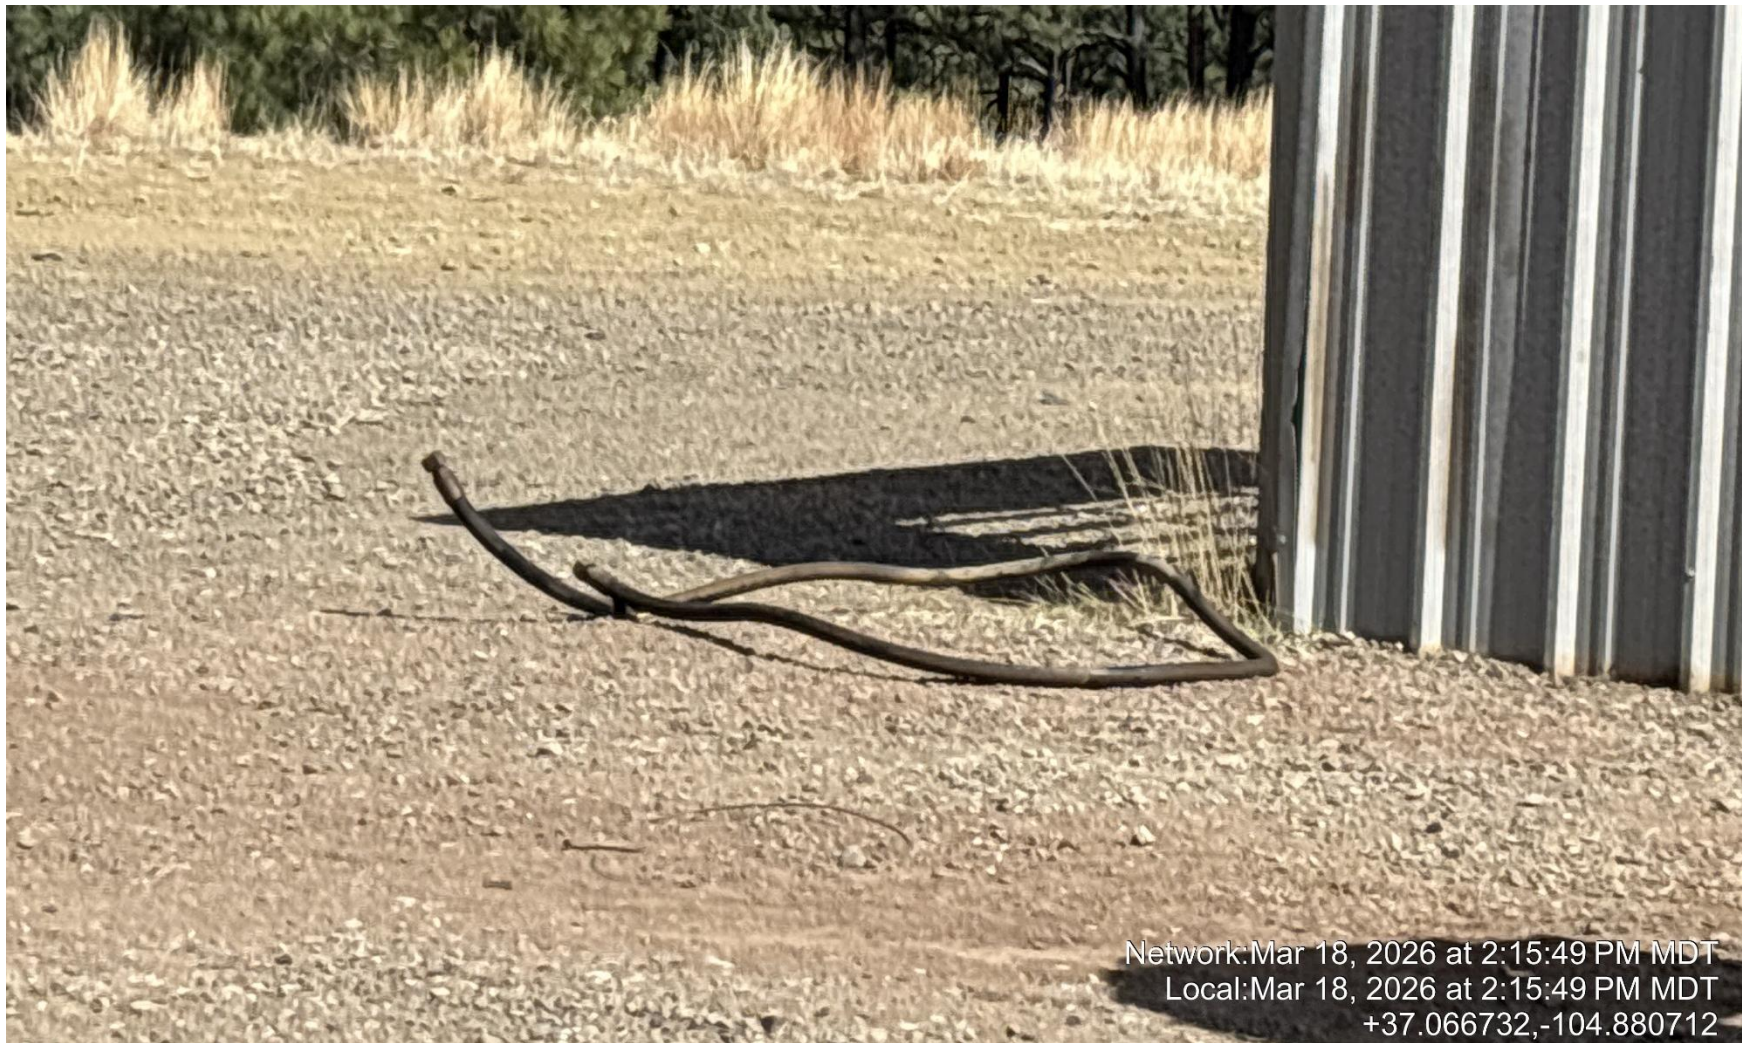
PHOTO 8: UNUSED EQUIPMENT (PIPE ON EDGE OF PIT). REMOVE UNUSED EQUIPMENT PER RULE 606. CA DATE 3/24/2026.

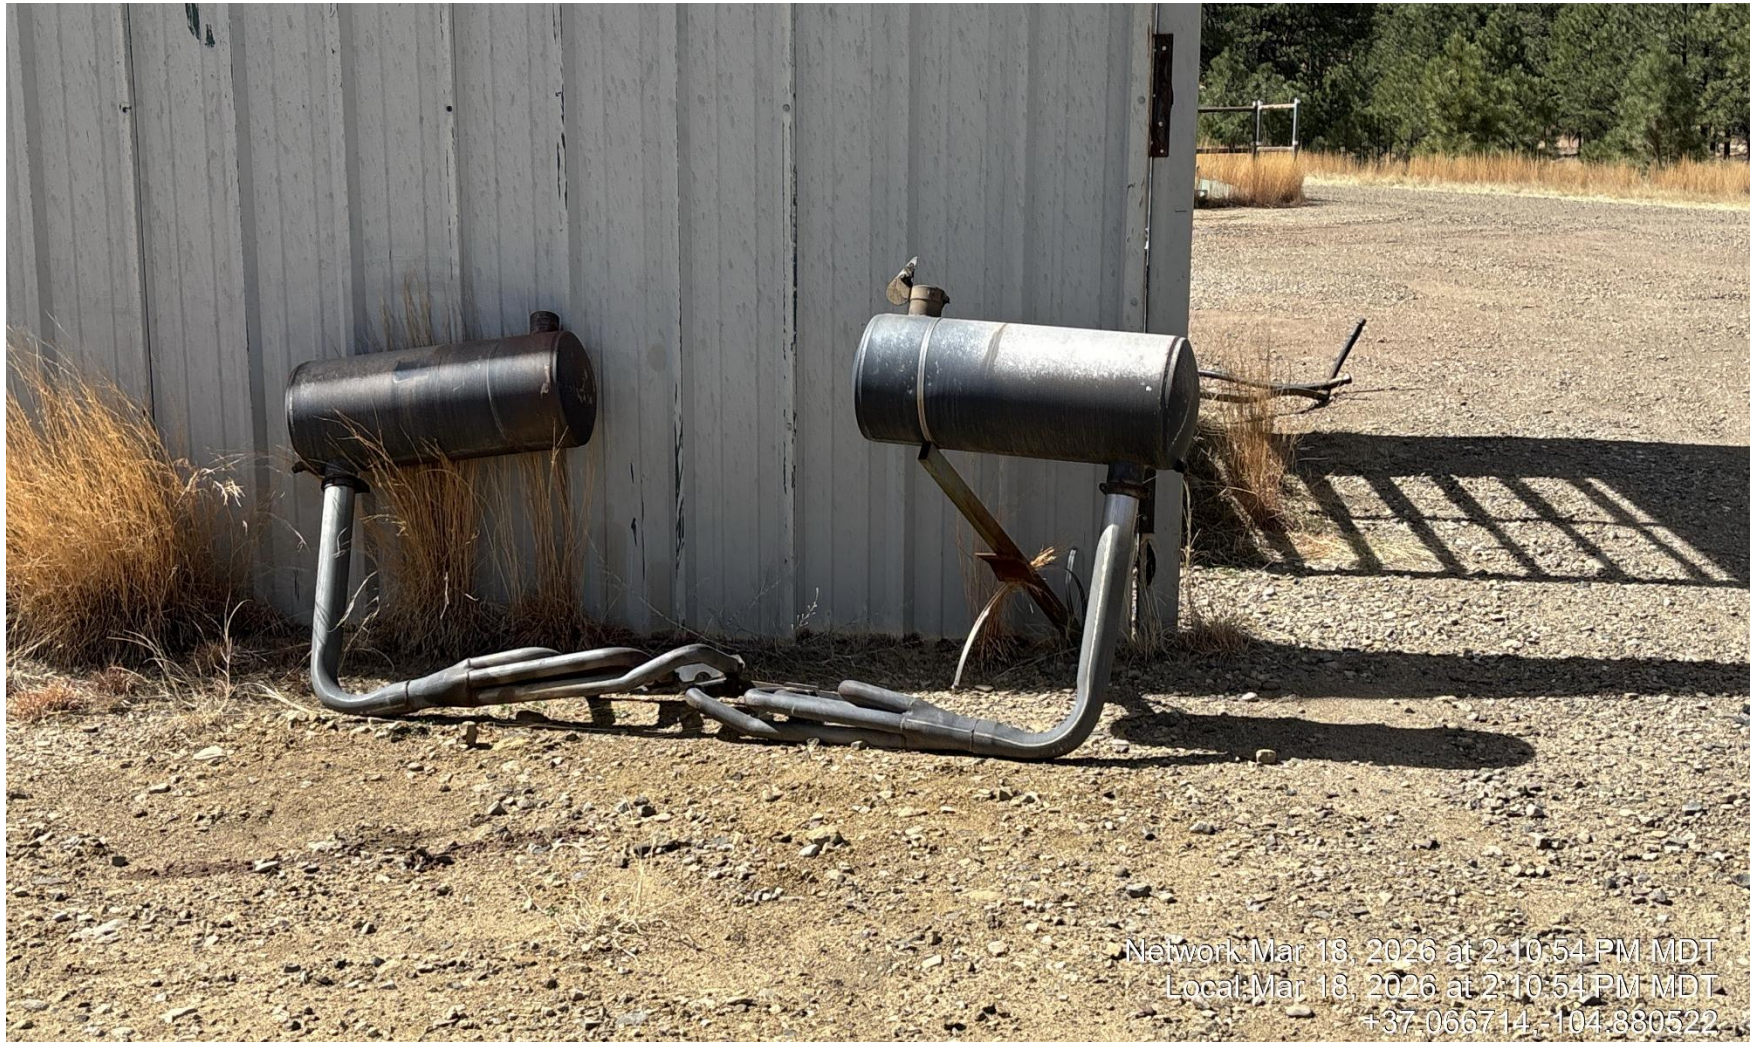
PHOTO 9: UNUSED EQUIPMENT (HYDRALIC HOSE NEAR PRIME MOVER SOUND WALLS). REMOVE UNUSED EQUIPMENT PER RULE 606. CA DATE 3/24/2026.

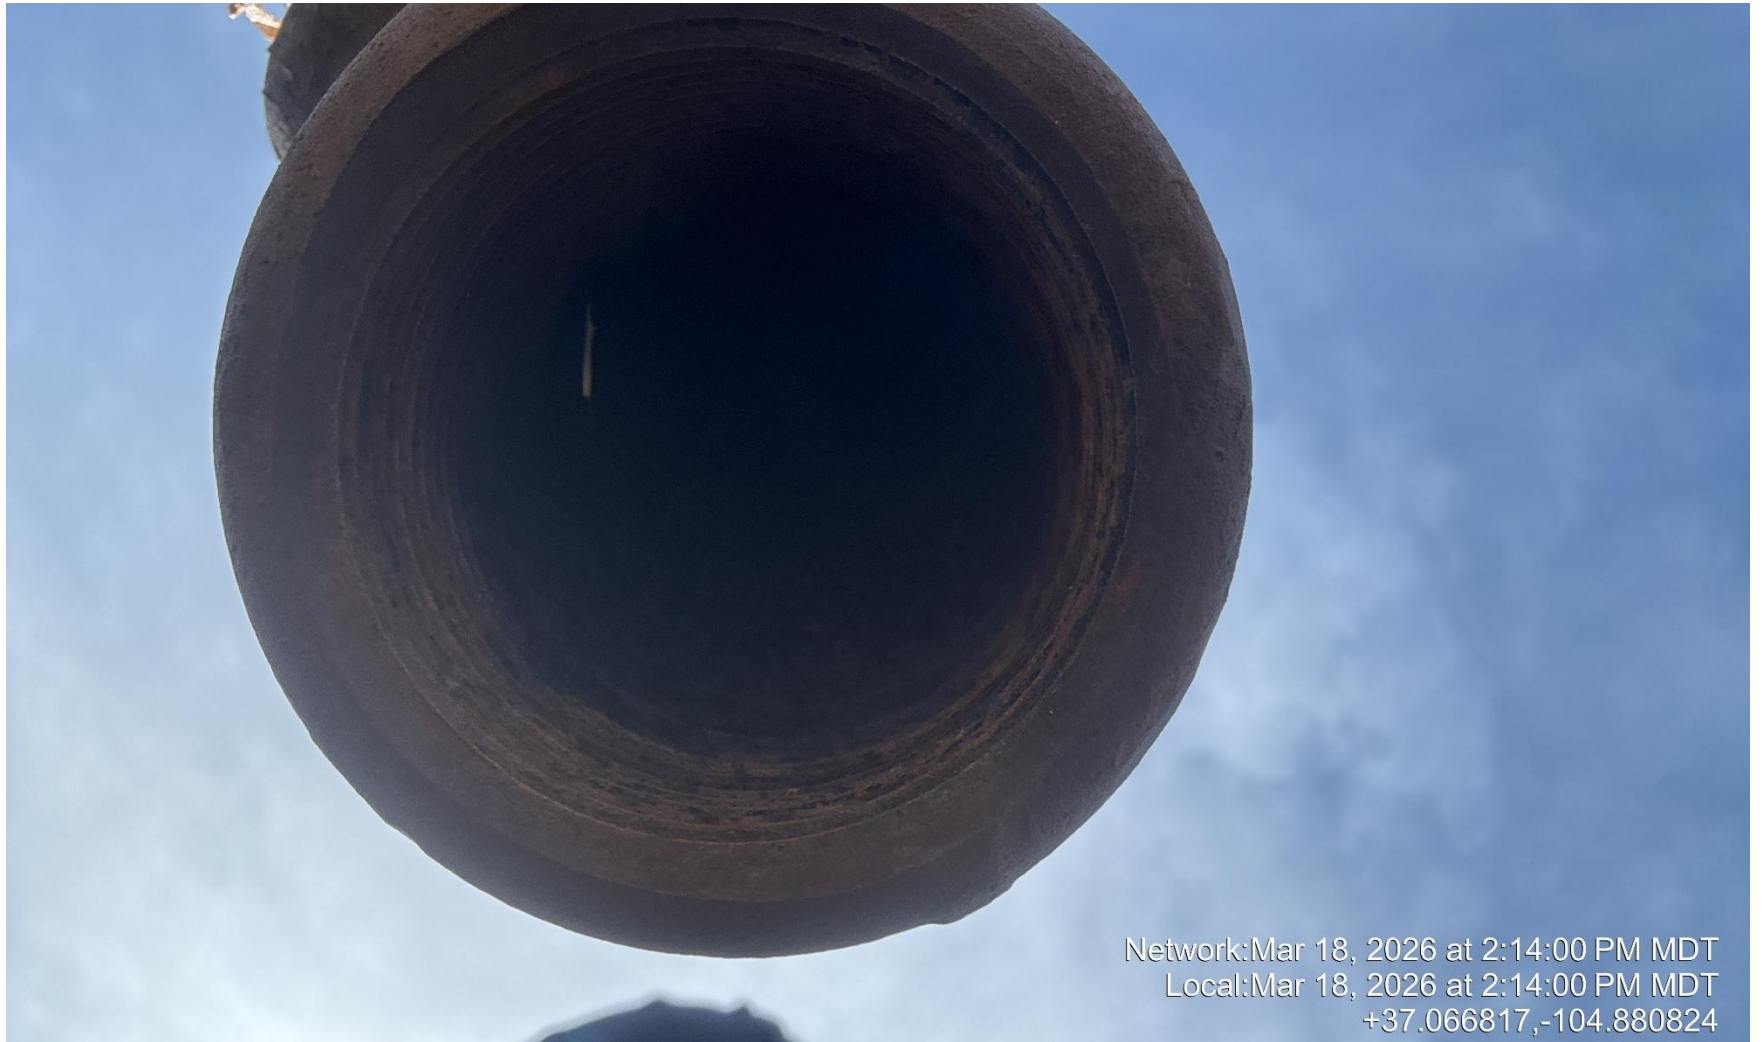
PHOTO 10: UNUSED EQUIPMENT (2 PRIME MOVER HEADERS). REMOVE UNUSED EQUIPMENT PER RULE 606. CA DATE 3/24/2026.
